Land at Kerrier Way, Camborne

Report date: 11.10.2023
Report author: Giles Maund
Reviewed by: Carey Turner
Client: MeiLoc
Your ref: Kerrier Way
Our ref: GEO1740158135

Mining Risk Assessment Plan
Land at Kerrier Way, Camborne

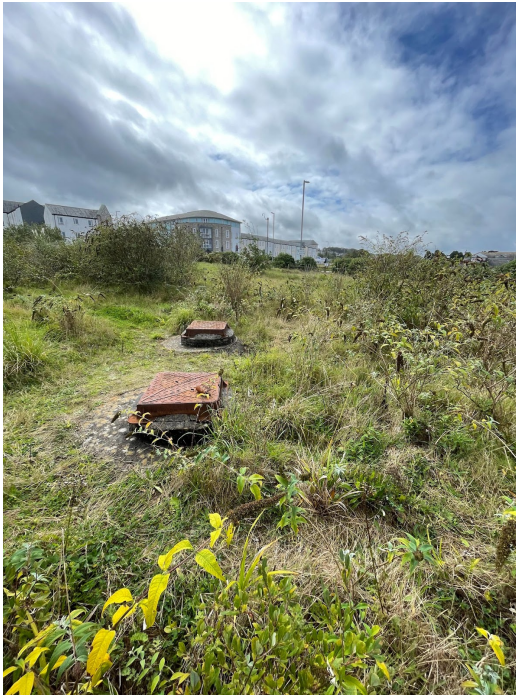
A view of the site and the manholes indicating the presence of SWW services in the vicinity if the possible tunnel:

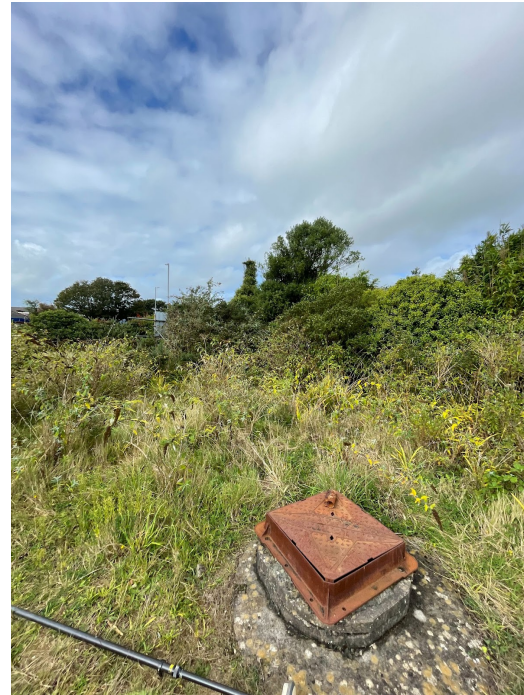
View of the site at the time of the site visit:

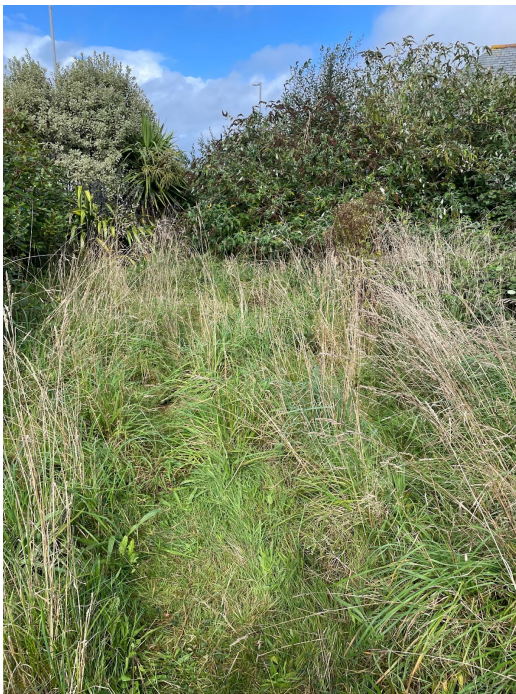
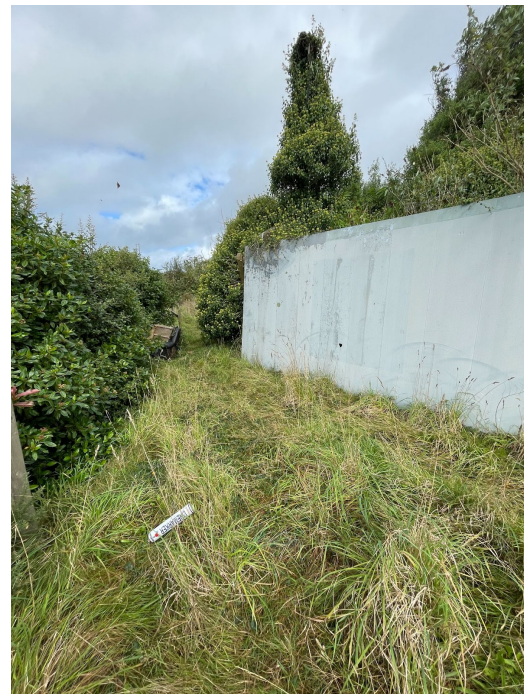
View of the site at the time of the site visit:
