Refurbishment & Demolition Survey Report

Site Address: The Almonry
High Street
Battle
TN33 0EA

Client Name: Battle Town Council

Survey Date: 21st November 2019

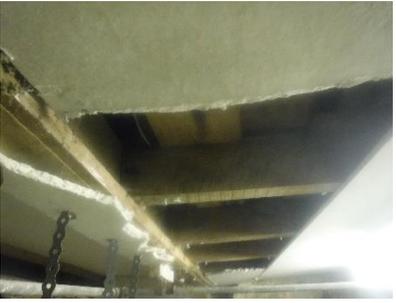
Floor	Room No.	Room Description	Material Risk Score ('MRS')			Accessibility Risk Score ('ARS')			Extent (m, m ² , m ³ or no.)	Recommendations				
	Basement	B01	Basement	Product Type 1-3	Surface Treatment 0-3	Extent of Damage 0-3	Asbestos Type	'MRS' RATING	Room Type / Activity 0-3	Location of Item in Room 0-3	Access Equipment on Site 0-3	'ARS' RATING	REMOVE (if applicable)	<input type="checkbox"/>	
	Sample No.	Item Description										Total Risk Rating	ENCAPSULATE / REPAIR	<input type="checkbox"/>	
	13	Ceiling panels & debris					NADIS						Label & Manage	<input type="checkbox"/>

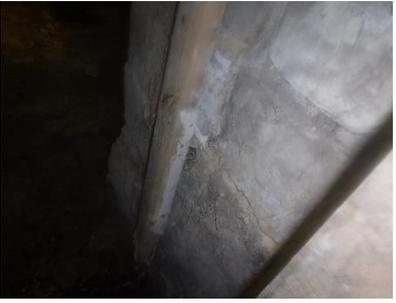
Floor	Room No.	Room Description	Material Risk Score ('MRS')			Accessibility Risk Score ('ARS')			Extent (m, m ² , m ³ or no.)	Recommendations				
	Basement	B01	Basement	Product Type 1-3	Surface Treatment 0-3	Extent of Damage 0-3	Asbestos Type	'MRS' RATING	Room Type / Activity 0-3	Location of Item in Room 0-3	Access Equipment on Site 0-3	'ARS' RATING	REMOVE (if applicable)	<input type="checkbox"/>	
	Sample No.	Item Description										Total Risk Rating	ENCAPSULATE / REPAIR	<input type="checkbox"/>	
	Ref 13	Panel debris to door frame					NADIS						Label & Manage	<input type="checkbox"/>

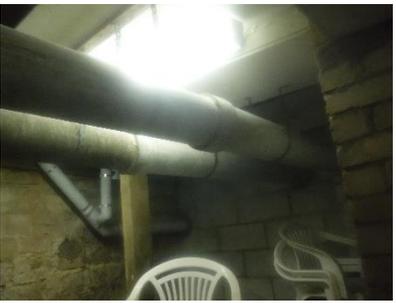
Product Type:		Cement				Licensable Asbestos Material		<input type="checkbox"/>			
				Asbestos Type:		Chrys <input checked="" type="checkbox"/> Amos <input type="checkbox"/> Croc <input type="checkbox"/> Anth <input type="checkbox"/> Act <input type="checkbox"/> Trem <input type="checkbox"/>				Non-Licensable Asbestos Material		<input checked="" type="checkbox"/>

Floor	Room No.	Room Description	Material Risk Score ('MRS')			Accessibility Risk Score ('ARS')			Extent (m, m ² , m ³ or no.)	Recommendations				
	Basement	B01	Basement	Product Type 1-3	Surface Treatment 0-3	Extent of Damage 0-3	Asbestos Type	'MRS' RATING	Room Type / Activity 0-3	Location of Item in Room 0-3	Access Equipment on Site 0-3	'ARS' RATING	6m REMOVE (if applicable)	<input checked="" type="checkbox"/>	
	Sample No.	Item Description										Total Risk Rating	ENCAPSULATE / REPAIR	<input type="checkbox"/>

14	Flue pipes x 2		1	1	0	1	VERY LOW	3	3	3	HIGH	LOW	Label & Manage	<input type="checkbox"/>
	Additional Comments:

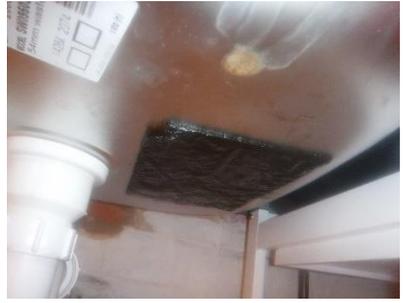
Floor	Room No.	Room Description	Material Risk Score ('MRS')			Accessibility Risk Score ('ARS')			Extent (m, m ² , m ³ or no.)	Recommendations				
	Sample No.	Item Description		Product Type 1-3	Surface Treatment 0-3	Extent of Damage 0-3	Asbestos Type	'MRS' RATING	Room Type / Activity 0-3	Location of Item in Room 0-3	Access Equipment on Site 0-3	'ARS' RATING	Total Risk Rating		
	Ground	G02	Kitchenette & Utility				NADIS						REMOVE (if applicable)	<input type="checkbox"/>	
	05	Sink pad											ENCAPSULATE / REPAIR	<input type="checkbox"/>	
Additional Comments:

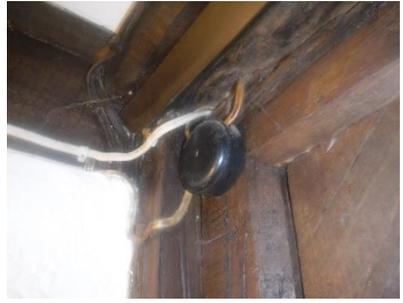
Product Type:		Reinforced Composite				Licensable Asbestos Material		<input type="checkbox"/>			
				Asbestos Type:		Chrys <input checked="" type="checkbox"/> Amos <input type="checkbox"/> Croc <input type="checkbox"/> Anth <input type="checkbox"/> Act <input type="checkbox"/> Trem <input type="checkbox"/>				Non-Licensable Asbestos Material		<input checked="" type="checkbox"/>

Floor	Room No.	Room Description	Material Risk Score ('MRS')			Accessibility Risk Score ('ARS')			Extent (m, m ² , m ³ or no.)	Recommendations				
	Sample No.	Item Description		Product Type 1-3	Surface Treatment 0-3	Extent of Damage 0-3	Asbestos Type	'MRS' RATING	Room Type / Activity 0-3	Location of Item in Room 0-3	Access Equipment on Site 0-3	'ARS' RATING	Total Risk Rating		
	Ground	G03	Meeting Room									X1	REMOVE (if applicable)	<input checked="" type="checkbox"/>	
	Ref 04	Bakelite electrical unit		1	0	0	1	VERY LOW	3	3	3	HIGH	LOW	LABEL & MANAGE	<input type="checkbox"/>

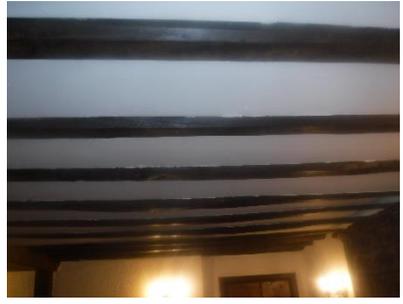
Floor	Room No.	Room Description	Material Risk Score ('MRS')			Accessibility Risk Score ('ARS')			Extent (m, m ² , m ³ or no.)	Recommendations				
	Sample No.	Item Description		Product Type 1-3	Surface Treatment 0-3	Extent of Damage 0-3	Asbestos Type	'MRS' RATING	Room Type / Activity 0-3	Location of Item in Room 0-3	Access Equipment on Site 0-3	'ARS' RATING	Total Risk Rating		
	Ground	G03	Meeting Room										REMOVE (if applicable)	<input type="checkbox"/>	
	06 & Ref 06	Ceiling panels					NADIS						ENCAPSULATE / REPAIR	<input type="checkbox"/>

Ceiling panels											LABEL & MANAGE	<input type="checkbox"/>	
Additional Comments:

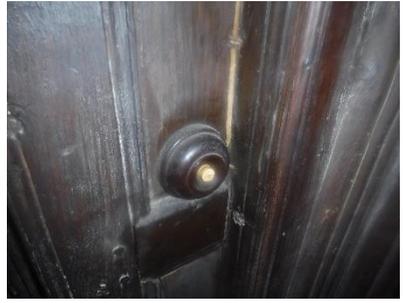
Product Type:		Reinforced Composite				Licensable Asbestos Material		<input type="checkbox"/>					
		Asbestos Type:		Chrys <input checked="" type="checkbox"/> Amos <input type="checkbox"/> Croc <input type="checkbox"/> Anth <input type="checkbox"/> Act <input type="checkbox"/> Trem <input type="checkbox"/>				Non-Licensable Asbestos Material		<input checked="" type="checkbox"/>

Floor	Room No.	Room Description	Material Risk Score ('MRS')			Accessibility Risk Score ('ARS')			Extent (m, m ² , m ³ or no.)	Recommendations				
	Ground	G04	Hall	Product Type 1-3	Surface Treatment 0-3	Extent of Damage 0-3	Asbestos Type	'MRS' RATING	Room Type / Activity 0-3	Location of Item in Room 0-3	Access Equipment on Site 0-3	'ARS' RATING	X1	REMOVE (if applicable)	<input checked="" type="checkbox"/>
	Sample No.	Item Description											Total Risk Rating	ENCAPSULATE / REPAIR	<input type="checkbox"/>

Ref 04	Bakelite doorbell		1	0	0	1	VERY LOW	3	3	3	HIGH	LOW	LABEL & MANAGE	<input type="checkbox"/>
	Additional Comments:

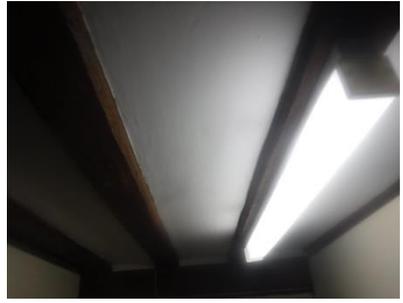
Floor	Room No.	Room Description	Material Risk Score ('MRS')			Accessibility Risk Score ('ARS')			Extent (m, m ² , m ³ or no.)	Recommendations				
	Ground	G04	Hall	Product Type 1-3	Surface Treatment 0-3	Extent of Damage 0-3	Asbestos Type	'MRS' RATING	Room Type / Activity 0-3	Location of Item in Room 0-3	Access Equipment on Site 0-3	'ARS' RATING		REMOVE (if applicable)	<input type="checkbox"/>
	Sample No.	Item Description											Total Risk Rating	ENCAPSULATE / REPAIR	<input type="checkbox"/>

Ref 06	Ceiling panels					NADIS							LABEL & MANAGE	<input type="checkbox"/>
	Additional Comments:

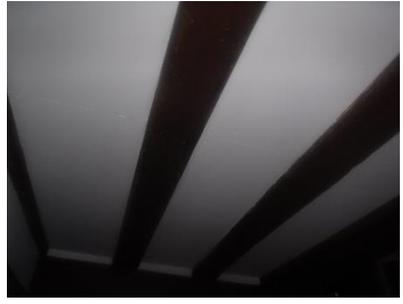
Floor	Room No.	Room Description	Material Risk Score ('MRS')			Accessibility Risk Score ('ARS')			Extent (m, m ² , m ³ or no.)	Recommendations				
	Ground	G05	Hall	Product Type 1-3	Surface Treatment 0-3	Extent of Damage 0-3	Asbestos Type	'MRS' RATING	Room Type / Activity 0-3	Location of Item in Room 0-3	Access Equipment on Site 0-3	'ARS' RATING		REMOVE (if applicable)	<input type="checkbox"/>
	Sample No.	Item Description											Total Risk Rating	ENCAPSULATE / REPAIR	<input type="checkbox"/>

Ref 06	Ceiling panels					NADIS							LABEL & MANAGE	<input type="checkbox"/>
	Additional Comments:

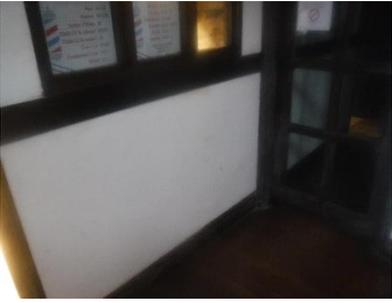
Floor	Room No.	Room Description	Material Risk Score ('MRS')			Accessibility Risk Score ('ARS')			Extent (m, m ² , m ³ or no.)	Recommendations				
	Ground	G05	Hall	Product Type 1-3	Surface Treatment 0-3	Extent of Damage 0-3	Asbestos Type	'MRS' RATING	Room Type / Activity 0-3	Location of Item in Room 0-3	Access Equipment on Site 0-3	'ARS' RATING		REMOVE (if applicable)	<input type="checkbox"/>
	Sample No.	Item Description											Total Risk Rating		
07 & Ref 07	Textured coating to walls					NADIS							LABEL & MANAGE	<input type="checkbox"/>	
Additional Comments:

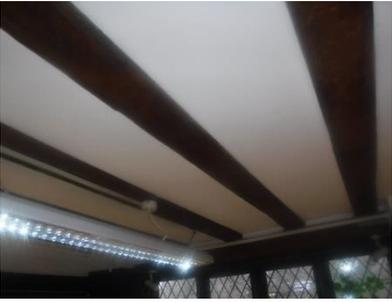
Floor	Room No.	Room Description	Material Risk Score ('MRS')			Accessibility Risk Score ('ARS')			Extent (m, m ² , m ³ or no.)	Recommendations				
	Ground	G06	Parlour	Product Type 1-3	Surface Treatment 0-3	Extent of Damage 0-3	Asbestos Type	'MRS' RATING	Room Type / Activity 0-3	Location of Item in Room 0-3	Access Equipment on Site 0-3	'ARS' RATING		REMOVE (if applicable)	<input type="checkbox"/>
	Sample No.	Item Description											Total Risk Rating		
Ref 06	Ceiling panels					NADIS							LABEL & MANAGE	<input type="checkbox"/>	
Additional Comments:

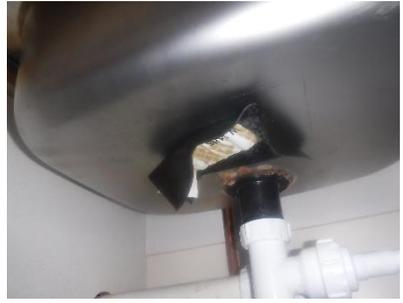
Floor	Room No.	Room Description	Material Risk Score ('MRS')			Accessibility Risk Score ('ARS')			Extent (m, m ² , m ³ or no.)	Recommendations				
	First	0103	Kitchen	Product Type 1-3	Surface Treatment 0-3	Extent of Damage 0-3	Asbestos Type	'MRS' RATING	Room Type / Activity 0-3	Location of Item in Room 0-3	Access Equipment on Site 0-3	'ARS' RATING		REMOVE (if applicable)	<input type="checkbox"/>
	Sample No.	Item Description											Total Risk Rating		
	09	Sink pad					NADIS							LABEL & MANAGE	<input type="checkbox"/>
Additional Comments:

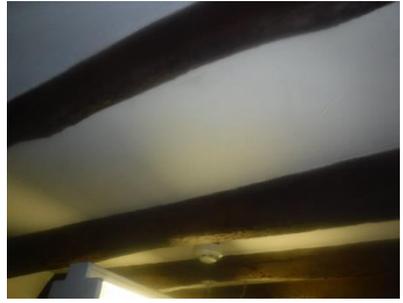
Floor	Room No.	Room Description	Material Risk Score ('MRS')			Accessibility Risk Score ('ARS')			Extent (m, m ² , m ³ or no.)	Recommendations				
	First	0105	Office	Product Type 1-3	Surface Treatment 0-3	Extent of Damage 0-3	Asbestos Type	'MRS' RATING	Room Type / Activity 0-3	Location of Item in Room 0-3	Access Equipment on Site 0-3	'ARS' RATING		REMOVE (if applicable)	<input type="checkbox"/>
	Sample No.	Item Description											Total Risk Rating		
	10	Textured coating to ceiling					NADIS							LABEL & MANAGE	<input type="checkbox"/>
Additional Comments:

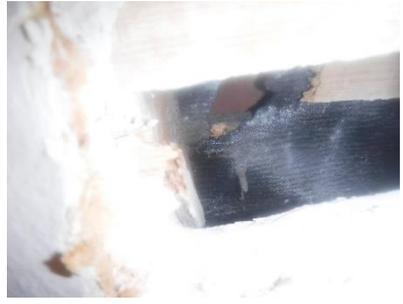
Floor	Room No.	Room Description	Material Risk Score ('MRS')			Accessibility Risk Score ('ARS')			Extent (m, m ² , m ³ or no.)	Recommendations				
	First	0105	Office	Product Type 1-3	Surface Treatment 0-3	Extent of Damage 0-3	Asbestos Type	'MRS' RATING	Room Type / Activity 0-3	Location of Item in Room 0-3	Access Equipment on Site 0-3	'ARS' RATING		REMOVE (if applicable)	<input type="checkbox"/>
	Sample No.	Item Description											Total Risk Rating		
	11	Sarking felt to external walls in works area					NADIS							LABEL & MANAGE	<input type="checkbox"/>

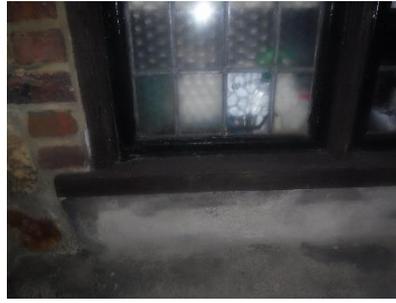
Floor	Room No.	Room Description	Material Risk Score ('MRS')			Accessibility Risk Score ('ARS')			Extent (m, m ² , m ³ or no.)	Recommendations				
	External	EX03	Side Elevation	Product Type 1-3	Surface Treatment 0-3	Extent of Damage 0-3	Asbestos Type	'MRS' RATING	Room Type / Activity 0-3	Location of Item in Room 0-3	Access Equipment on Site 0-3	'ARS' RATING		REMOVE (if applicable)	<input type="checkbox"/>
	Sample No.	Item Description													
	Ref 02	Putty to windows					NADIS							LABEL & MANAGE	<input type="checkbox"/>
Additional Comments:
