Arboricultural Impact Assessment Report.

In Relation to Proposed Demolition of the
Former Public House - The Springfield,
Milton Keynes.

Produced by Dan MacIntyre, Arboricultural Consultant for
MacIntyre Trees.

Date	July 2021
Report Ver.	2160_Fv1

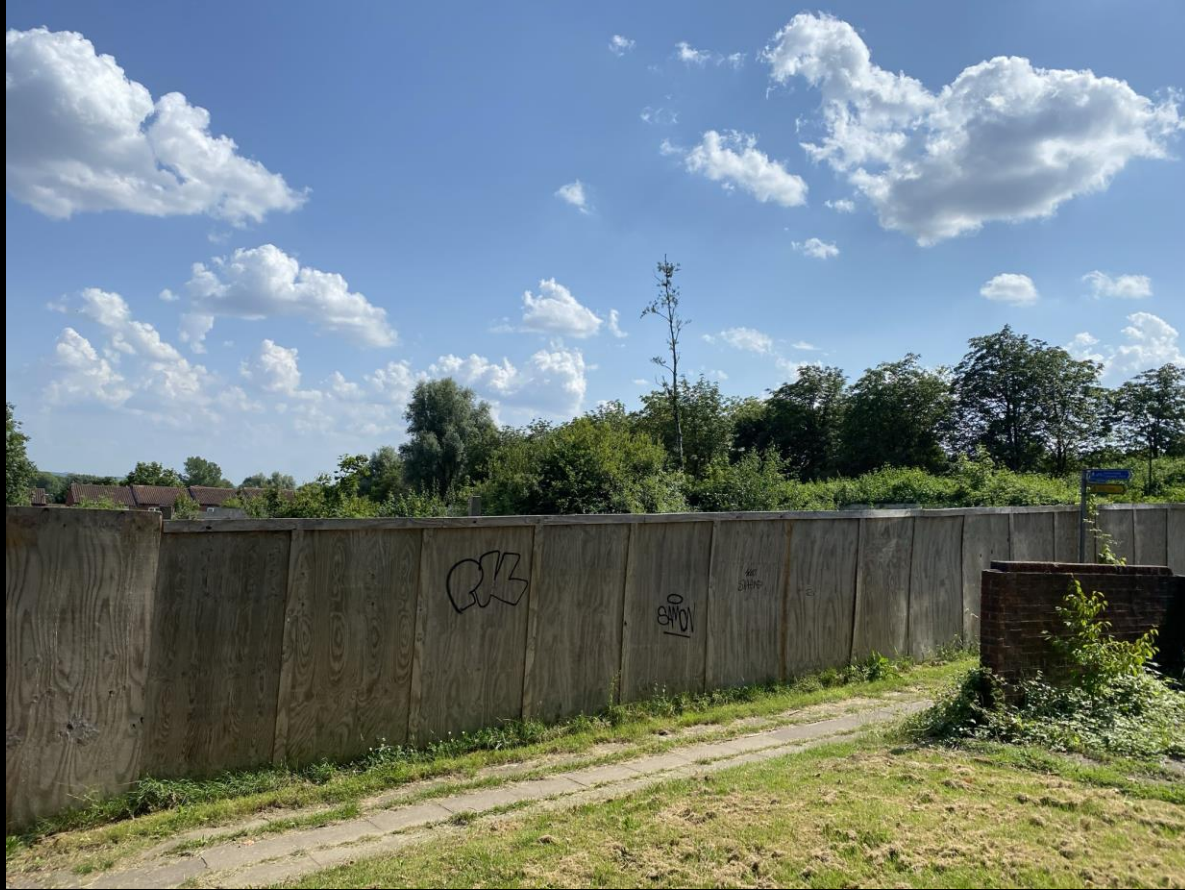
Tree T1 - Centre

- 3.2. A greater number of trees previously grew within the car park of the site, although these have been removed in recent years leaving only tree T1, a very poorly formed and poor condition Alder tree. This tree is unlikely to survive in the short-term and so has being classed as a category U specimen.

- 4.2 No trees specifically need to be removed to enable the demolition although I recommend that tree T1 (Cat U) and the vegetation within the site be removed to provide greater working space and to provide a 'blank canvas' from which to develop the future site layout.

- 4.5 It is recommended that the lower limbs of tree T1 be pruned to give at least 2m clearance from the building as the lower foliage currently rests on the roof.

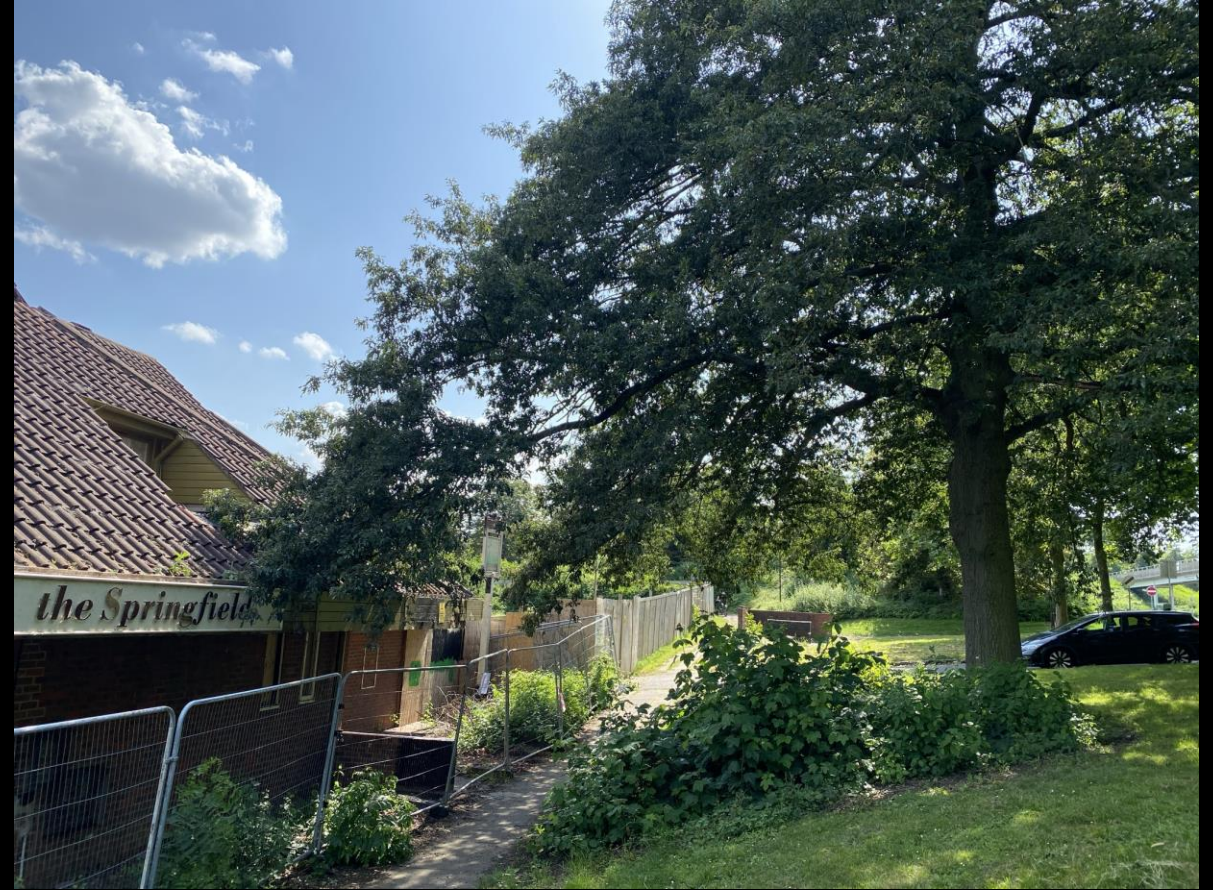
Drooping growth of Tree T2 on roof.

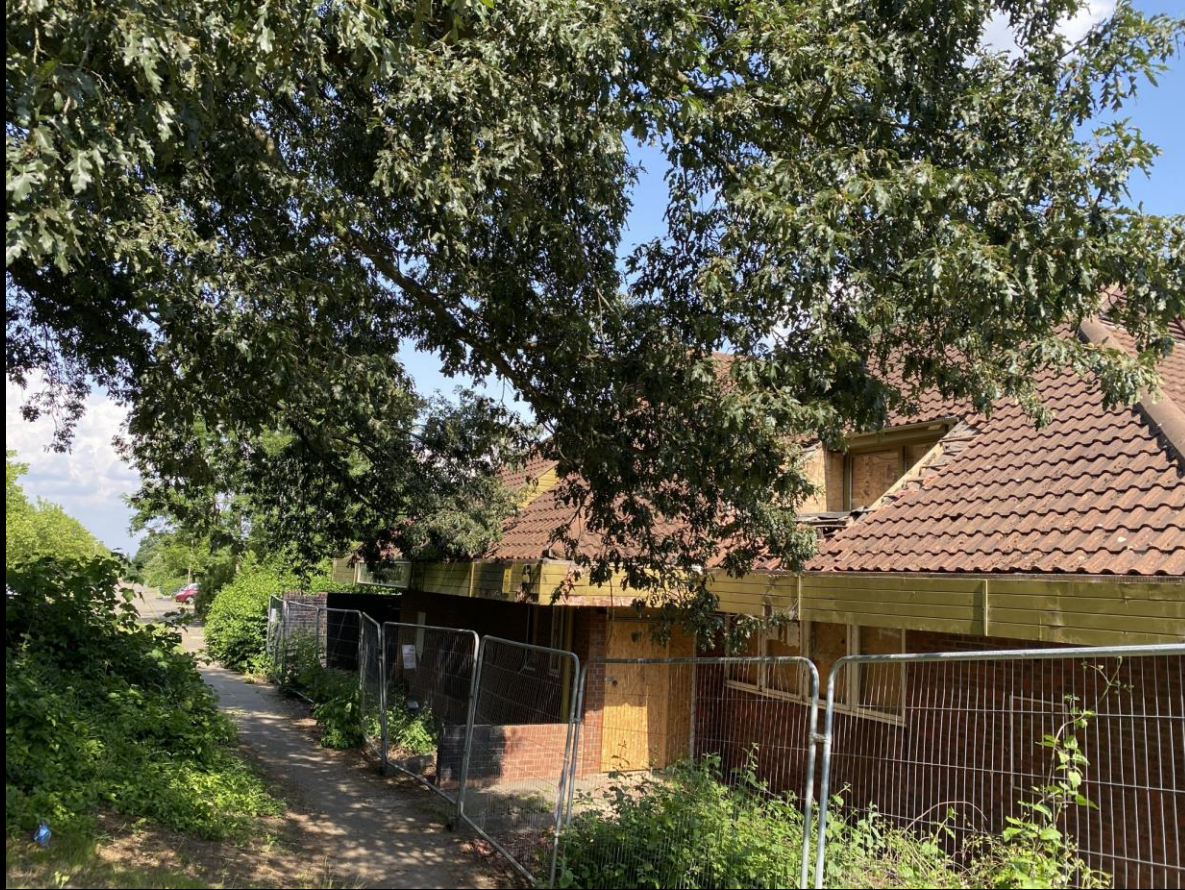
Tree T2, Foliage on roof. Pruning recommended

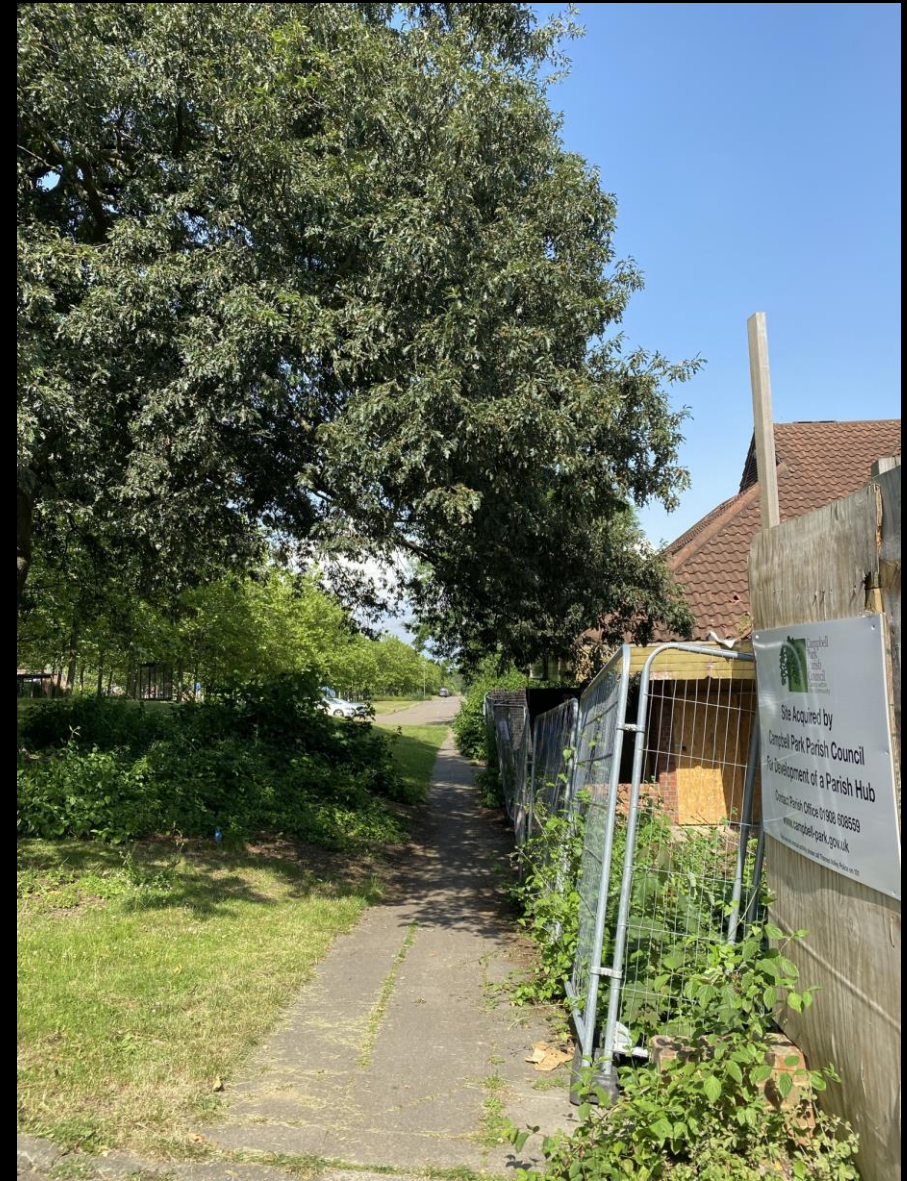
Tree T2, Foliage on roof

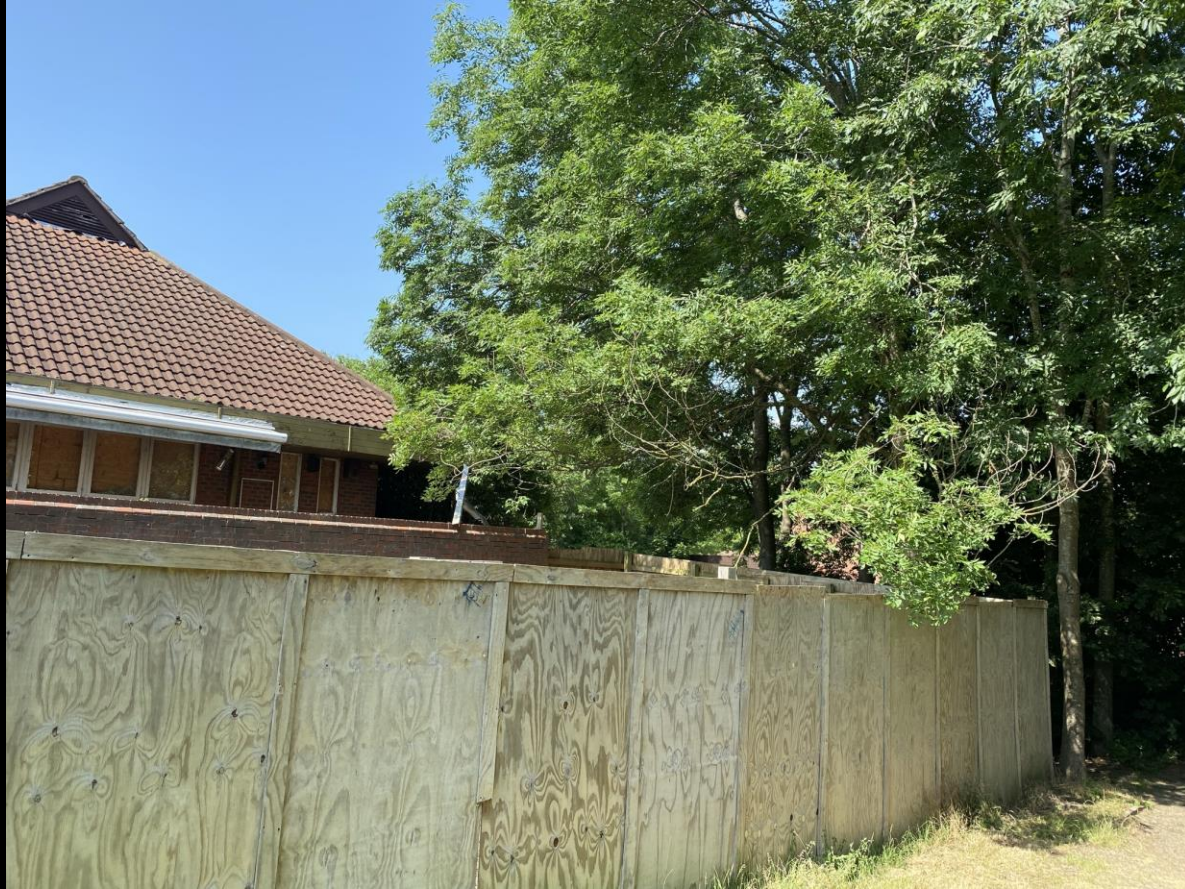
Overhang from group G4, Pruning recommended.

- 4.7 A small amount of drooping branch growth from two trees within group G4 will also need to be pruned to give at least 2m clearance from the building roof and any walls that are to be demolished. Similarly, the growth from group G5 will also need to be trimmed to give around 1-2m clearance between the roof to enable its demolition.

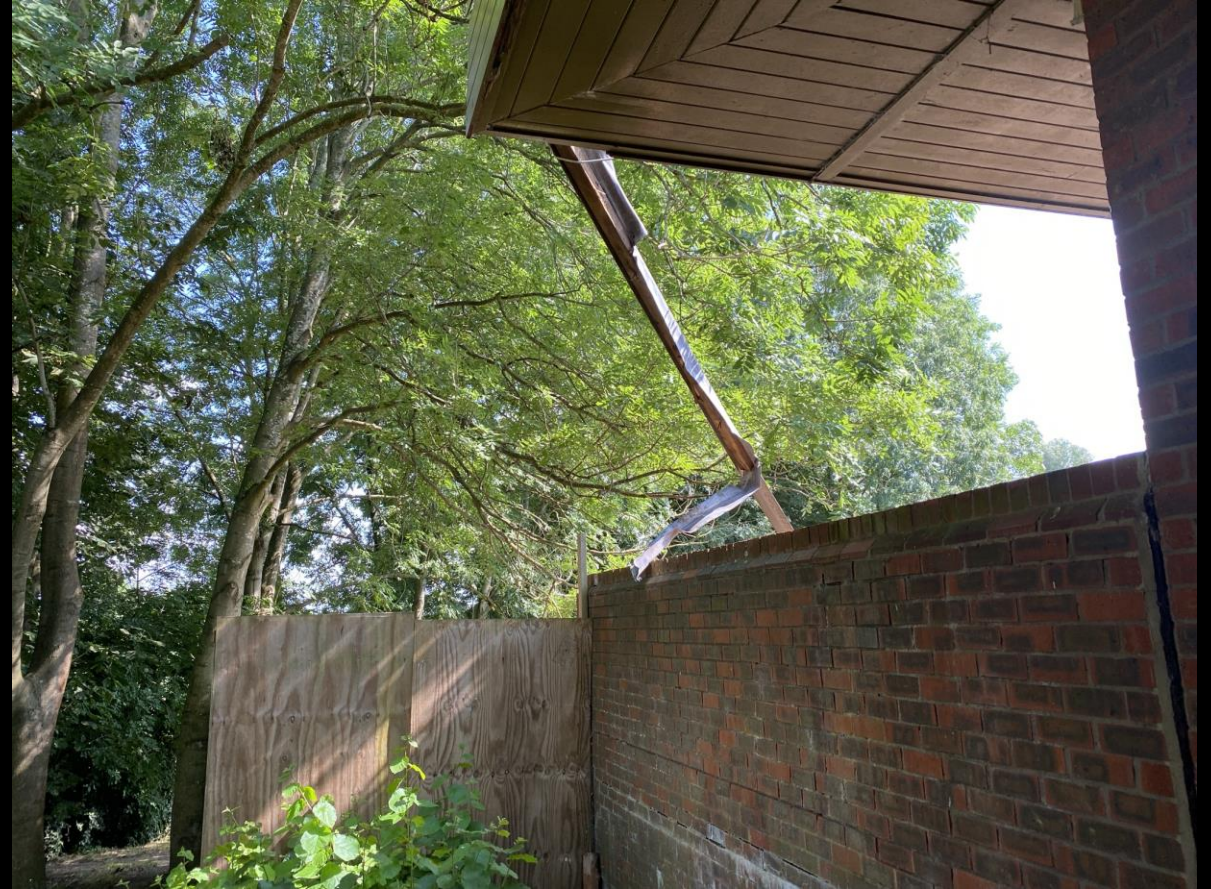
Overhang from group G4

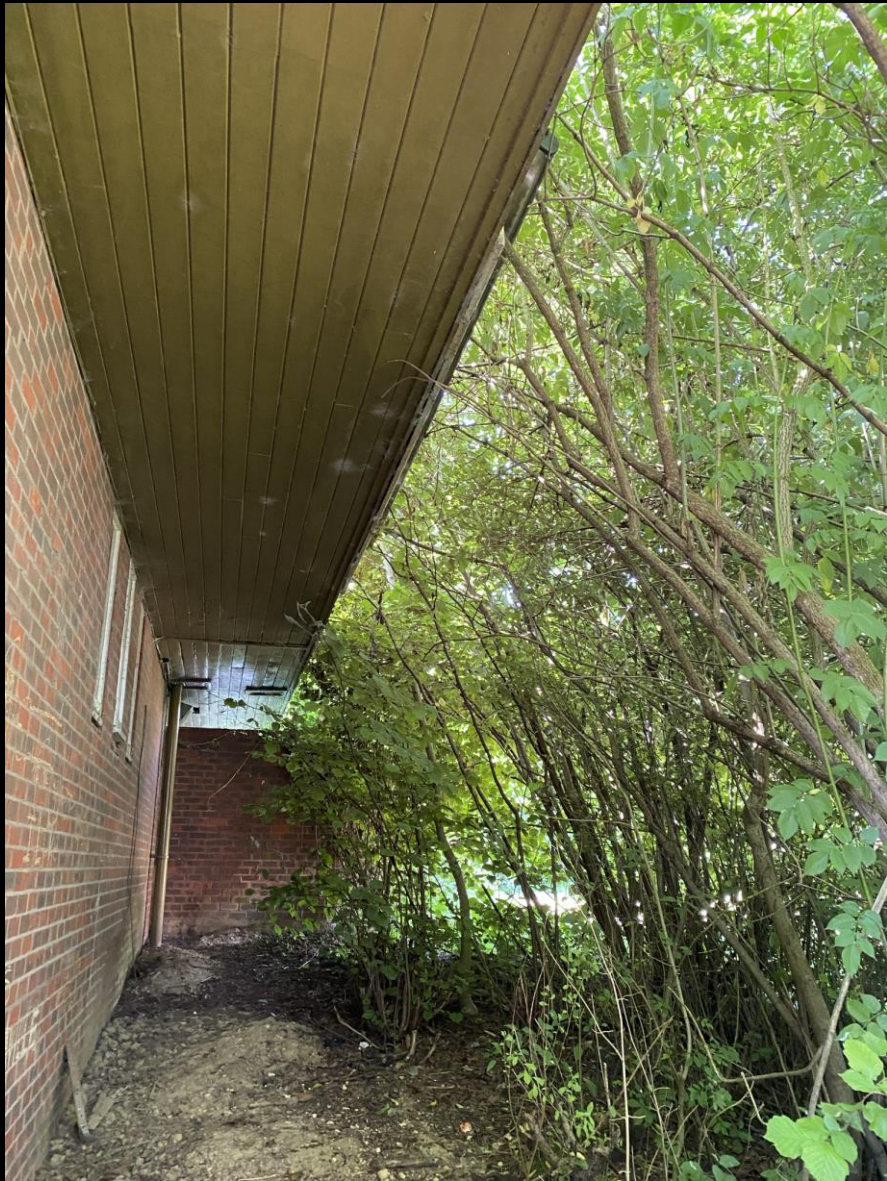
- 3.7. Group G5 comprises a small area of Hazel and shrub growth, which grows adjacent to the pub building on the eastern flank. Whilst it offers some good environmental and ecological benefits, it is not a prominent feature within the landscape, and has been classed as a category C feature.

Group G5. Trimming to clear roof recommended.
