HORNCastle CEMETERY CHAPEL

Project No. 6013

YORKSILLS DRAWINGS 6013/01 & 100
CHAPEL LAYOUT SKETCH

YORK SILLS INSPECTION REPORT LETTER

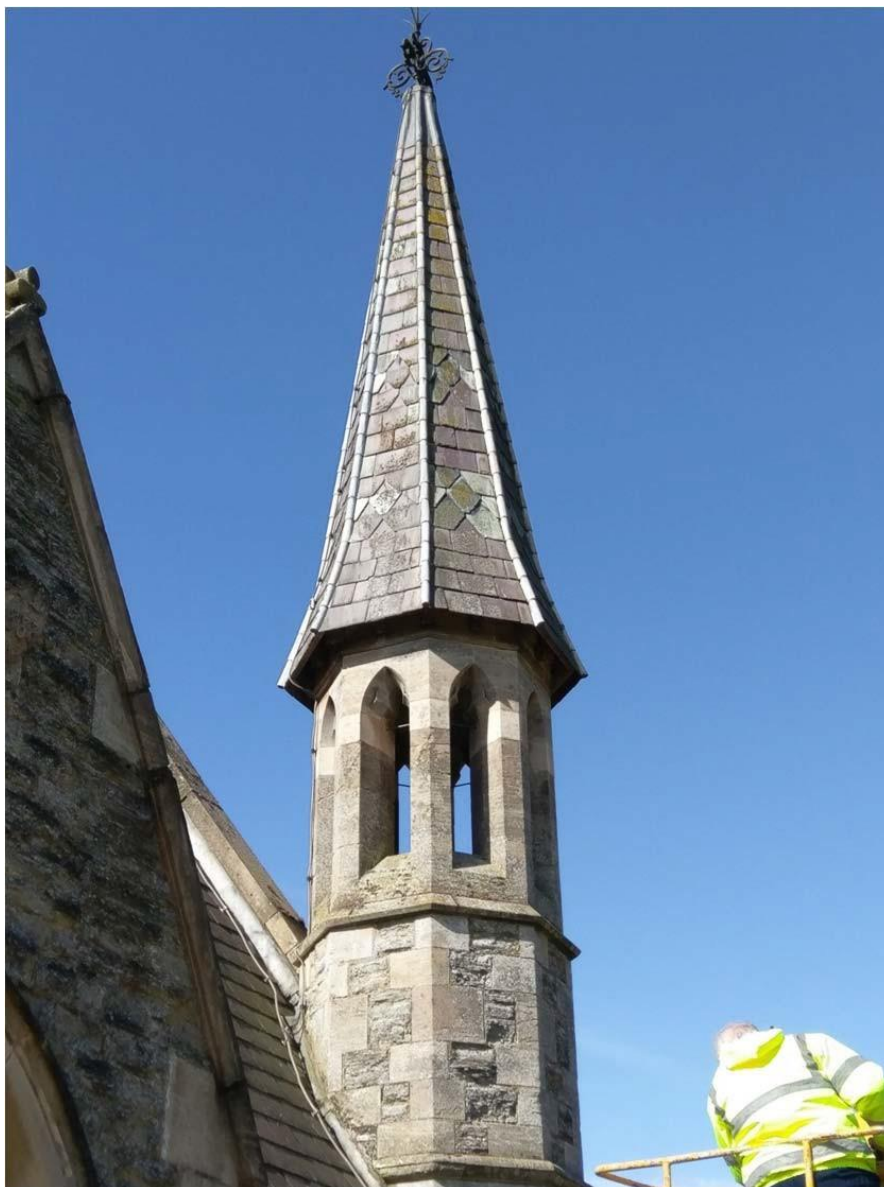
The Chapel is a late Victorian freestanding single storey structure and is Grade II listed. On the northwest corner of the Chapel stands an octagonal tower (*Photo 1*) of coursed masonry construction surmounted with a large capstone, anchored by a large central tie bar (*Photo 2*). This capstone forms the plinth upon which are seated eight dressed stone columns supporting the eaves level band of stonework (*Photo 3*) which, in turn, supports a timber wallplate and the timber spire structure above.

P1 – General view from Northeast

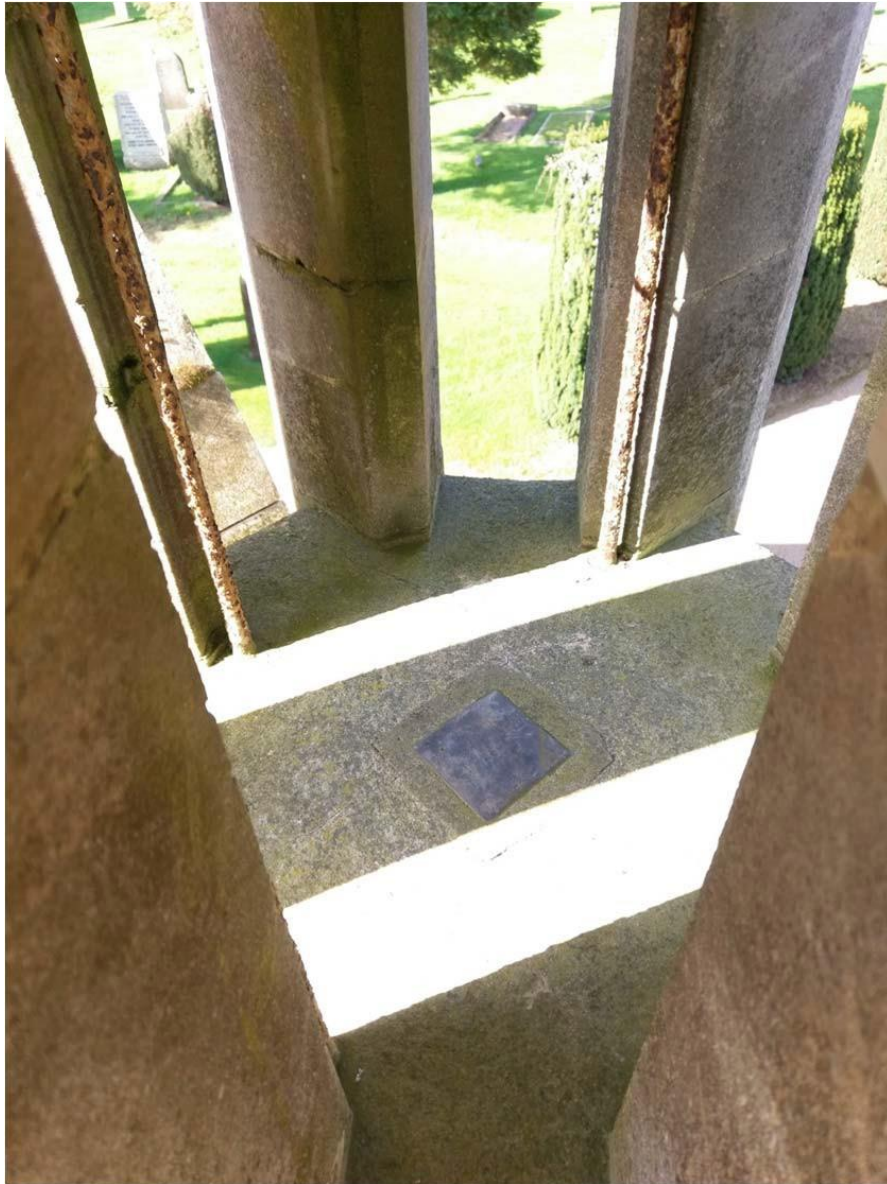
At each of the four positions where the wallplate tie beams meet the wallplates, tie bars extend from the wallplate tie beams down to the plinth/capstone. It is not known whether these tie bars are wrought iron or steel, however they are corroded but this does not appear to have affected their structural cross section significantly.

P2 – Plinth / cap stone with central tie bar

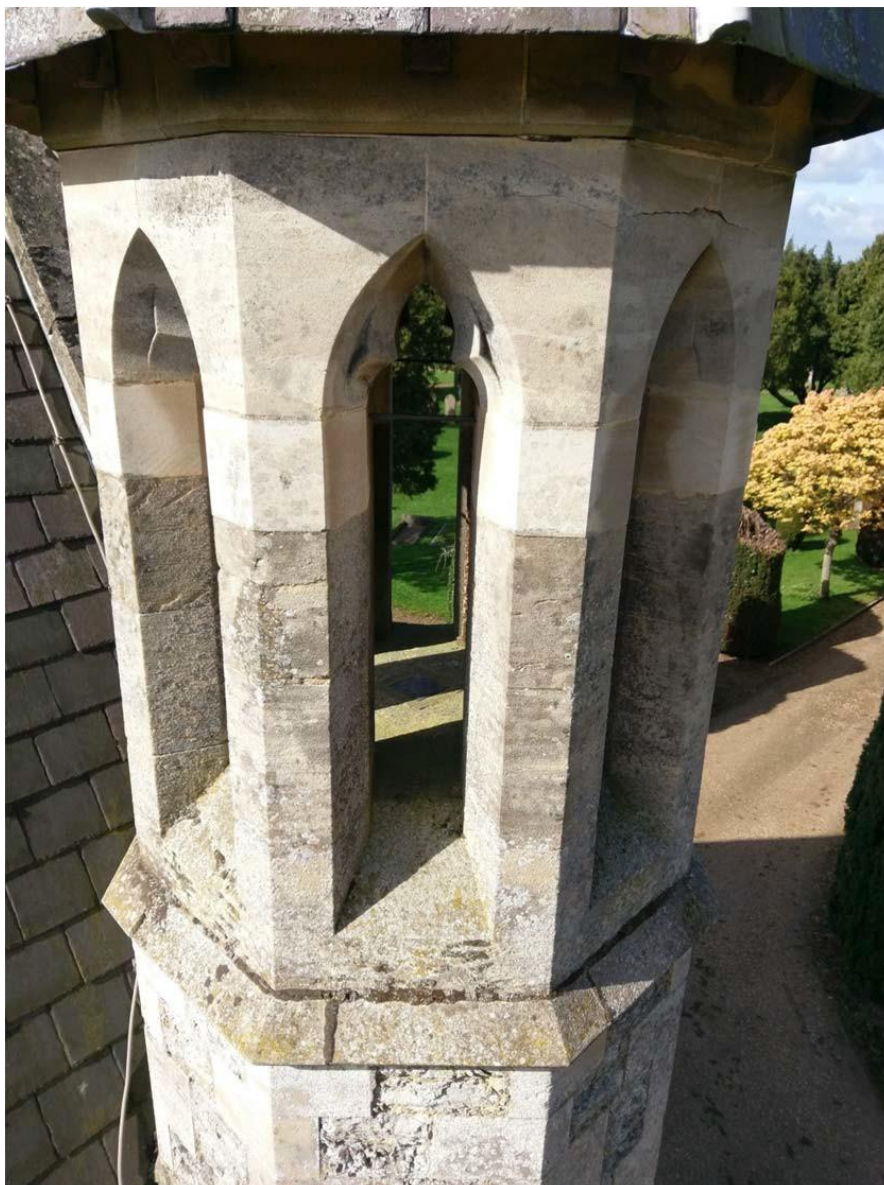
P3 – Dressed stone columns

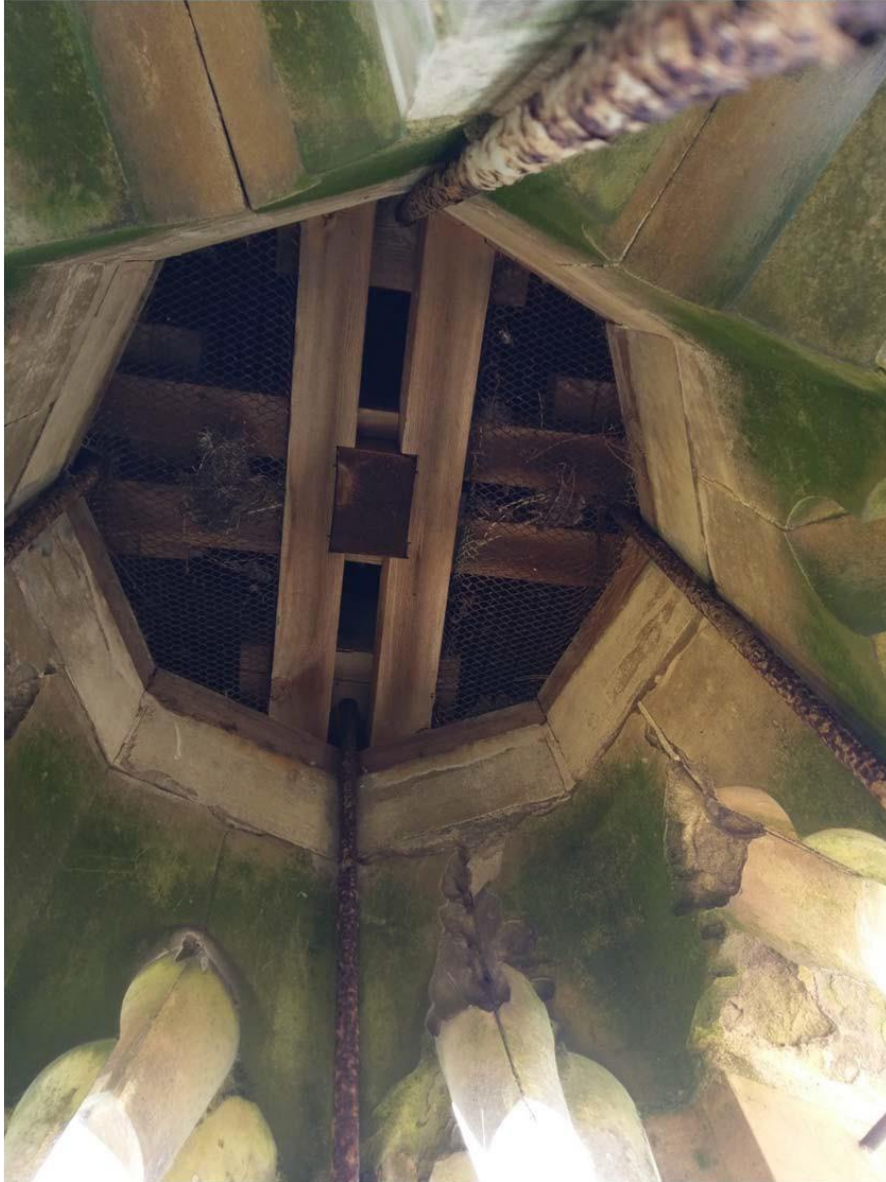
The roof structure appears to be generally in good condition where visible. There were some slightly misaligned wallplate joints and rafter birds-mouths which were not flushly aligned with the stonework, however this is quite likely to be misalignment at the time of reconstruction rather than a sign of any movement of the roof. The roof is well tied down and in good alignment generally with no signs of recent movement.

P4 – Internal view of roof structure (north at bottom of picture)

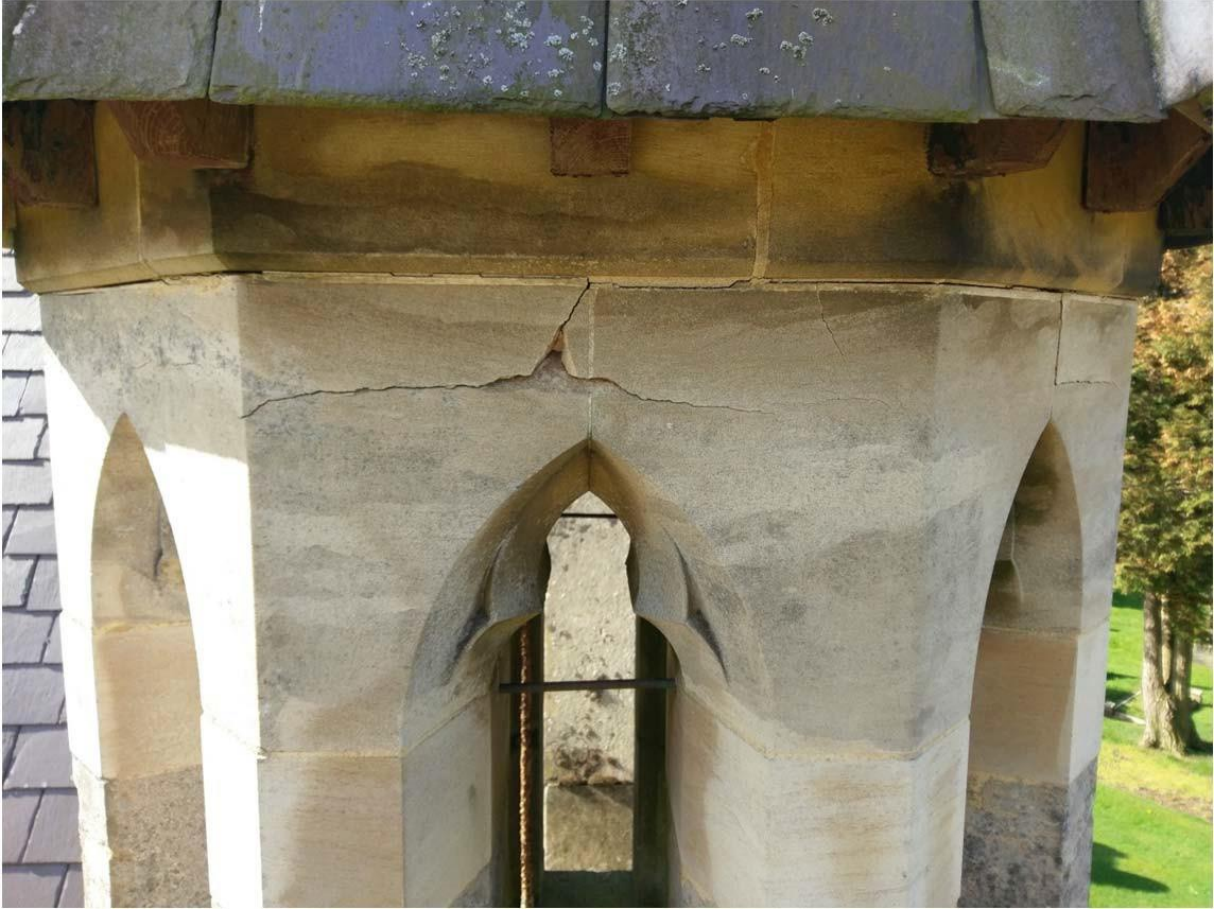
A horizontal crack occurs in the bed joint immediately above the arched openings below the corbelled stonework. This horizontal crack extends almost completely around the circumference of the tower and exhibits vertical displacement of approximately 2-3mm fairly uniformly around the tower.

Immediately below the same bed joint, the perpend joint between adjacent column sections (at the head of the arched openings) exhibits spalling of the outer face of the stonework or cracking indicating the early signs of spalling to all sides of the tower.

To the north elevation (*Photo 5*), some of the spalled stonework fragments were loose and were removed for safety reasons. To the southwest corner, some of the small infill stones between the rafter above the corbel course were loose and one of these stones was removed as a safety precaution (*Photo 6*).

Whilst a lack of access internally prevented us from definitively ascertaining the cause of the cracking, it is very likely that the cause of the cracking is expansion of corroding embedded metalwork. It is likely that wrought iron or steel cramps are present between the adjacent stones of the top of the arched openings. The expansion of the corroding metalwork is causing the upper stonework to lift away from the lower stonework, creating the gap observed in the bed joint.

It is likely that the same piece of corroding metalwork is also causing the outer face of the stonework to spall. Left unaltered, the metalwork will continue to corrode and expand, causing further damage to the stonework and eventually threatening the stability of the spire.

P5 – Horizontal cracked bed joint and spalling face (north elevation)

It is recommended that the corroding metalwork is removed and replaced with new stainless steel or phosphor bronze as appropriate and provide indented stone repairs to the worst affected areas of spalling. Less severe spalling may be glued in place using a suitable compound.

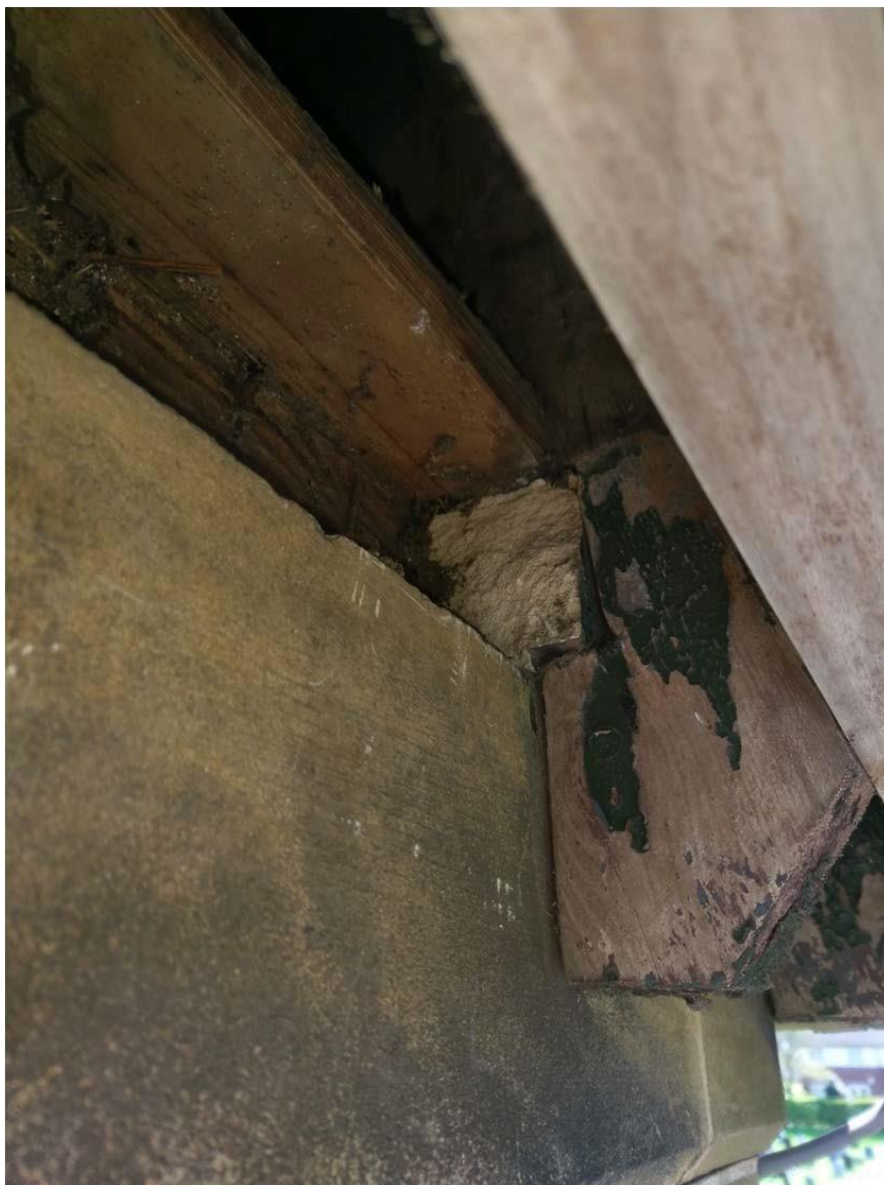
P6 – Loose corbel stone removed from southwest elevation

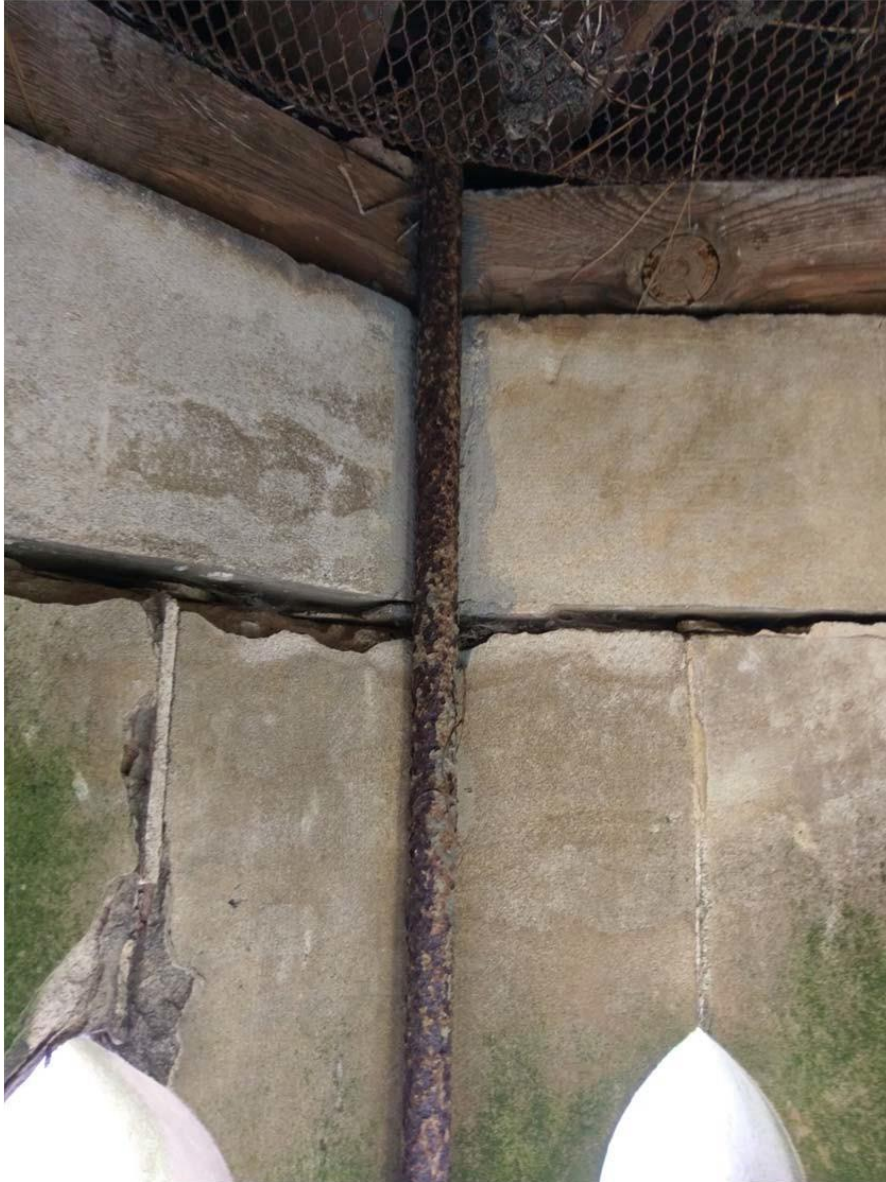
Internal viewing of the tower is difficult, as between the columns is only 180mm. Nevertheless, it could be clearly seen that the same bed joint which exhibited vertical displacement externally had the same movement internally (*Photo 7*). There also appeared to be more degradation of the bed joint mortar internally than externally.

P7 – Horizontal bed joint cracking

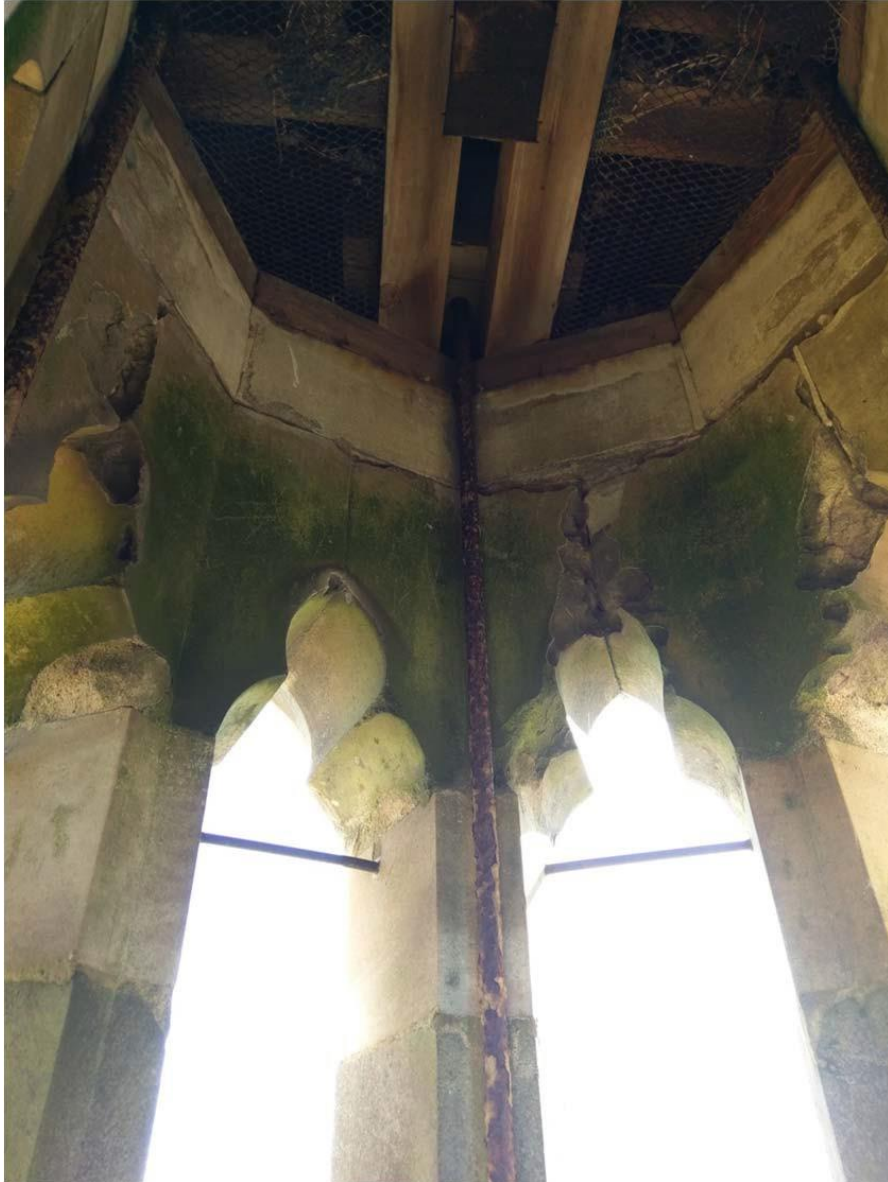
To the northeast corner, there was also some significant stonework erosion around the mortar bed joints and perpend joints (*Photo 8*). This does not appear to be recent or ongoing, and is quite likely due to the cement pointing internally which was reportedly present prior to the lightning strike in 1993. The current mortar all appears to be lime-based.

P8 – Eroded stonework internally
