# ASBESTOS RE-INSPECTION REPORT

Client	Swindon Borough Council
Site	Bowls Club, Penhill Park, Hillary Close, Swindon, Wiltshire, SN25 3AQ
Date started	14 May 2020 to 15 May 2020
Date completed	15 May 2020
Date report issued	19 May 2020
Survey reference	J507453
Lead surveyor	Stephen Davies
Assistant surveyor	N/A
UPRN	N/A

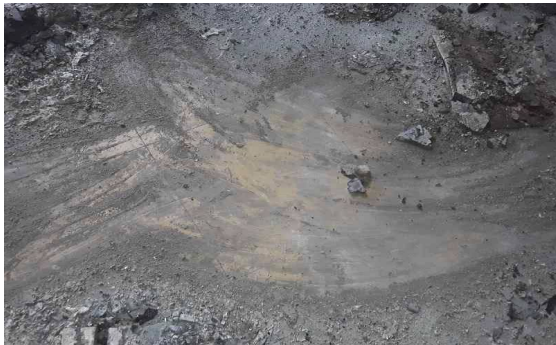
J507453 #1	/AD005723 {BE008975}	Penhill Park Bowls Club	Ground Floor	Main Hall 06	Floor	Floor tiles and adhesive	Chrysotile	3 Very Low Material Risk	Risk code E	
Comments						Next reinspection	Extent	Recommended action	Action Timescale	Date action completed
Area covered in debris from fire damage.						05/2021	20m²	Monitor and manage		
Material Status Change: No Change						Reinspection Comments:

Item Reference	J507453 #1
	Sample reference number	/AD005723 {BE008975}
	Client name	Swindon Borough Council
	Site address	Bowls Club, Penhill Park, Hillary Close, Swindon, Wiltshire, SN25 3AQ
	Date surveyed	14/05/20 TO 15/05/20
	Date analysed	
	Building	Penhill Park Bowls Club
	Floor level	Ground Floor
	Room	Main Hall 06
	Position	Floor
	Item description	Floor tiles and adhesive
	Condition / damage	(1) Low Damage
	Surface treatment	(0) Reinforced plastics, resins, vinyl tiles, well bound materials, bitumen adhesives, damp proof co
	Product type	Floor Tiles
<b>Recommended Action</b>		Monitor and manage
<b>Comments:</b> Area covered in debris from fire damage.		
<b>Material Status Change: No Change</b>		
	Accessibility	Medium
	Material assessment score	3
	Risk code	Risk code E
	Reinspection Comments:

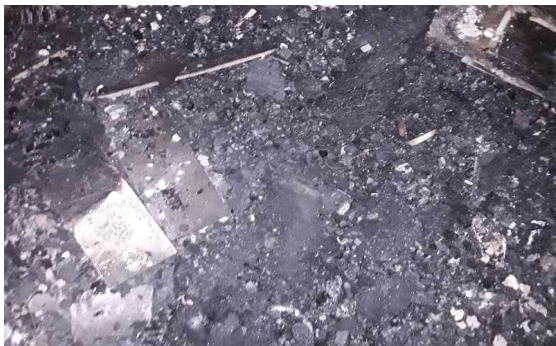
J507453 #2	As Sample /AD005723 {BE008975}	Penhill Park Bowls Club	Ground Floor	Kitchen 01	Floor	Floor tiles and adhesive	Chrysotile*	3 Very Low Material Risk	Risk code E	
Comments						Next reinspection	Extent	Recommended action	Action Timescale	Date action completed
Area covered in debris from fire damage.						05/2021	6m²	Monitor and manage		
Material Status Change: No Change						Reinspection Comments:

Item Reference	J507453 #2
	Sample reference number	As Sample /AD005723 {BE008975}
	Client name	Swindon Borough Council
	Site address	Bowls Club, Penhill Park, Hillary Close, Swindon, Wiltshire, SN25 3AQ
	Date surveyed	14/05/20 TO 15/05/20
	Date analysed	
	Building	Penhill Park Bowls Club
	Floor level	Ground Floor
	Room	Kitchen 01
	Position	Floor
	Item description	Floor tiles and adhesive
	Condition / damage	(1) Low Damage
	Surface treatment	(0) Reinforced plastics, resins, vinyl tiles, well bound materials, bitumen adhesives, damp proof co
	Product type	Floor Tiles
<b>Recommended Action</b>		Monitor and manage
<b>Comments:</b> Area covered in debris from fire damage.		
<b>Material Status Change: No Change</b>		
	Accessibility	Medium
	Material assessment score	3
	Risk code	Risk code E
	Reinspection Comments:

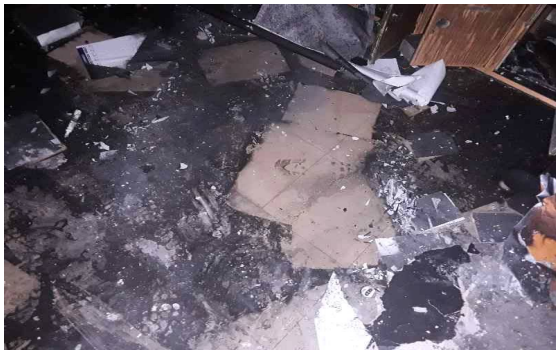
Item Reference	Sample	Building	Floor	Room	Position	Item desc	Conclusion	Material Assessment	Risk code	
J507453 #3	As Sample /AD005723 {BE008975}	Penhill Park Bowls Club	Ground Floor	Changing Room 02	Floor	Floor tiles and adhesive	Chrysotile*	3 Very Low Material Risk	Risk code E	 
Comments						Next reinspection	Extent	Recommended action	Action Timescale	Date action completed
Area covered in debris from fire damage.						05/2021	10m²	Monitor and manage		
Material Status Change: No Change						Reinspection Comments:

Item Reference	J507453 #3
		Sample reference number	As Sample /AD005723 {BE008975}
		Client name	Swindon Borough Council
		Site address	Bowls Club, Penhill Park, Hillary Close, Swindon, Wiltshire, SN25 3AQ
		Date surveyed	14/05/20 TO 15/05/20
		Date analysed	
		Building	Penhill Park Bowls Club
		Floor level	Ground Floor
		Room	Changing Room 02
		Position	Floor
		Item description	Floor tiles and adhesive
		Condition / damage	(1) Low Damage
		Surface treatment	(0) Reinforced plastics, resins, vinyl tiles, well bound materials, bitumen adhesives, damp proof co
		Product type	Floor Tiles
		Asbestos Type	Chrysotile*
<b>Recommended Action</b>		Monitor and manage	Accessibility
<b>Comments:</b> Area covered in debris from fire damage.		Material assessment score	3
<b>Material Status Change: No Change</b>		Risk code	Risk code E
		Reinspection Comments:

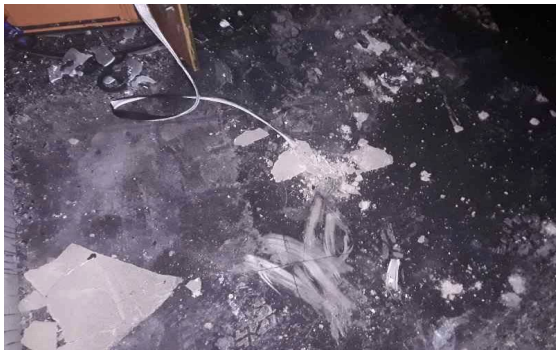
Item Reference	Sample	Building	Floor	Room	Position	Item desc	Conclusion	Material Assessment	Risk code	
J507453 #4	/AD005275 {BE008976}	Penhill Park Bowls Club	Ground Floor	Changing Room 04	Floor	Floor tiles and adhesive	Chrysotile	3 Very Low Material Risk	Risk code E	 
Comments						Next reinspection	Extent	Recommended action	Action Timescale	Date action completed
Area covered in debris from fire damage.						05/2021	8m²	Monitor and manage		
Material Status Change: No Change						Reinspection Comments:

Item Reference	J507453 #4
		Sample reference number	/AD005275 {BE008976}
		Client name	Swindon Borough Council
		Site address	Bowls Club, Penhill Park, Hillary Close, Swindon, Wiltshire, SN25 3AQ
		Date surveyed	14/05/20 TO 15/05/20
		Date analysed	
		Building	Penhill Park Bowls Club
		Floor level	Ground Floor
		Room	Changing Room 04
		Position	Floor
		Item description	Floor tiles and adhesive
		Condition / damage	(1) Low Damage
		Surface treatment	(0) Reinforced plastics, resins, vinyl tiles, well bound materials, bitumen adhesives, damp proof co
		Product type	Floor Tiles
		Asbestos Type	Chrysotile
<b>Recommended Action</b>		Monitor and manage	Accessibility
<b>Comments:</b> Area covered in debris from fire damage.		Material assessment score	3
<b>Material Status Change: No Change</b>		Risk code	Risk code E
		Reinspection Comments:

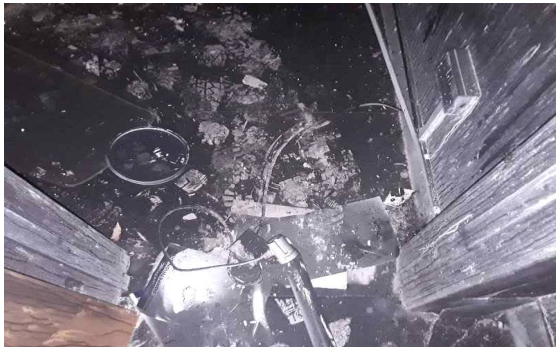
Item Reference	Sample	Building	Floor	Room	Position	Item desc	Conclusion	Material Assessment	Risk code	
J507453 #5	/AD005726 {BE008977}	Penhill Park Bowls Club	Ground Floor	Changing Room 04	Floor	Floor tiles and adhesive	Chrysotile	3 Very Low Material Risk	Risk code E	 
Comments						Next reinspection	Extent	Recommended action	Action Timescale	Date action completed
Area covered in debris from fire damage.						05/2021	1m²	Monitor and manage		
Material Status Change: No Change						Reinspection Comments:

Item Reference	J507453 #5
Sample reference number	/AD005726 {BE008977}
Client name	Swindon Borough Council
Site address	Bowls Club, Penhill Park, Hillary Close, Swindon, Wiltshire, SN25 3AQ
Date surveyed	14/05/20 TO 15/05/20
Date analysed	
Building	Penhill Park Bowls Club
Floor level	Ground Floor
Room	Changing Room 04
Position	Floor
Item description	Floor tiles and adhesive
Condition / damage	(1) Low Damage
Surface treatment	(0) Reinforced plastics, resins, vinyl tiles, well bound materials, bitumen adhesives, damp proof co
Product type	Floor Tiles
Asbestos Type	Chrysotile
Extent	1m <sup>2</sup>
Recommended Action	Monitor and manage
Comments:	Area covered in debris from fire damage.
Material Status Change: No Change

Item Reference	J507453 #5
Sample reference number	/AD005726 {BE008977}
Client name	Swindon Borough Council
Site address	Bowls Club, Penhill Park, Hillary Close, Swindon, Wiltshire, SN25 3AQ
Date surveyed	14/05/20 TO 15/05/20
Date analysed	
Building	Penhill Park Bowls Club
Floor level	Ground Floor
Room	Changing Room 04
Position	Floor
Item description	Floor tiles and adhesive
Condition / damage	(1) Low Damage
Surface treatment	(0) Reinforced plastics, resins, vinyl tiles, well bound materials, bitumen adhesives, damp proof co
Product type	Floor Tiles
Asbestos Type	Chrysotile
Extent	1m <sup>2</sup>
Accessibility	Medium
Material assessment score	3
Risk code	Risk code E
Reinspection Comments:

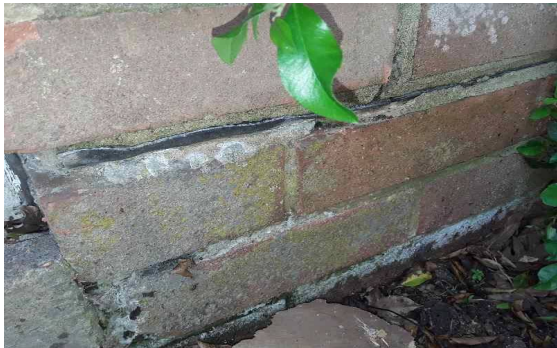
Item Reference	Sample	Building	Floor	Room	Position	Item desc	Conclusion	Material Assessment	Risk code	
J507453 #6	/AD005728 {BE008978}	Penhill Park Bowls Club	External	External	Low level brickwork	Damp proof course	Chrysotile	3 Very Low Material Risk	Risk code E	 
Comments						Next reinspection	Extent	Recommended action	Action Timescale	Date action completed
						05/2021	Throughout	Monitor and manage		
Material Status Change: No Change						Reinspection Comments:

Item Reference	J507453 #6	
	Sample reference number	/AD005728 {BE008978}	
	Client name	Swindon Borough Council	
	Site address	Bowls Club, Penhill Park, Hillary Close, Swindon, Wiltshire, SN25 3AQ	
	Date surveyed	14/05/20 TO 15/05/20	
	Date analysed		
	Building	Penhill Park Bowls Club	
	Floor level	External	
	Room	External	
	Position	Low level brickwork	
	Item description	Damp proof course	
	Condition / damage	(1) Low Damage	
	Surface treatment	(0) Reinforced plastics, resins, vinyl tiles, well bound materials, bitumen adhesives, damp proof co	
	Product type	Bitumen Products	
Asbestos Type	Chrysotile		
Extent	Throughout		
Recommended Action	Monitor and manage	Accessibility	Low
Comments:		Material assessment score	3
		Risk code	Risk code E
Material Status Change: No Change		Reinspection Comments:
