BUILDING CONDITION SURVEY

**Penhill Bowls Club
Sevenfields
Inglesham Road
Swindon
SN2 5BY**

**Central Swindon North Parish Council
Pinetrees Community Centre
The Circle
Swindon
SN2 1RF**

Date of Inspection: 15 May 2023

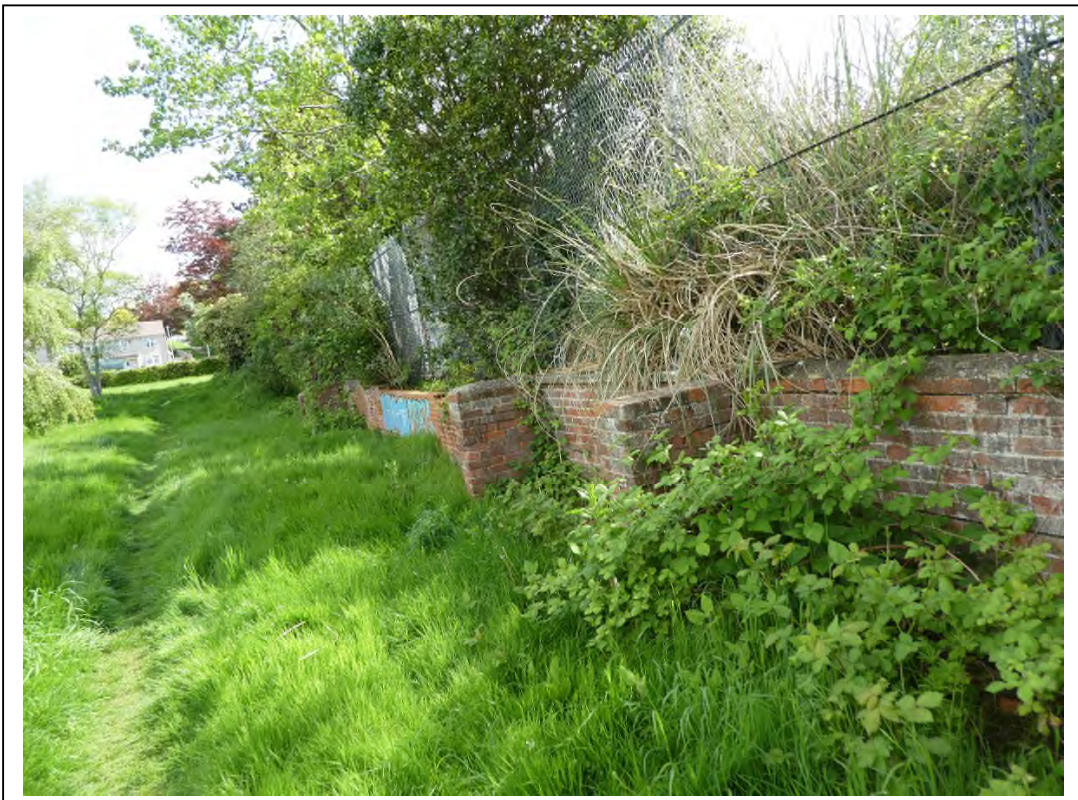
REAR RETAINING WALL

There has been structural damage to the south-west garden retaining brick walls where there are a number of substantial trees. The fields to the north-west are at a lower level, this retaining wall has been cracked and damaged due to tree action. Sections will require to be rebuilt, a structural builder will be able to advise and cost on repair.

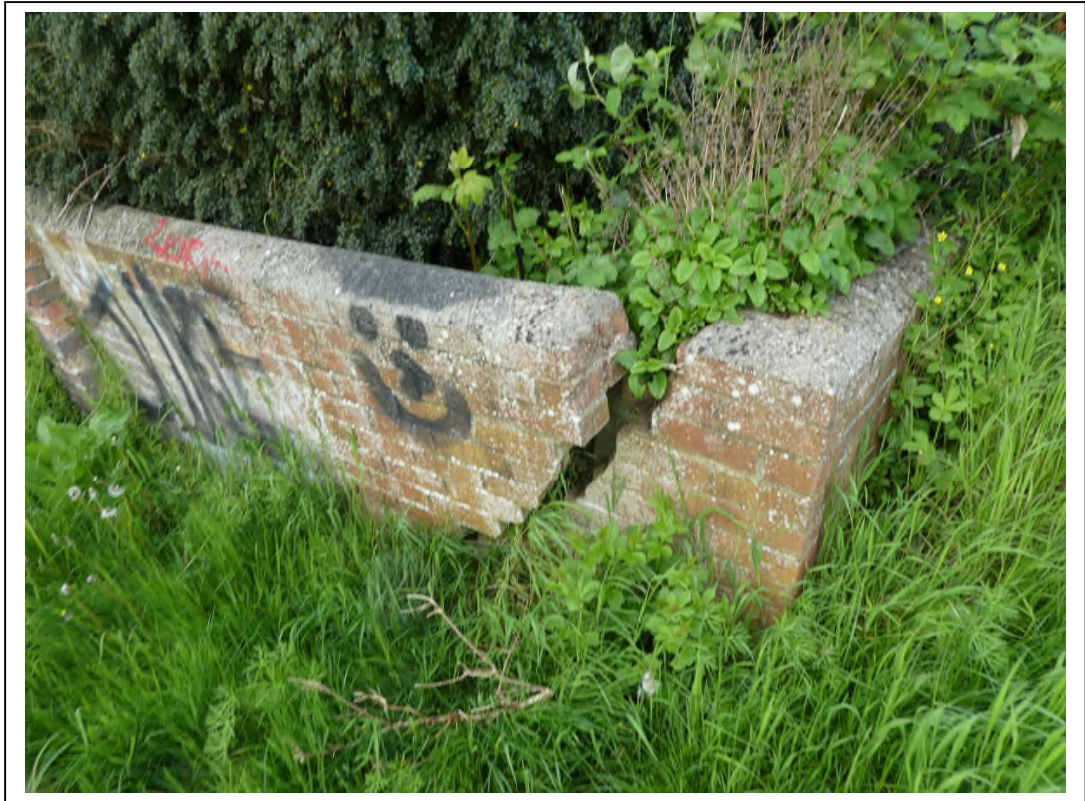
REAR RETAINING WALL DAMAGE

The gardens are in need of substantial improvement of the garden walls on the north-west elevation, in need of repair and rebuilding in sections. A tree surgeon's report should be obtained on management and maintenance to prevent future structural issues. Fencing will require repair in areas, improvement of the drainage, parking area with additional soakaways to be considered.

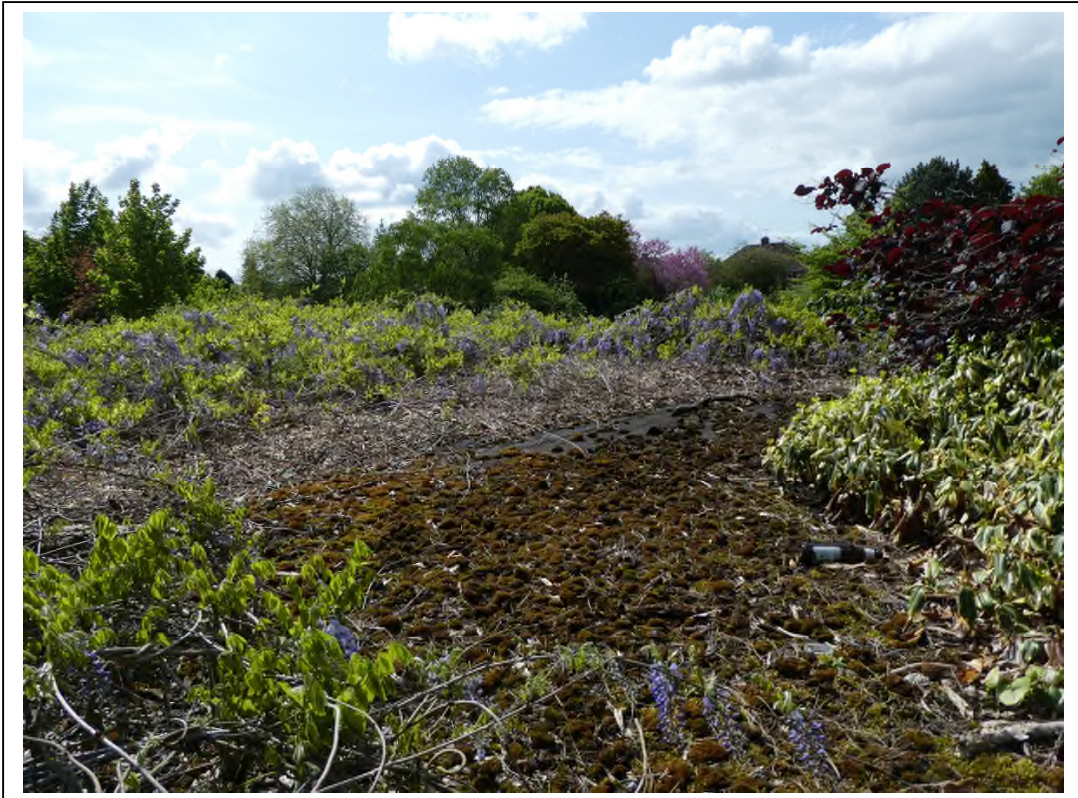
ROOF

The flat roof structure is in need of complete replacement, it is currently overgrown with plant growth due to substantial structural damage to the underlying support timbers. These require to be replaced and a new roof installed. This should be replaced completely over the whole building. Section of the roof timbers could be left in place over the external female and male wc's on further investigations which do not appear to have been substantially fire damaged with the bowling club.

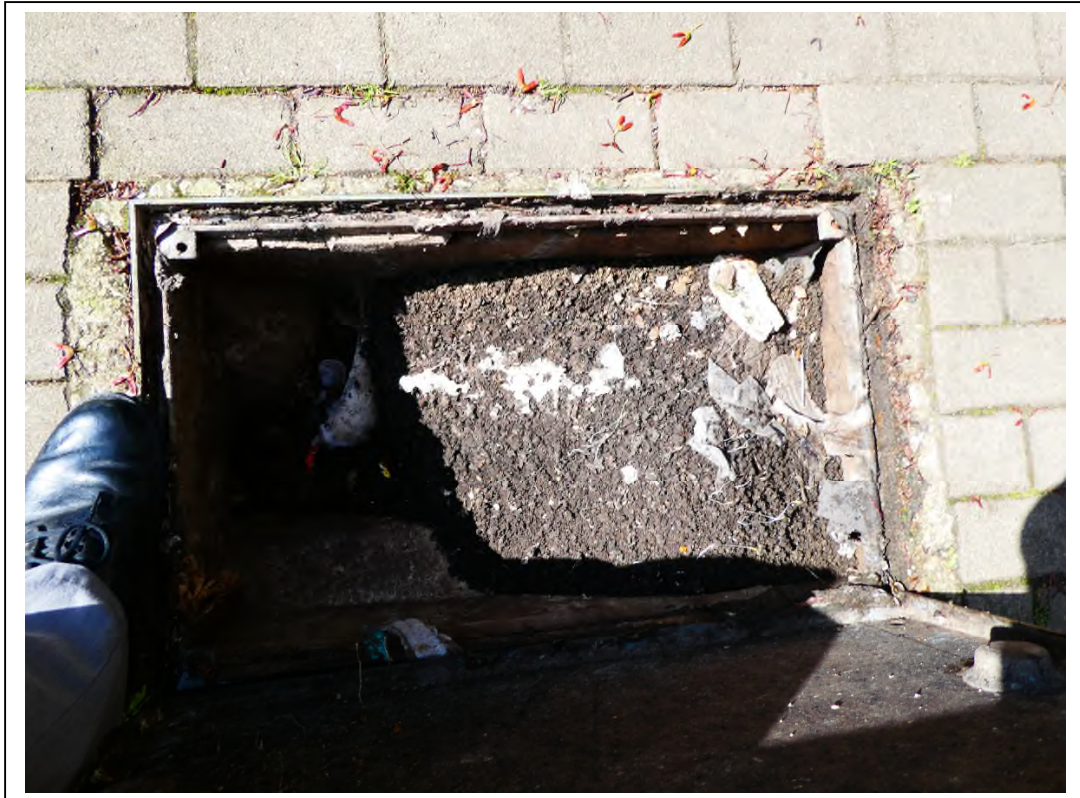
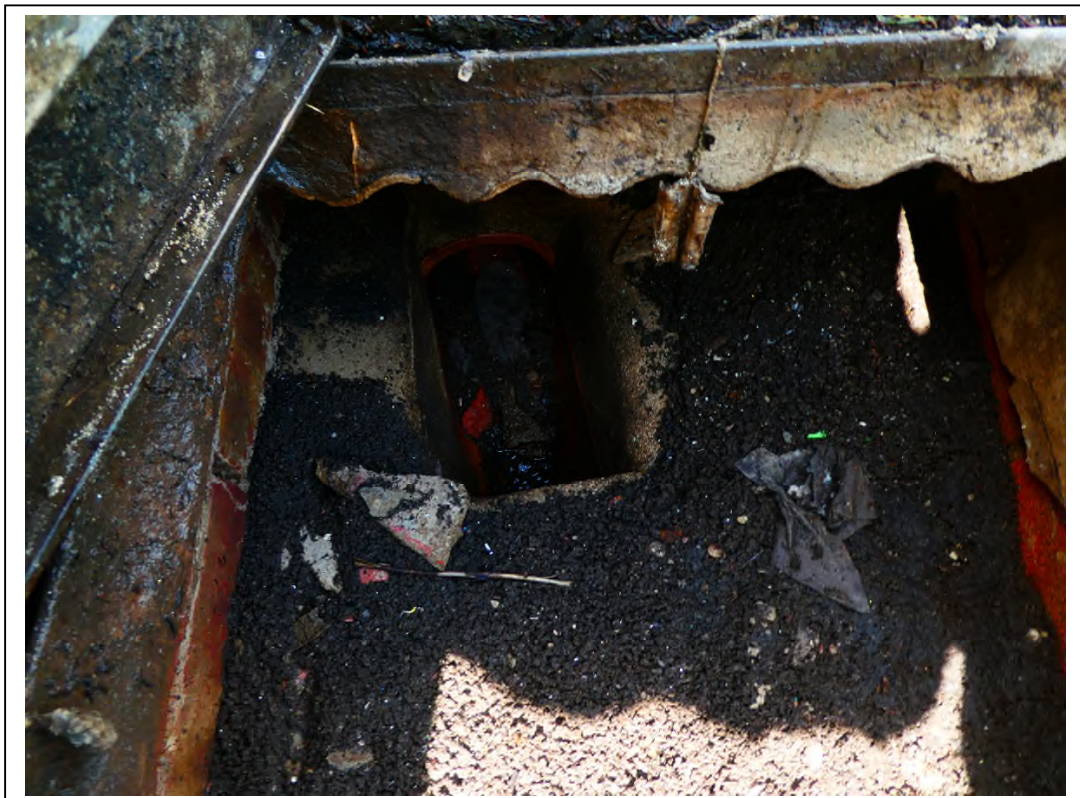
The foul manhole drain was blocked when we inspected. A full camera inspection/service should be carried out by a drainage company who should clean out the drains and advise you on the adequacy and repair as needed prior to any further works being undertaken.

REAR DRAINAGE MANHOLES BLOCKED UP

We would recommend as good maintenance that the manhole covers and gulleys in the garden be lifted, cleaned, greased and reset to provide an airtight fit. A water test and camera survey are the only accurate way of finding out for certain if the drain is watertight, and the general condition of underground pipes. Nevertheless, it is important to be certain that the drains are water tight as otherwise constant leakage over a long period of time may affect the stability of adjoining brickwork. This is particularly relevant where tree roots are close by.

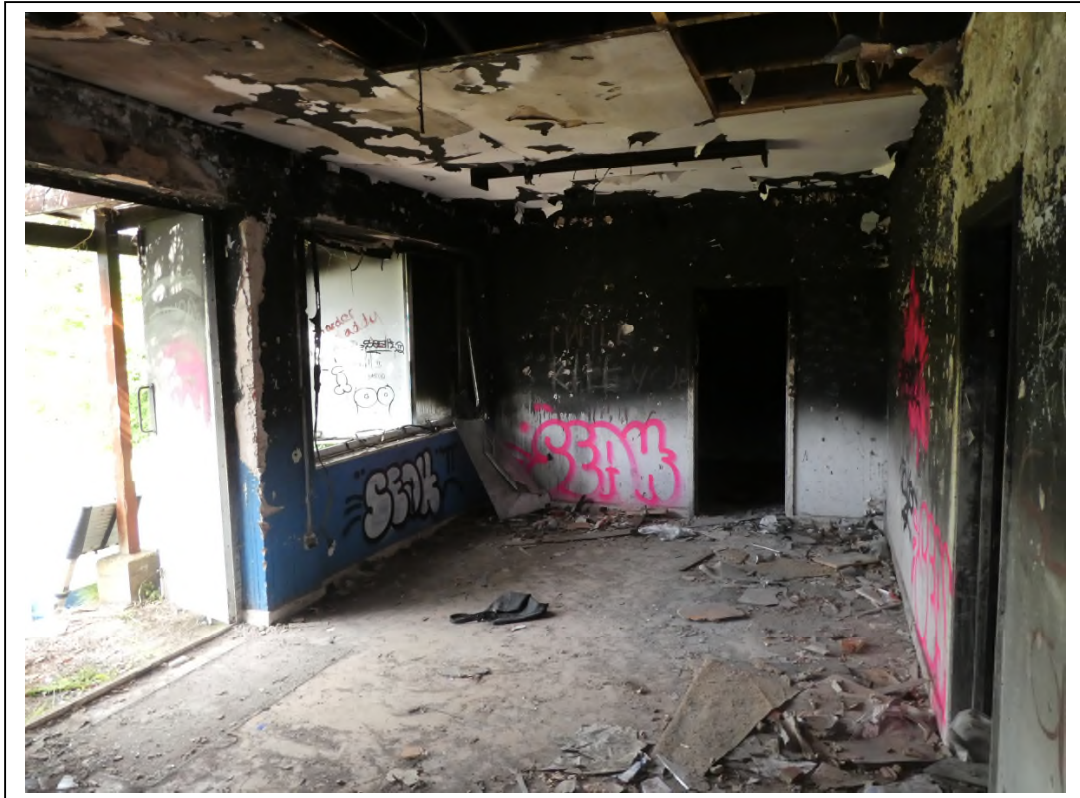
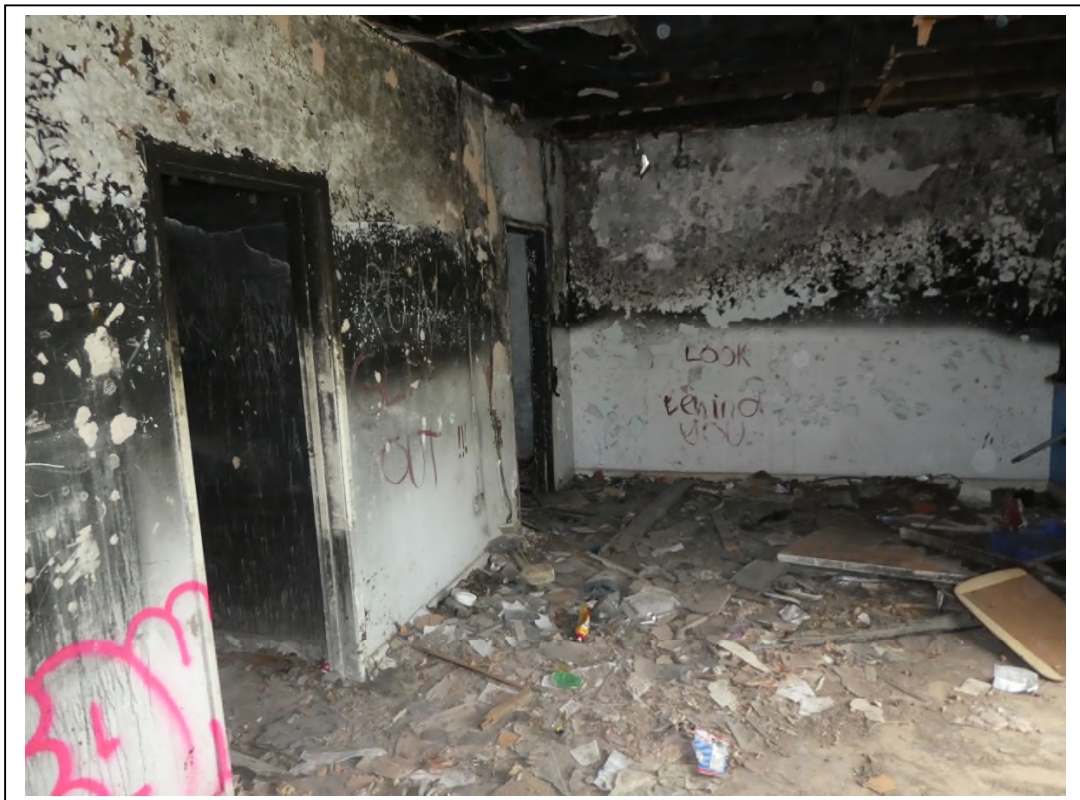
Internal cleaning of the fire damaged surfaces of the chemical smoke exposure to surfaces which will require to be specialist cleaned or plasterwork removed and replastered.

INTERNAL FIRE DAMAGE

All the internal doors, skirtings, fixtures and fittings will require replacement. A specialist removal contractor and fire damage repairer should carry out removal of all fixtures, roof work, and services prior to any specialist cleaning.

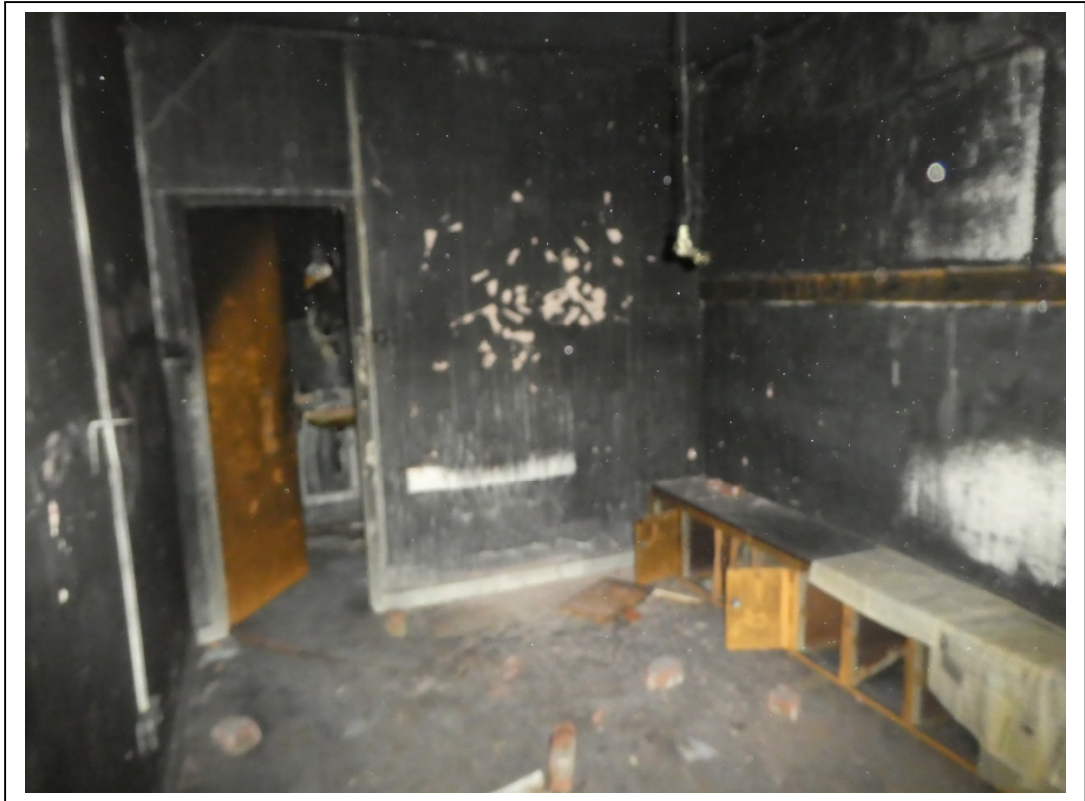
FIRE DAMAGE CHANGING ROOM

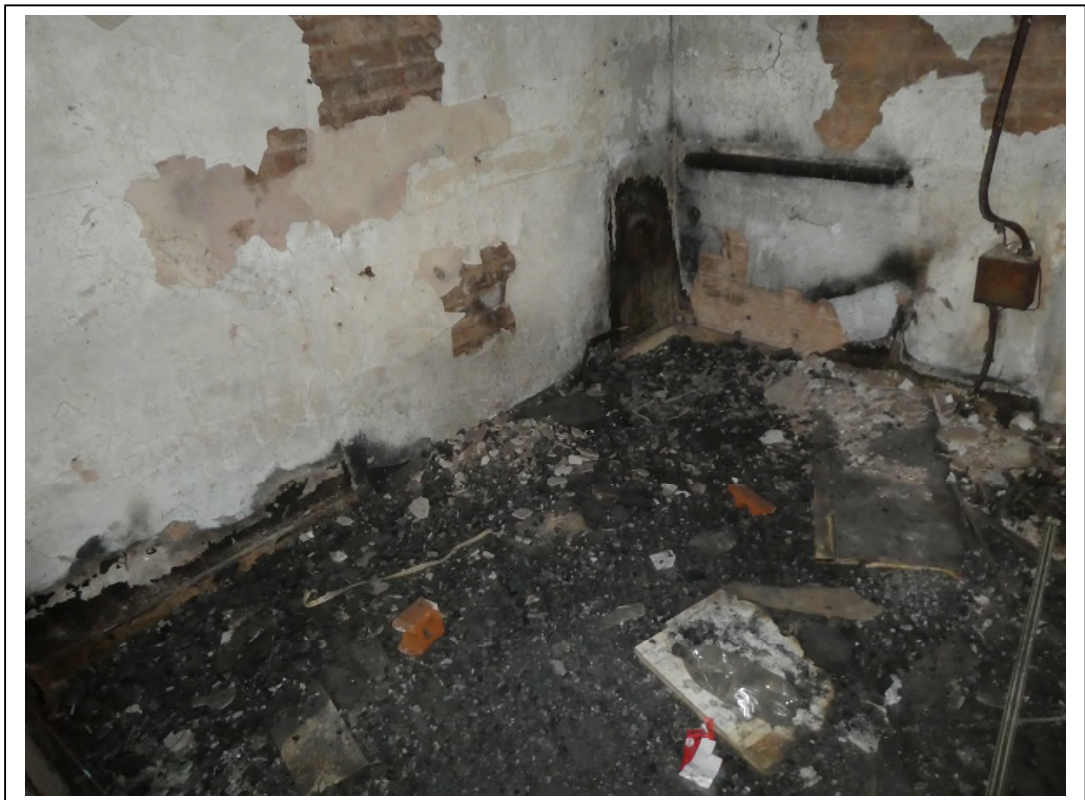
We checked ground floor walls with our moisture meter and we found that the walls and upper wall surfaces of the rear right office and service room were completely damp. We suspect this is where the fire commenced and was put out by the Fire Brigade. Complete removal of the internal renderwork would be prudent and the area dried out.

REAR RIGHT OFFICE WET WALLS

These are of solid brick construction, the walls to the rear right office service room was the source of the fire and the walls are substantially damp, the plaster requires to be removed, dried out with dehumidifiers and re-plastered. Other walls have been fire damaged with smoke chemical and these require to be either washed down or the plaster removed. A specialist fire contractor should advise you with regard to removal of the internal chemicals on the surfaces due to the fire. This will either include washing down prior to any application, or lining installed, or removal of the plaster. Your specialist contractor to advise and cost.

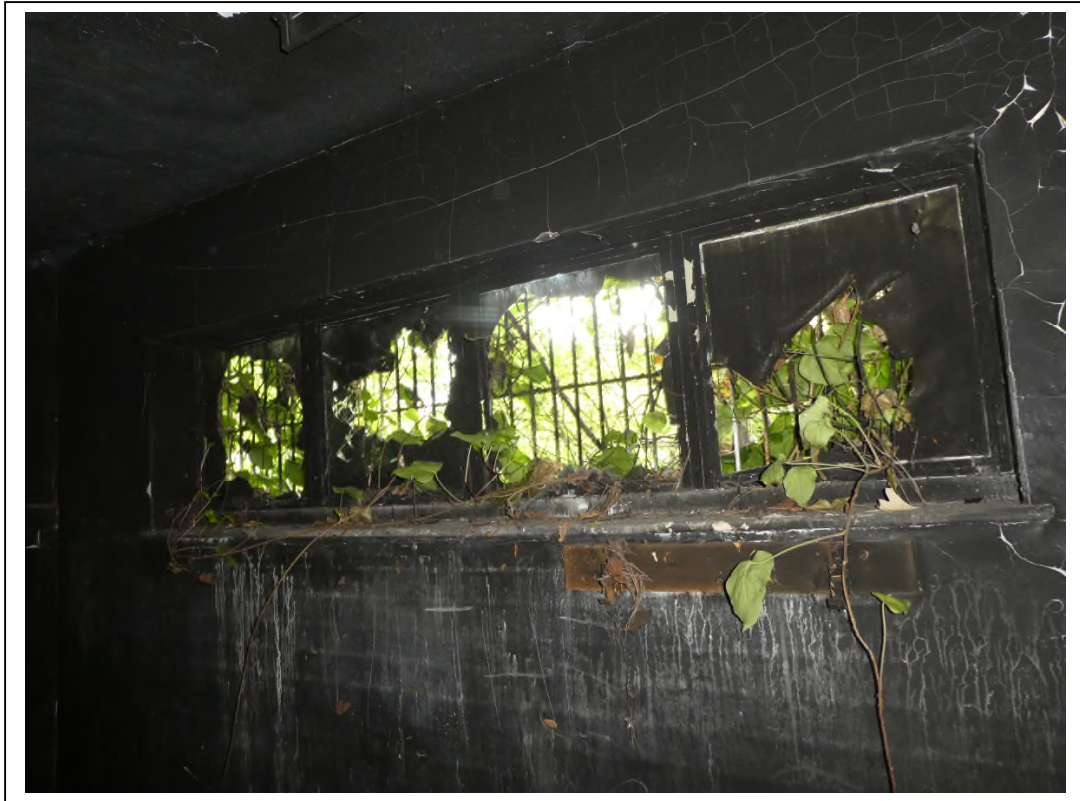
These consist of former softwood and UPvc double glazed windows units which were completely destroyed with the recent fire and are in need of complete replacement. A double-glazing specialist should advise and cost the replacement of these windows. Some of the external windows have metal bars for security which you may wish to retain or clean the metal for the smoke damage and redecorate for security purposes.

WINDOWS FIRE DAMAGE

The windows could be replaced with new UPvc triple glazing and improved insulated windows.

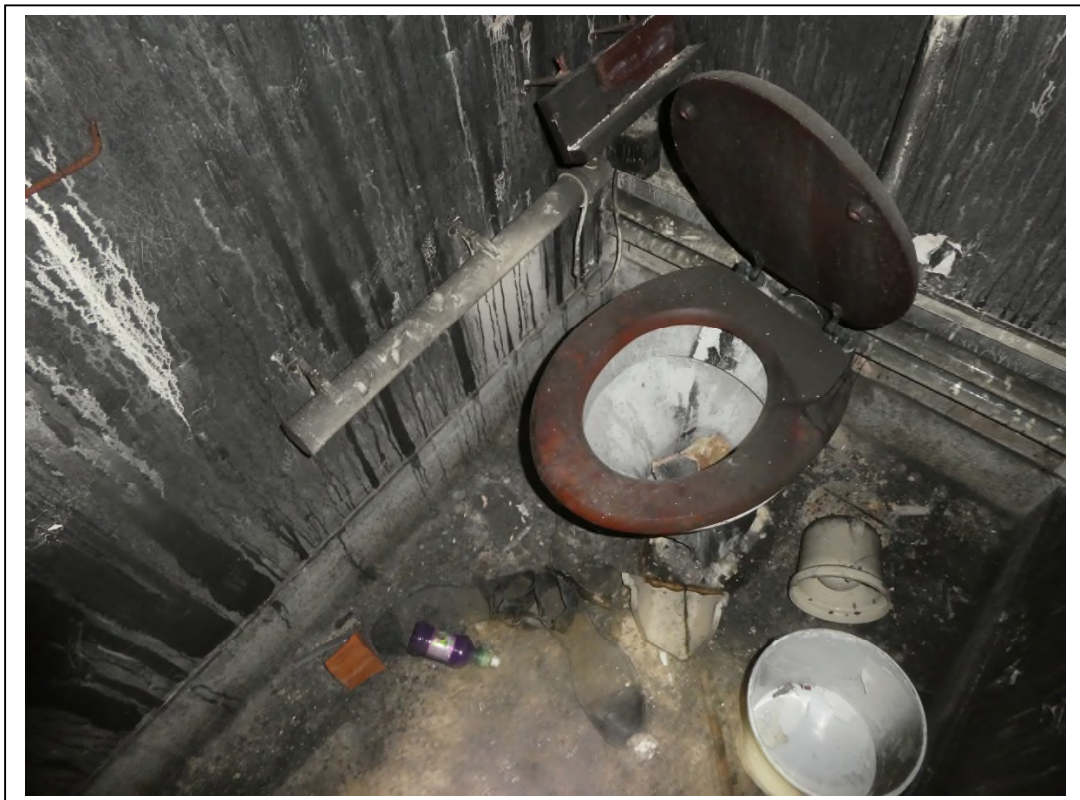
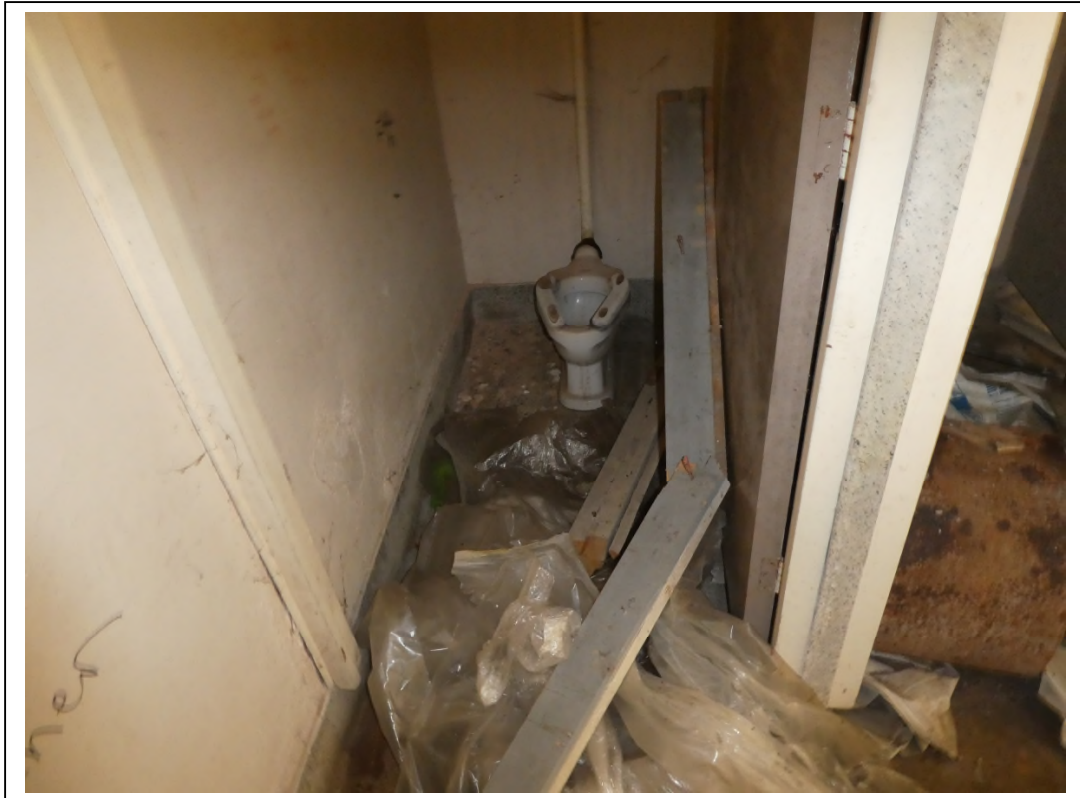
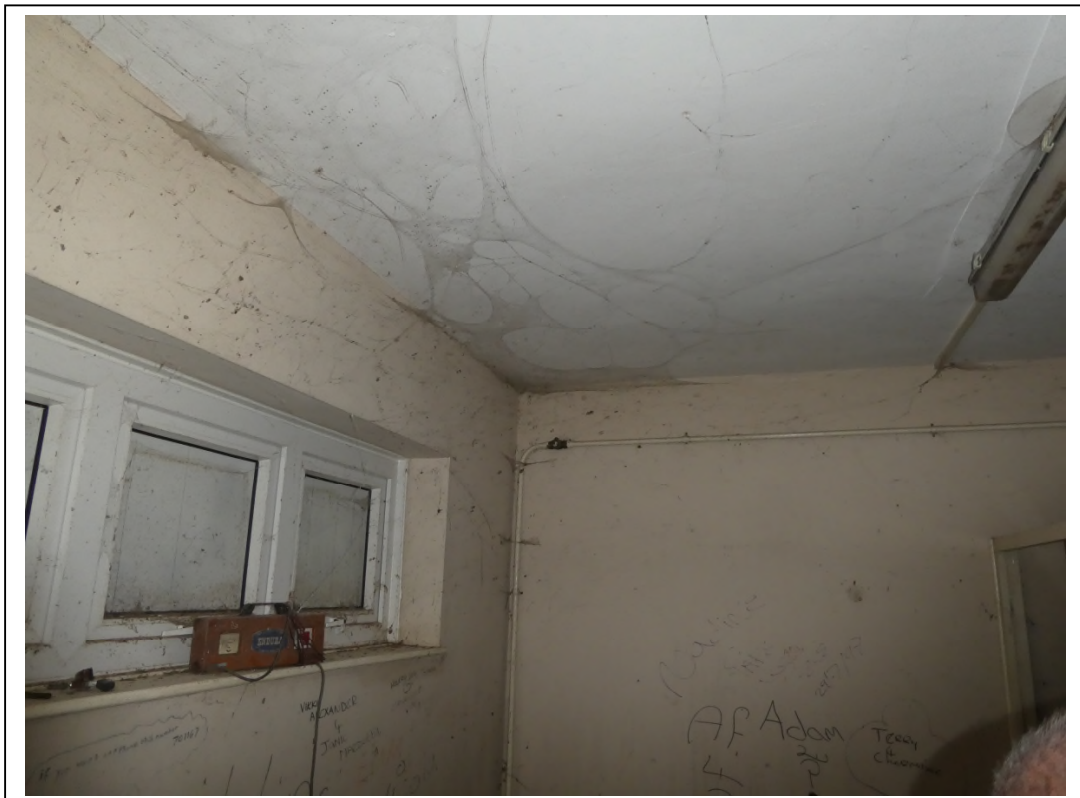
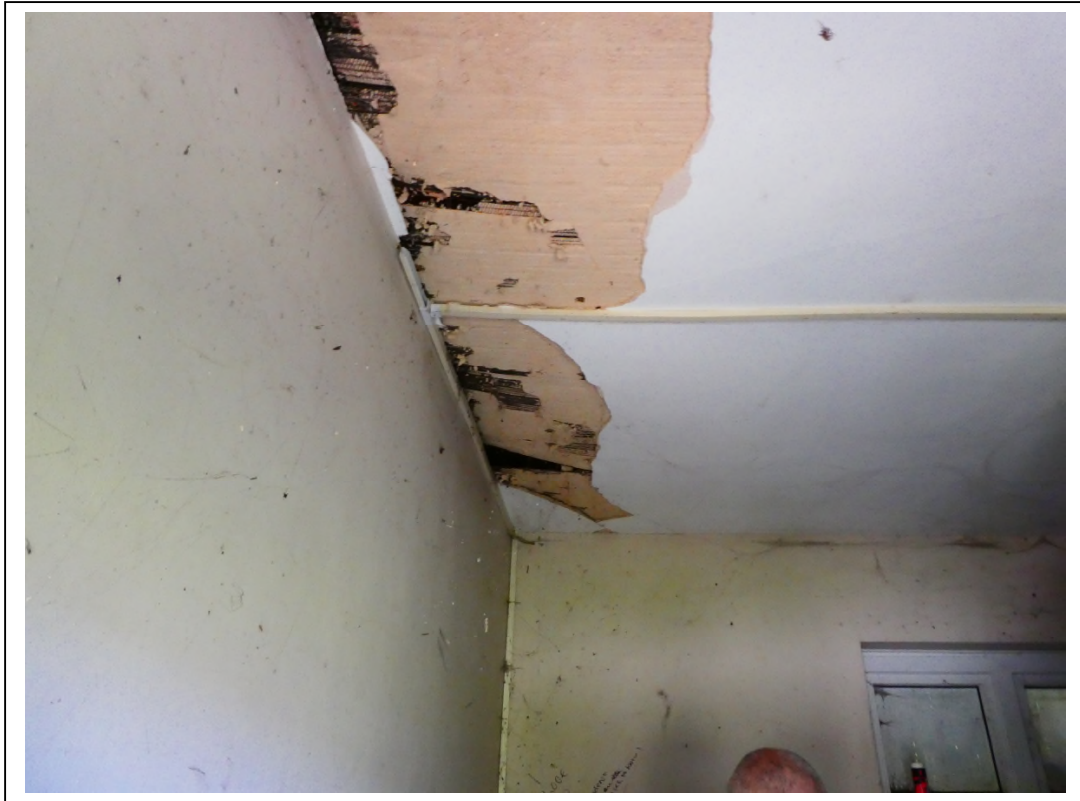
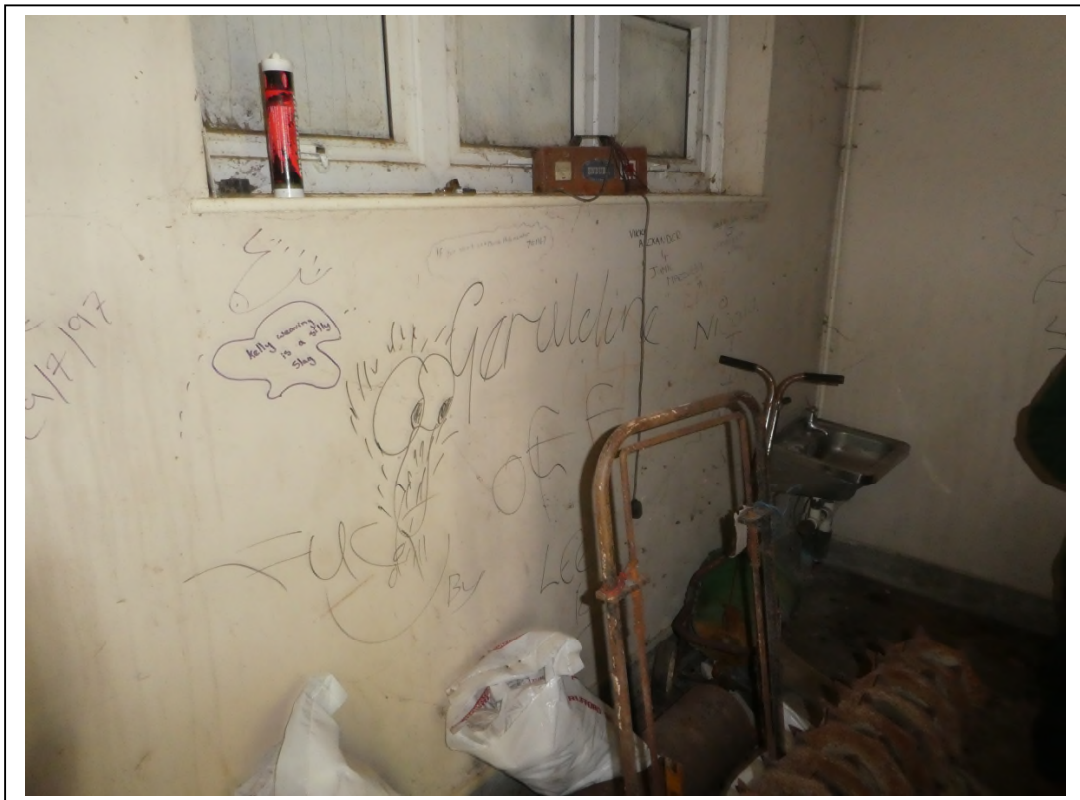
REAR TOILETS

There is substantial graffiti on the external brickwork which should be cleaned off. External timberwork should be redecorated where needed. The doors to the rear toilets are in poor condition requiring replacement. The external timberwork should also be replaced and improved.

A complete refurbishment of all fixtures, fittings, and replacement of plumbing was required to include the north-west attached female and male wc's which are also in poor condition and require complete replacement with refurbishment of the internal areas.

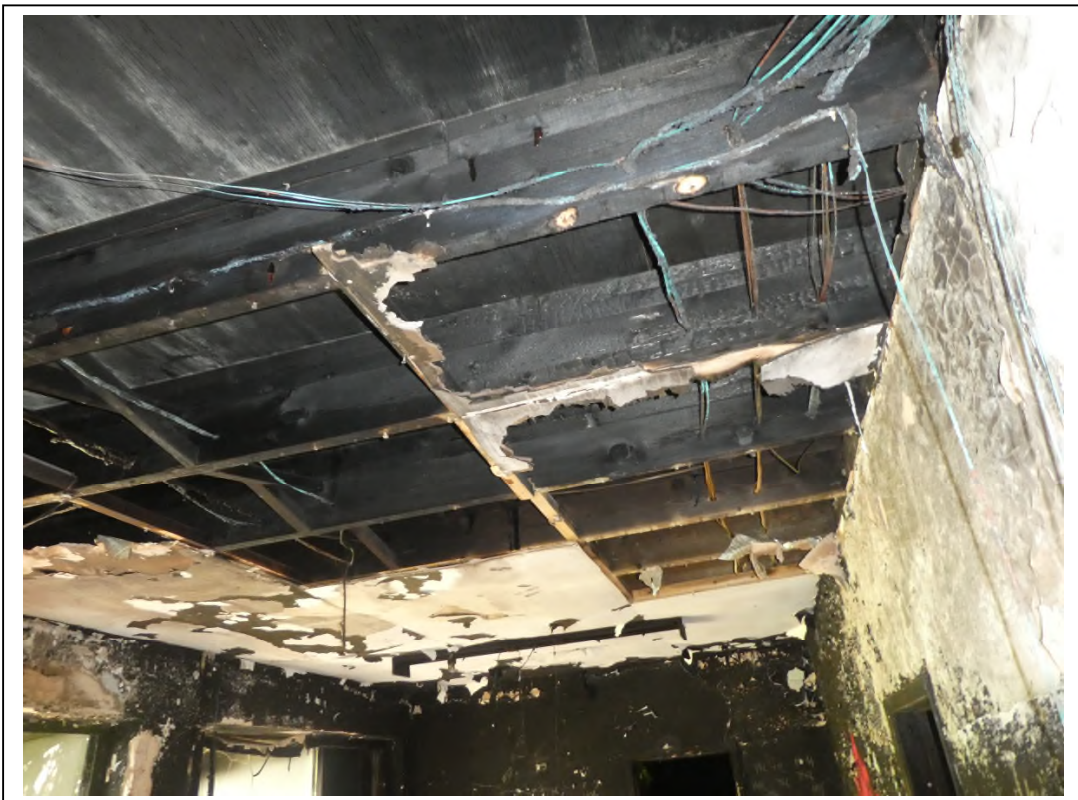
The roof voids were exposed from the fire damaged and ceilings were pulled down following the fire indicating 225 mm joists x 50 mm at approximately 600 mm centres. The timbers have been substantially damaged to the bowling club, the ceiling appeared still in place to the attached female wc and we assume also in the male wc which could be retained on further investigation. The existing timbers are fire damaged with smoke, reduced in size to sections and complete replacement of the roof with new felted covering is required. On reconstruction the insulation should be increased to modern standards and should include the external wc's to bring the EPC value to a lettable value. You should also consider providing ventilation and breathable ventilation into the void. An architect, structural builder and roofer should advise, design, and cost this repair work.

We found no evidence of any timber woodworm. There is substantial timber fire damage to the roof joists and rafters running under the flat roof section which will require complete replacement on refurbishment.

FIRE DAMAGE ROOF STRUCTURE

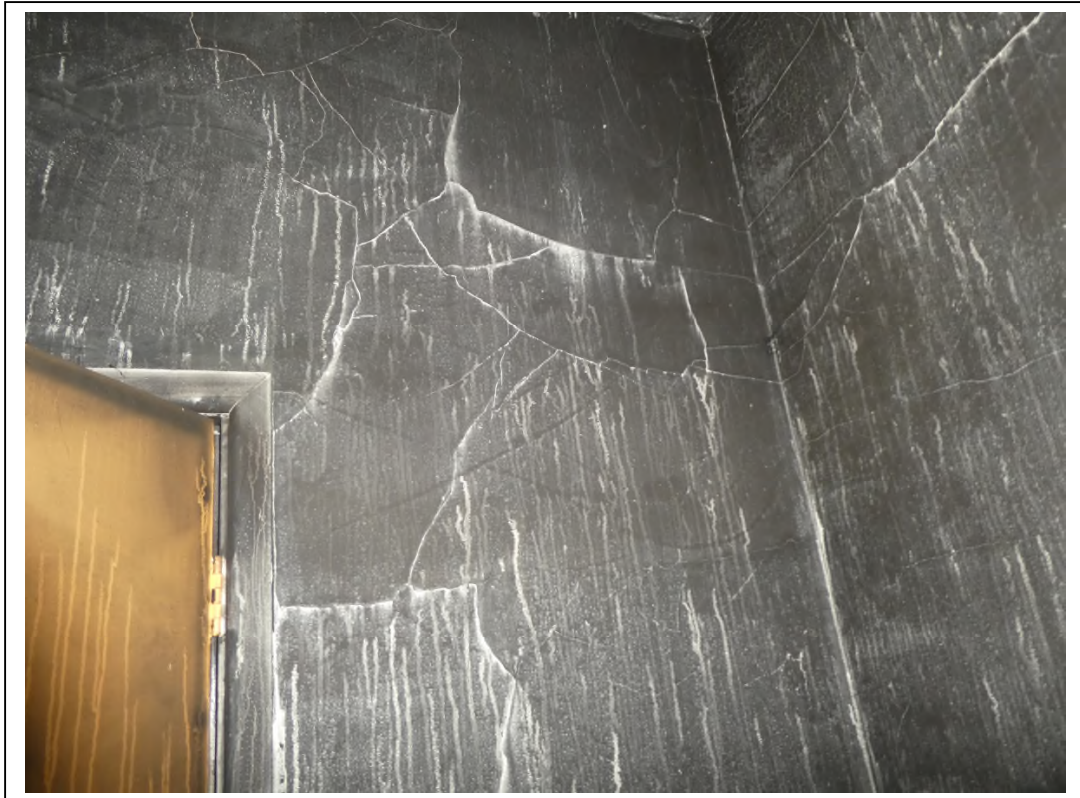
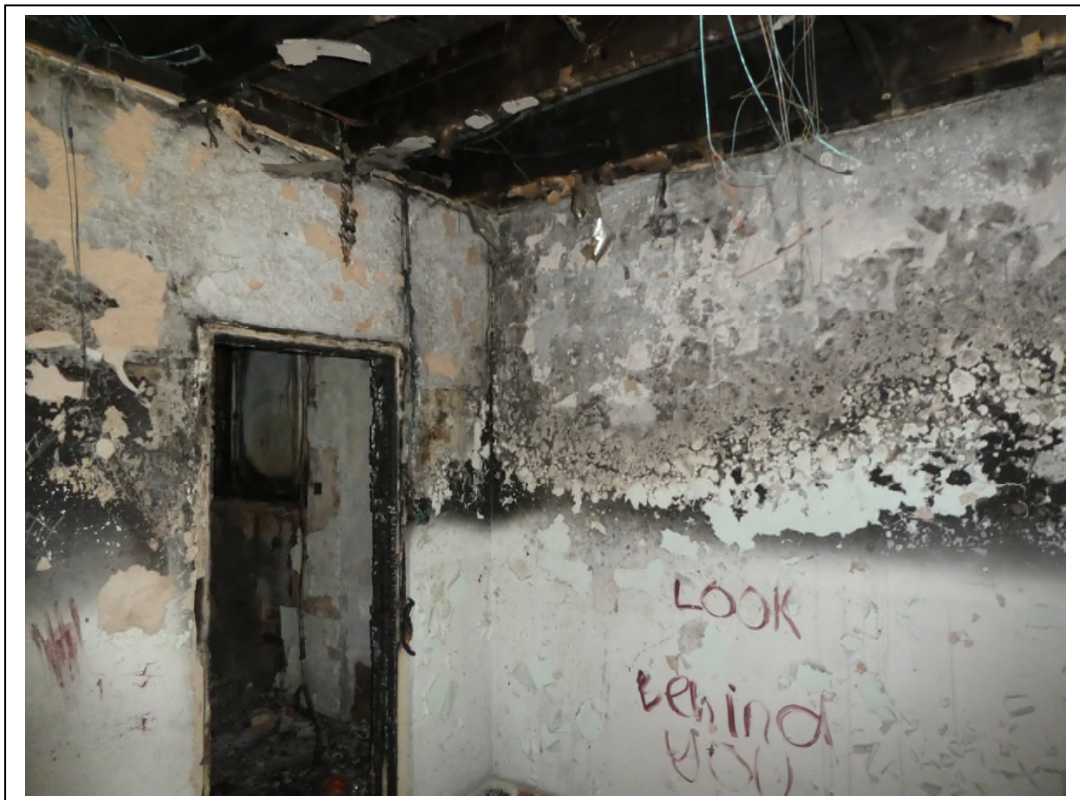
A number of fire damaged cracks were noted to internal surfaces, which have been caused by shrinkage and fire. Making good is required and likely to require areas to be replastered, the plaster to be hacked away and replastered following cleaning by a specialist. Whilst these cracks are not structurally significant, making good is required.

INTERNAL CRACKED [PLASTER
