# Built structures bat report

**Site:** Goss Moor NNR

**Client:** Natural England

**Date:** December 2021

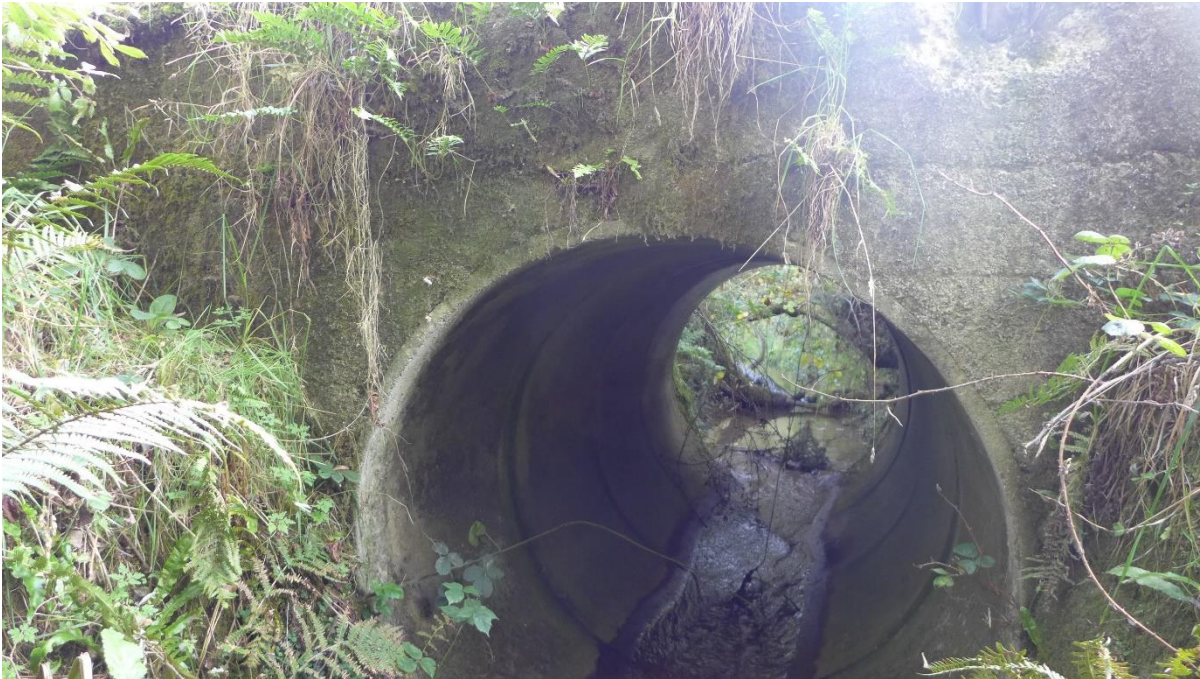
#### **Structure 1 (SW9581859751) Multi-use Trail Between Toads Hole and Gothers**

**Description:** Large concrete pipe with metal bridge above. Some gaps where interlocking pipe section met, approximately 15mm.

**Bat roost potential:** Low.

**Comments:** Limited day roost potential in gap where pipes meet. Potential night roost. Suitable for bat box enhancement on the wall.

**Further surveys:** Daytime inspections May to September to establish bat use.

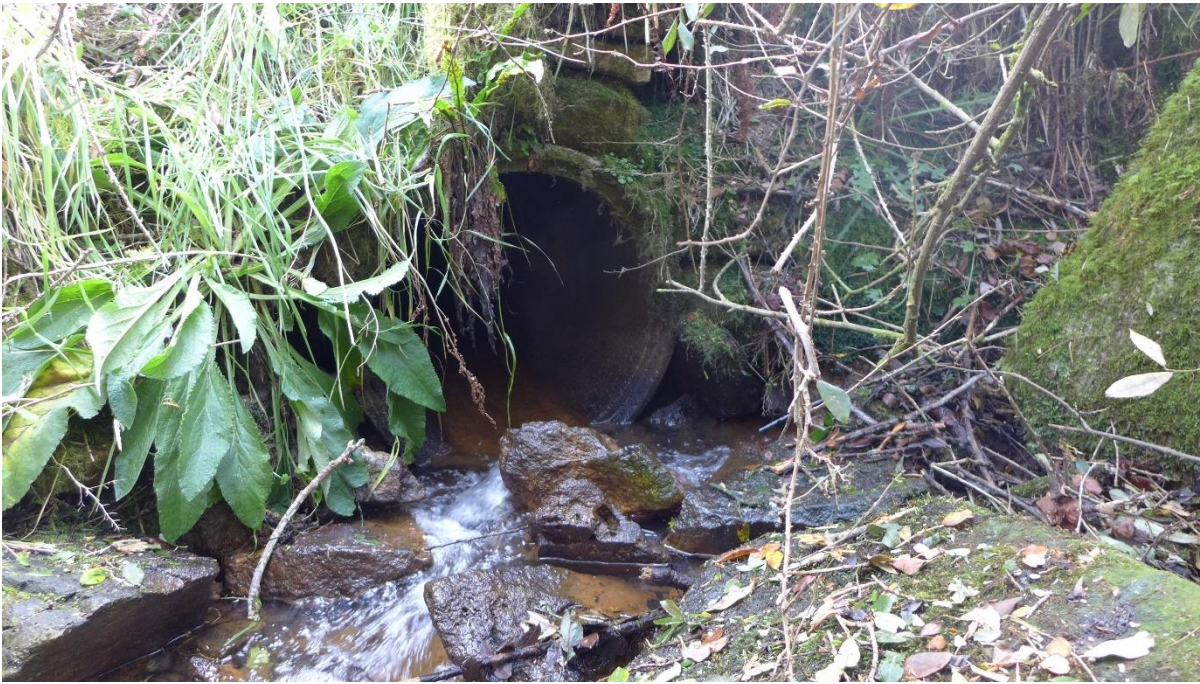
#### **Structure 2 (SW9583759756) Multi-use trail Between Toads Hole and Gothers**

**Description:** Culvert under track.

**Bat roost potential:** Negligible.

**Comments:** Little room for roosting bats and water level will be too high for periods.

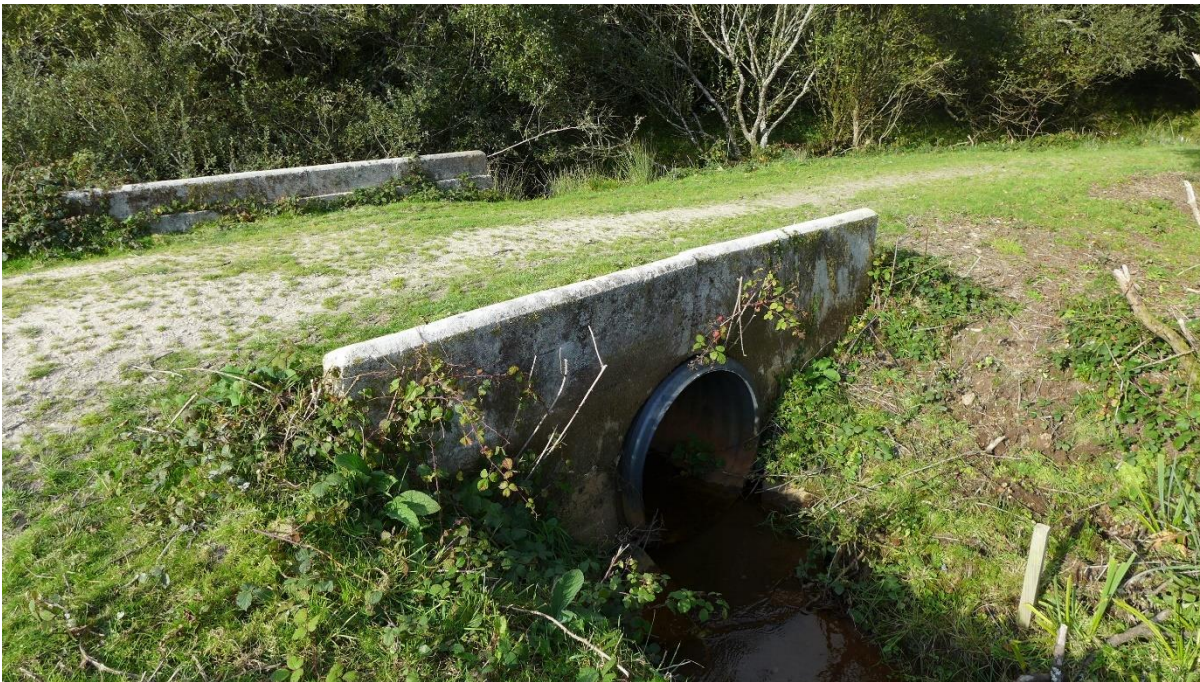
**Structure 3 (SW9519160012) River Fal and Gothers track**

**Description:** Concrete bridge over large plastic pipe.

**Bat roost potential:** Negligible.

**Comments:** Space inside limited, no crevices and smooth material.

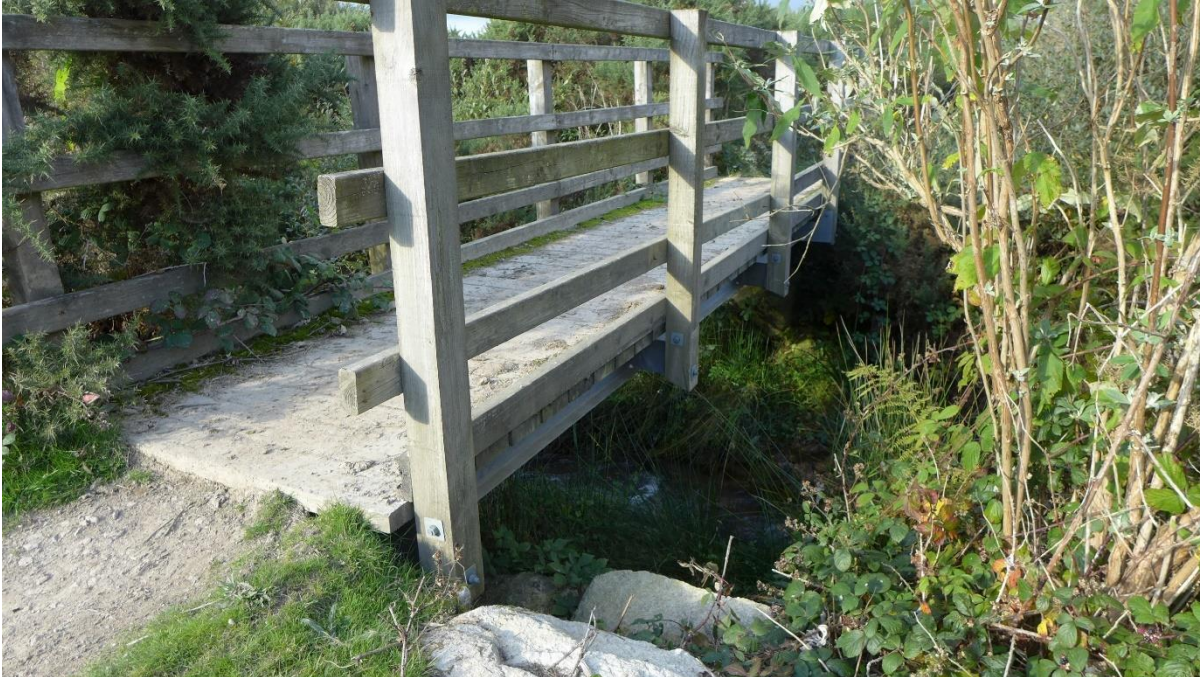
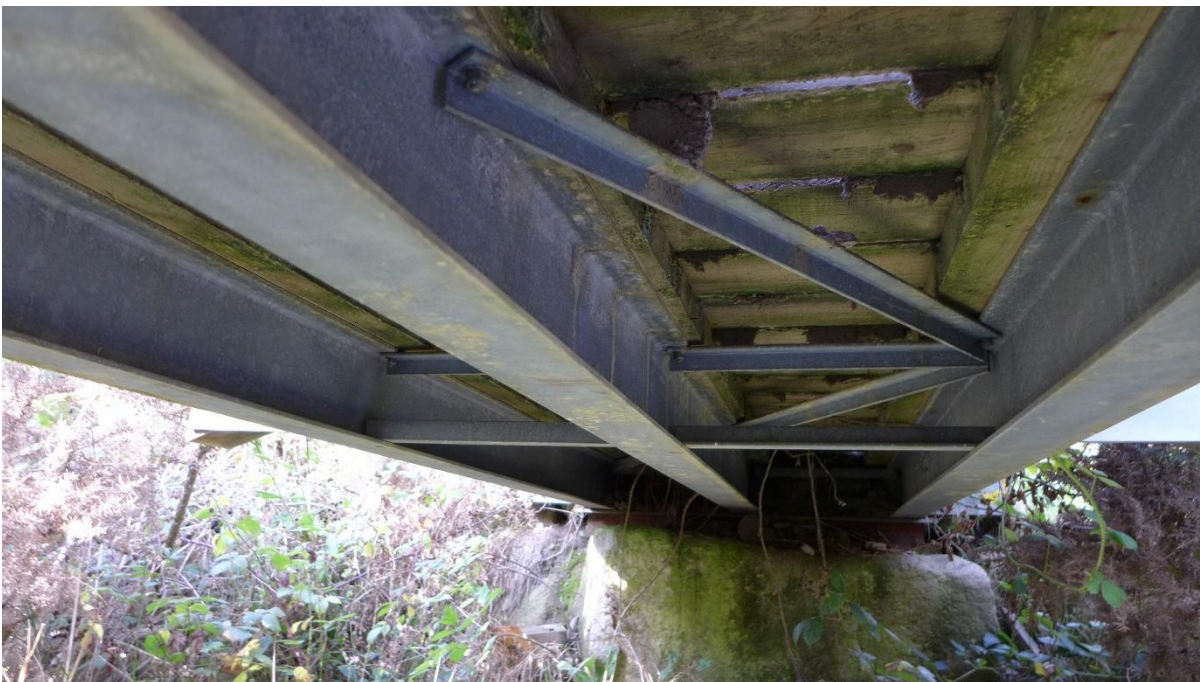
**Structure 4 (SW9541860126) Confluence of River Fal and Pendine Ditch**

**Description:** Wood and metal framed bridge

**Bat roost potential:** Low potential

**Comments:** No day roost features; night roost potential with good ground clearance and plenty of structures suitable for hanging bats. Suitable for bat box enhancement.

**Further surveys:** Camera trapping to check for night roost use.

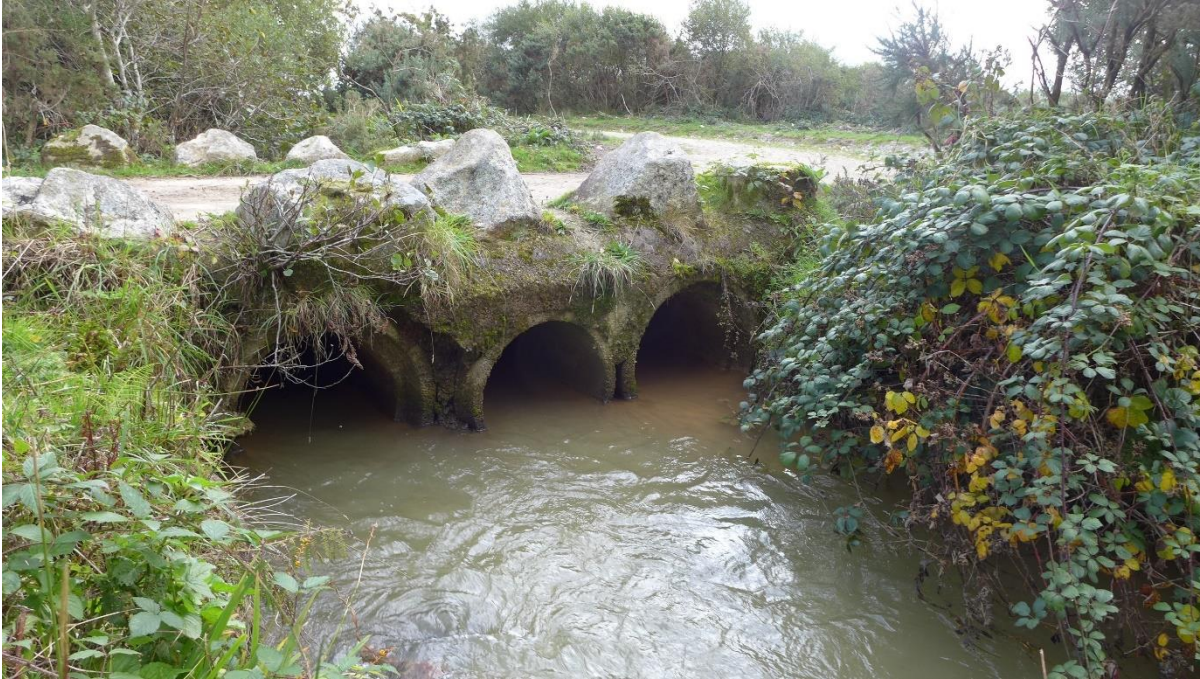
**Structure 5 (SW9510960042) Gothers Track near Blockhouse**

**Description:** Three concrete culverts beneath concrete bridge.

**Bat roost potential:** Negligible.

**Comments:** The water level was high so not examined inside. However, it was clear that there was little room inside for roosting bats.

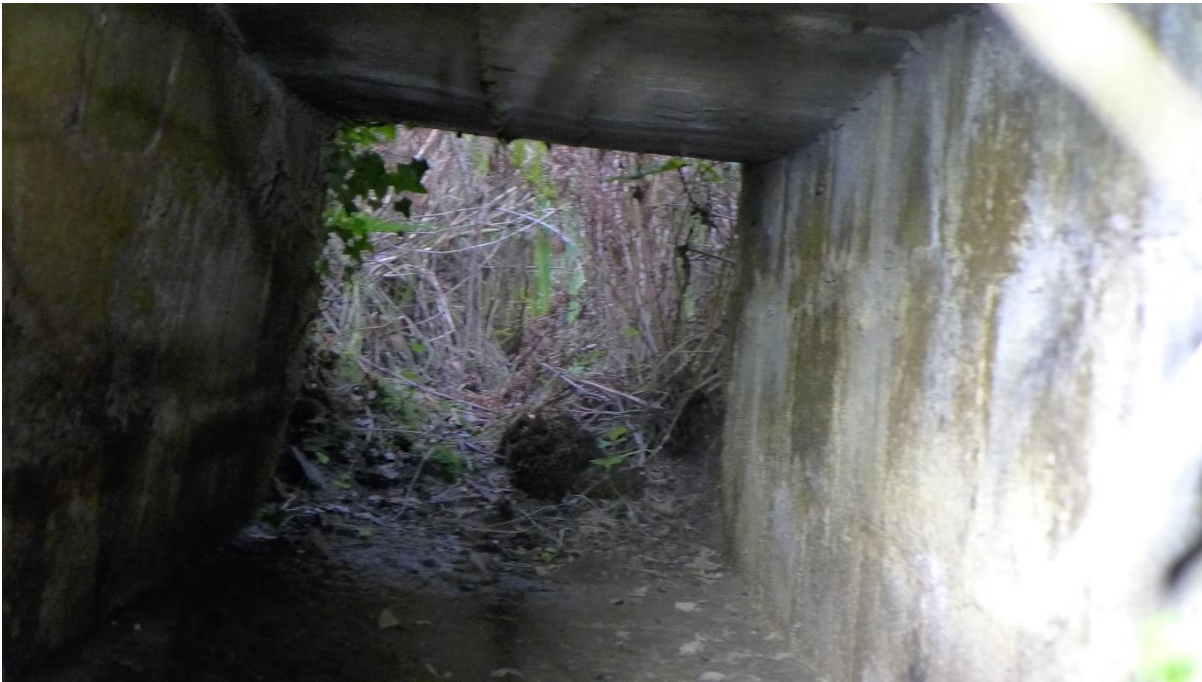
**Structure 6 (SW9467060108) Southerly Pool Track**

**Description:** Long, square concrete culvert beneath track, heavily overgrown with bramble at each end, Dry, no running water. Smooth surfaces within.

**Bat roost potential:** In its current state, negligible. However, it has significant potential for enhancement.

**Comments:** Scrub clearance to open up the entrances would allow use as a possible night roost. Provision of bat boxes would increase the structure's usefulness for bats by providing crevices.

**Further surveys:** In its current condition, none needed. After access improvement, remote monitoring.

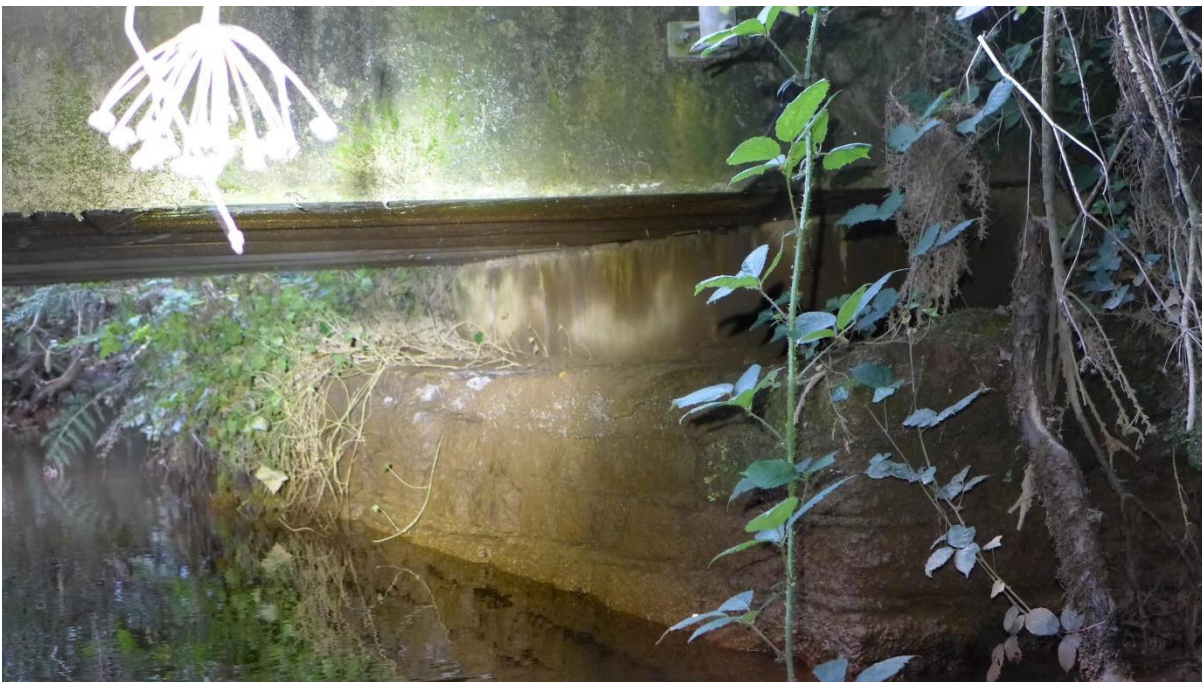
**Structure 7 (SW9464560151) Southerly Pool Track Entrance**

**Description:** Wide concrete slab over the river with metal rails. Substantial space beneath; smooth surfaces, broad shelf at the side.

**Bat roost potential:** Moderate potential for night roosting and day roosting bats.

**Comments:** Water depth prevented close inspection. Potential for enhancement through bat box provision.

**Further surveys:** Camera trapping and remote monitoring.

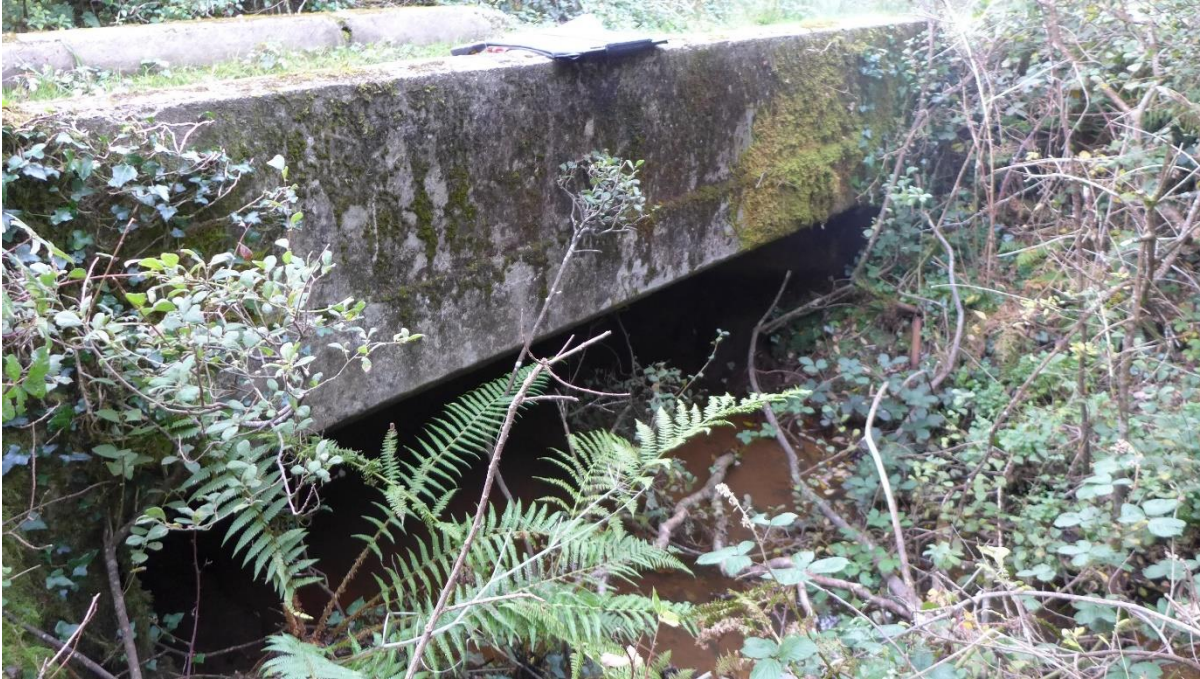
**Structure 8 (SW9454160243) Gothers Track Approaching Geraghtys**

**Description:** Wide concrete slab, completely smooth surfaces beneath.

**Bat roost potential:** Low. Possible use as a night and day roost by hanging bat species. No suitable crevices for other species.

**Comments:** Needs a little scrub clearance to open the structure up.

**Further surveys:** Camera trapping and remote monitoring.

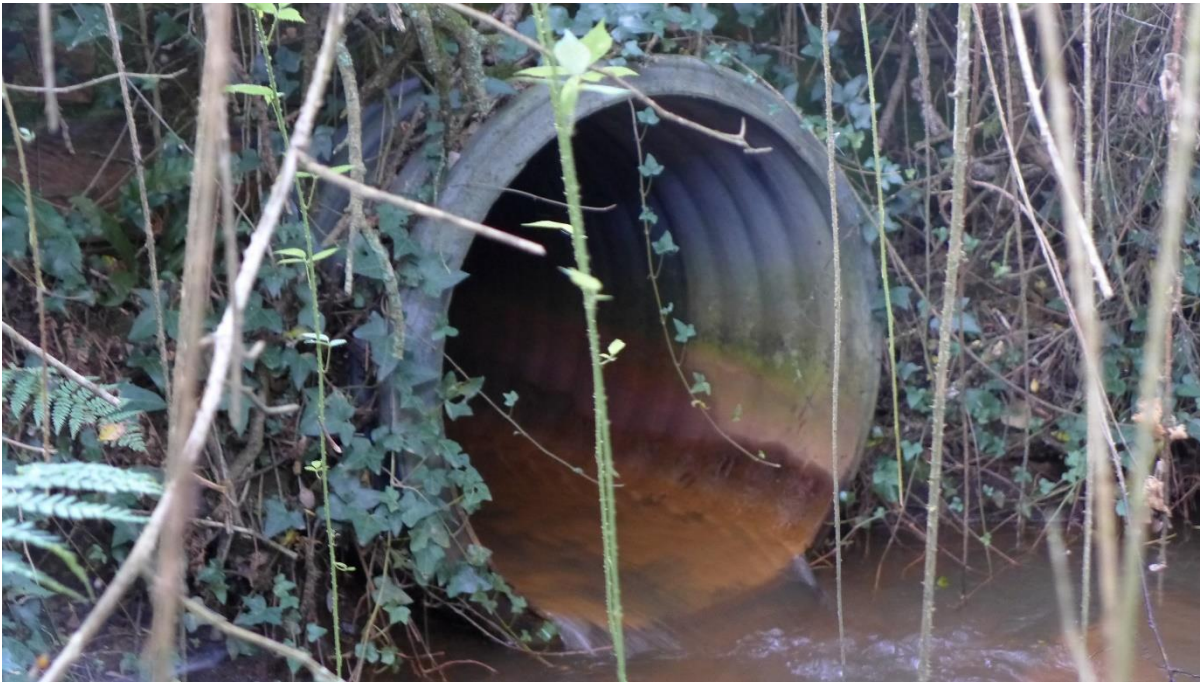
**Structure 9 (SW9452360330) Entrance to Geraghtys**

**Description:** Pipe beneath concrete bridge.

**Bat roost potential:** Low.

**Comments:** Possible use as a night roost.

**Further surveys:** Camera trapping.

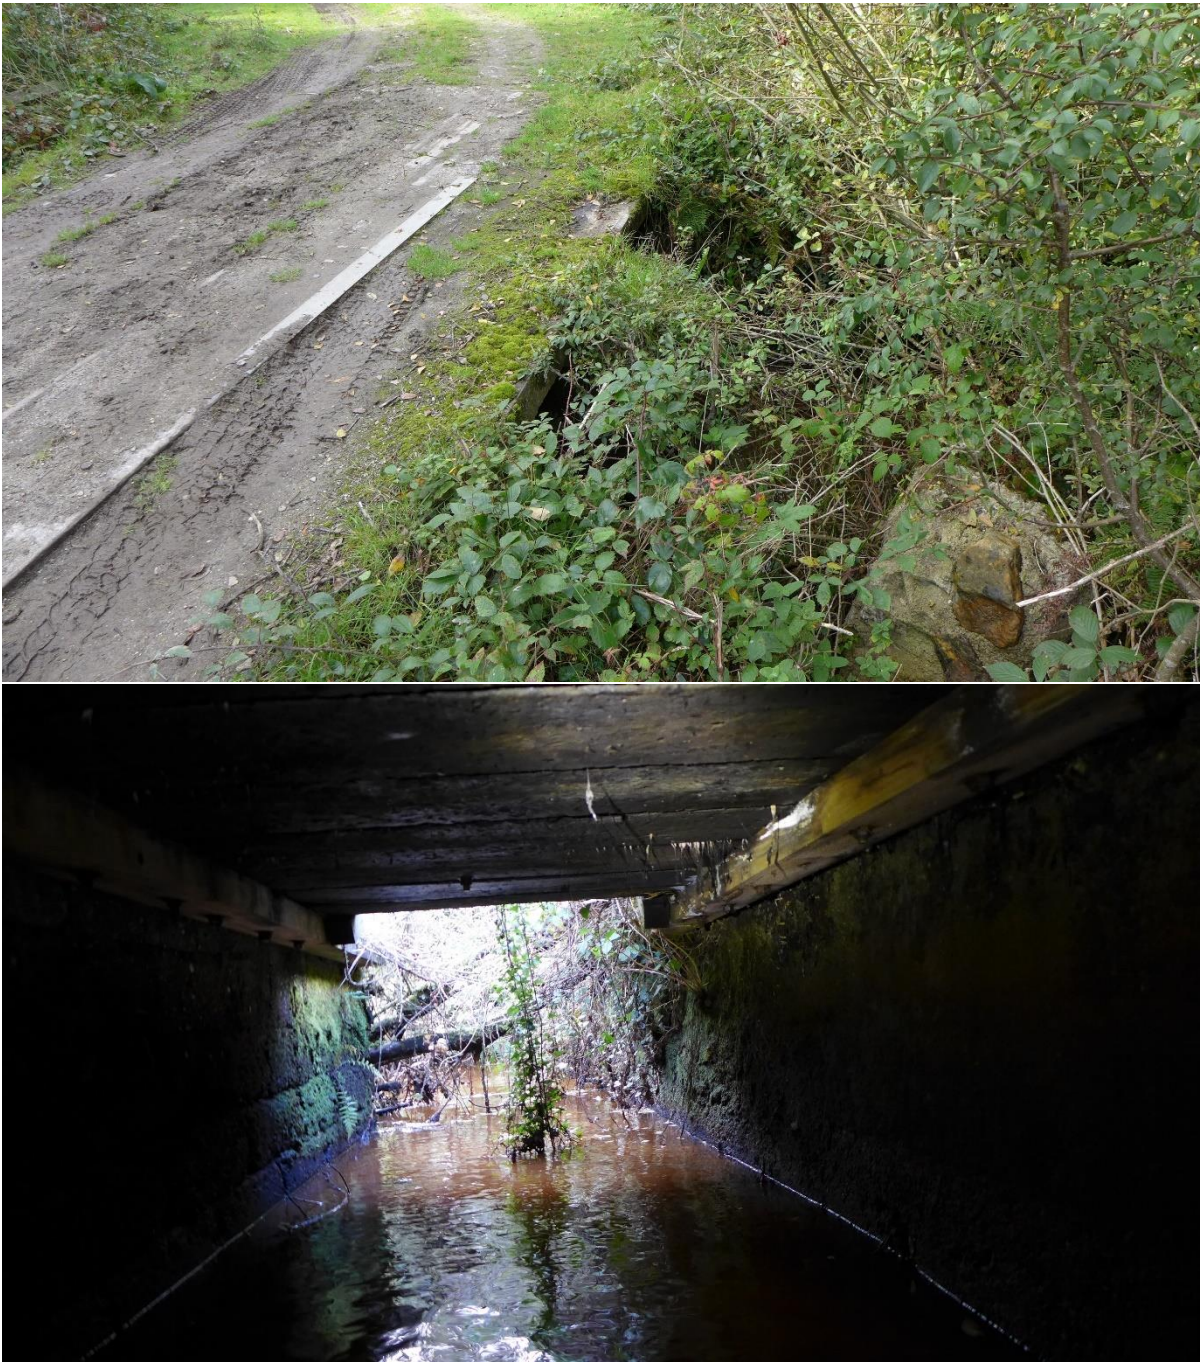
**Structure 10 (SW9461060332) Northerly Pool Track Near Geraghtys**

**Description:** Long structure with stone sides, made up of multiple sleepers running parallel with the track. Two long lengths of wood, one each side, to which the sleepers are bolted, with a significant gap present along their length between the wood and the stone.

**Bat roost potential:** Moderate with management. In its current state negligible.

**Comments:** Needs significant vegetation clearance to make it accessible to bats. Suitable gaps present for crevice-roosting bats.

**Further surveys:** After management, emergence surveys and remote monitoring in September.

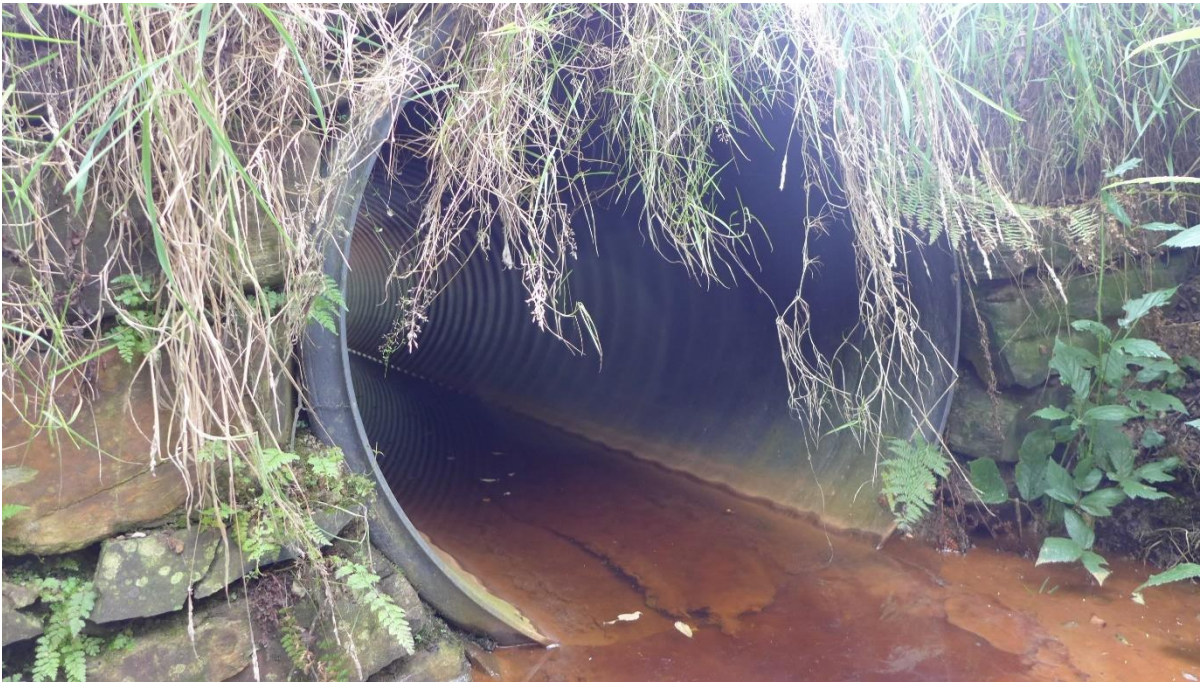
**Structure 11 (SW9484960155) Gothers Track Between Blockhouse and Geraghtys**

**Description:** Long plastic pipe underneath track above. Smooth surfaces inside, no crevices.

**Bat roost potential:** Low potential, possible occasional use as a night roost.

**Comments:** Herald moth hibernating inside. Keep vegetation clear of the entrance through management.

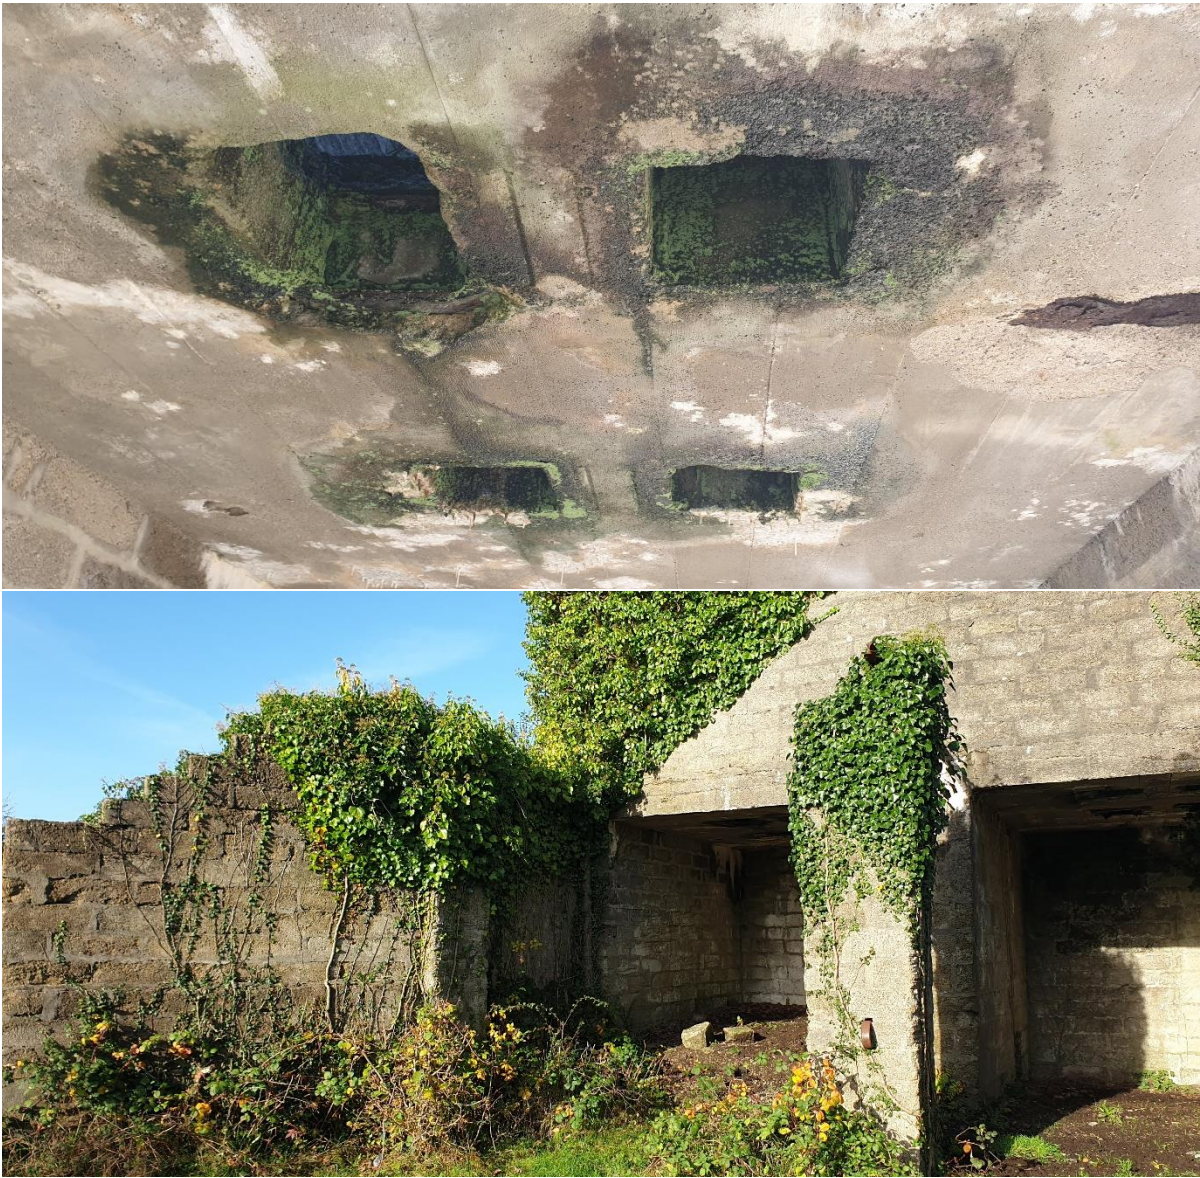
### **Structure 12 (SW9503460111) Central Goss Moor**

**Description:** Concrete building with two 'rooms' on the ground floor and open access for bats. Heavily ivy-clad externally. Some crevices present at the junction of block walls in places. Eight square holes in the roof lead from the ground floor to the floors above and offer places for bats to roost.

**Bat roost potential:** Moderate potential. Almost certainly used as a night roost; some potential for day roosting bats but a lot of potential for enhancement. With work it could be made into a suitable day-roost for horseshoe bats and crevice-roosting species, as well as a hibernation roost and increased value as a night roost.

**Comments:** Only the ground floors examined as no means of access to the level above.

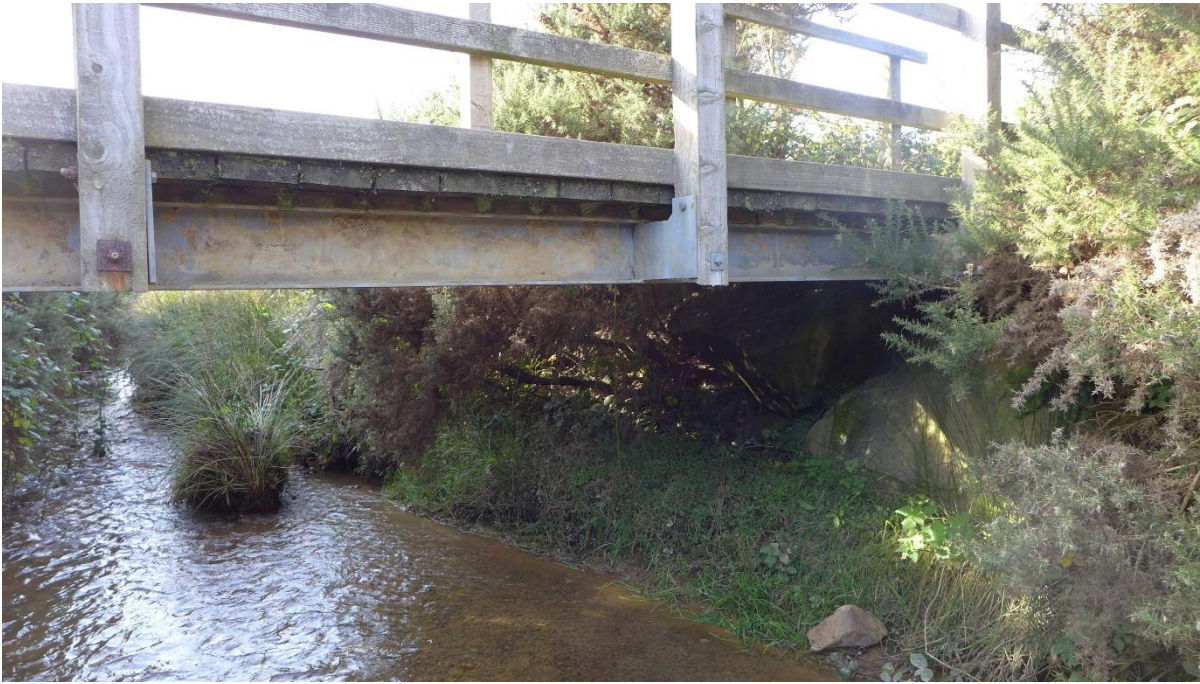
### **Structure 13 (SW9633660153) River Fal Near Dipping Platform**

**Description:** Wood and metal bridge structure with large clearance above the water beneath.

**Bat roost potential:** Moderate for night roosting bats.

**Comments:** Very likely to be used by bats at night but unsuitable as a day roost due to lack of crevices and very open aspect. Potential for enhancement through provision of bat boxes.

**Further surveys:** Camera trapping and remote monitoring.

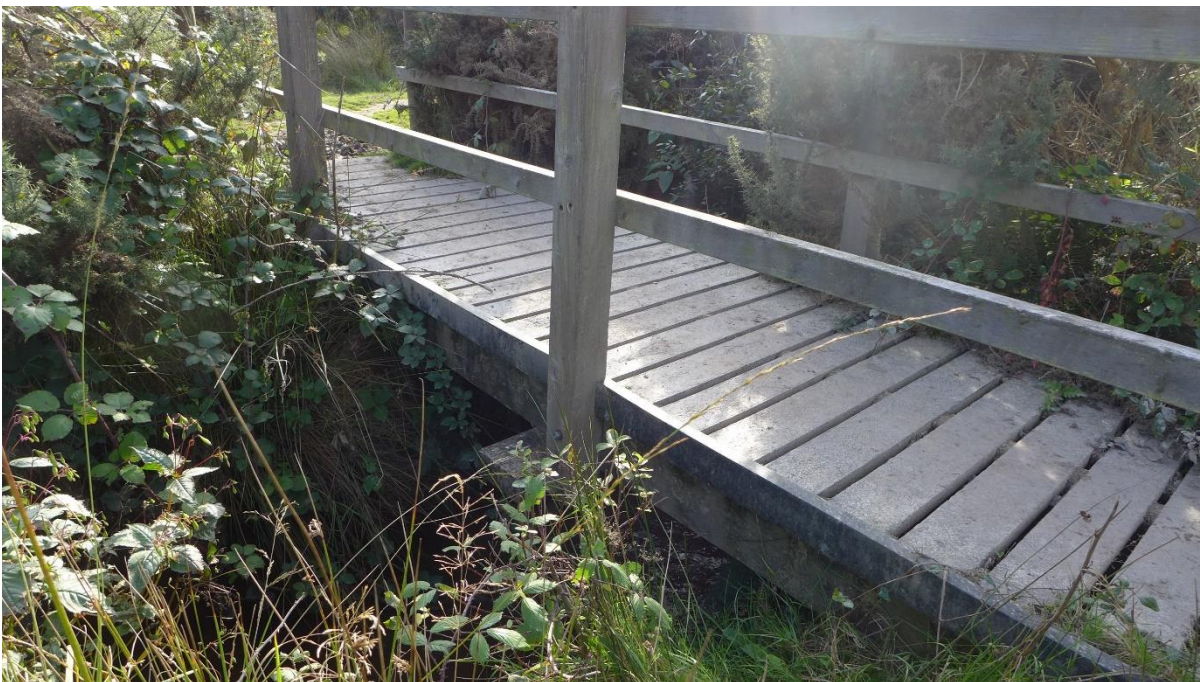
#### **Structure 14 (SW9603760131) River Fal at Marsh Fritillary Trail**

**Description:** Wooden bridge.

**Bat roost potential:** Negligible currently. Potential space beneath for night roost bats but needs scrub clearance to improve access.

**Comments:** No suitable crevices for day-roosting bats but potential for use as a night roost could be improved through management work.

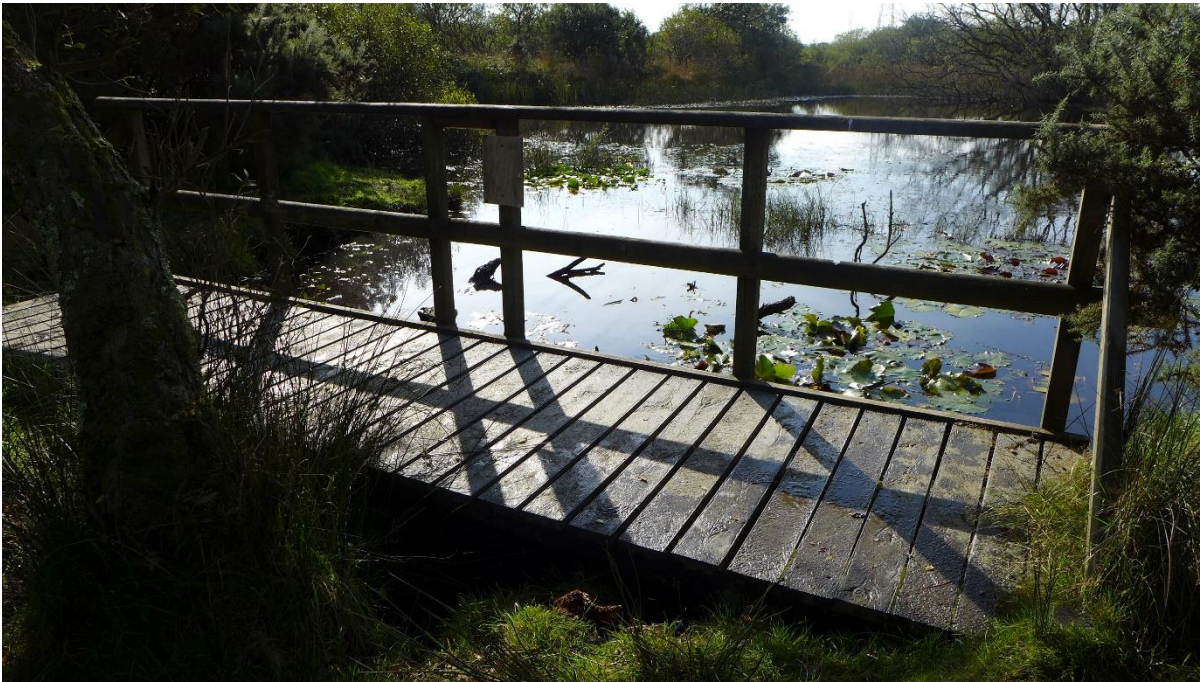
**Structure 15 (SW9637860130) Dipping Pond**

**Description:** Wooden bridge beside small lake.

**Bat roost potential:** Negligible.

**Comments:** Water level close to the bottom of the bridge throughout the year, leaving little potential for roosting bats. It is possible that bats may occasionally hang from the wooden rails as a night feeding roost, interspersed with forays over the water to catch insects.

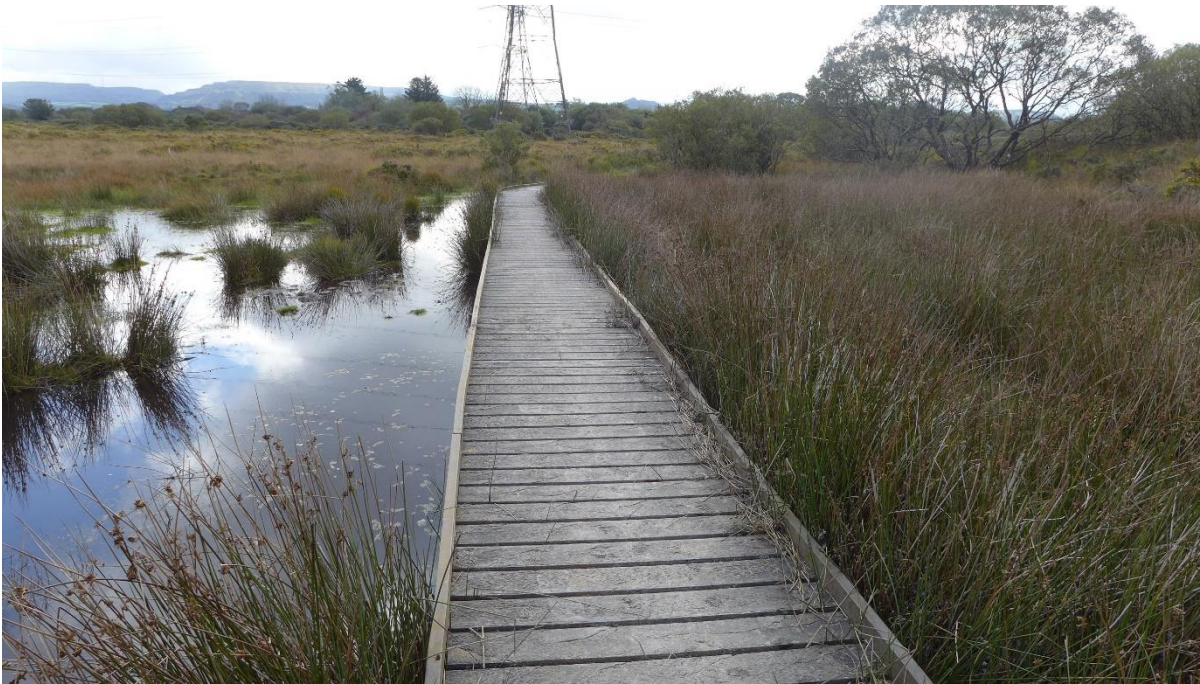
**Structure 16 (SW9598460047) Marsh Fritillary Trail**

**Description:** Plastic boardwalk over large area of standing water.

**Bat roost potential:** Negligible.

**Comments:** Approximately 40cm clearance between the water and the boardwalk did not offer sufficient space for use as a night roost at any time of year.

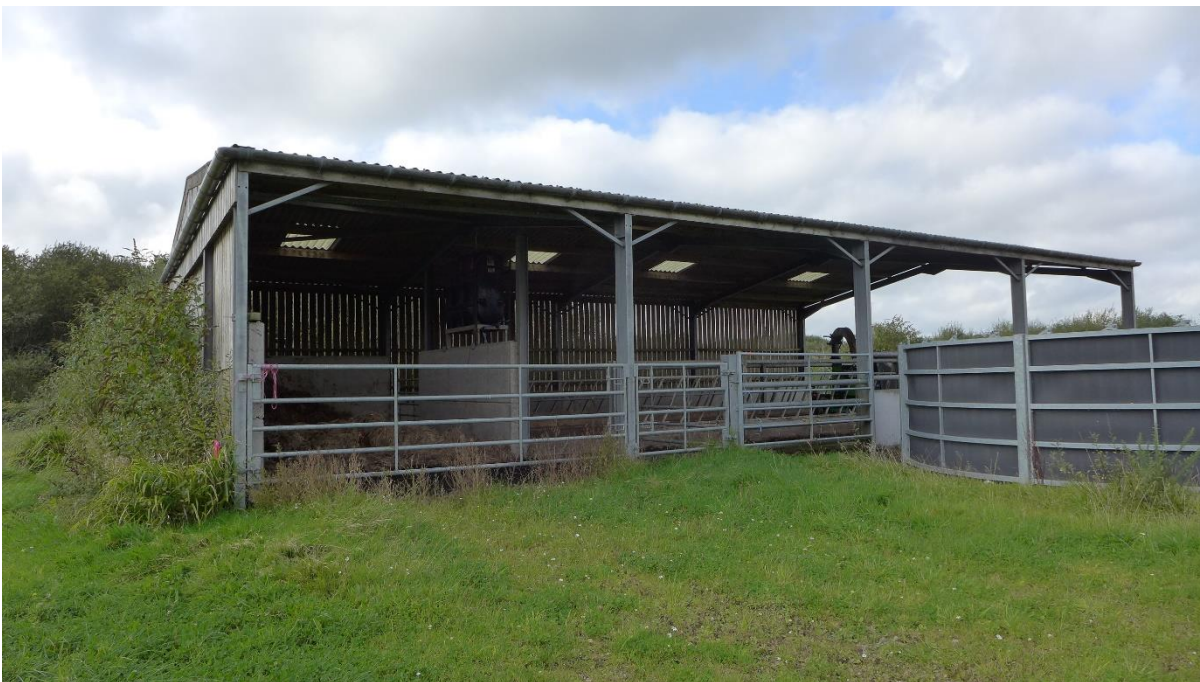
### **Structure 17 (SW9446360380) Geraghtys**

**Description:** Steel-framed building with wooden walls and a corrugated asbestos sheeted roof, open on two sides of the building.

**Bat roost potential:** Low

**Comments:** Easy access makes it a likely night roost; gaps between beams and the roof offer some potential for day-roosting bats.

**Further surveys:** Emergence surveys, May to September.

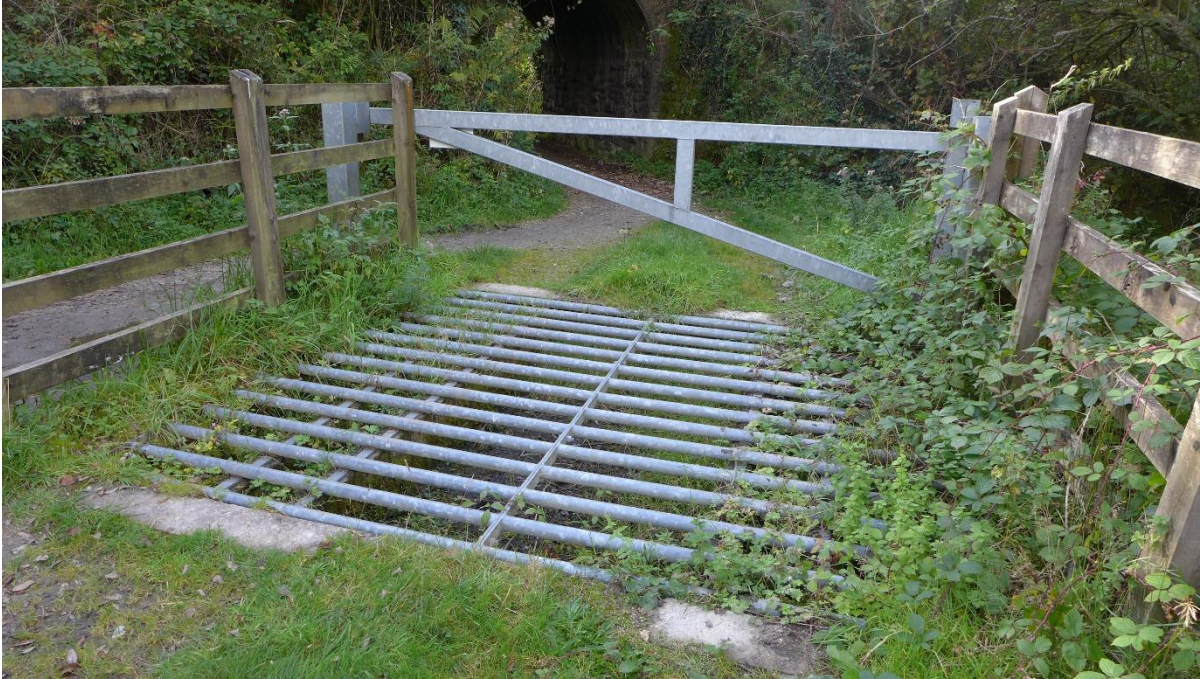
**Structure 18 (SW9432058816) Next to Dommellick Cattle Arch**

**Description:** Metal cattle grid.

**Bat roost potential:** Negligible.

**Comments:** Space below the grid but not enough for bats.

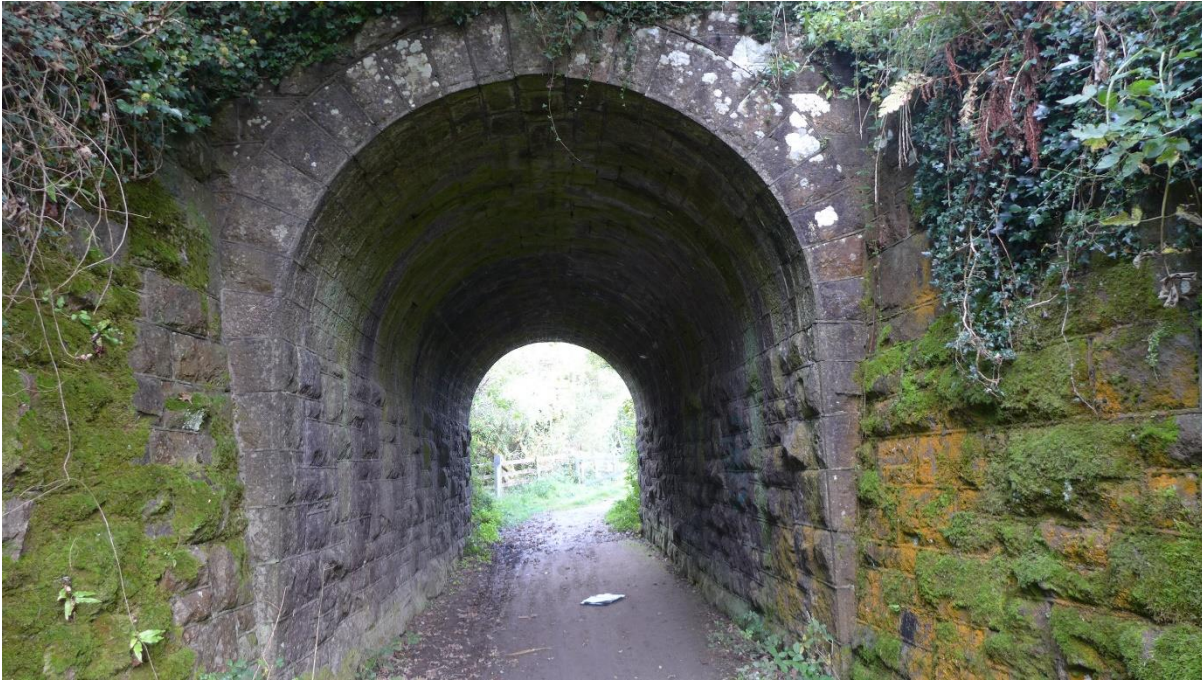
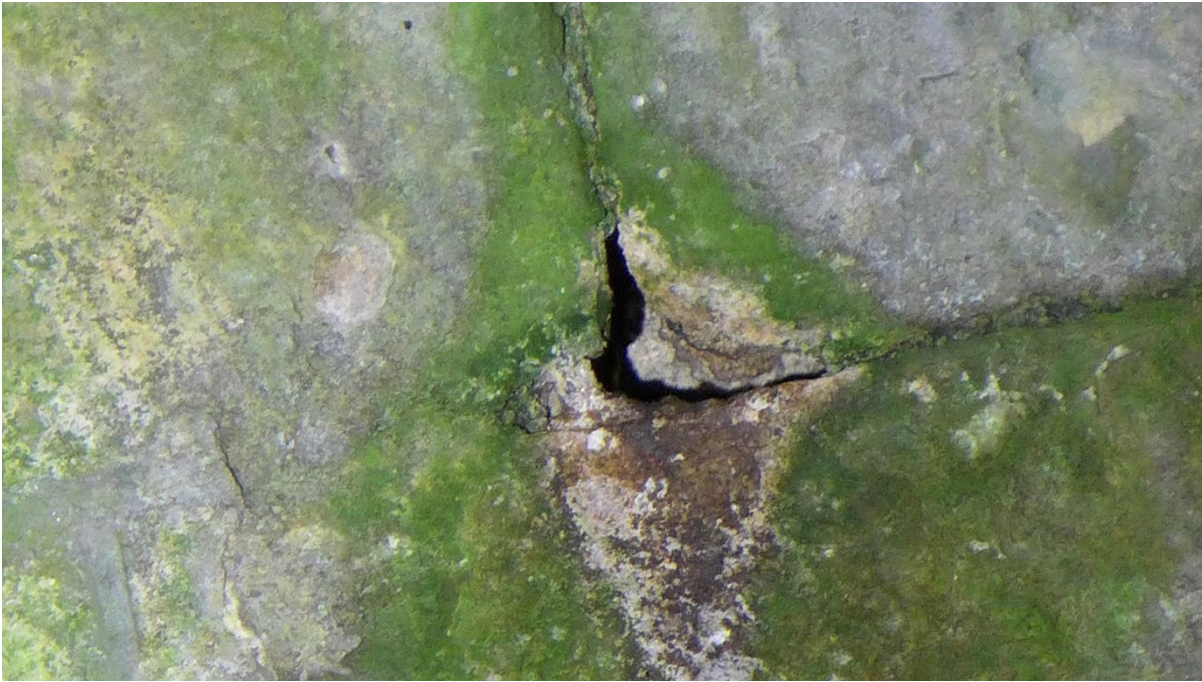
**Structure 19 (SW9430458816) Dommellick End of the Multi-use Trail**

**Description:** Stone-built cattle arch.

**Bat roost potential:** None.

**Comments:** Some gaps in the ceiling and the sides where mortar was missing from around the stones. Light ivy covering externally but not enough to host bats. Potential for night roosting and crevice-dwelling day-roosting bats.

**Further surveys:** Emergence surveys, May to September.

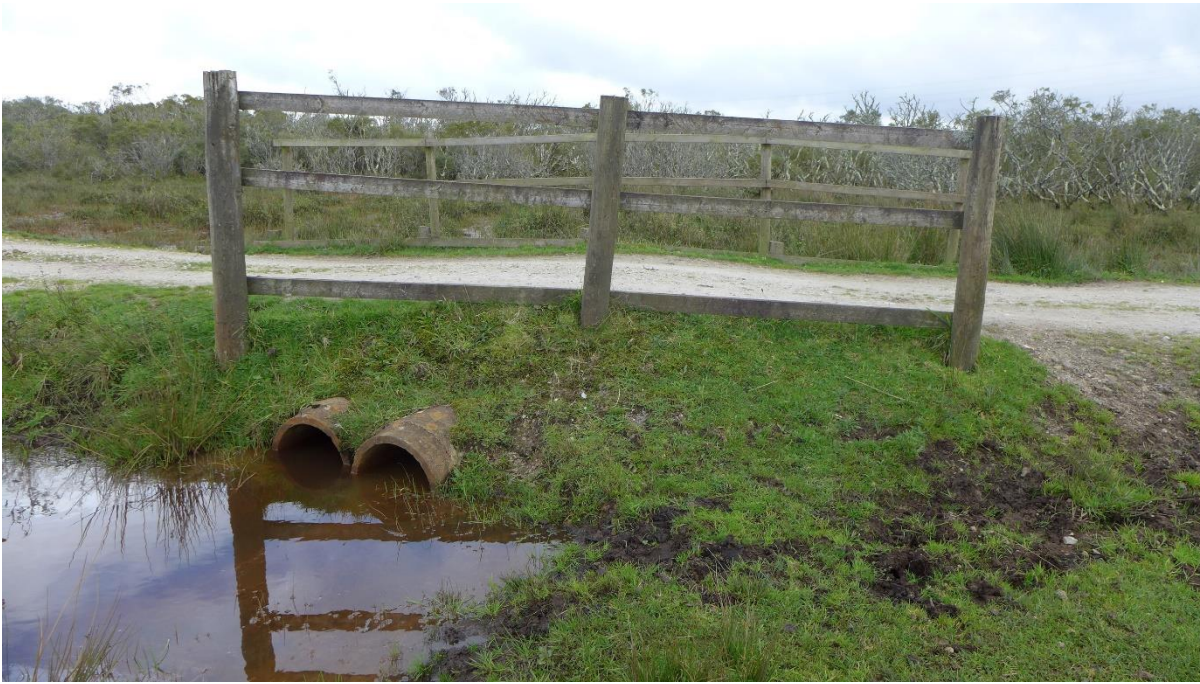
**Structure 20 (SW9546759595) Multi-use Trail at Kink to the West of Gothers Track**

**Description:** Two small concrete pipes beneath track.

**Bat roost potential:** None.

**Comments:** Only 20cm clearance from the water surface and the top of the pipes.

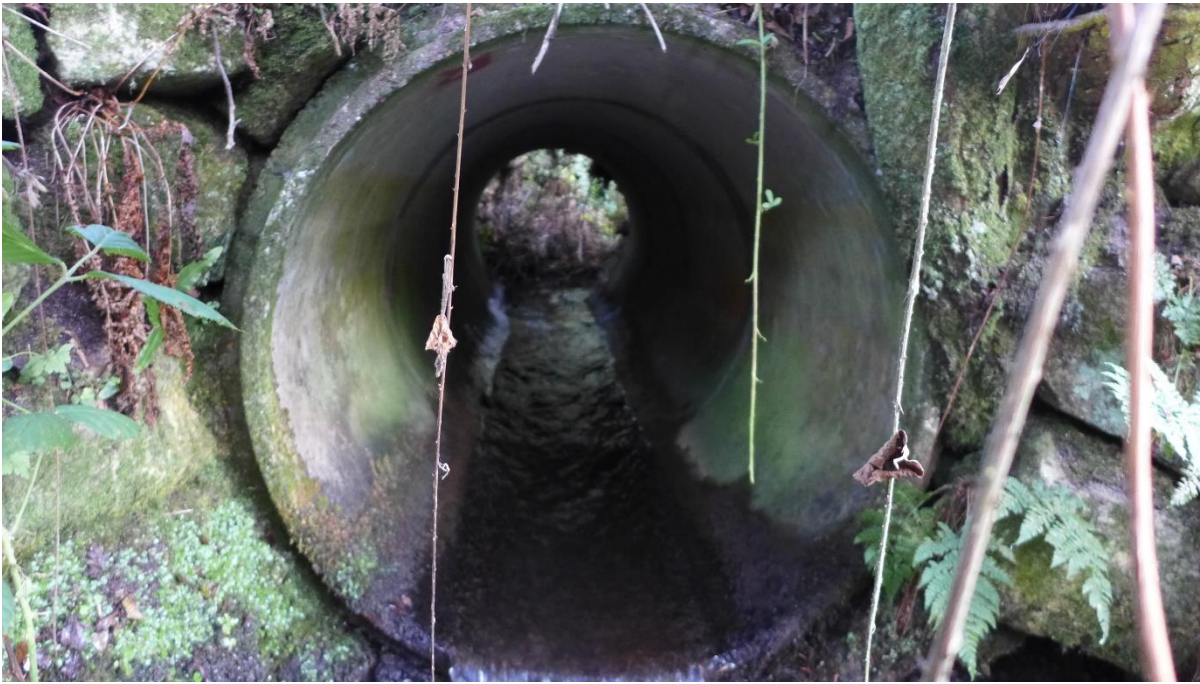
**Structure 22 (SW9618259336) Where Track Splits at Salt Box**

**Description:** Concrete pipe with smooth surfaces inside, c. 1.2m diameter.

**Bat roost potential:** Low.

**Comments:** Potential for use as a night roost or even a day roost by hanging bat species. Needs some vegetation clearance to open up access.

**Further surveys:** Camera trapping and remote monitoring.
