# Built structures bat report

**Site:** Goss Moor NNR

**Client:** Natural England

**Date:** December 2021

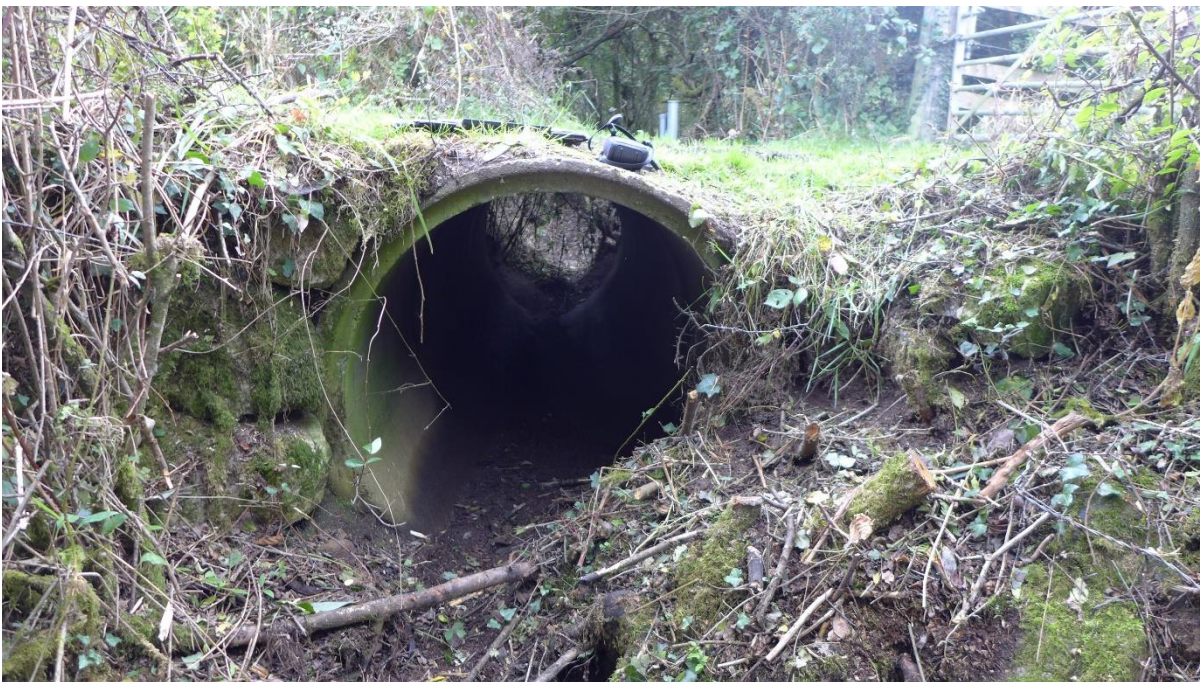
**Structure 23 (SW9524159285) From Field 9 on the East Side of Penrose Veor onto Goss Moor**

**Description:** Large concrete pipe beneath track. Damp and muddy inside but no running water. Smooth interior with no crevices.

**Bat roost potential:** Low.

**Comments:** Night roost potential.

**Further surveys:** Camera trapping and remote monitoring.

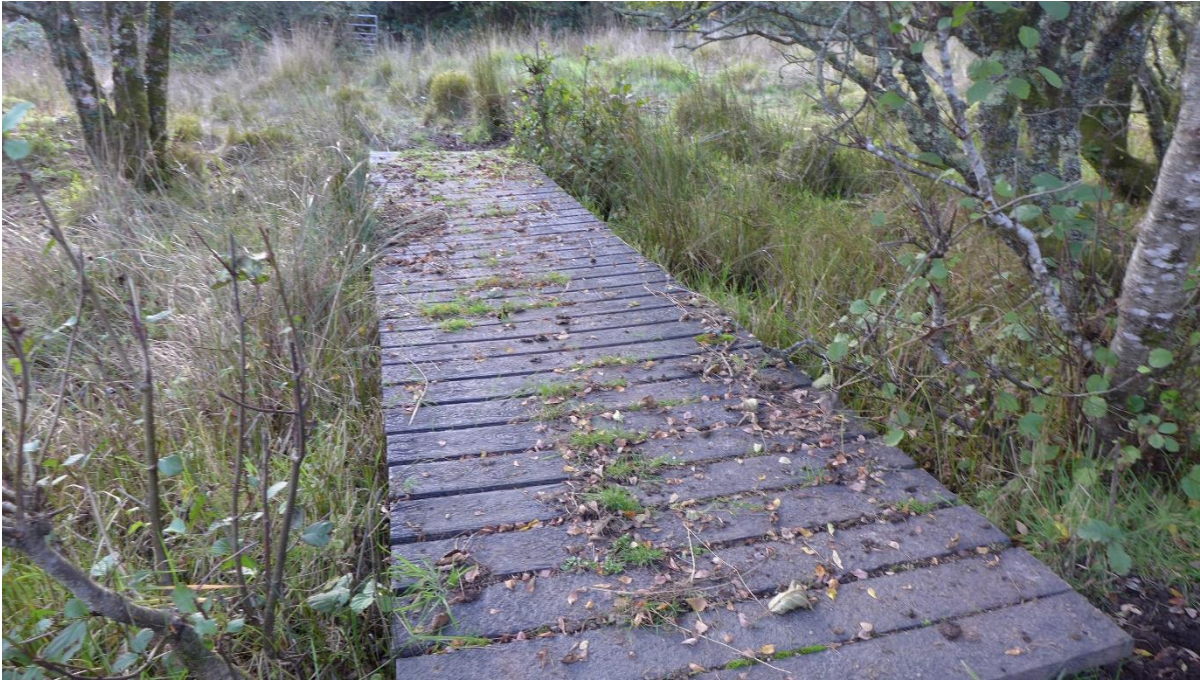
**Structure 24 (SW9346959669) Adder Field**

**Description:** Plastic boardwalk.

**Bat roost potential:** None.

**Comments:** Too low to the ground and vegetated underneath to offer any potential for roosting bats.

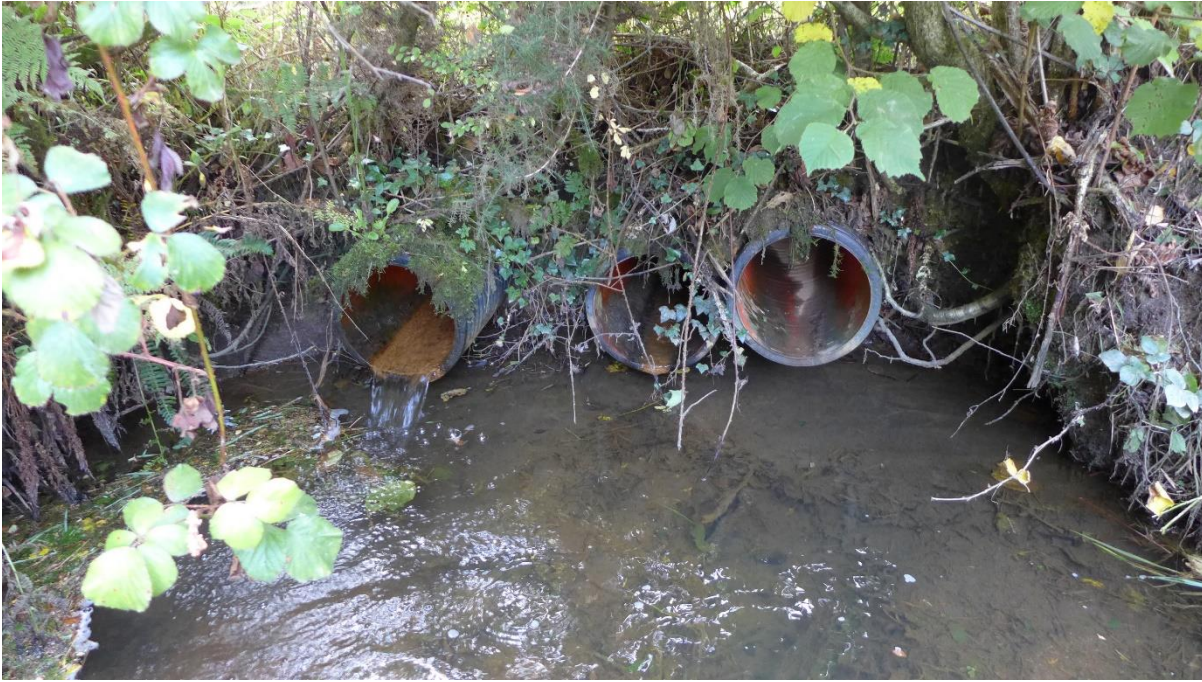
**Structure 25 (SW9343559631) Gaverigan Field**

**Description:** Three-piped culvert, pipes c. 30cm diameter.

**Bat roost potential:** None.

**Comments:** Pipes too small to offer any roost potential.

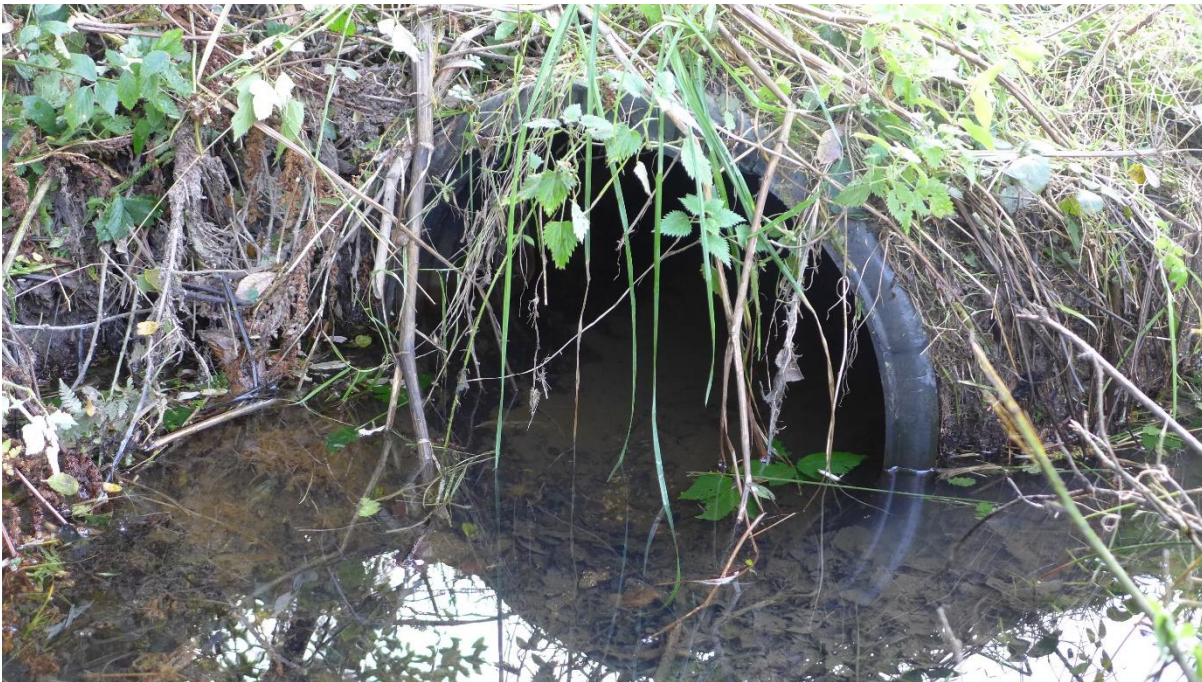
**Structure 26 (SW9339059634) Gaverigan Field**

**Description:** Plastic pipe of c. 40cm diameter. Obscured by vegetation.

**Bat roost potential:** Negligible.

**Comments:** Little space for roosting bats and obscured by vegetation so unlikely to be used.

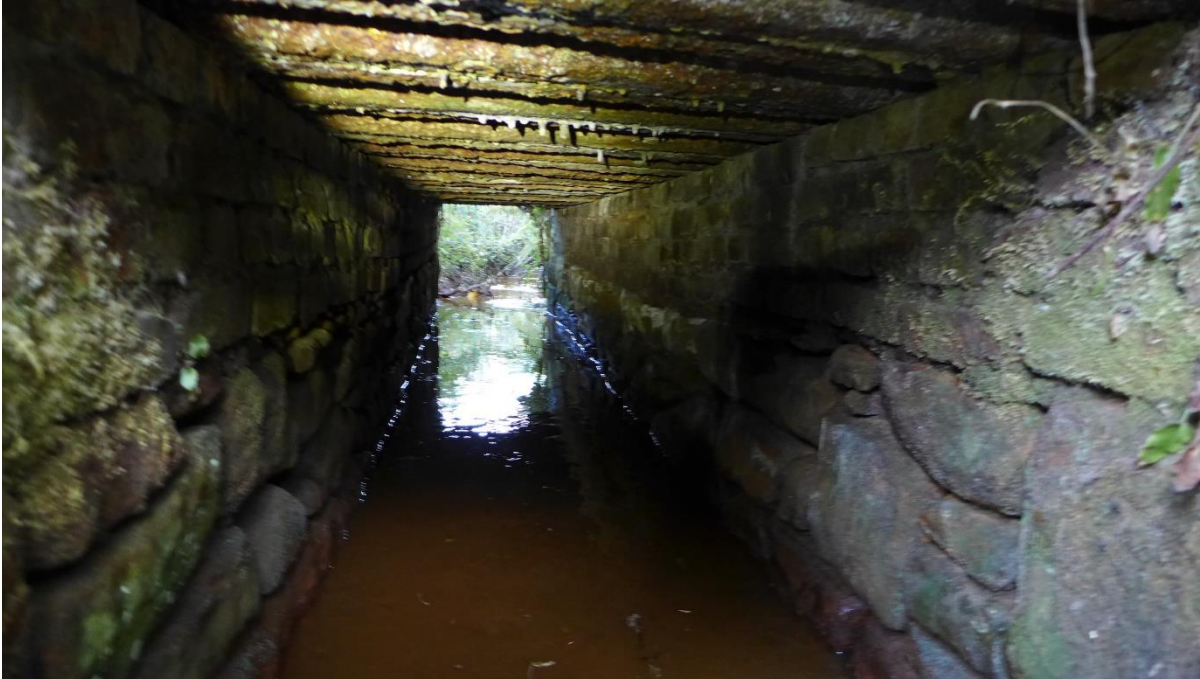
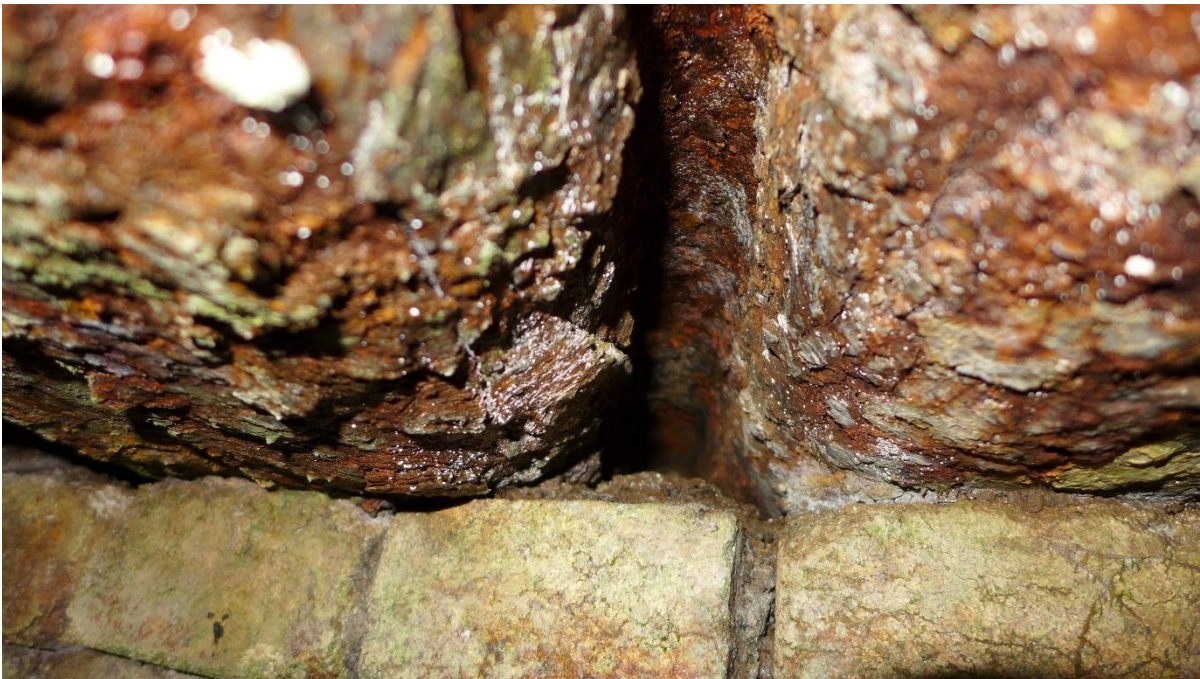
**Structure 27 (SW9367559594) Across Trail Next to Donkey Field North Entrance**

**Description:** Square culvert, stone built. Approximately 1.2m clearance from the water to the roof.

**Bat roost potential:** Moderate.

**Comments:** Substantial gaps in stone walls and between rusting corrugated roof material.

**Further surveys:** Emergence surveys and remote monitoring, May to September.

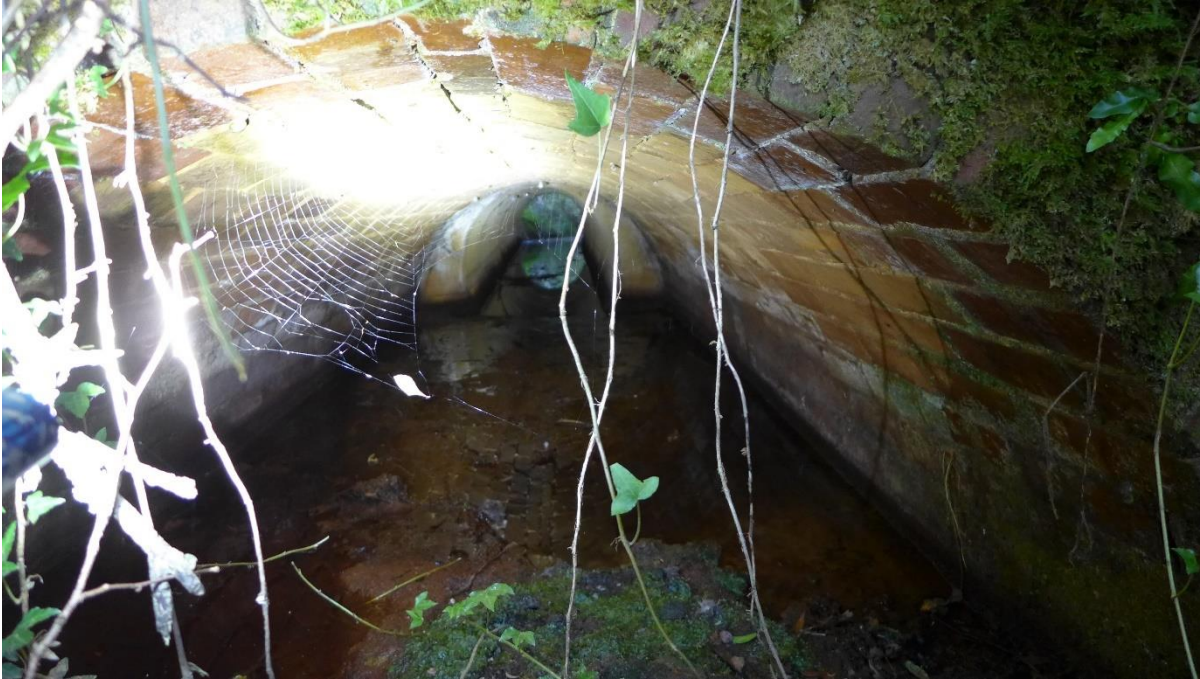
**Structure 28 (SW9370359380) Donkey Field South Entrance**

**Description:** Long arched brick structure with approximately 80cm clearance between water and the ceiling.

**Bat roost potential:** Moderate.

**Comments:** Possible day and night roost. Needs scrub clearance at each end to improve access.

**Further surveys:** Emergence survey and remote monitoring.

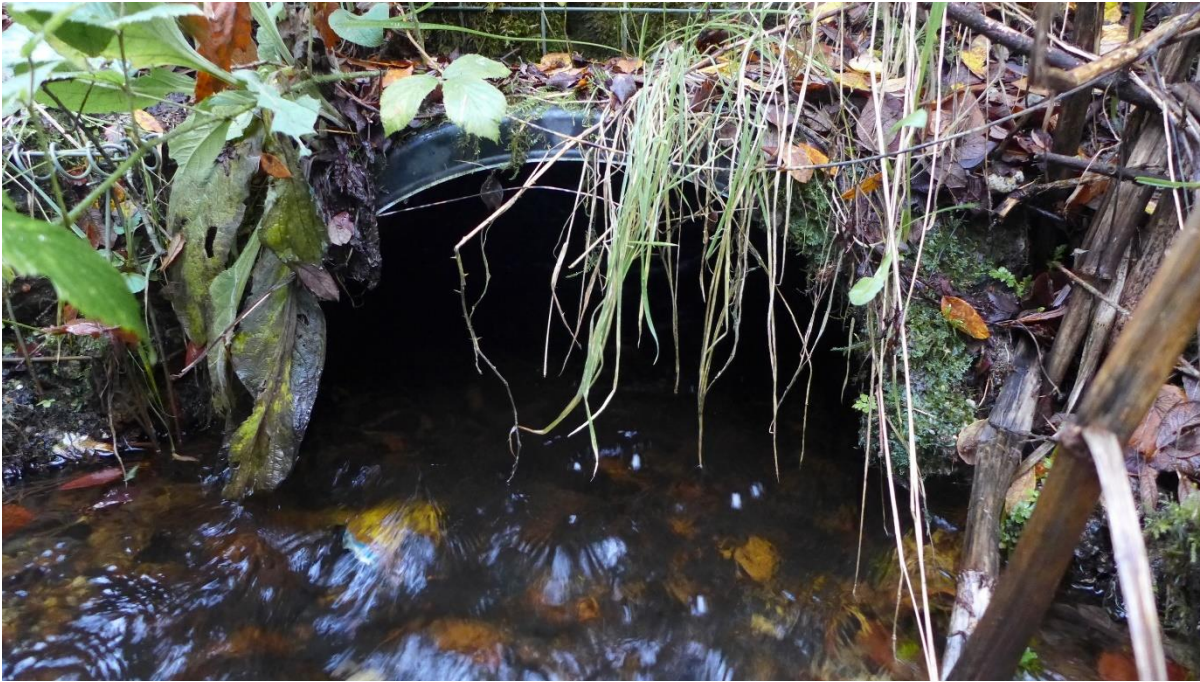
**Structure 29 (SW9525160769) Lily Pond Loop East Entrance Off Old A30**

**Description:** Single plastic pipe. Even though the water was shallow (approximately 10cm deep) it left very little space inside the pipe.

**Bat roost potential:** None.

**Comments:** Too little space to be of any value for bats.

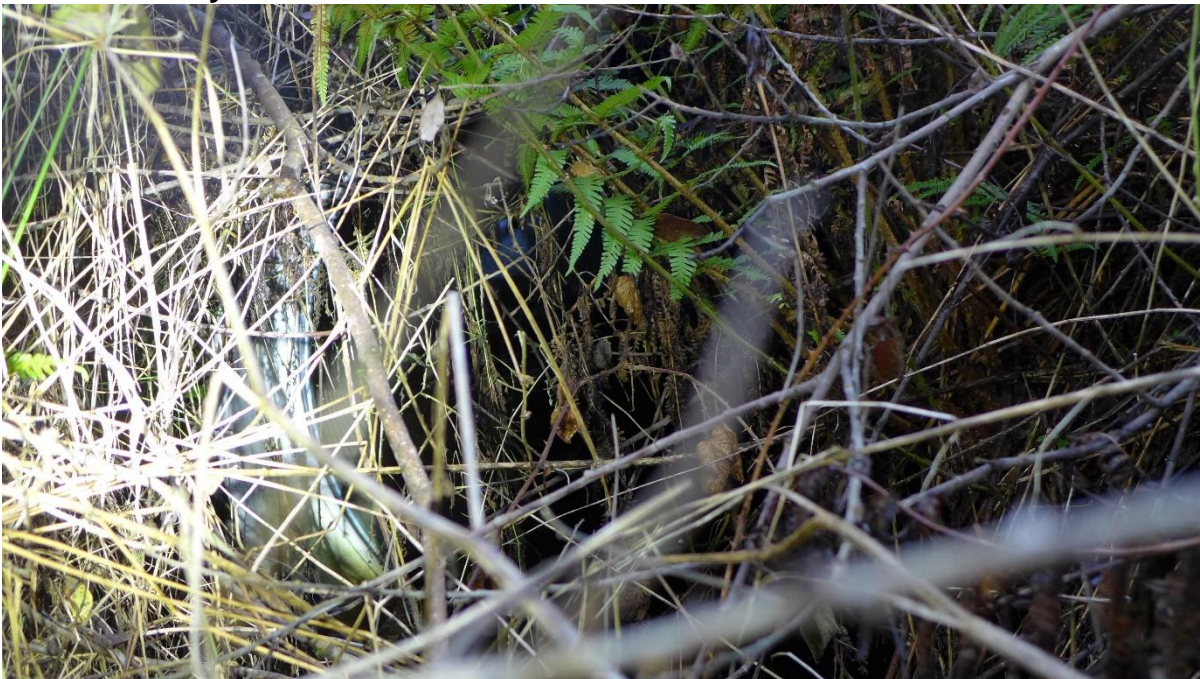
**Structure 30 (SW9605460979) East Entrance to Dinosaur Pen Off Old A30 Carpark**

**Description:** Single plastic pipe. Very overgrown with vegetation.

**Bat roost potential:** None.

**Comments:** Too little space to be of any value for bats and heavily overgrown with vegetation, impeding access.

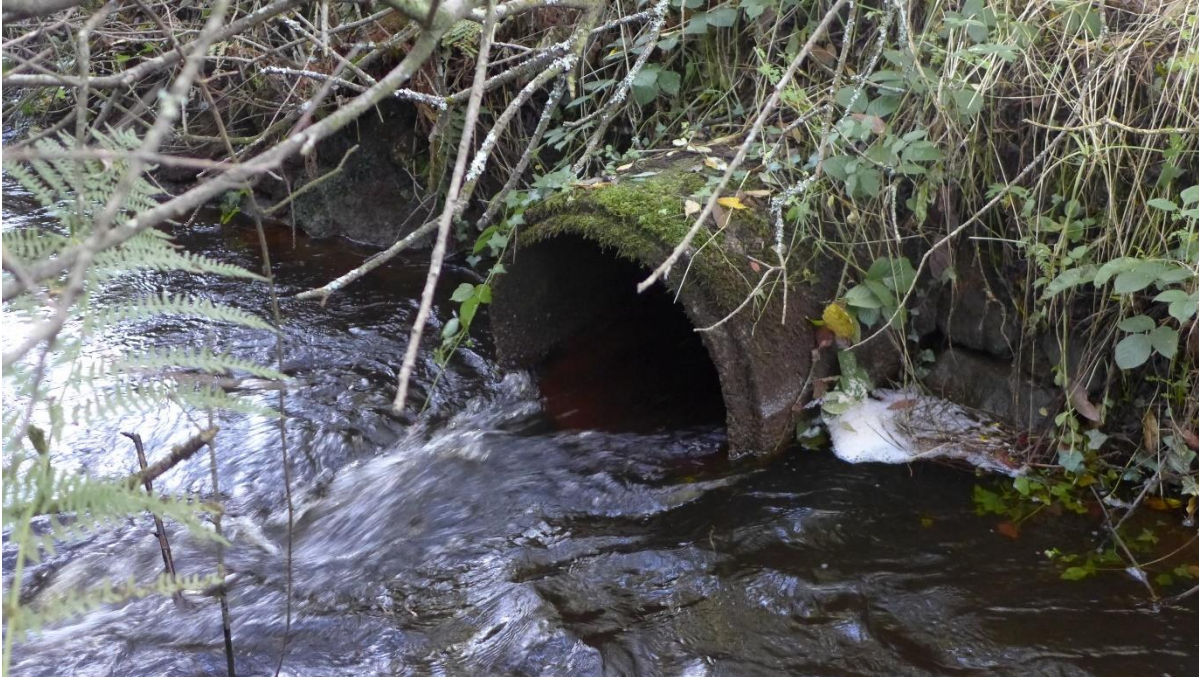
**Structure 31 (SW9499260942) Where Track to Duddons Branches off From Lily Pond Loop**

**Description:** Two plastic pipes.

**Bat roost potential:** None.

**Comments:** Too little space to be of any value for bats (approximately 20cm from top of pipe to the water surface).

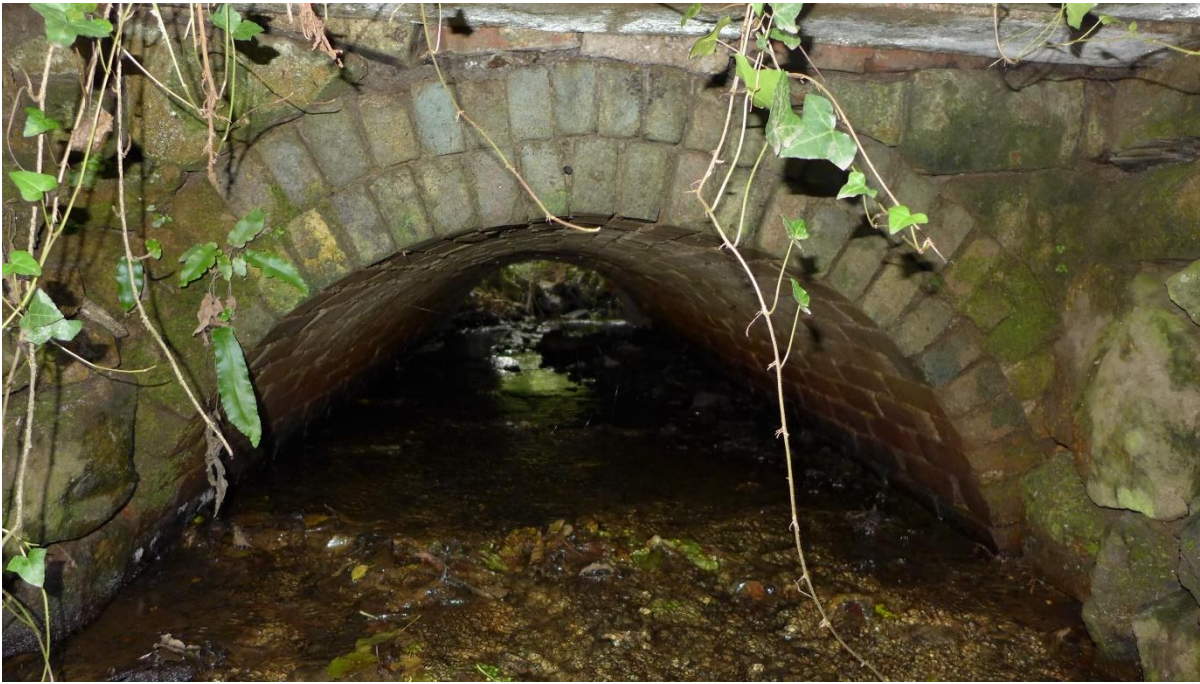
**Structure 32 (SW9369758729) South End of Track From Gaverigan Onto Road at Domellick**

**Description:** Brick-built arched culvert beneath track. Shallow-flowing water, approximately 70cm clearance from the water surface to the top of the culvert.

**Bat roost potential:** Moderate.

**Comments:** Some bricks had fallen out and others were falling, creating potential for crevice-roosting bats in the substantial alcoves left behind. Close examination not possible at this time of year due to safety concerns, operating in a confined space with flowing water and loose bricks. This may be more feasible in the summer months. Some cracks and crevices also present in the outer part of the bridge, which held potential for roosting bats.

**Further surveys:** Daytime search in the summer months. Remote monitoring and camera trapping.

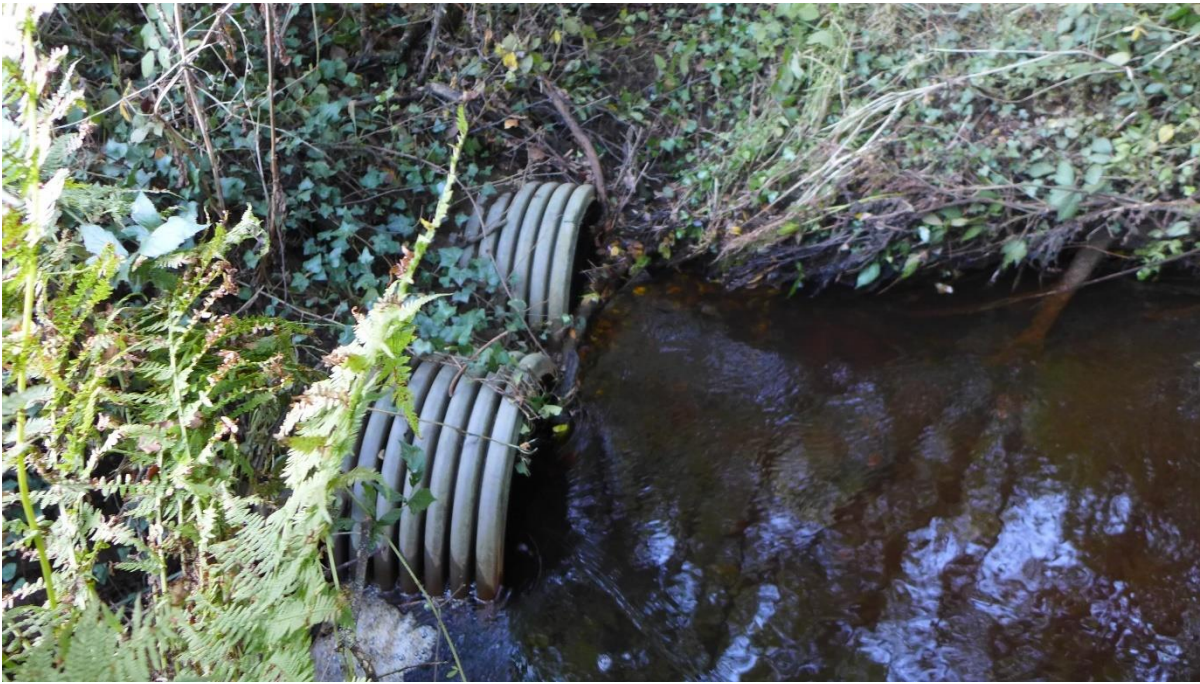
**Structure 34 (SW9472760574) Old A30 Near Lily Pond Loop West Entrance**

**Description:** Two plastic pipes, culvert under the old A30.

**Bat roost potential:** None.

**Comments:** Water level almost filling the pipes, leaving approximately 40cm clearance.

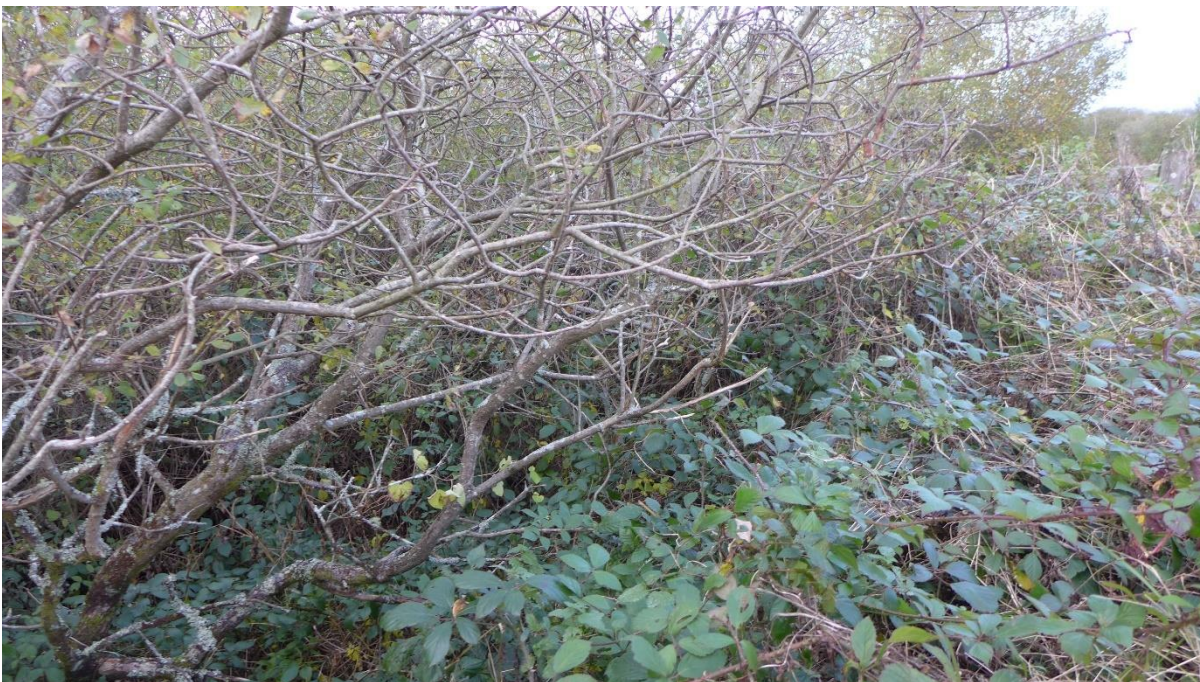
**Structure 35 (SW9559360908) West Entrance to Dinosaur Pen Off Old A30**

**Description:** Culvert beneath concrete bridge. Totally impenetrable scrub.

**Bat roost potential:** None.

**Comments:** Not possible to examine properly due to the degree of vegetation growth. However, for the same reason it is not accessible to bats.

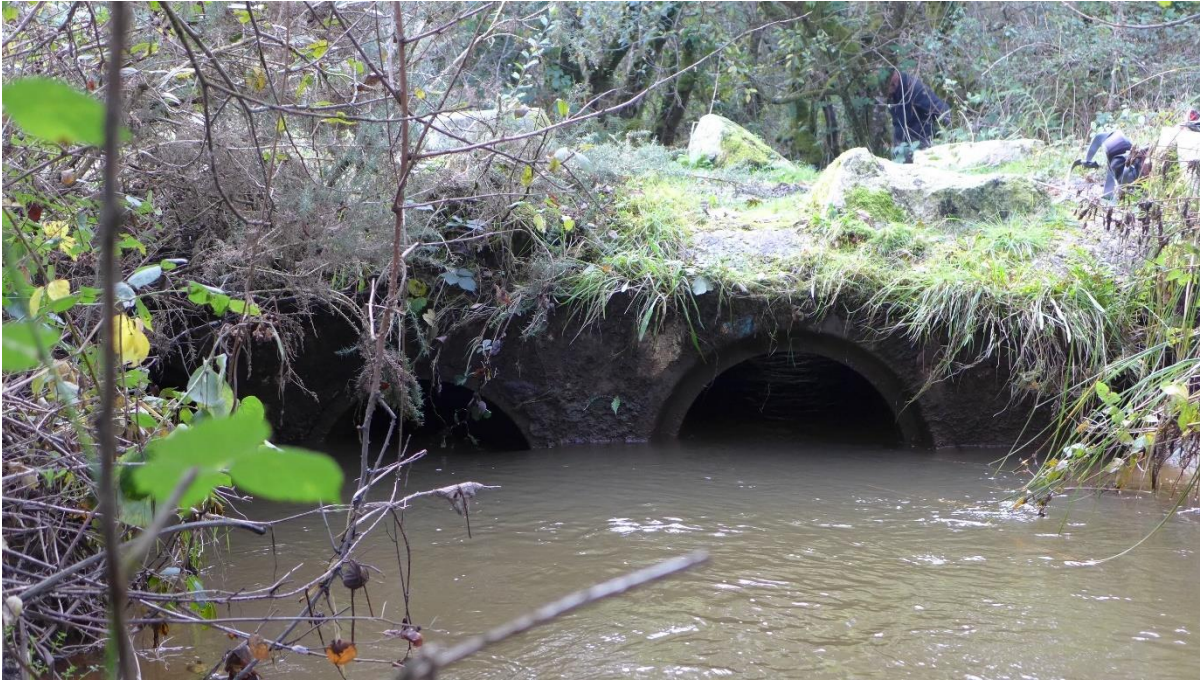
**Structure 36 (SW9403659896) Western End of Track Between Geraghtys Entrance to the Railway Embankment near St Dennis Junction**

**Description:** Three concrete culverts beneath a concrete bridge.

**Bat roost potential:** Low.

**Comments:** Water level very high, preventing close examination. May have some roost potential in the summer months when the water level is lower.

**Further surveys:** Daytime inspection in summer months.

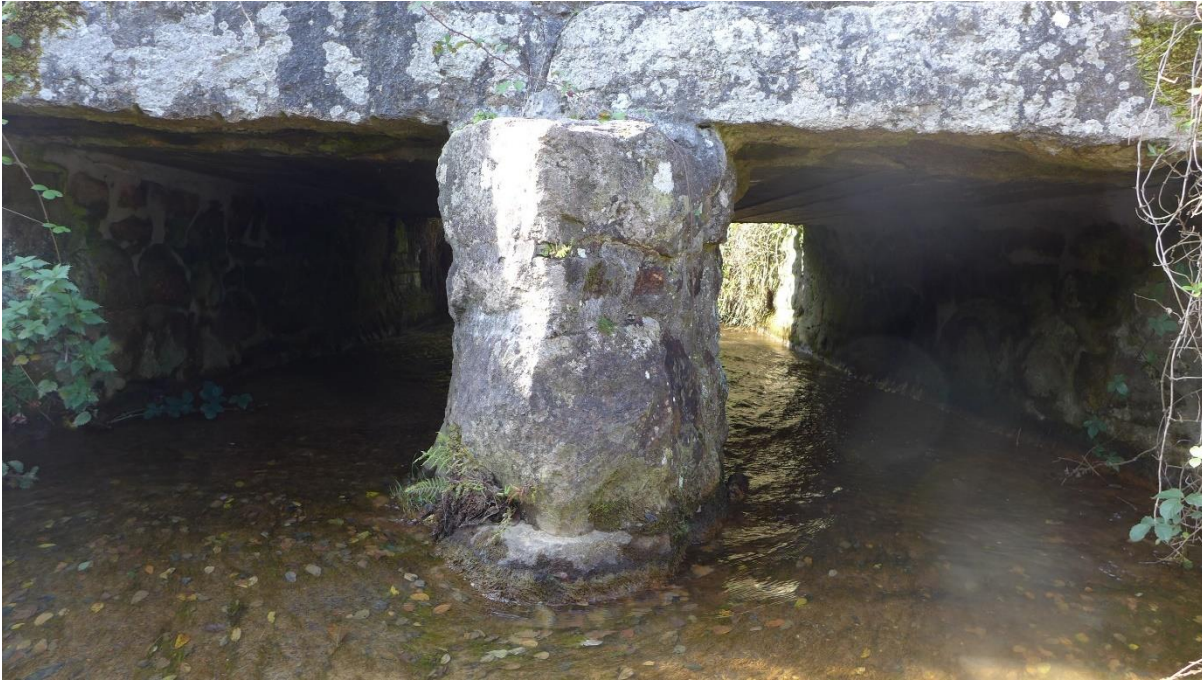
**Structure 37 (SW9658160129) Tregoss Bridge**

**Description:** Stone bridge with two square culverts.

**Bat roost potential:** Moderate.

**Comments:** Very suitable for roosting bats, both night roosting and day roosting. Some crevices present.

**Further surveys:** Emergence surveys in the summer months and remote monitoring.

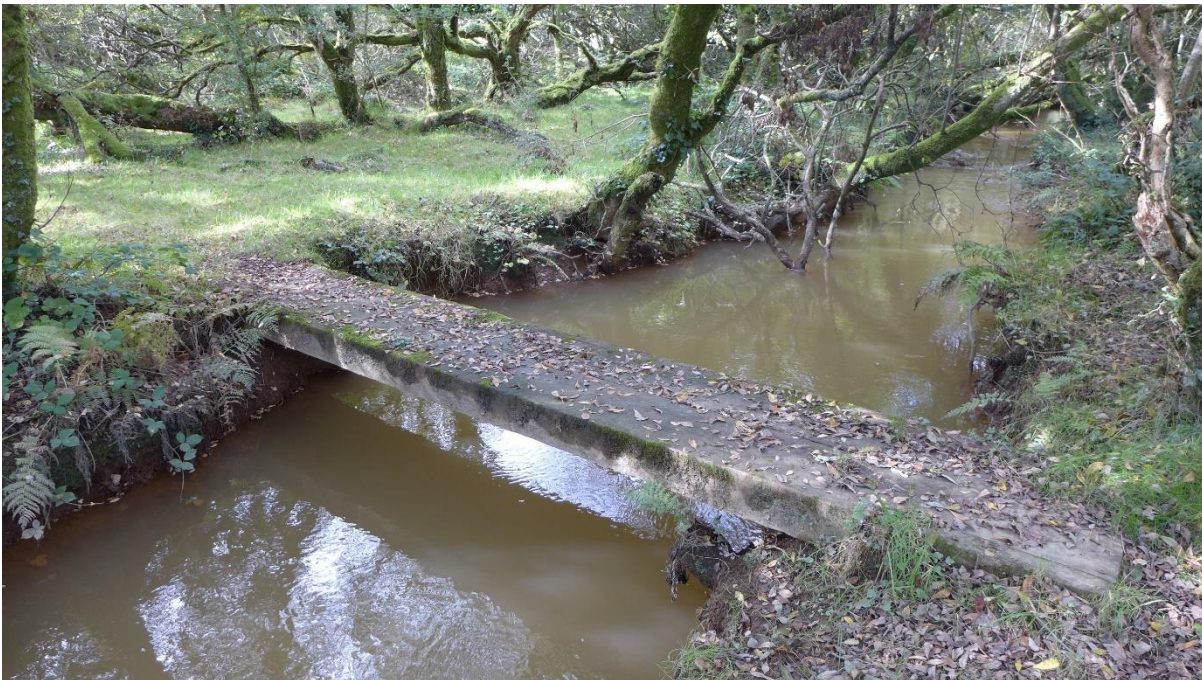
**Structure 38 (SW9462160167) Gothers Track approaching Geraghtys (left hand side within woodland)**

**Description:** Two wooden sleepers over the river.

**Bat roost potential:** Low.

**Comments:** May be occasionally used as a night roost by bats foraging over the water.

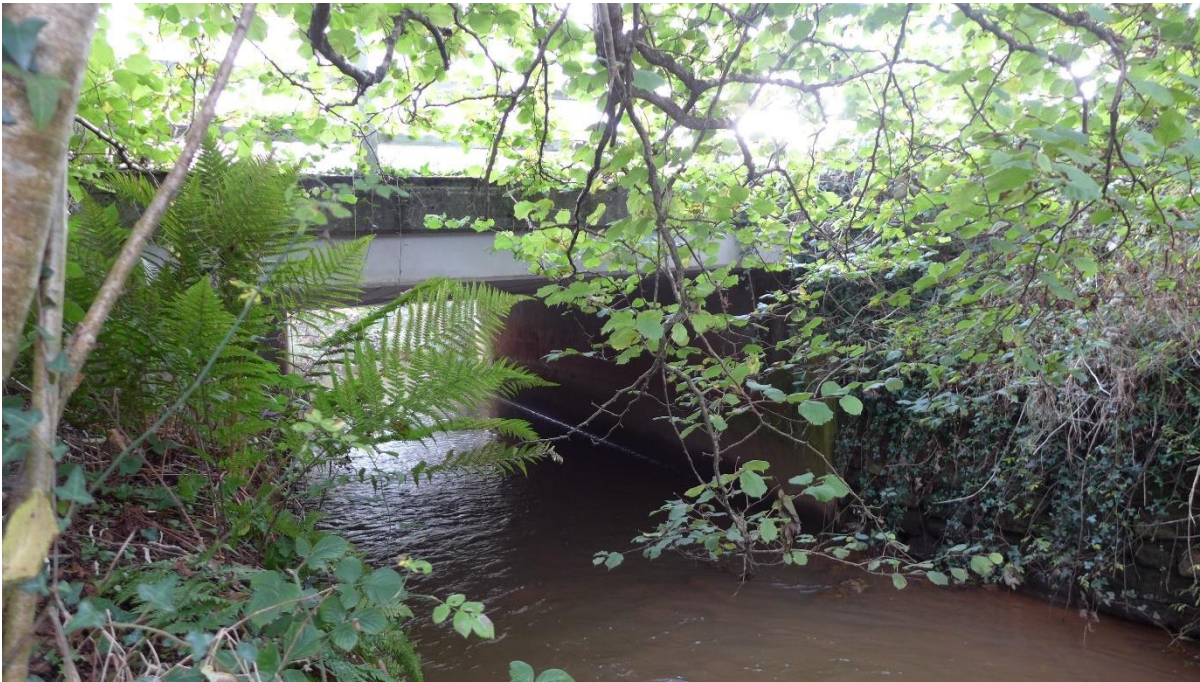
**Structure 39 (SW9373858721) Road bridge over Fal on St Dennis road**

**Description:** Concrete road bridge over the river. Broad and high clearance above the water (approximately 3m).

**Bat roost potential:** Moderate.

**Comments:** Not examined at close quarters due to water height. May be used as a night roost by bats foraging over the water.

**Further surveys:** Daytime inspection in the summer months.

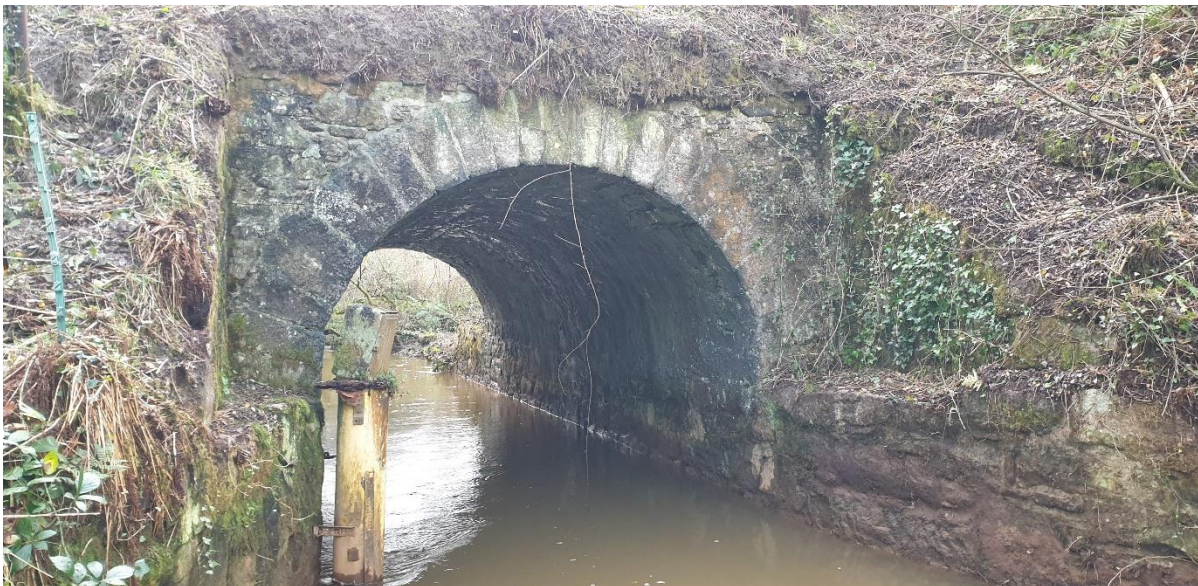
**Structure 40 (SW9386159567) St Dennis railway embankment**

**Description:** Stone-built arched bridge over the River Fal. Broad and high clearance above the water (approximately 5m).

**Bat roost potential:** Moderate.

**Comments:** Not examined at close quarters due to water height. Study through binoculars suggested the potential for cracks and crevices within the interior stonework.

**Further surveys:** Emergence surveys in the summer months.
