**Principal Designer's
Pre-Construction Information Pack
on
The Byways, 11 Court Close,
Kirby Muxloe, Leicester, LE9 2DD
For
Kirby Muxloe Parish Council**

CONTENTS

THE BYWAYS, 11 COURT CLOSE, KIRBY MUXLOE, LEICESTER, LE9 2DD
FOR
KIRBY MUXLOE PARISH COUNCIL

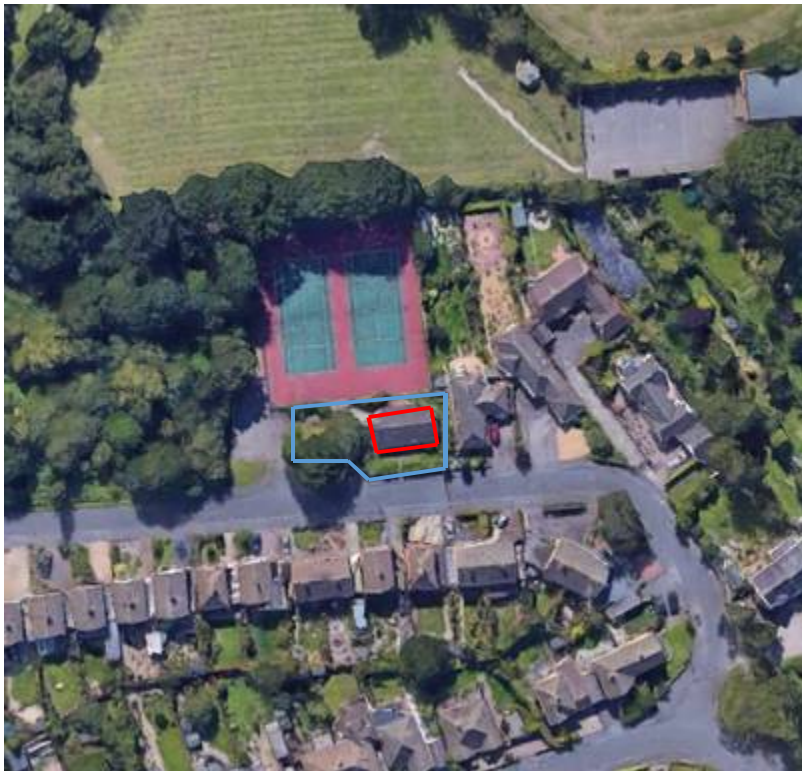
Image 1 – Site Plan

- 1.1.2 The site plan above indicates the site boundary, approximately shown in blue, with the building that is subject to the refurbishment/modernisation works outlined in red.

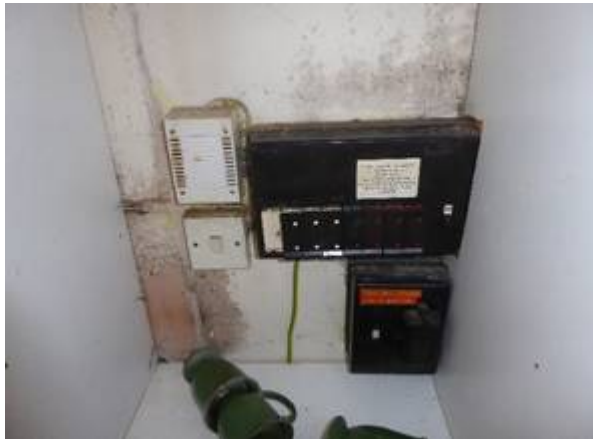
- 4.2.1 There is slight mould growth to walls/ceilings etc. and this should be cleaned down/removed using appropriate PPE.
- 4.2.2 The rewirable dated electrical consumer unit is situated within the basement cupboard of the kitchen and the rear door currently binds against the wall mounted boiler that is equally situated within the kitchen.
- 4.2.3 There is no evidence that there is any contaminated land on this site.

Photograph 19 – Electrical consumer unit within the base unit of the kitchen

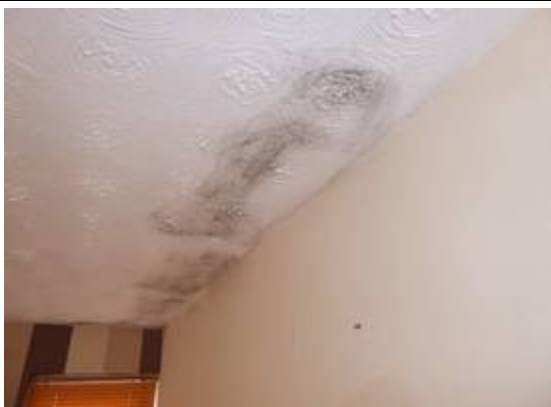
Photograph 29 – Typical image of mould growth to the rear living/dining room ceiling

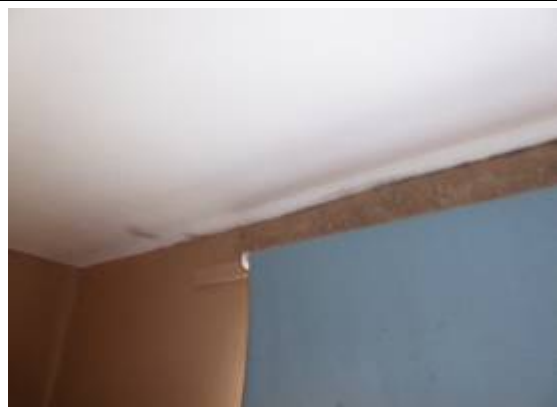
Photograph 30 – Typical image of mould to the rear bedroom ceiling

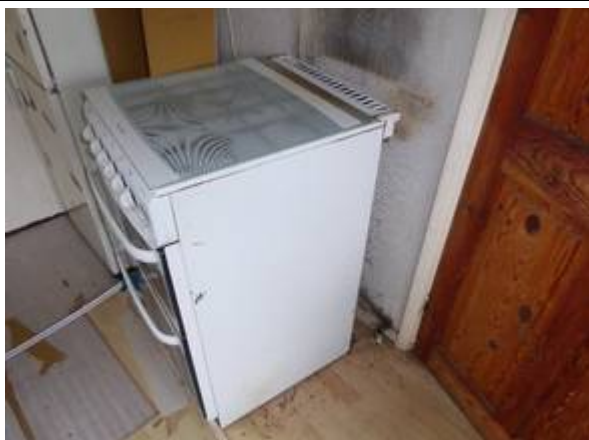
Photograph 31 – Suspected gas main within the kitchen floor
