Soft Landscape Management Plan Framework
Kingsley Park Recreation Ground
for
Whitchurch Town Council

Final Document version 2

12 June 2020

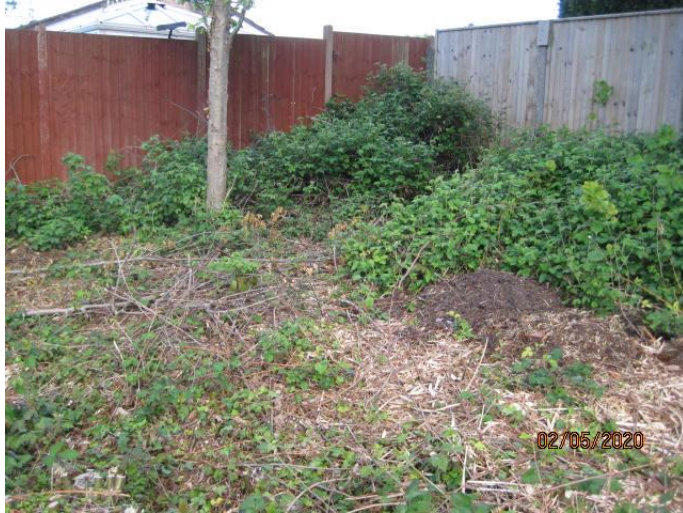
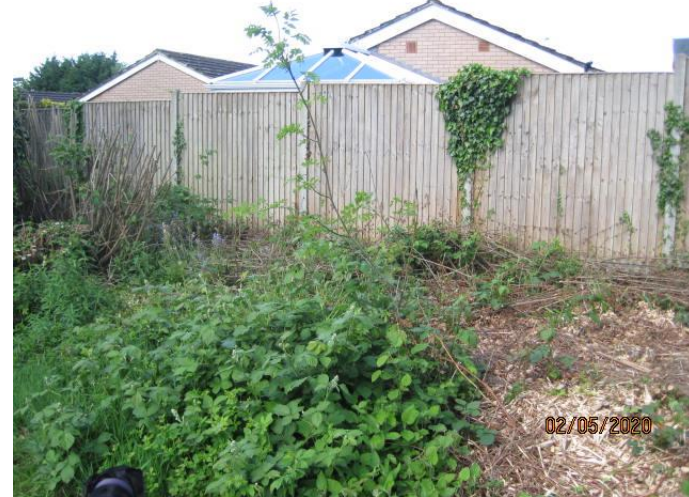
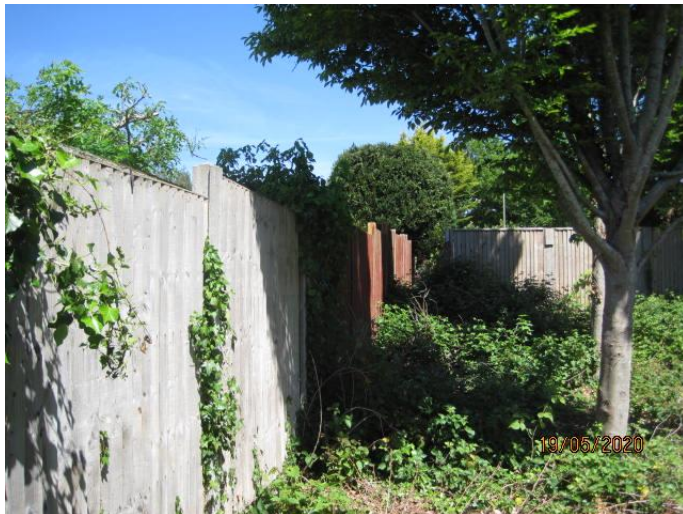
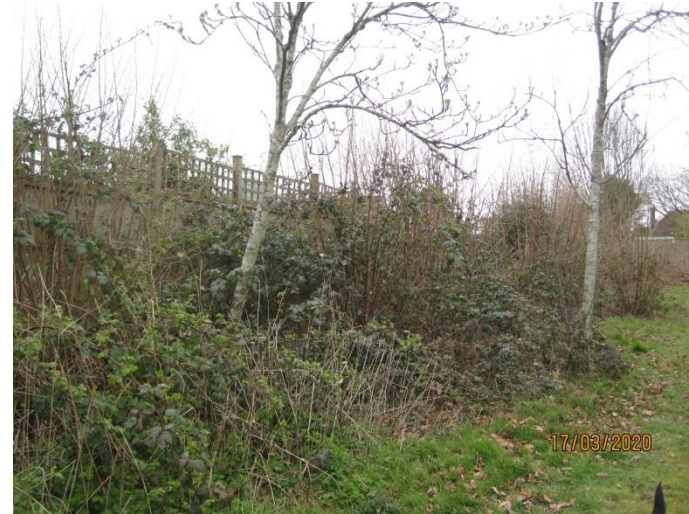
Poor examples of existing management

- **Established mixed native hedgerow along western boundary:** main species is coppiced hazel with occasional holly; elder; blackthorn; hawthorn. All species cut down to ground level in 2017 including hazel. Mature holly trees cut down. Significant gaps now evident in hedgerow. Majority of planted single stem specimen trees among vegetation retained. Material shredded on site and spread around the stumps smothering existing ground flora and discouraging re-establishment of hedgerow species. Logs left on site.

- **Small native copse along southern part of the site:** Main species include hazel; blackthorn; guelder rose; field maple; alder; rowan. Minimal maintenance carried out on existing vegetation at the request of residents whose gardens back onto the park for reasons of privacy and conservation. Portugal laurel reduced in height adjacent fence. Shredded bark spread around planted area has had detrimental effect creating gaps in existing planting for reasons outlined above.

- **Shredded Bark:** shredded and spread on site around base of vegetation creating issues with existing planting and maintenance.

- Issue: Spreading shredded waste around existing planted areas is unsightly; prevents re-establishment of native mix species and ground flora creating gaps which encourages dog fouling and dumping of garden rubbish. This has become a particular problem in the conservation copse.

- Issue: Cutting down mature hedgerow along W boundary has resulted in loss of some species eg hawthorn, elder, guelder rose and has created gaps for docks, brambles and nettles. This does not look attractive and is difficult to manage.

- Action: shredded waste to be removed offsite instead of spreading among existing planted areas. Infill gaps with suitable species eg hawthorn. Temporary protective fencing eg stockproof fencing to be erected along outer edge of copse to avoid trampling and ensure successful establishment of infill planting.

- Action: Infill gaps with new planting to re-establish diverse mature hedgerow boundary using suitable species eg hawthorn transplants which will be consistent with E boundary in terms of visual amenity and easier to maintain in the long term. NB It may prove more beneficial in the long term to eventually replace existing coppiced hazel as dominant species with hawthorn along W boundary.

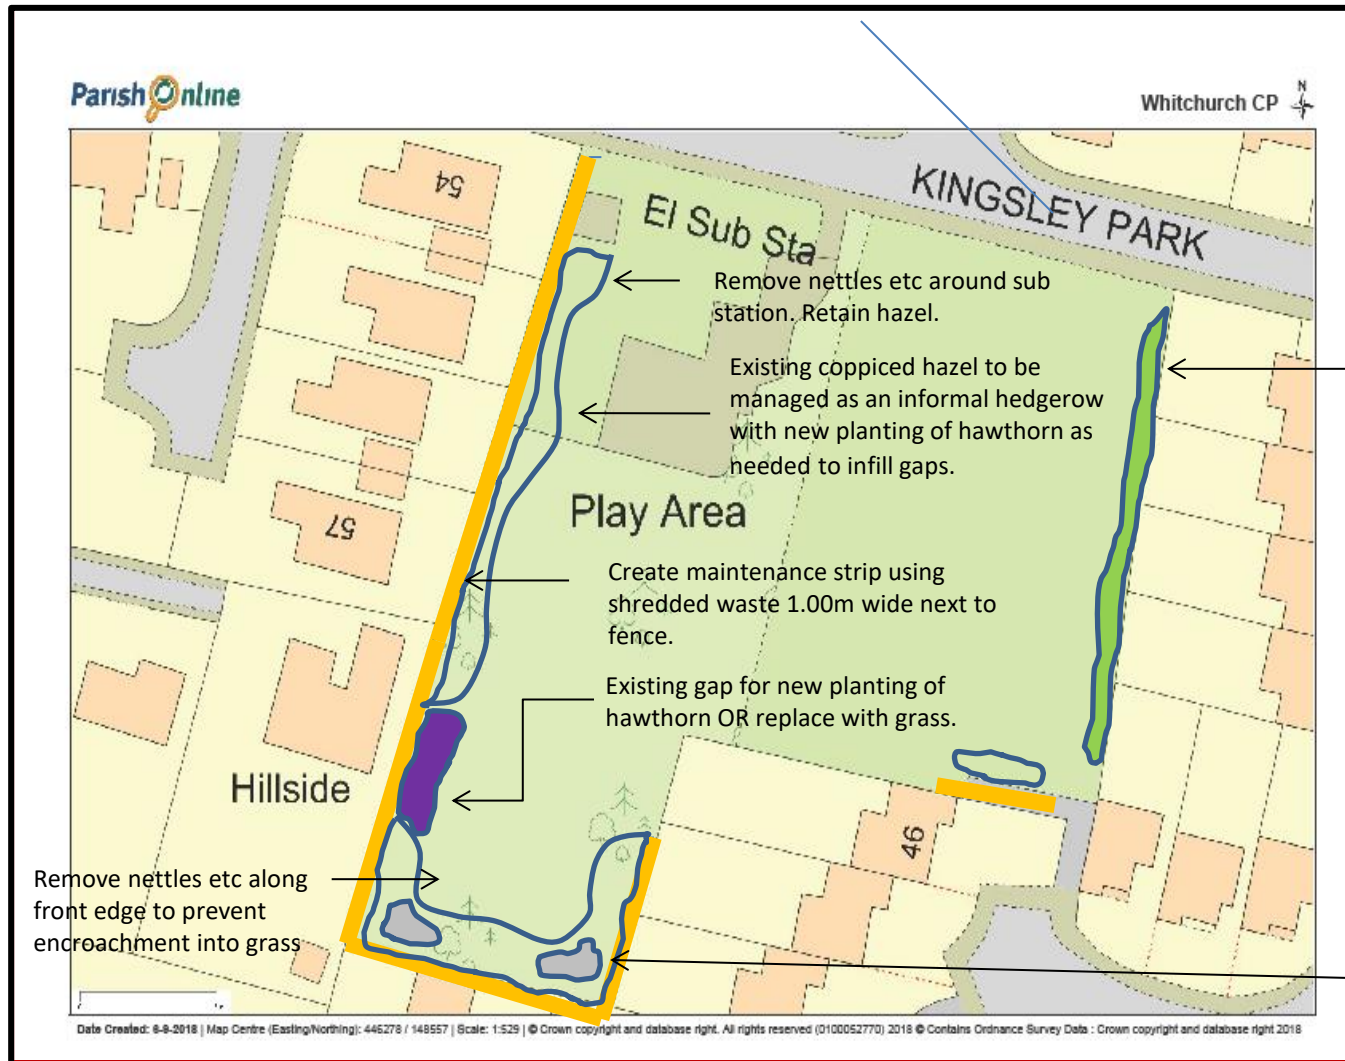
Outline first stage proposals for discussion (indicative only) ref site meeting on 10th June 2020

Existing hawthorn hedge to remain as existing.

NB new planting to be protected by temporary protective fencing to assist establishment eg 1.5m height stockproof fencing.

New planting of hawthorn whips in gaps between existing trees and hazel coppice.
