12016/GL  
27th April 2012

### **DAME ALICE OWEN'S SCHOOL - FLOOD RISK**

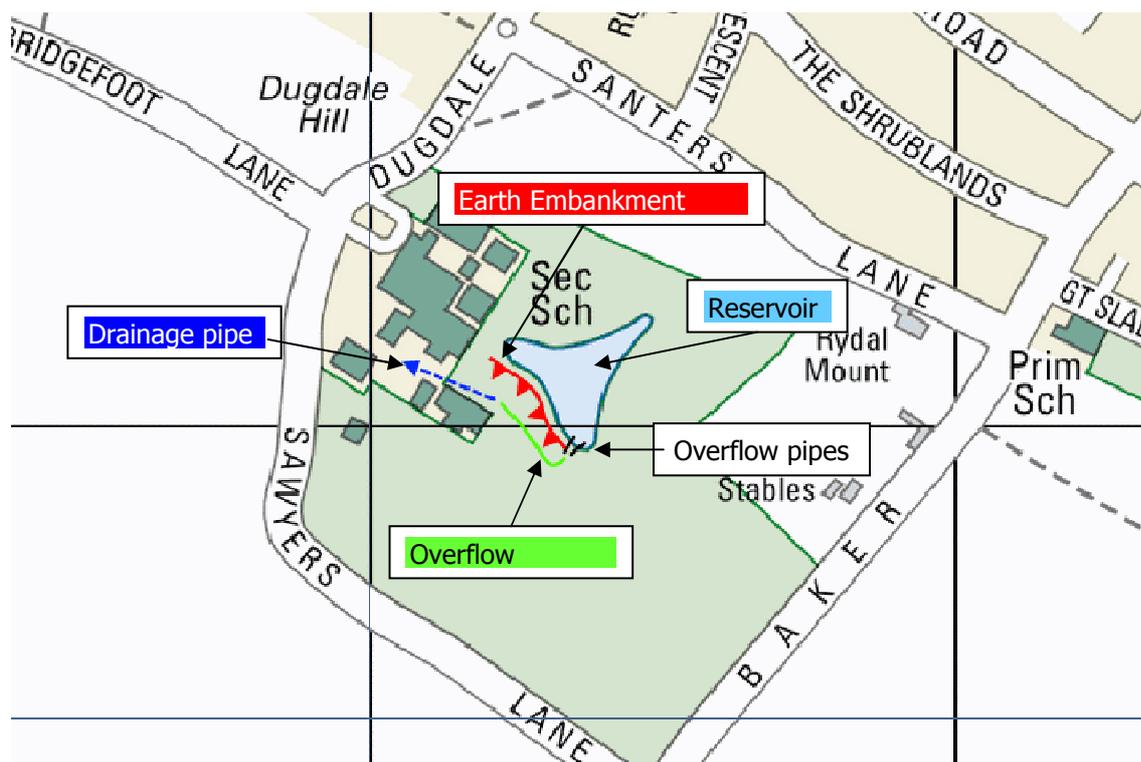
Figure 3 - location of reservoir showing key features

The reservoir has a surface area of approximately 4,500m<sup>2</sup> with a maximum depth of approximately 3.5m (providing an approximate volume of 5,200m<sup>3</sup>). On this basis it is not registered under the Reservoirs Act (1975).

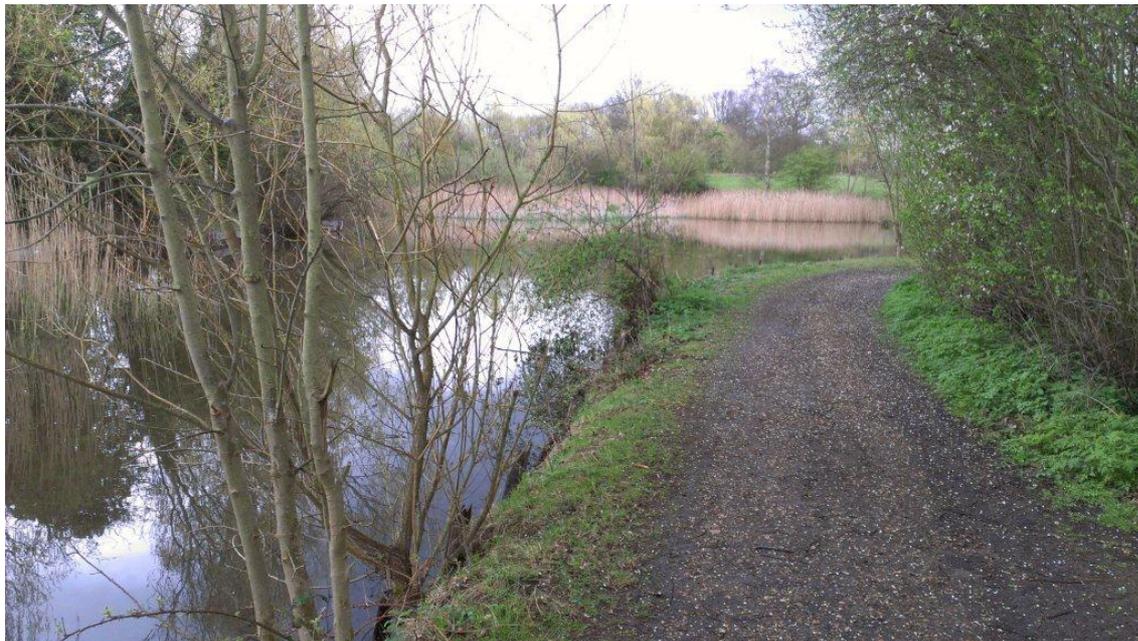
The dam itself is an earth embankment structure (photograph 1) with two (approximately 300mm from observation) overflow pipes at the eastern end. There is no emergency spillway. The overflow pipes discharge to an overflow channel (at a gradient of approximately 1:12) which turns sharply to the north-west and descends at a gradient of approximately 1:10. Flow is then conveyed via a 150mm pipe, to another section of open channel and into a 225mm diameter pipe in a north-westerly direction and beneath the existing buildings.

Photograph 1 - Earth embankment dam

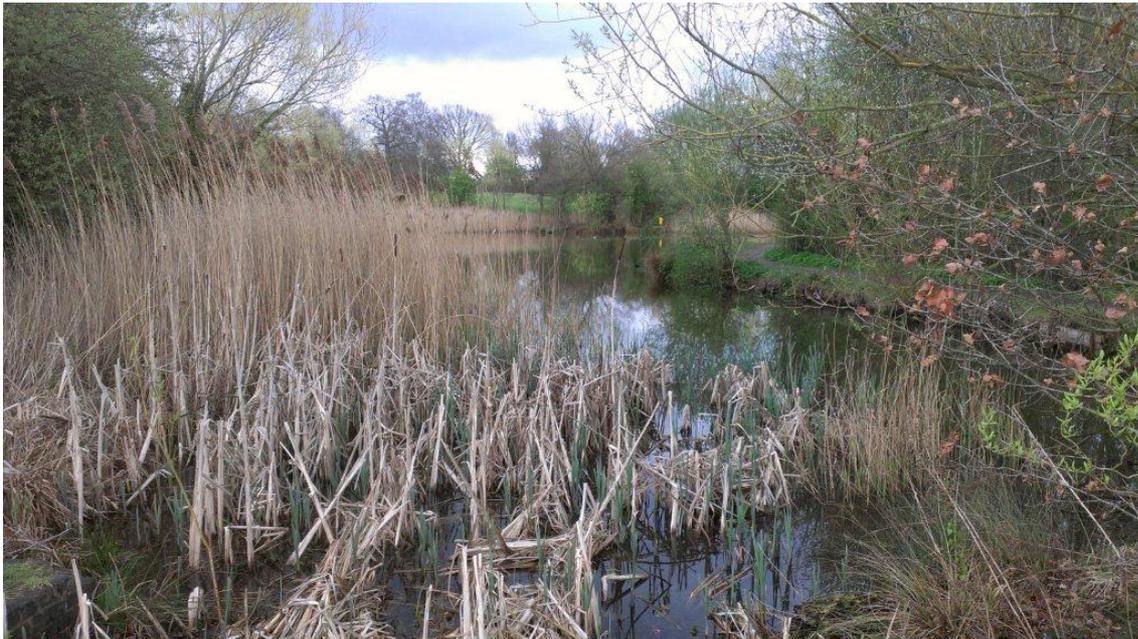
1. The earth embankment dam is well established with trees (photograph 2) and the downward slope had apparently been subject to various earthworks. There were concerning signs of seepage at the toe of the dam (photograph 3). Concerns were shared by GCG geotechnical engineers in a later discussion.

Photograph 2 - Earth embankment wall well established with trees

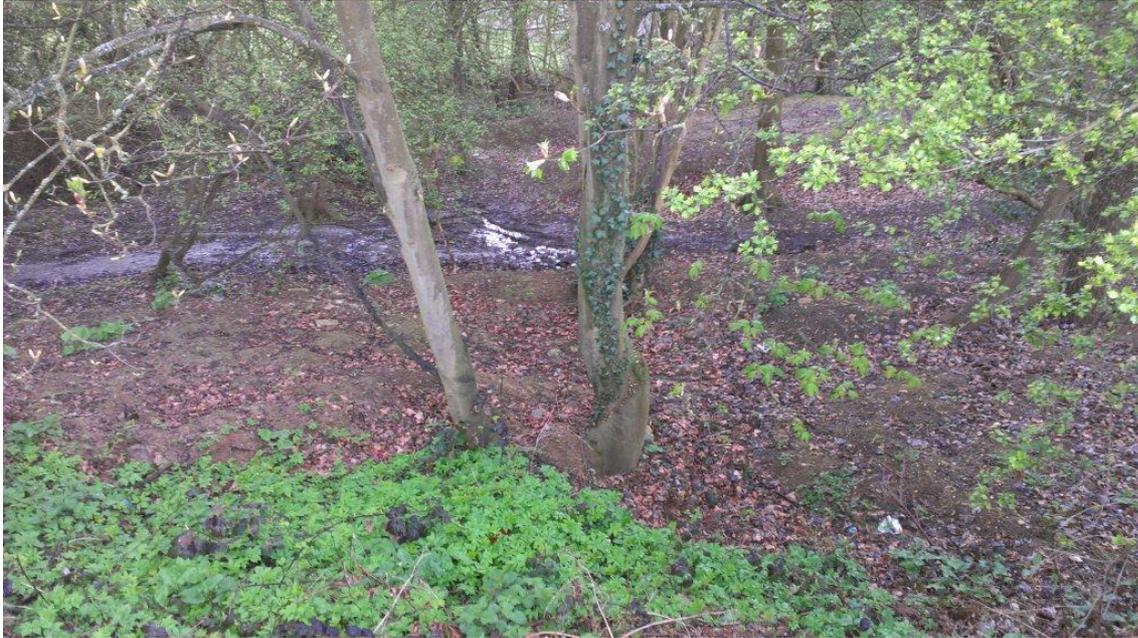
Photograph 3 - Seepage at the toe of the dam, also showing large tree growth on the earth embankment wall

1. Structural assessment of the earth-embankment dam (given that it is seeping at the toe of the dam) to update the study undertaken in 2004, and any remediation works. We understand that this assessment is already underway by GCG geotechnical engineers.

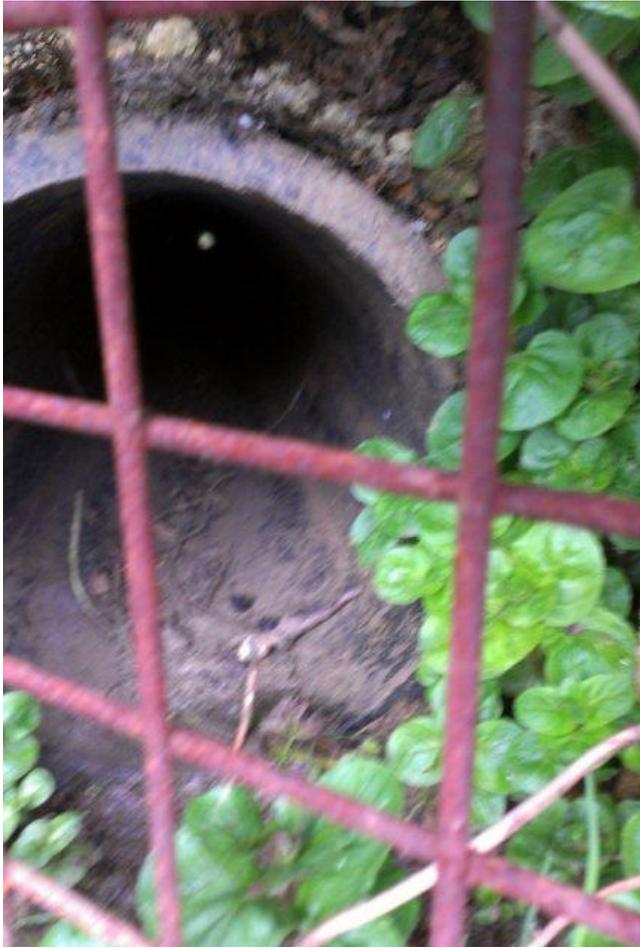
2. There are two overflow pipes, one PVC and the other clay approximately 300mm in diameter (the topographic survey records only a single outflow pipe 300mm in diameter, which conveys water beneath the gravel pathway before outcropping as 2 No. 250mm diameter pipes). The PVC pipe has a steel grate in place to prevent blockage (photograph 4) and appeared to be clear and in reasonable condition. The clay pipe is severely damaged, has no grate and at the time of the visit was blocked by a football (photograph 5). The caretaker was immediately notified of this blockage and the associated dangers for the dam structure.

Photograph 4 - PVC pipe at reservoir side looking through grate (spot of daylight at the far end showing that it is clear)

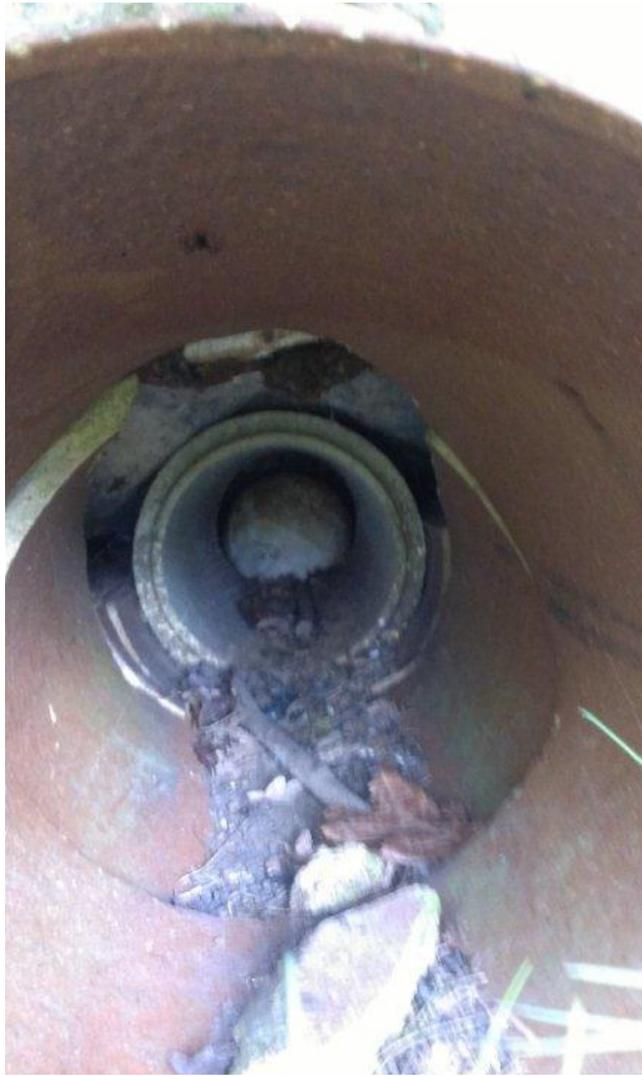
Photograph 5 - Damaged clay pipe overflow, blocked with football

2. Repair and maintenance of the overflow pipes (removal of the football),
3. Design and installation of a grill on reservoir side of the clay overflow (to prevent future blockage).

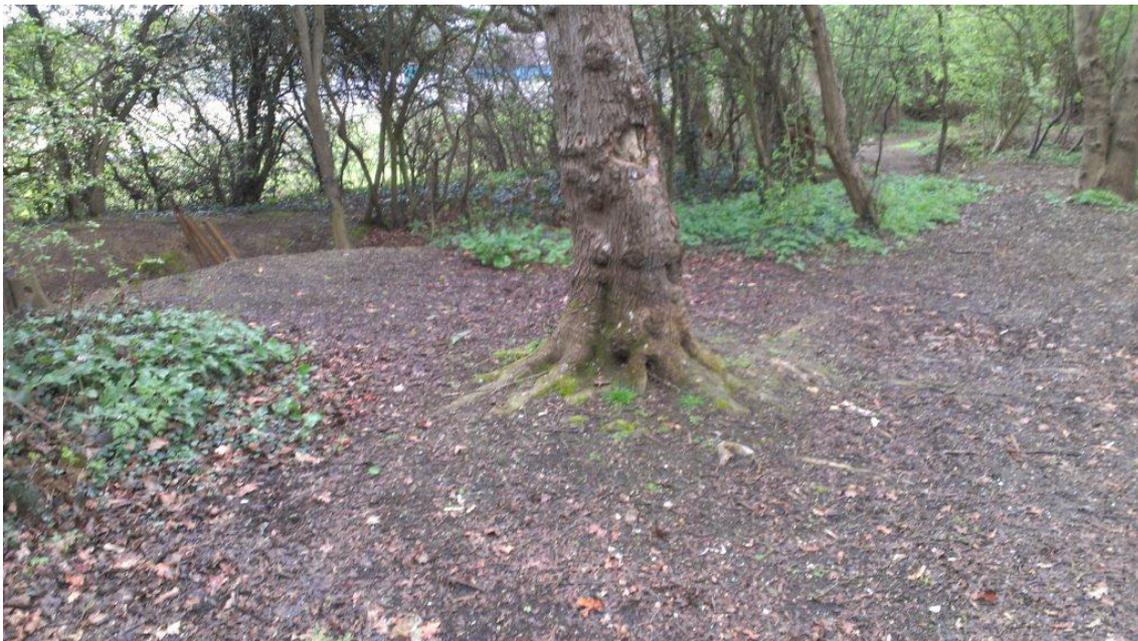
3. The overflow channel (photograph 6) should have capacity to convey any flow from the two overflow pipes, however it is a steep gradient and it is not reinforced against erosion and there are no structures in place to dissipate energy and trap silt. This arrangement will lead to siltation and eventual blockage of the downstream sewer infrastructure, and erosion of the channel banks.

Photograph 6 - Overflow channel looking towards sports hall

4. Maintenance of the existing overflow channel to remove debris and obstructions, and where necessary installation of reinforcement and energy dissipation to resist erosive forces.
