## ARBORICULTURAL SURVEY REPORT AND METHOD STATEMENT

**A MULTI USE GAMES AREA**

**NORMAN SCOTT PARK, CONISTON ROAD, PATCHWAY**

Prepared by: Ian Monger *MSc, BSc, (Hons), TechCert, (ArborA) MArborA*  
Checked by: Richard Hyett *MSc, MArborA, MICFor*  
Reference: N.2864

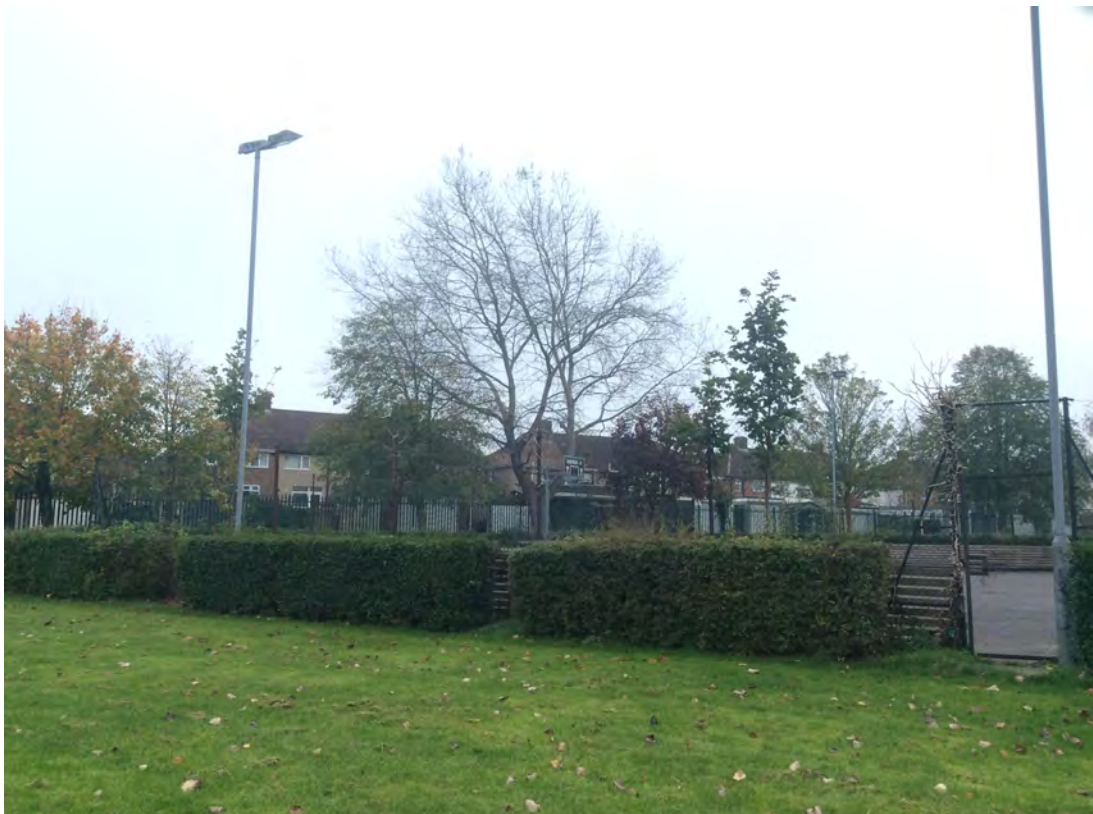
*Photo view 1: Picture of site looking south, with White Poplar T6 in centre.*

- 3.8 The RPA of White Poplar T6 extends into the existing MUGA footprint. It is presumed that the existing MUGA has a compacted sub-base. Poplar species trees have highly vigorous and adaptable root systems which can cope with minor disturbance. The removal of the existing surface within the tree's RPA will have no impact on tree health or longevity. The proposed new footprint is outside of the tree's RPA.

- 3.9 The protection of tree RPAs during construction will be a simple matter of installing protective barrier fencing in the positions shown and specified on the Tree Protection Plan. For simplicity and continuation of footpath access 'out of hours', the fencing would be installed on the outside edge of the existing tarmac footpath. The footpath is one of the most popular public uses of the site and would allow this use to be maintained when construction work is not taking place. This would mean a small part of the RPA of Lime spp. Tree T9 remains unprotected, but this would have no negative impact on tree health or longevity of this early-mature tree.
