Series 9000 Drainage CCTV

Coded Inspection Report Example

Project Name
DFDE453 Highgate Depot

Section Inspection - 18/10/2018 - ND074/0235X

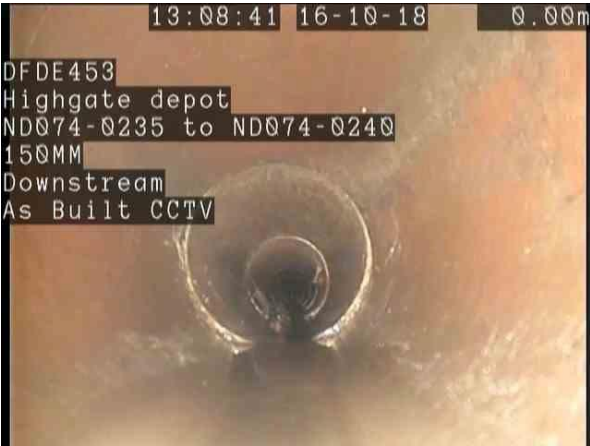
ND074_0235X_d34c0cfe-c749-452b-aec0-eca12172fd0a_20181018_194939_249.jpg, 00:00:00, 0.00 m

Start node type, catchpit, reference number: ND074/0235

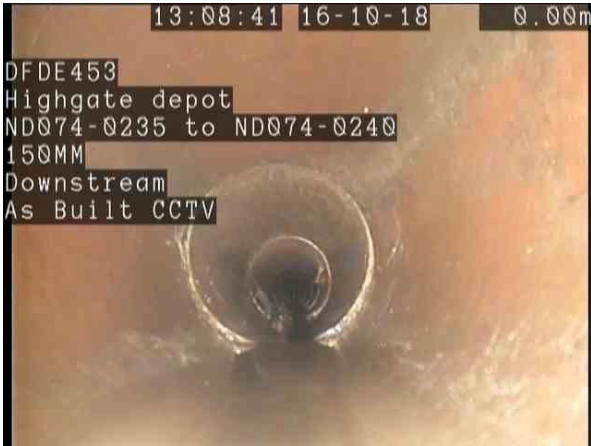
ND074_0235X_a38f08cf-8160-4cb4-9b8b-32d74a556471_20181018_194945_087.jpg, 00:00:00, 0.00 m

Water level, 5% of the vertical dimension

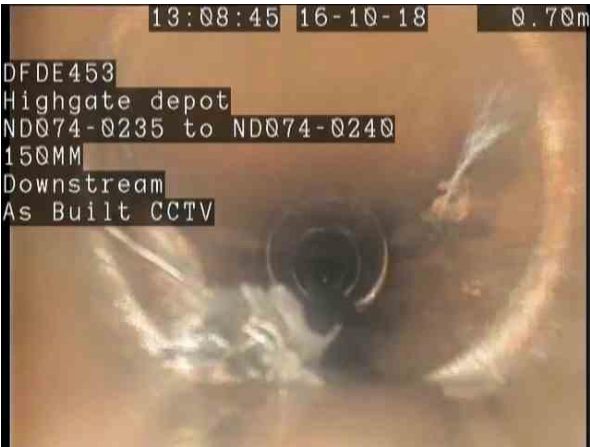
ND074_0235X_0e635ae4-788c-4101-af9a-b027c6558970_20181018_194959_477.jpg, 00:00:03, 0.70 m

Roots, fine at joint

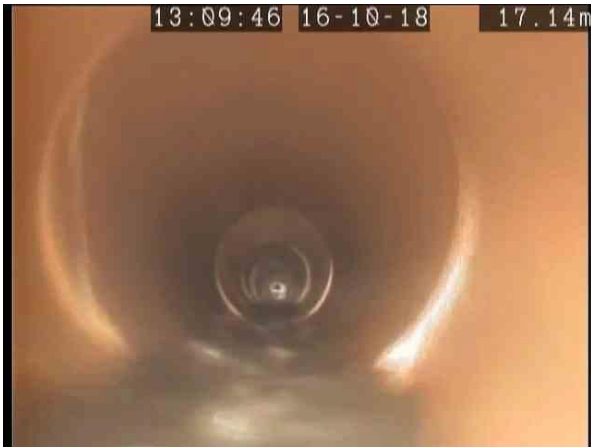
ND074_0235X_163291e0-75ac-48ef-95a2-2527c8609293_20181018_195117_299.jpg, 00:01:05, 17.14 m

Fracture, circumferential at joint from 8 o'clock to 10 o'clock
