STAGE
02 **CROYDON COLLEGE**
FECTF APPLICATION REPORT
OCTOBER 2021

Document title: Stage 2 FECTF Application Report
Project name: FECTF Refurbishment, Croydon College
Project reference: IALN20-0054
Revision / Date: v.3 / 07-10-2021

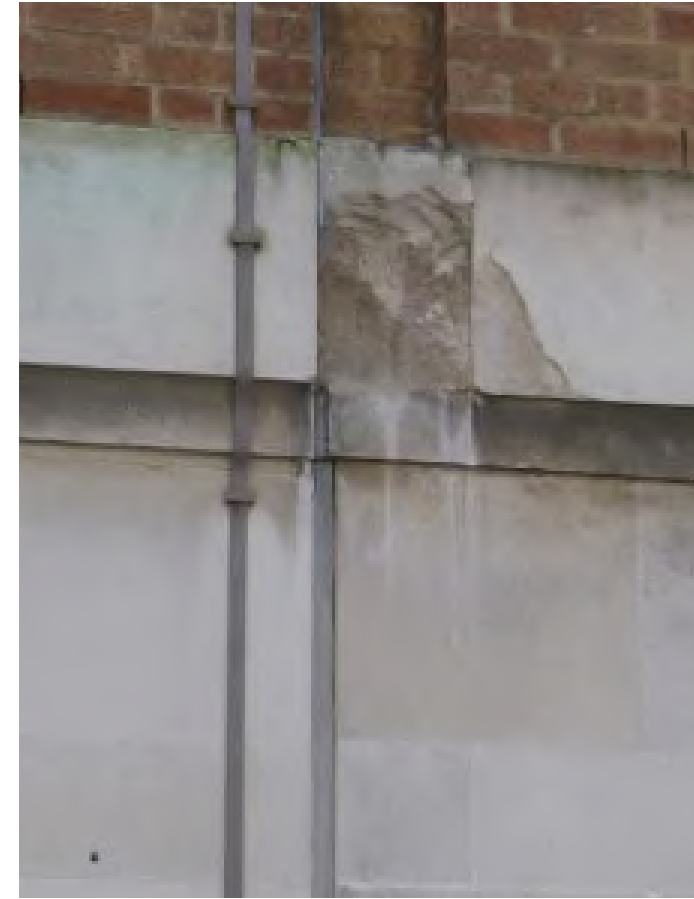
Exterior Photo - an example of an area of exterior stonework that has broken and fallen off

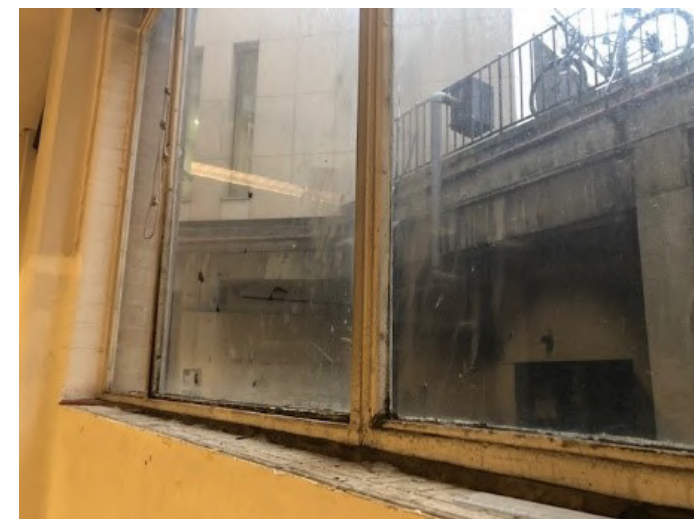
Window Photo - a single glazed, 1950's metal framed window

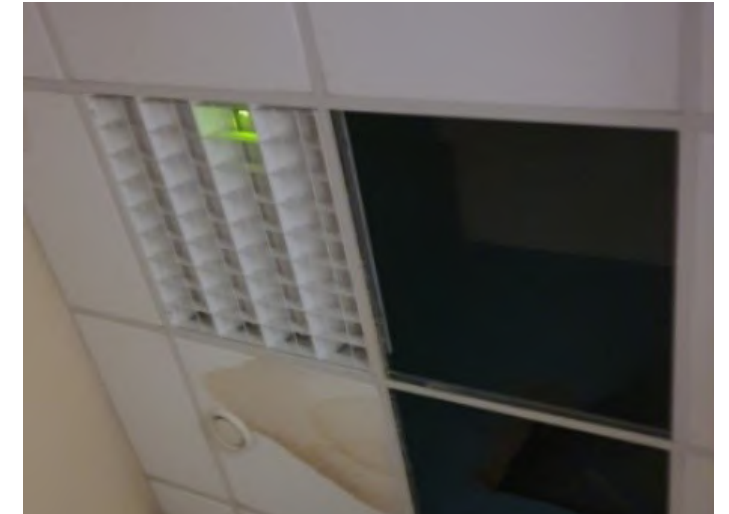
Interior Photo 1 - poor finishes, include ceilings

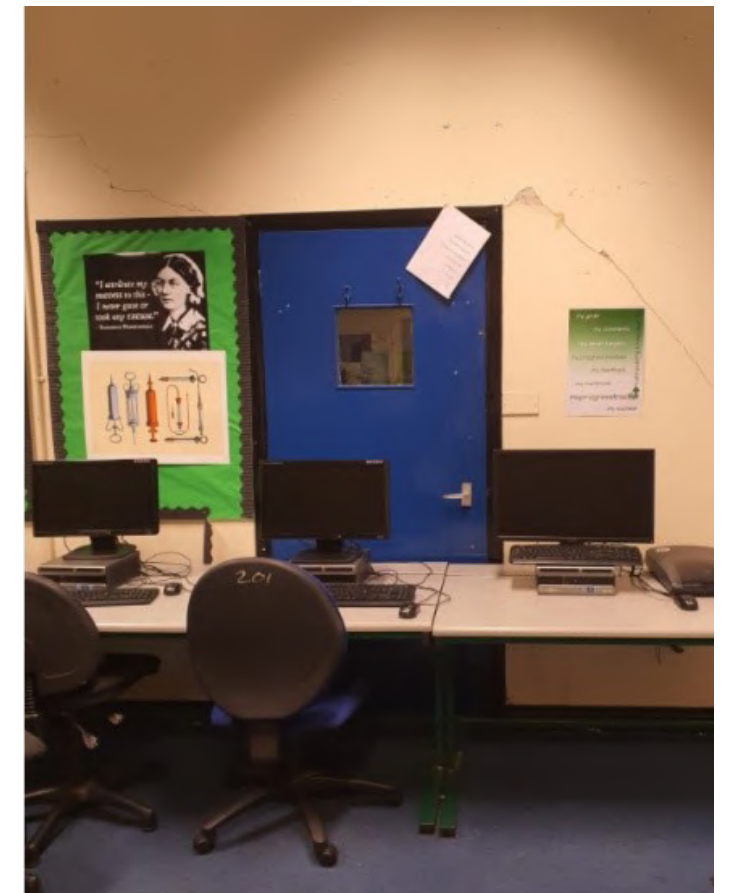
Interior Photo 2 - poor building conditions (note, significant crack across the wall) and lighting conditions create low quality learning environments for the students

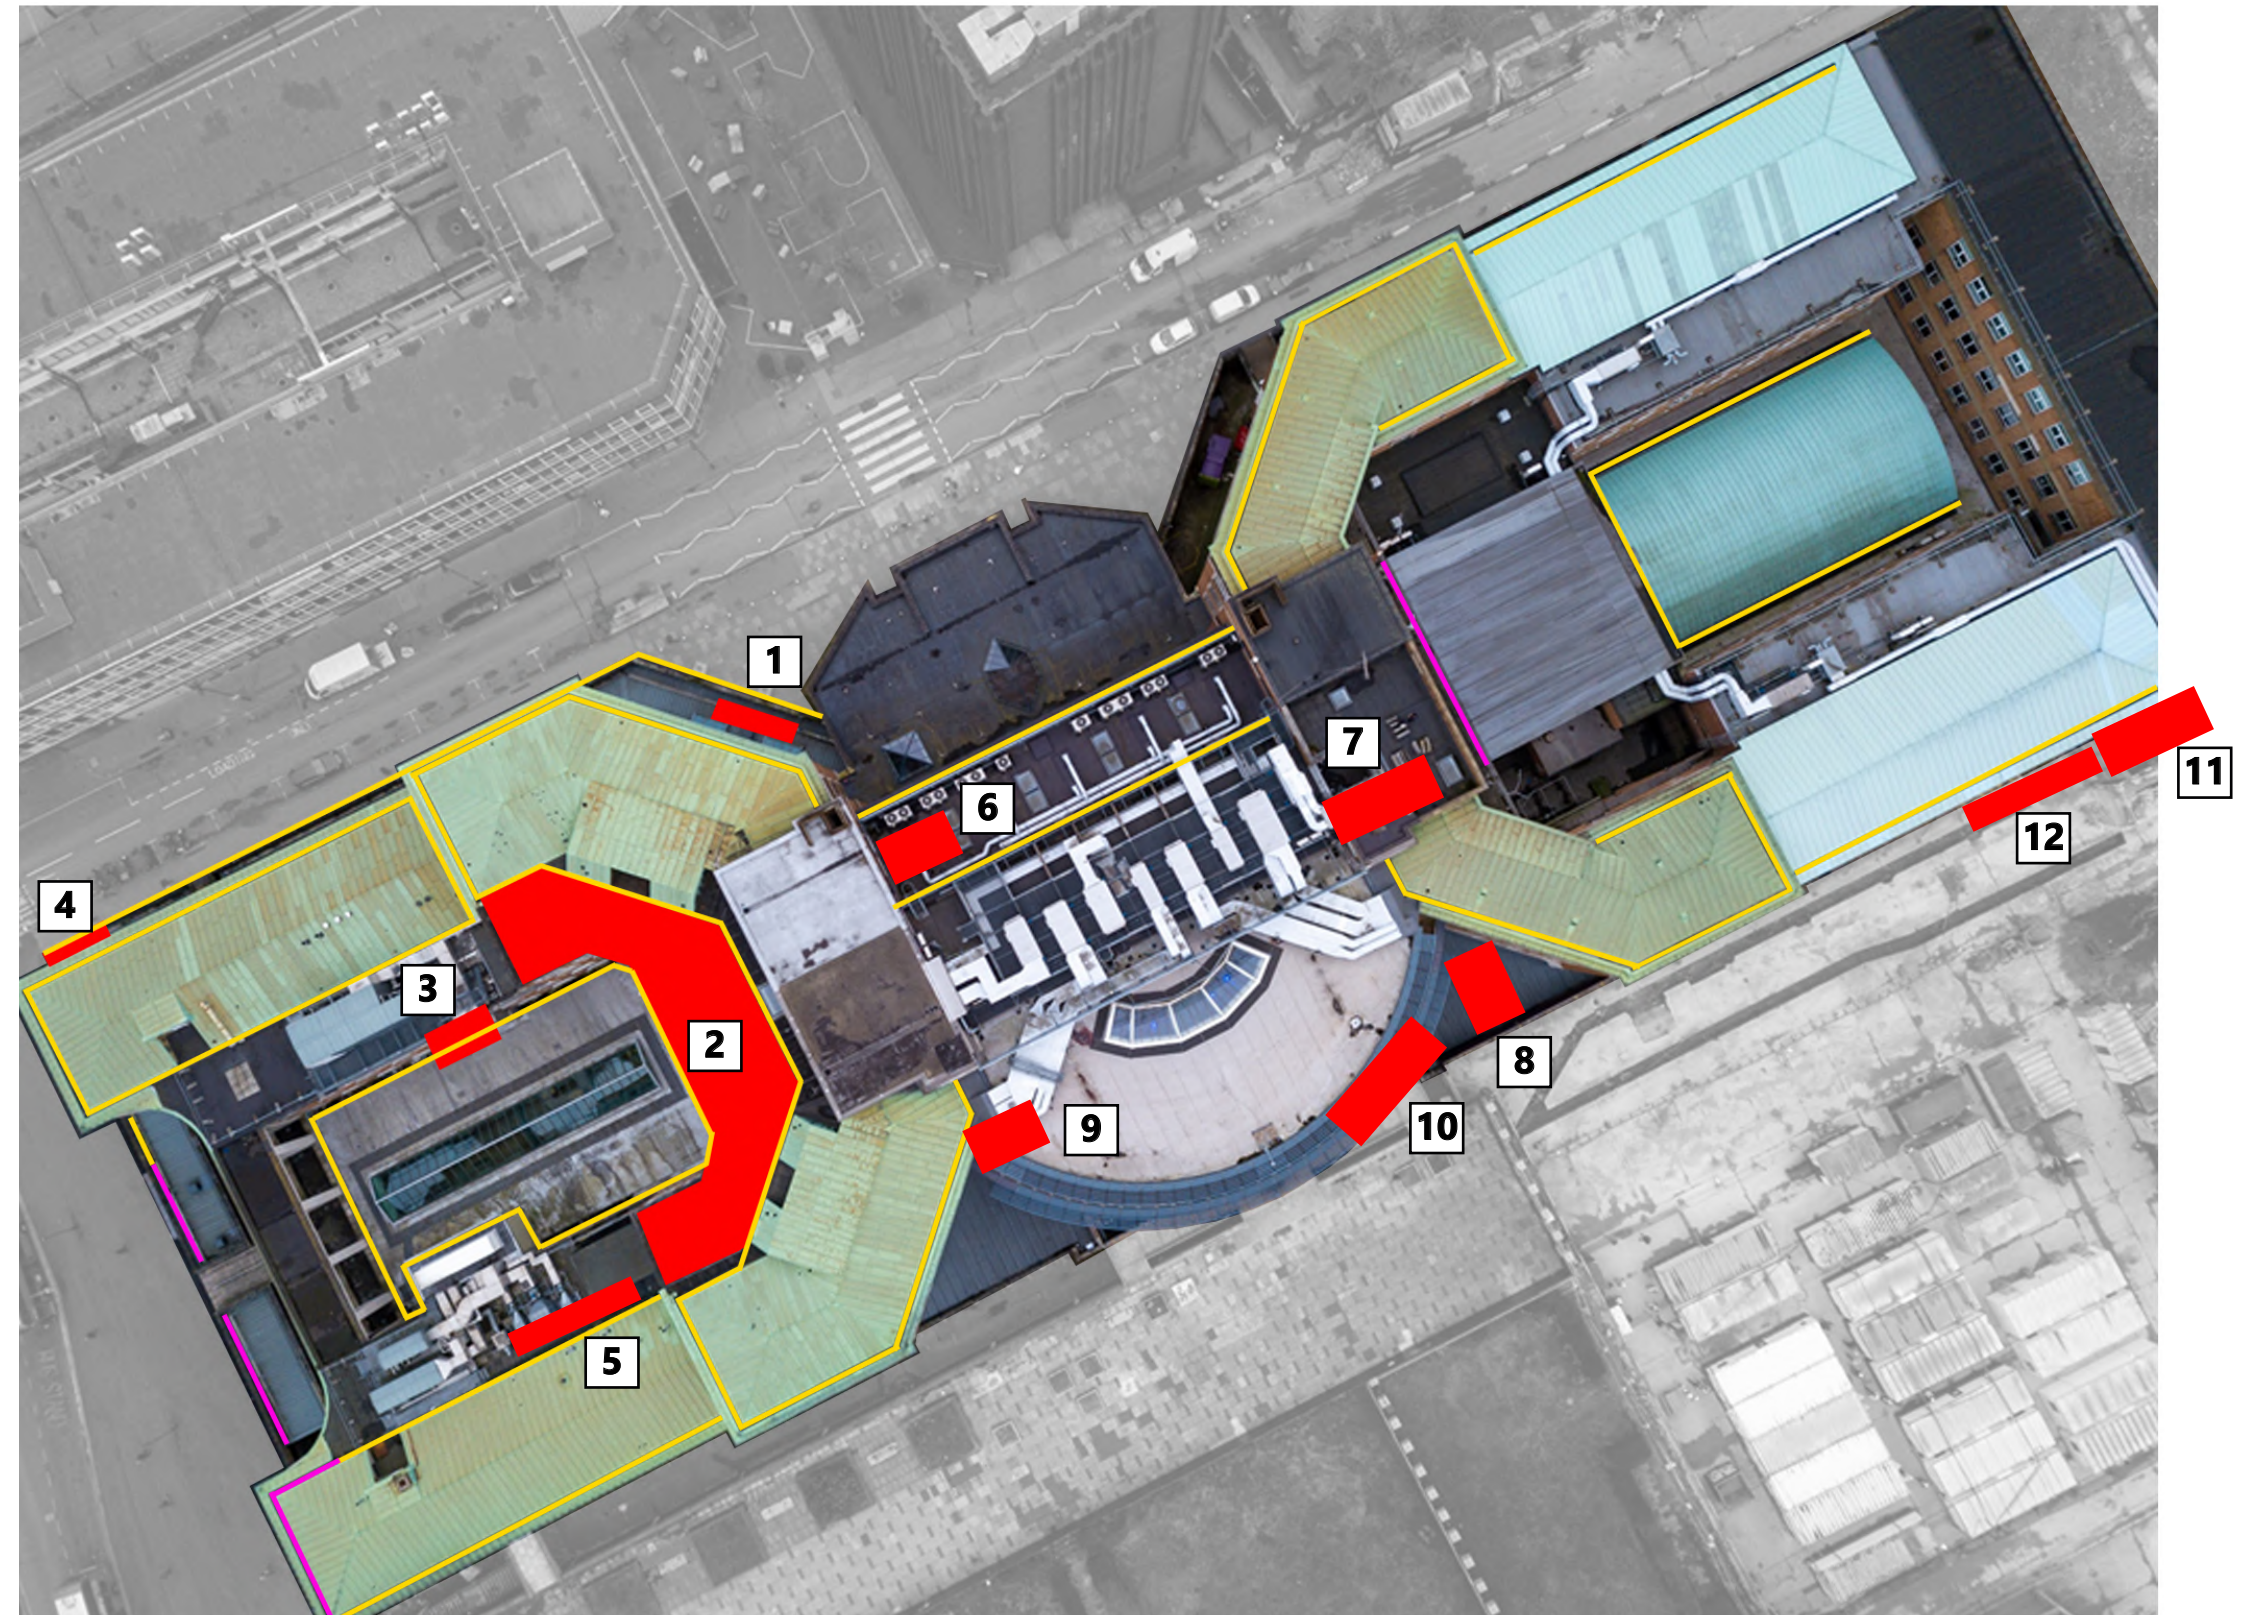
Roof in need of repair

1. Welding roof
2. 4th floor West roof
3. IT plant
4. Paint workshop
5. MIS guttering
6. Plant roof (archive exit)
7. Flat guttering
8. Ground floor rotunda roof
9. Room 426 leak
10. Principal balcony
11. Room 280
12. Ground floor East end gutter

All of the roofing works are small, localised repairs with exception of Item 2 below which will require a complete waterproof liquid roofing overlay.

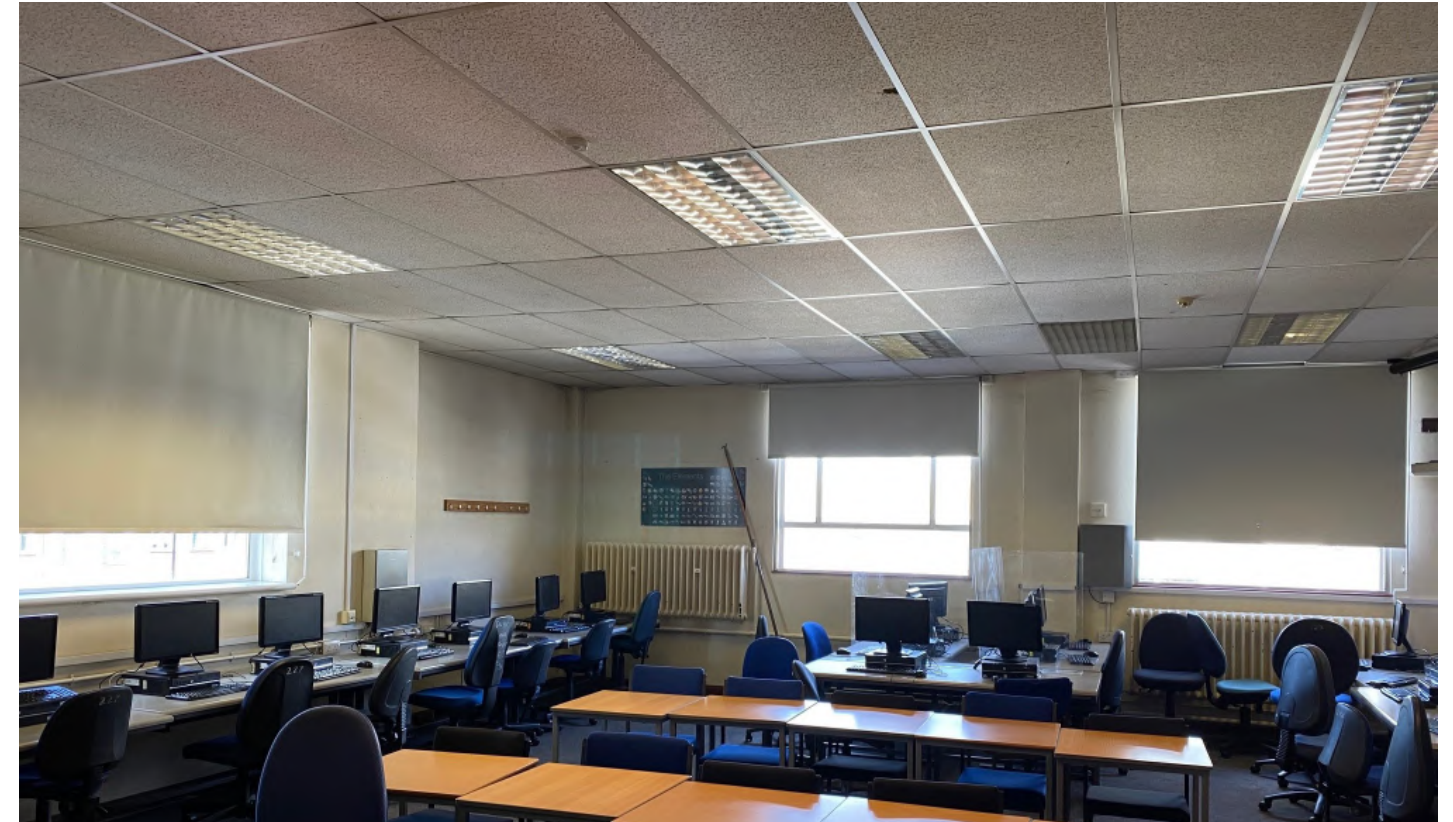
Classroom Photo 1 - 2nd floor classroom with single glazed, 1950's metal framed windows

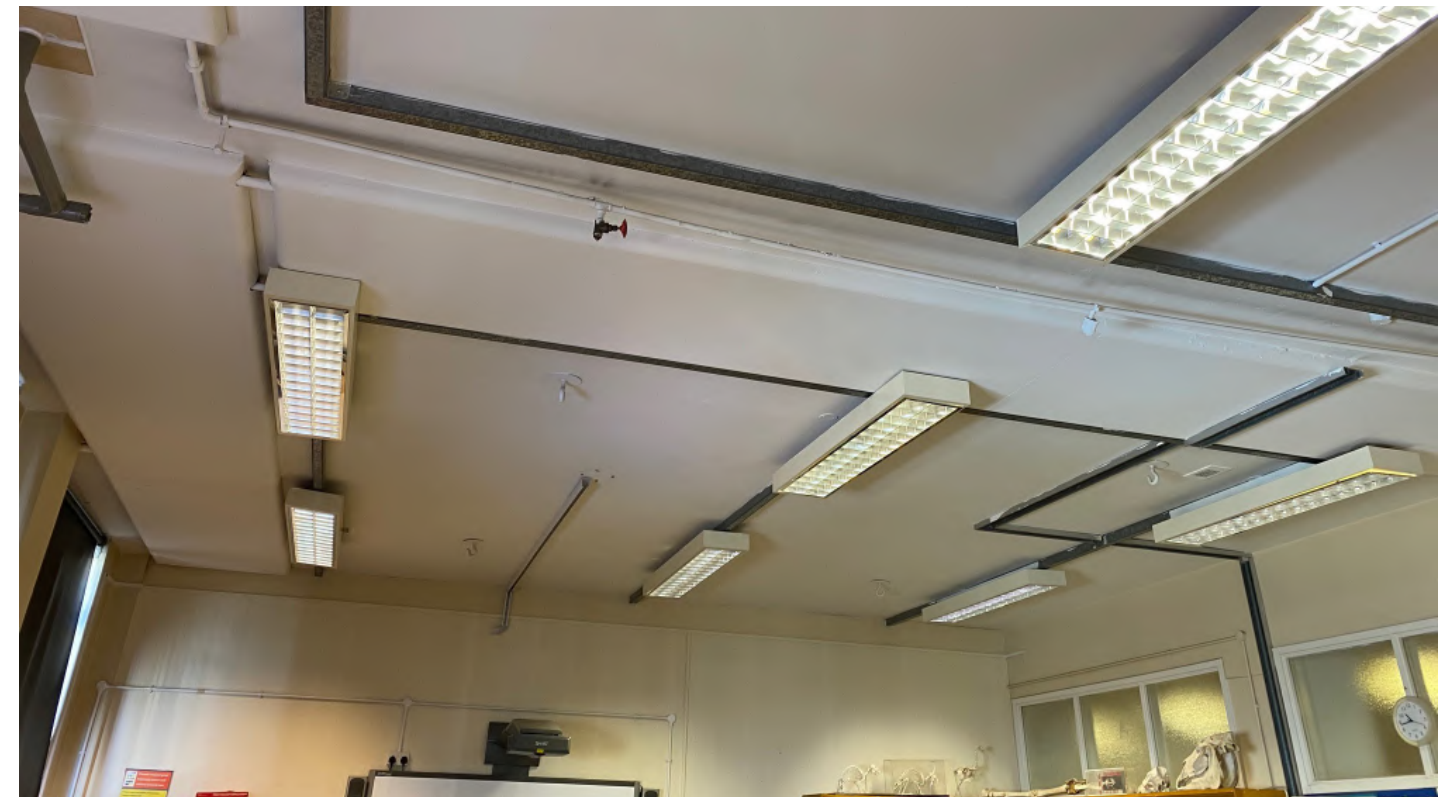
Classroom Photo 2 - 2nd floor classroom with exposed soffit - lacking a fitted ceiling - and surface mounted services and poor lighting provides a unwelcoming, poor and uninspiring learning environment
