Ferry Wetlands

Planning Application ref: 24/01262/FUL

Watervole Survey Results and Mitigation Statement
August 2024

Ferry Field Water Vole Survey May and July 2024

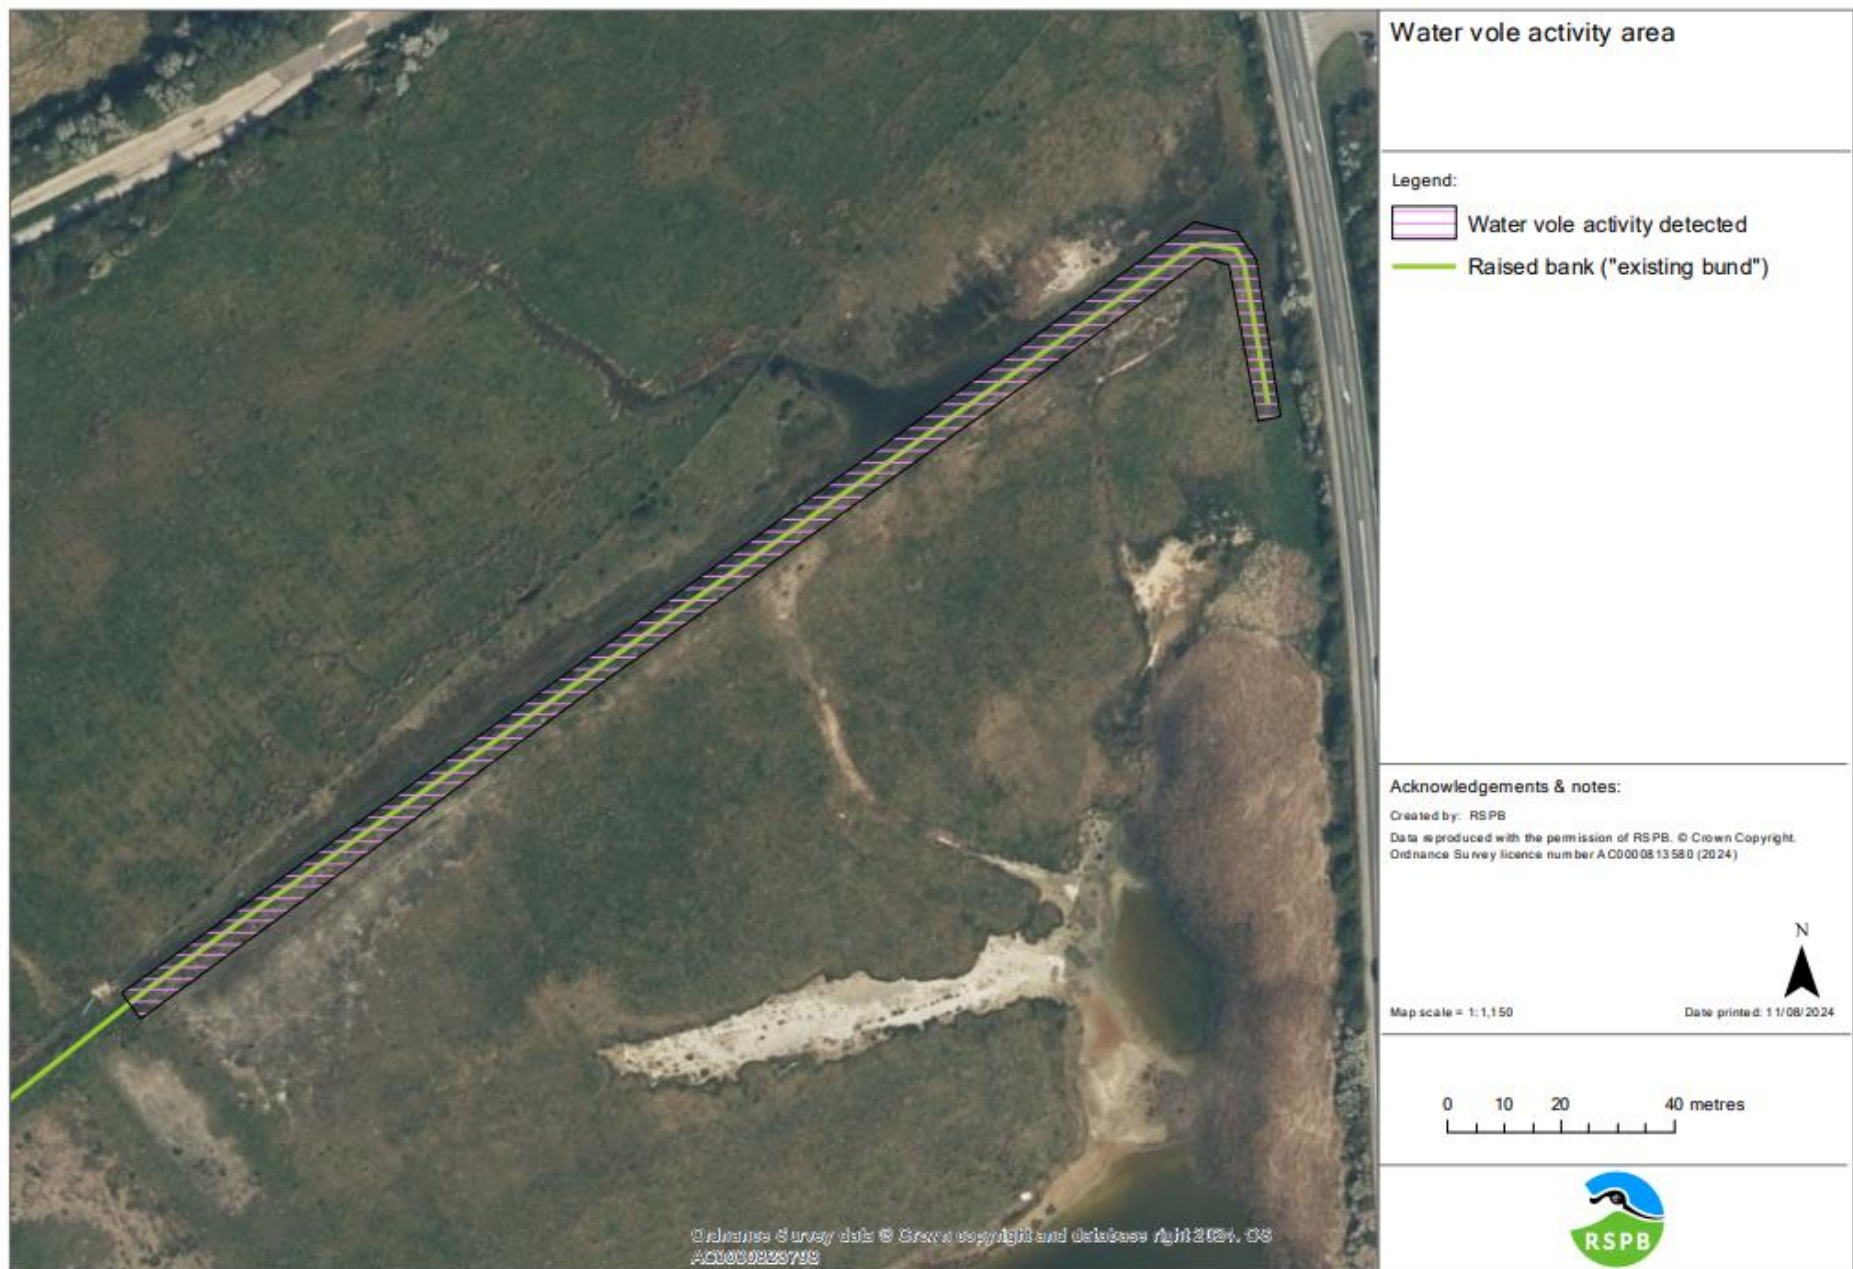
Signs of water vole activity were recorded during the survey undertaken on 27th May 2024, including latrines, feeding stations and suspected burrows, all found within close proximity along one eastern-most section of the central ditch running southwest to northeast across Ferry Field and a perpendicular ditch at the far eastern end next to the road, running north-south. Most of the signs were on or close to a raised bank (referred to in the project proposal as the “existing bund”, running along the south and west edges of the ditch) that was earmarked for removal in the original project proposal. The below map (fig.1) shows the extent of the area where the signs were found. It was not possible to determine if the burrows were occupied but the presence of fresh and trampled latrines and feeding stations would suggest that they were.

Fig 1. Map showing length of ditch with water vole activity in May 2024.

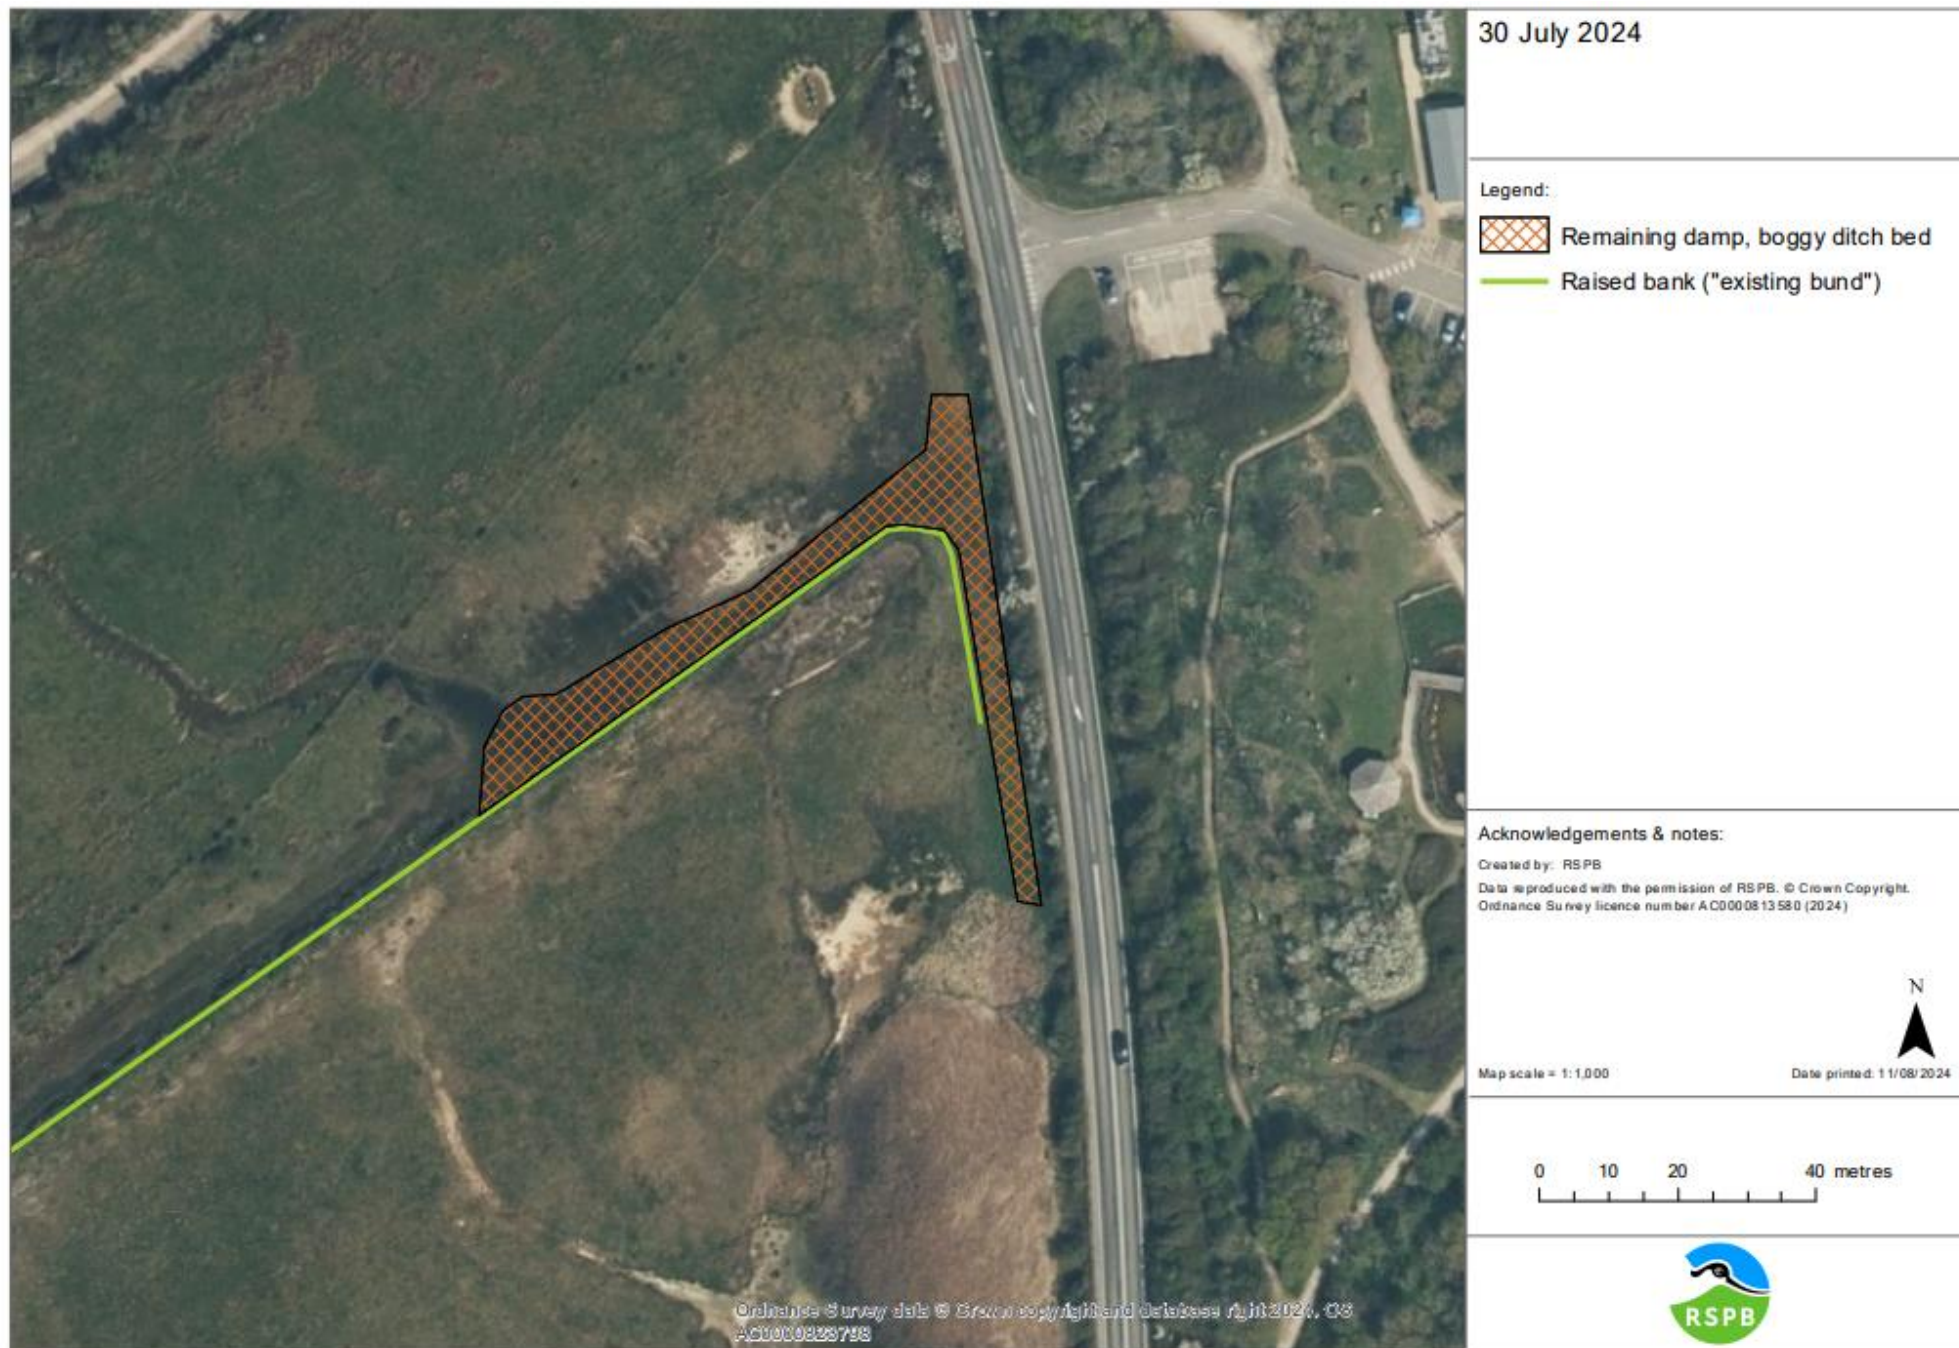
Fig. 2 Map showing remaining damp area of ditch in late July.

The ditch had almost completely dried out during the summer. A single area of damp mud remained in the area at the eastern extremity of the ditch at the elbow bend of the bank.

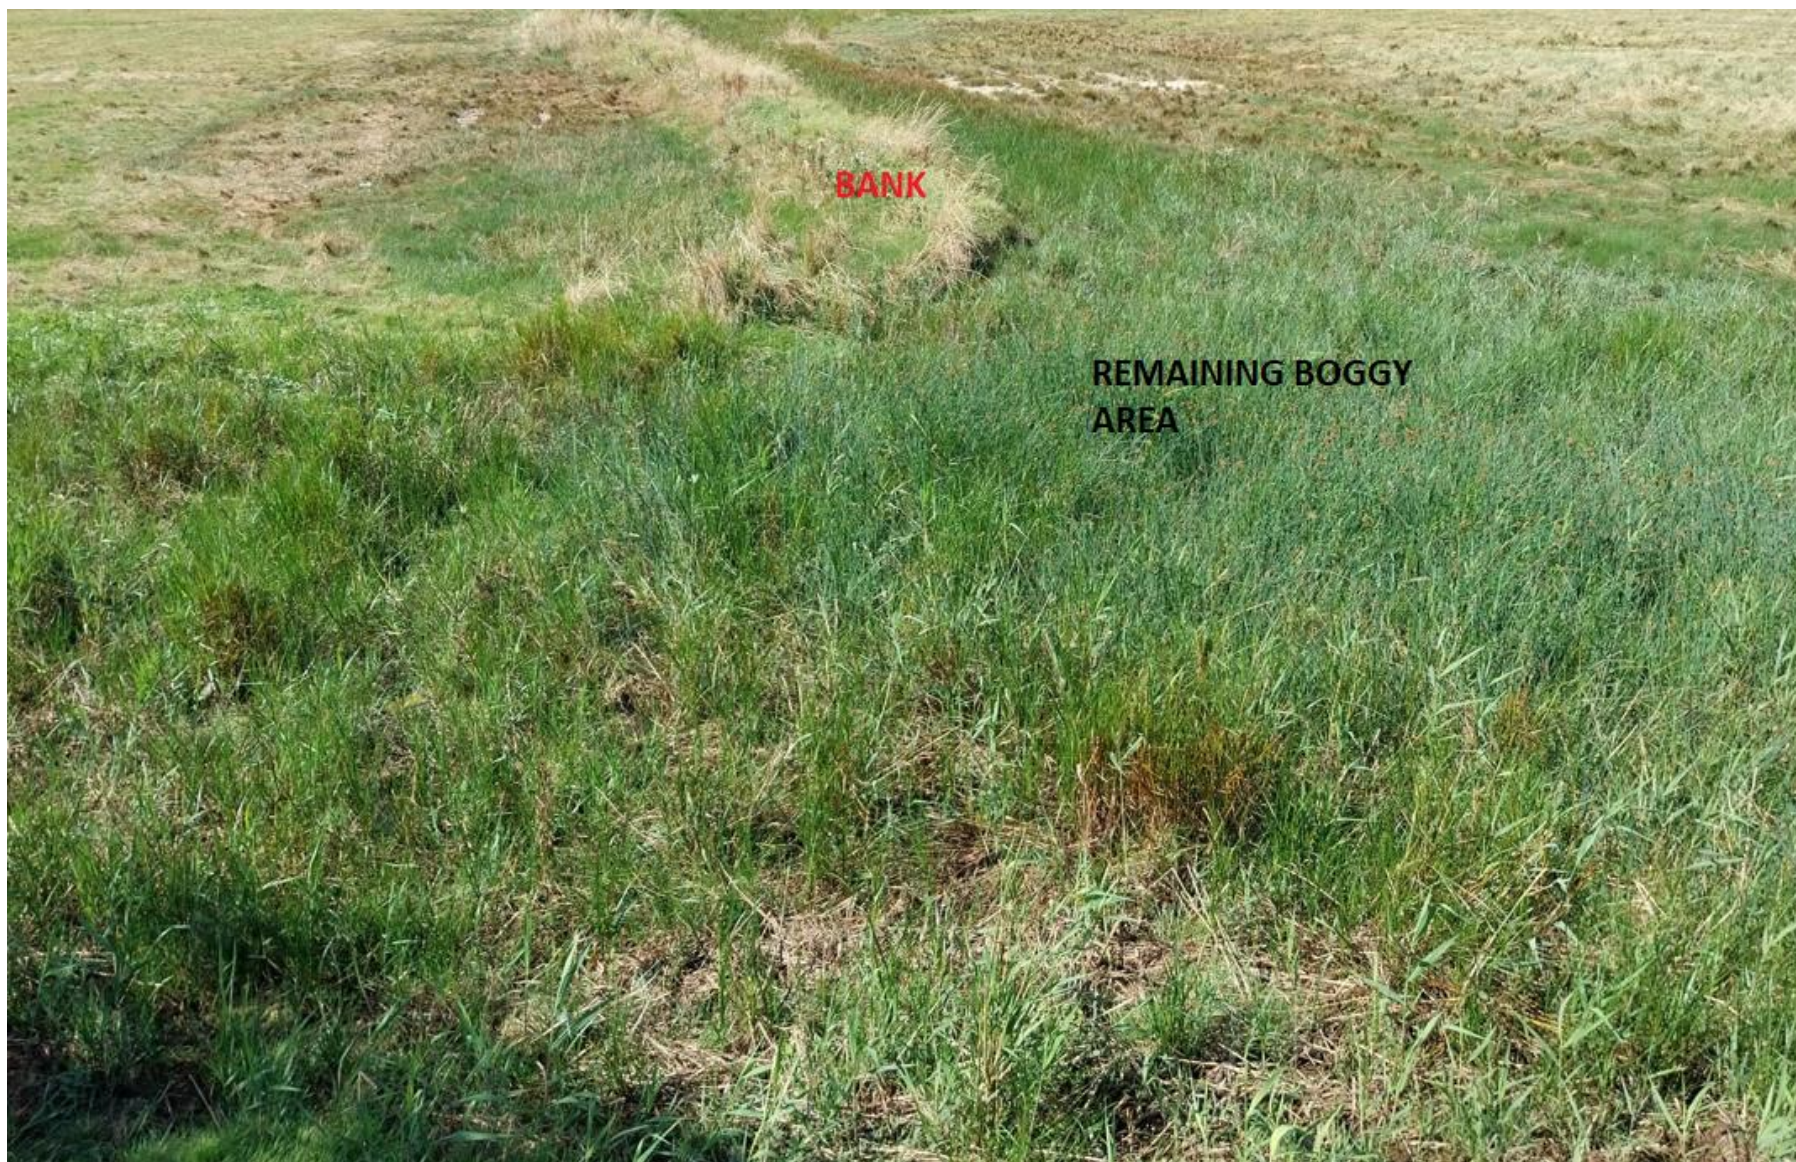
Fig. 3 Photo of remaining damp area in late July

A follow-up survey conducted on 30th of July revealed no obvious, recent signs of water vole activity (Fig I), apart from three small piles of vegetation with some ends nibbled at a 45 degree angle found at the eastern-most end of the central ditch in a sedge-dominated damp area (Figs 3 & J). These were deemed not to resemble typical water vole feeding stations and may have been the feeding signs of field or bank vole. No fresh latrines or obvious water vole feeding signs were recorded. Some of the burrows showed signs of recent activity in the form of small piles freshly excavated spoil at their entrances (Fig K), and given the absence of water vole droppings, it is possible that another rodent species may have been using the burrows.

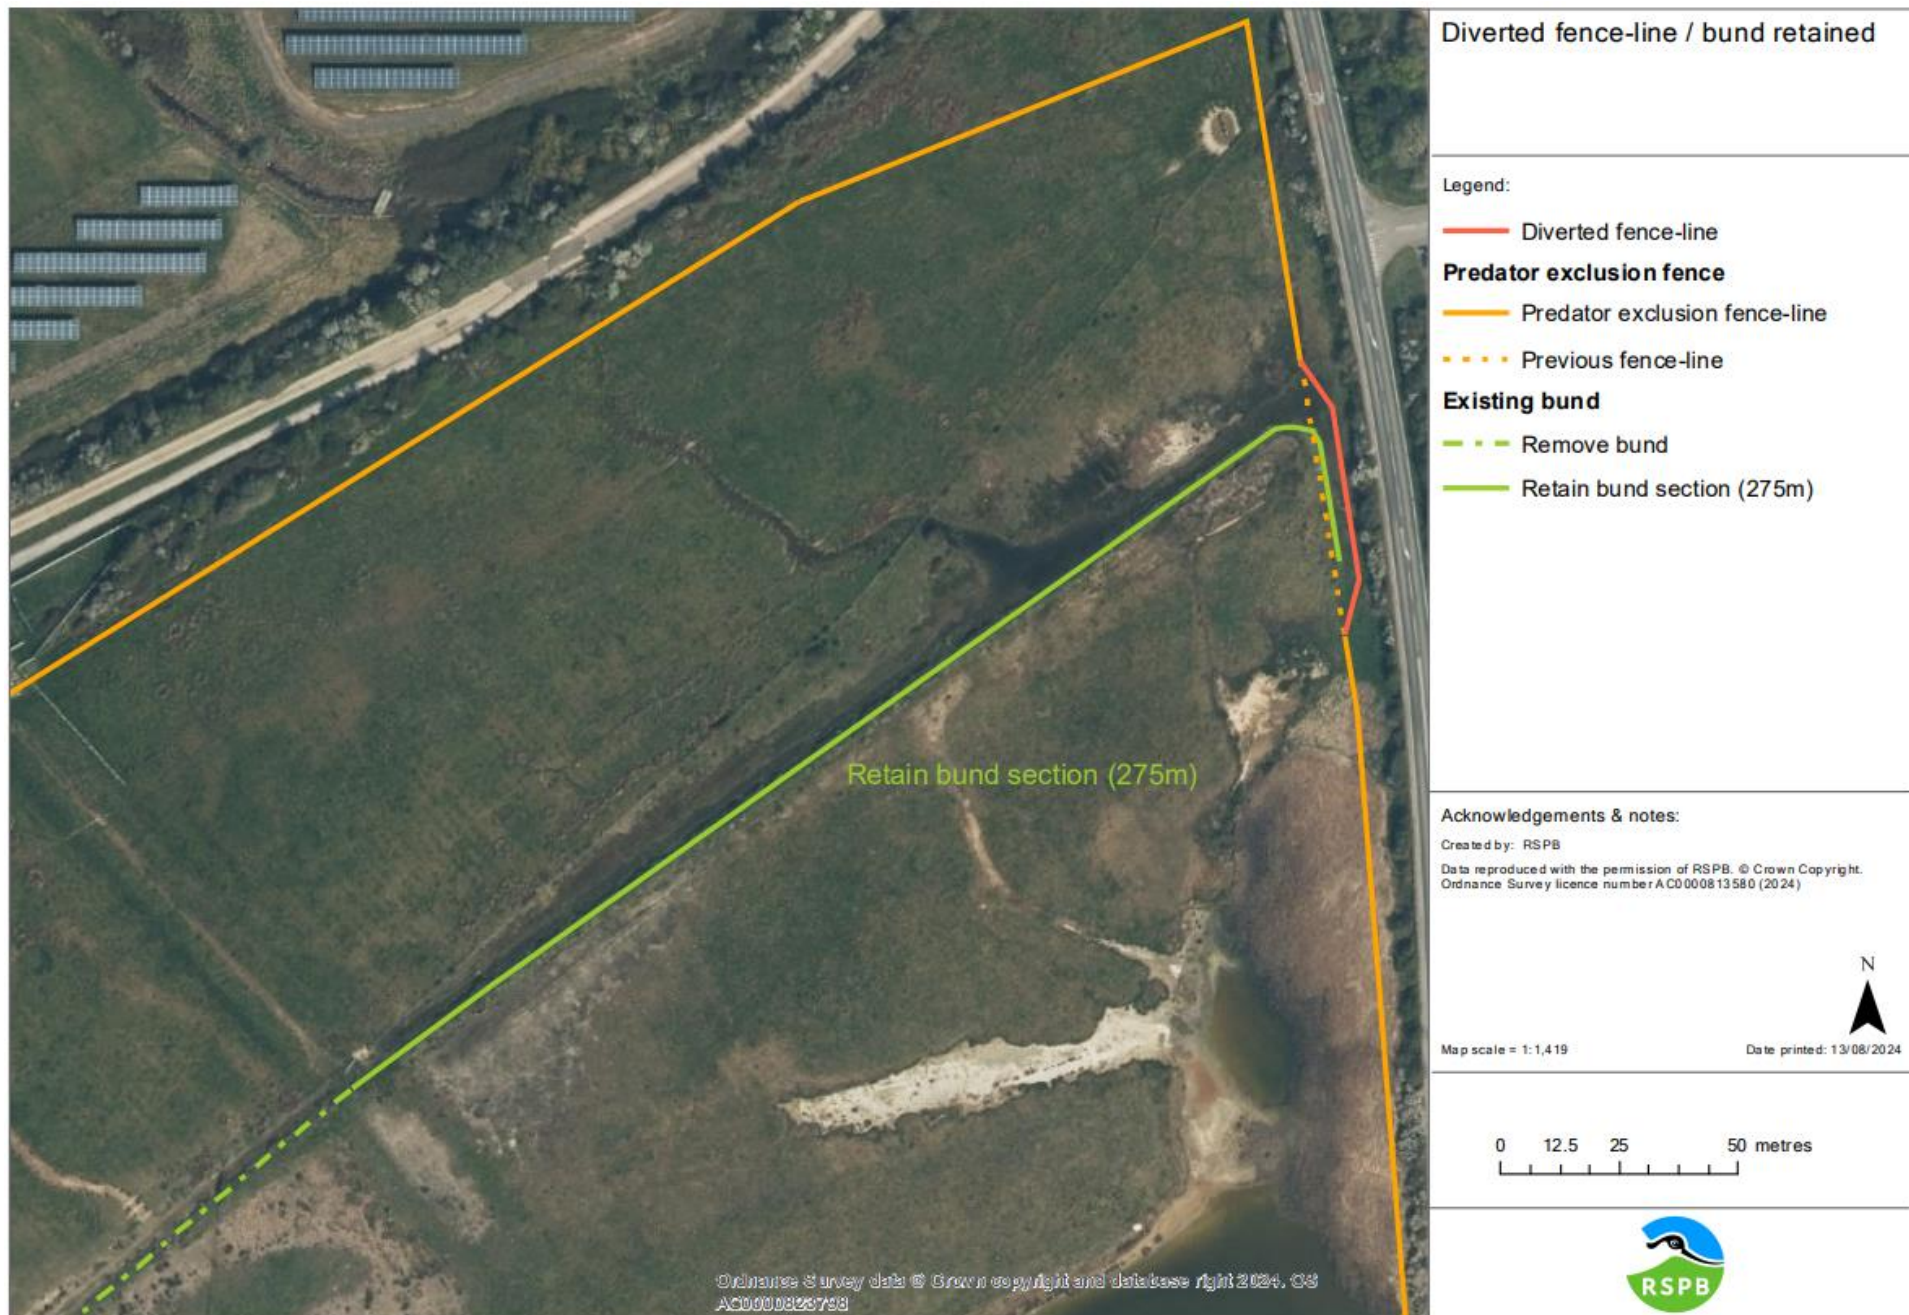
Fig. 4 Planned mitigation showing diverted fence line and bund to be retained

1. The c. 270m section of existing bund where water vole signs have been detected will be retained, with an additional 5m buffer zone at either end of retained bank left alone (Fig 4).
2. The line of the predator exclusion fence will be diverted away from the length of retained bank (bund) and run between the bank and the road, to provide a buffer. (see Fig. 4)

3. The cattle/vehicle crossing point that will be positioned elsewhere along the ditch to a location that away from retained bank, outside of the buffer zone.

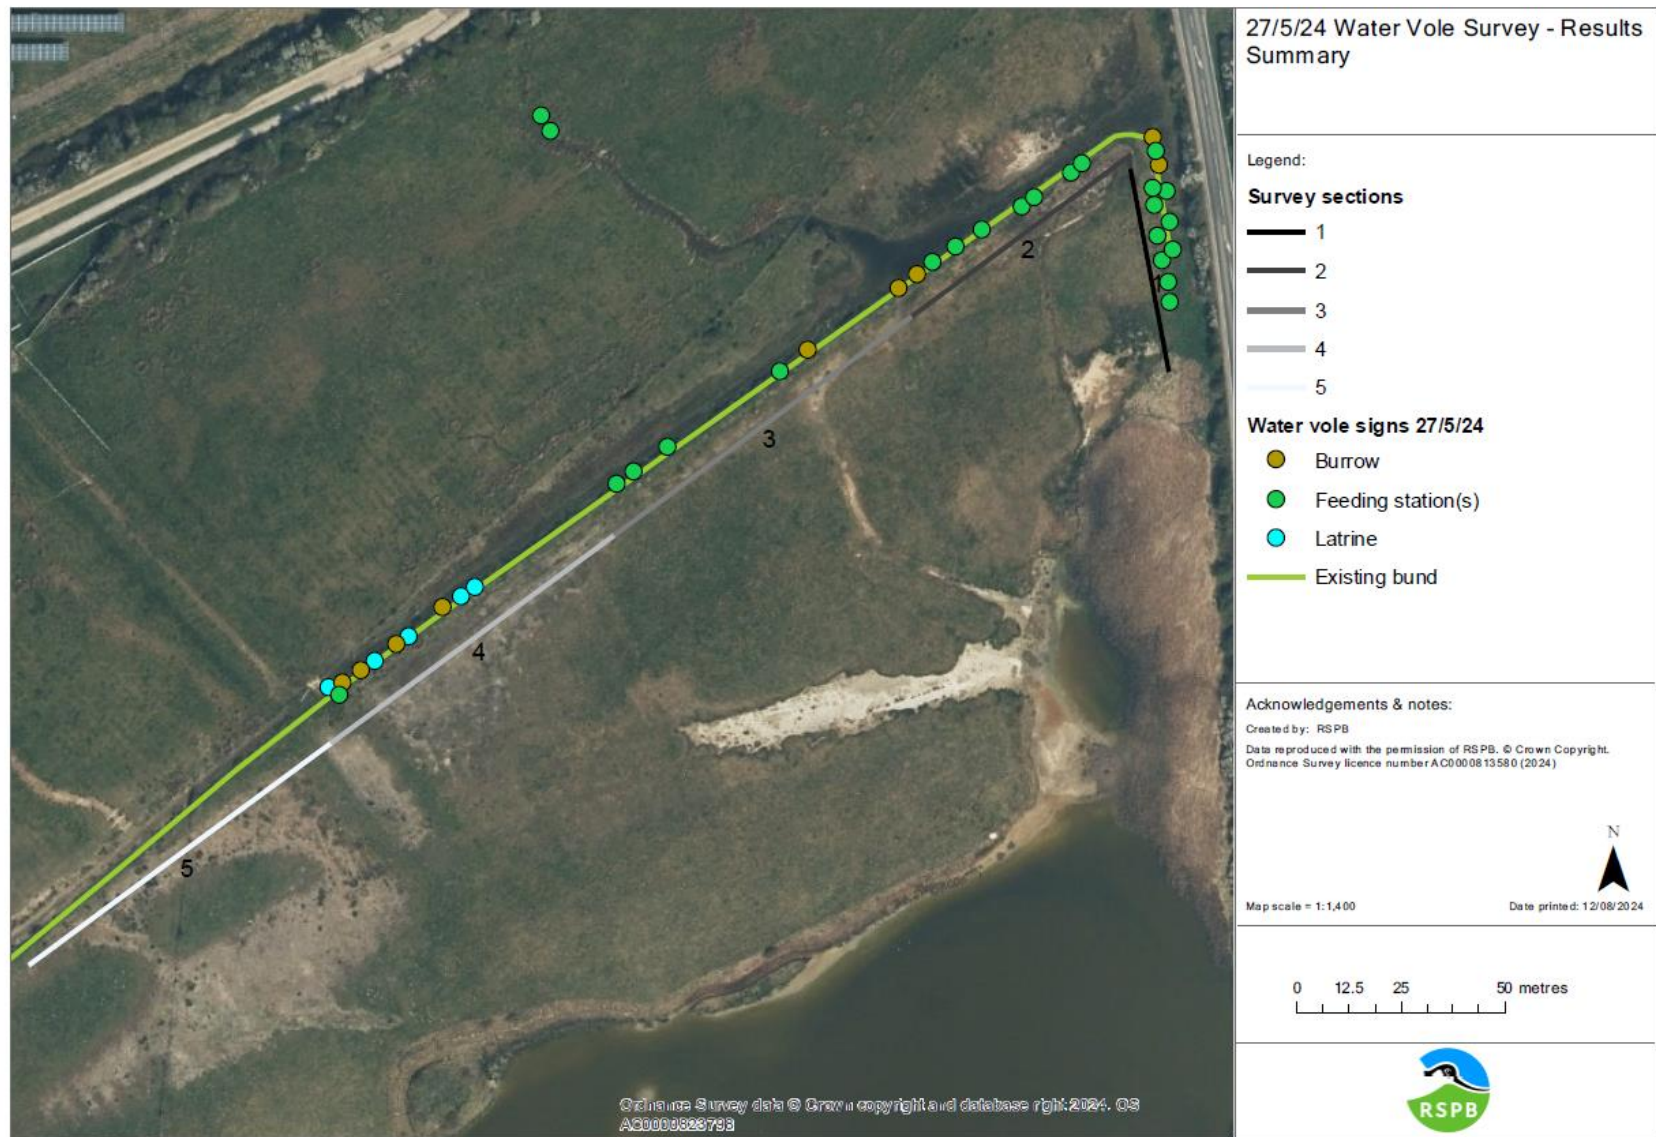
During the survey undertaken on 27th May 2024, signs of water vole activity were recorded, including latrines, feeding stations and c17 suspected burrows. (see images -some atypical shape so possibly not all made by water voles). All were found in close proximity along the southern bank of the central ditch running southwest to northeast across Ferry Field, at its north-eastern end (from SZ8540196422 in west to SZ8559296550 in east). In addition, feeding stations and burrows were found along a perpendicular ditch running north-south at the far eastern end next to the road, from SZ8559296550 to SZ8560896469). Feeding signs were also seen at the top of the very small shallow ditch flowing across the field from the north at SZ8545196563 but there was no suitable burrowing habitat there. No signs were found at the pond, To the south of point SZ8560896469 the ditch widens into a reedbed in which Reed Warblers were breeding so the survey did not extend beyond this point.

The below map (Fig. B) shows the extent of the area where these signs were found. It was not possible to determine if the burrows were occupied but the presence of fresh and trampled latrines and feeding stations would suggest they were.

Fig B. Survey results from 1st survey on 27 May 2024.

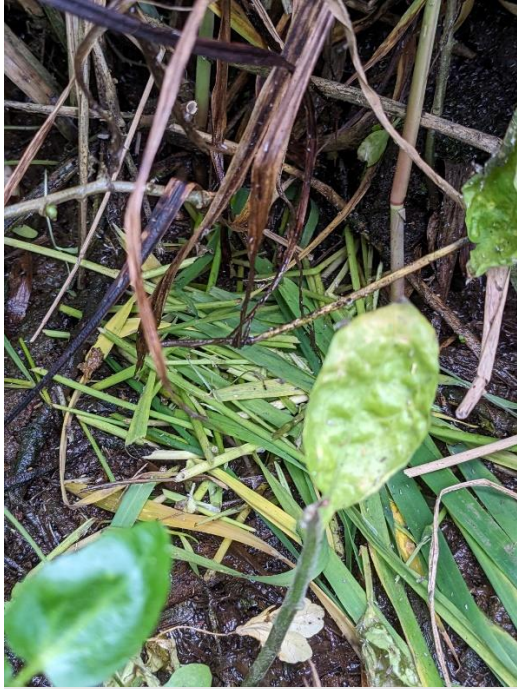
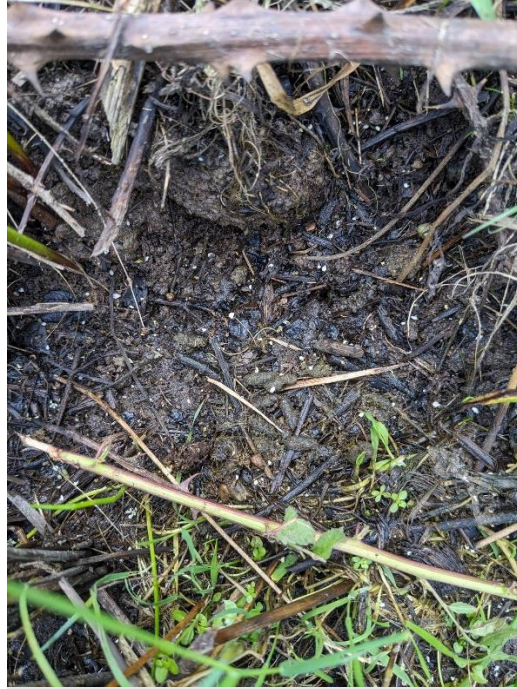
Fig C Feeding station with 45 degree cut ends. Fig D Latrine with tic-tac sized green/brown droppings

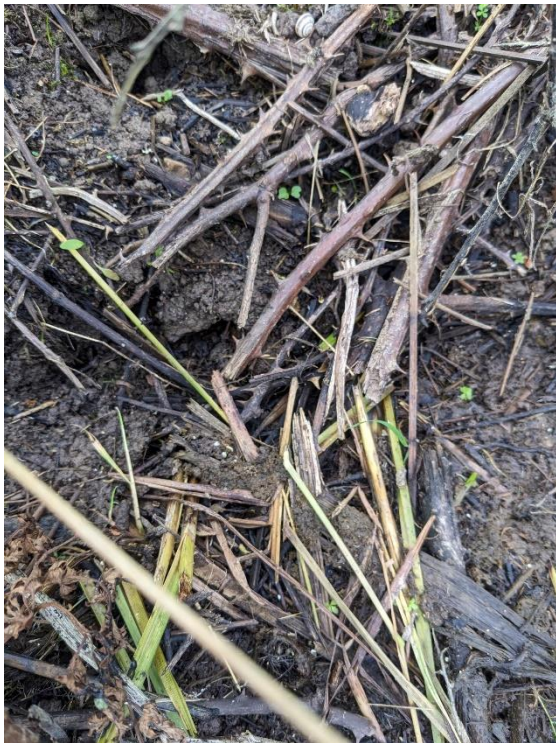
Fig E Trampled latrine

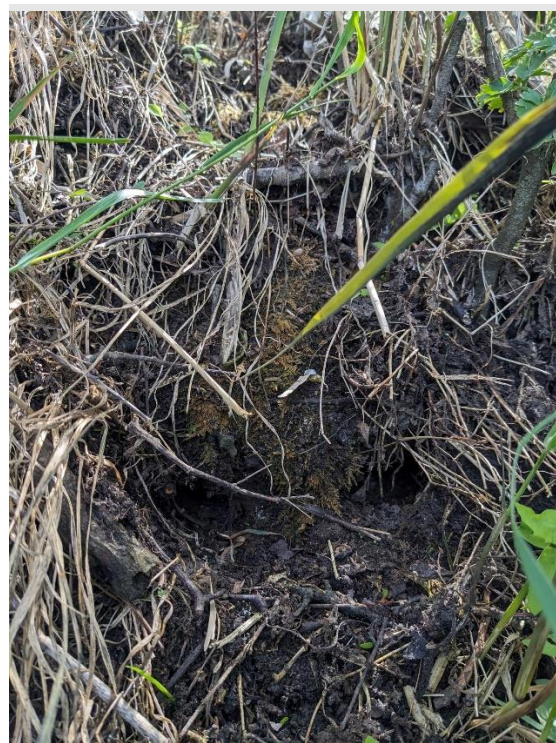
Fig F Burrows in ditch bank

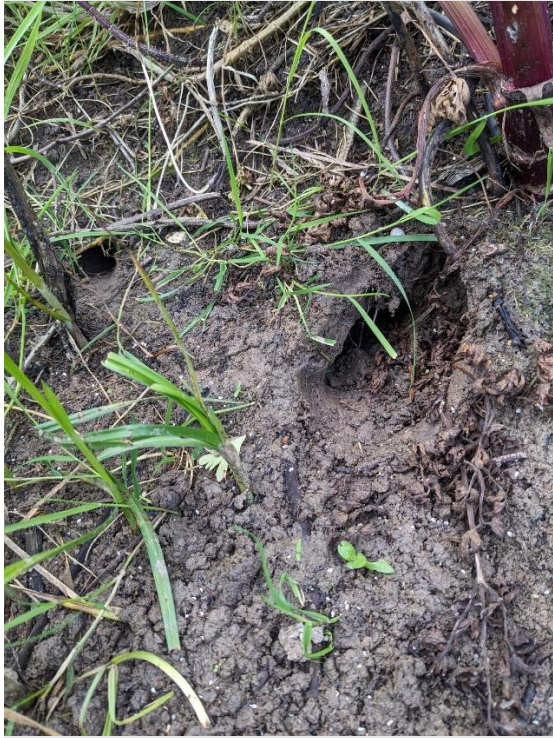
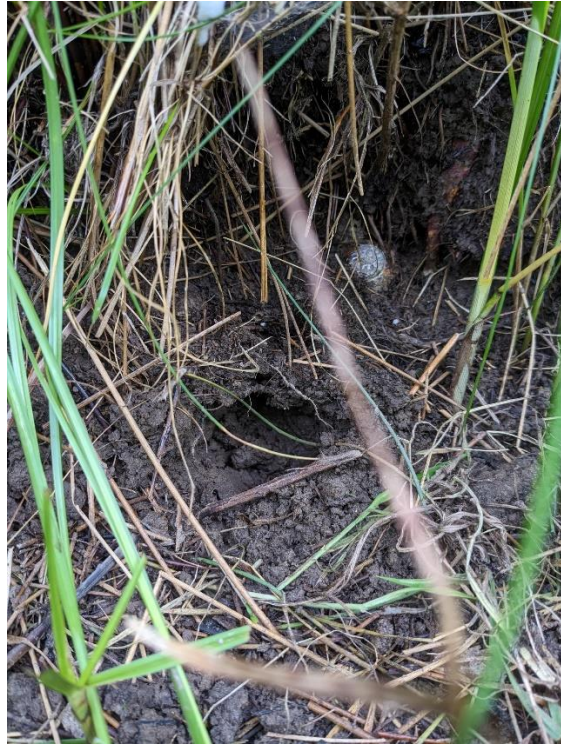
Fig G & H Burrows – both atypical shapes for water vole

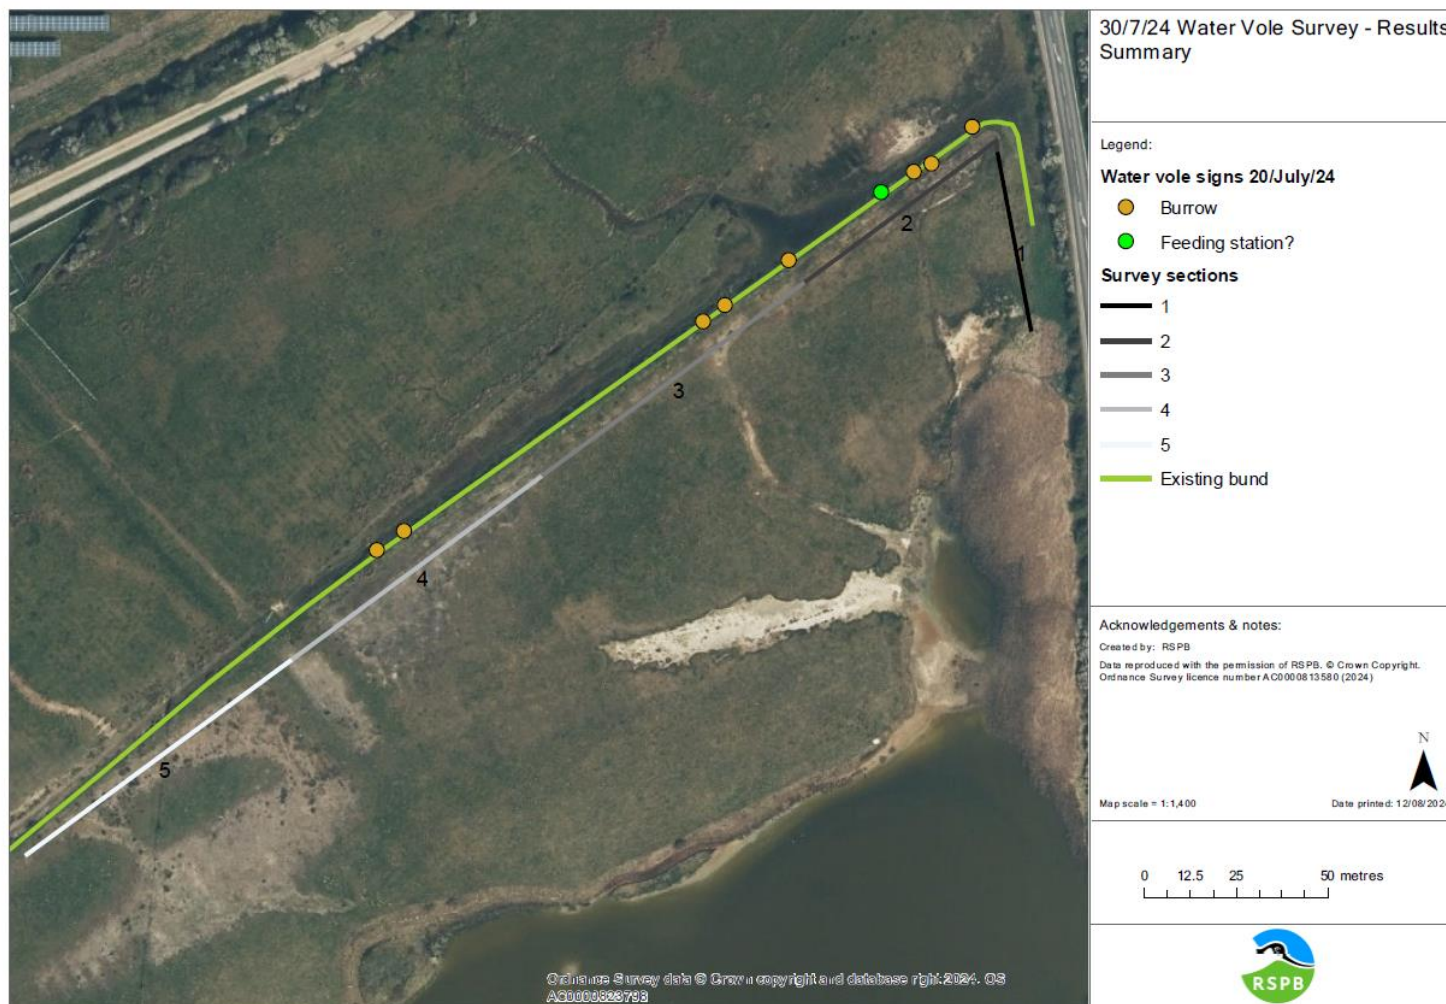
Fig I Map of water vole signs 30 July 2024

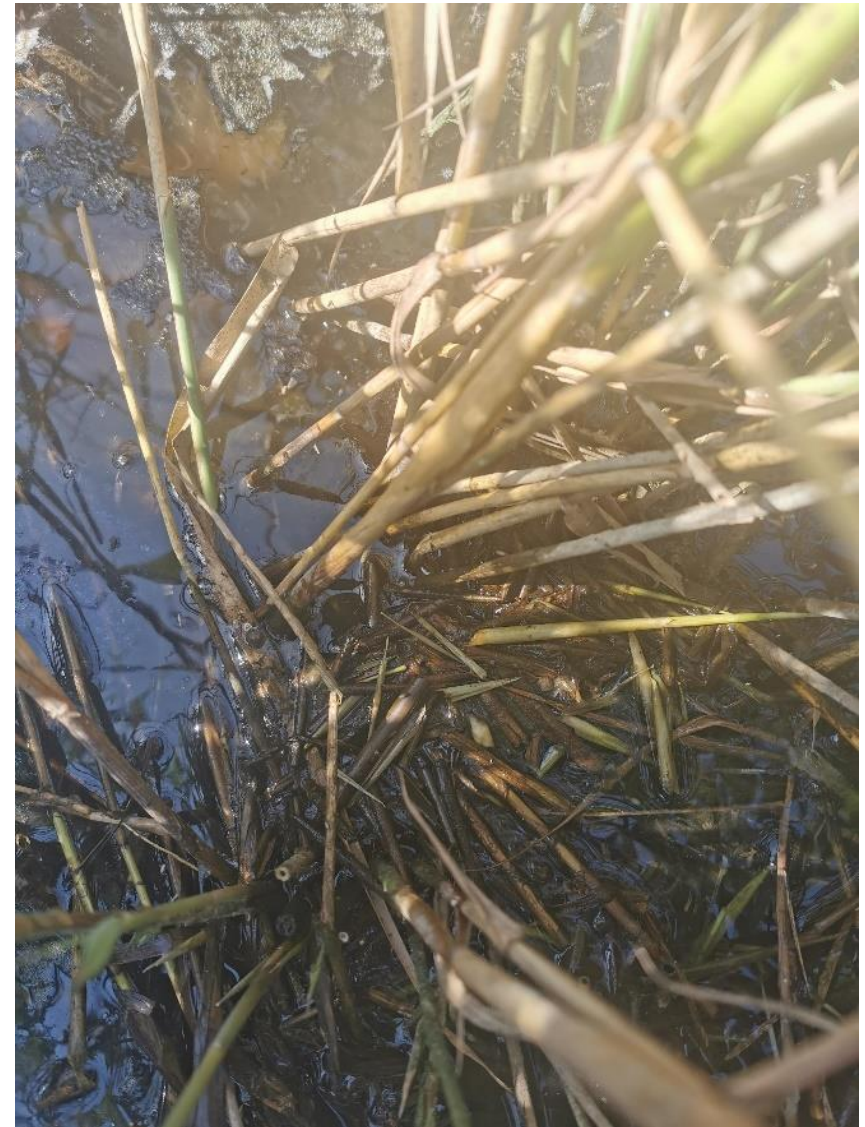
Fig J Feeding material in pile

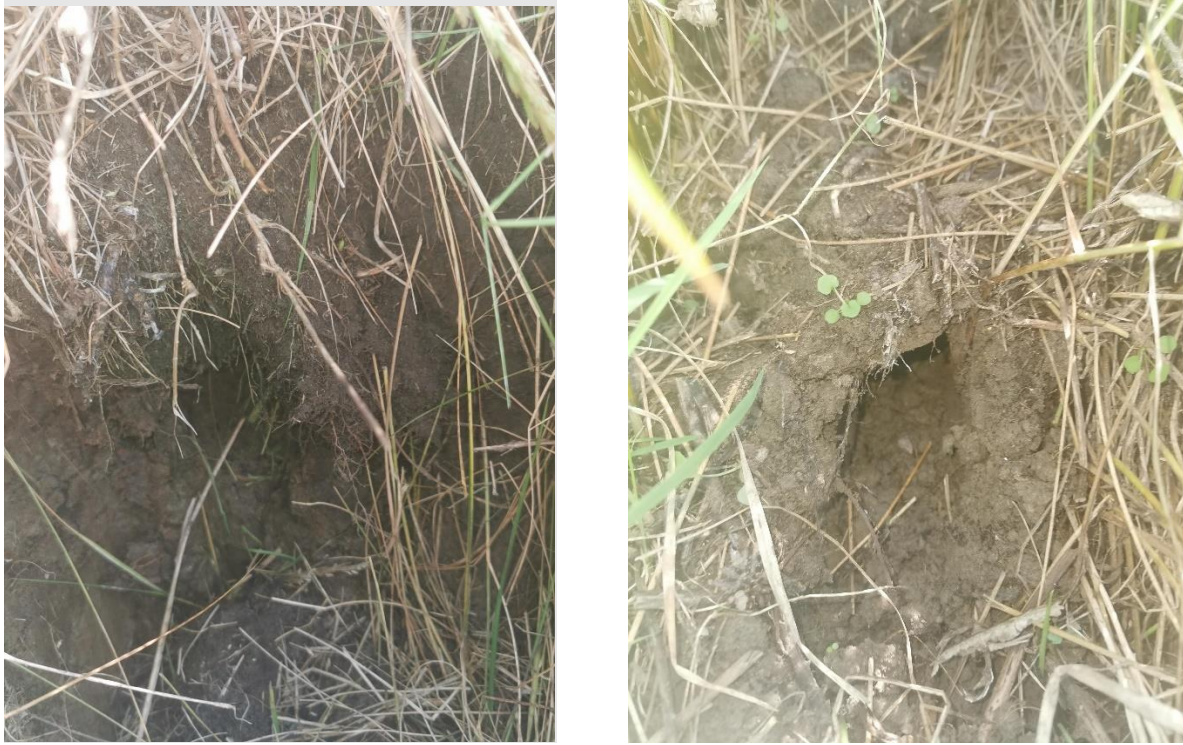
Fig K Burrows with freshly disturbed soil – atypical of water vole burrows
