PROPOSED WORKS AT
1 & 2 Strickland Place, Southwold, Suffolk, IP18 6HN
PRE-CONSTRUCTION INFORMATION
Construction (Design & Management) Regulations 2015

Refurbishment /Pre-Demolition Survey of Asbestos Materials at

**1 Strickland Place
Southwold
Suffolk
IP18 6HN**

Management Survey of Asbestos Materials at

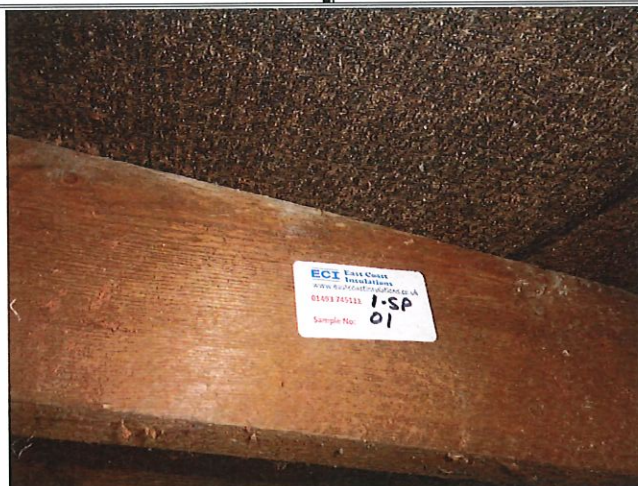
Photograph No:-
01

Accessibility	DIFFICULT 0	MEDIUM 2	EASY 6	Asbestos	Yes	No
Damaged	NO 0	MINOR 2	SEVERE 4			<input checked="" type="checkbox"/>
Friability	LOW 1	MEDIUM 2	HIGH 4	Amount :		
General Condition	GOOD 0	FAIR 2	POOR 4	Laboratory Results N.A.D.I.S.		
Algorithm Rating		Recommended Action:	High	Chrysotile		
			Medium	Amosite		
			Low	Crocidolite

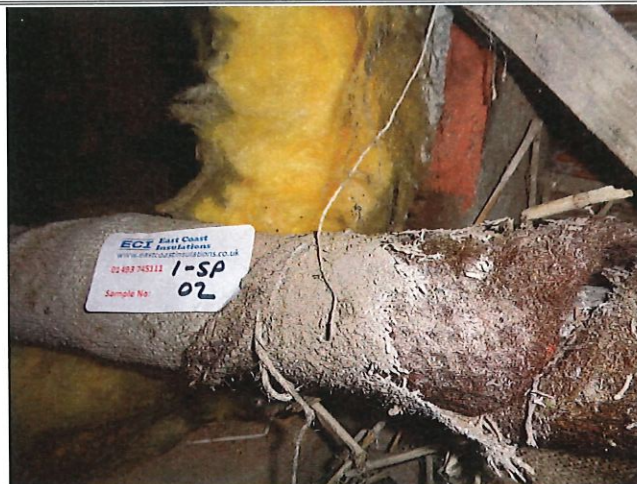
Photograph No:-
02

Accessibility	DIFFICULT 0	MEDIUM 2	EASY 6	Asbestos	Yes	No
Damaged	NO 0	MINOR 2	SEVERE 4			✓
Friability	LOW 1	MEDIUM 2	HIGH 4	Amount :		
General Condition	GOOD 0	FAIR 2	POOR 4	Laboratory Results N.A.D.I.S.		
Algorithm Rating		Recommended Action:	High	Chrysotile		
			Medium	Amosite		
			Low	Crocidolite

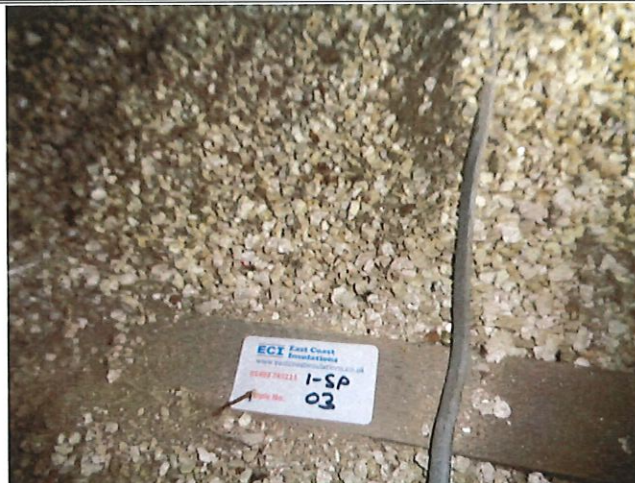
Photograph No:-
03

Accessibility	DIFFICULT 0	MEDIUM 2	EASY 6	Asbestos	Yes	No
Damaged	NO 0	MINOR 2	SEVERE 4			<input checked="" type="checkbox"/>
Friability	LOW 1	MEDIUM 2	HIGH 4	Amount :		
General Condition	GOOD 0	FAIR 2	POOR 4	Laboratory Results N.A.D.I.S.		
Algorithm Rating		Recommended Action:	High	Chrysotile		
			Medium	Amosite		
			Low	Crocidolite

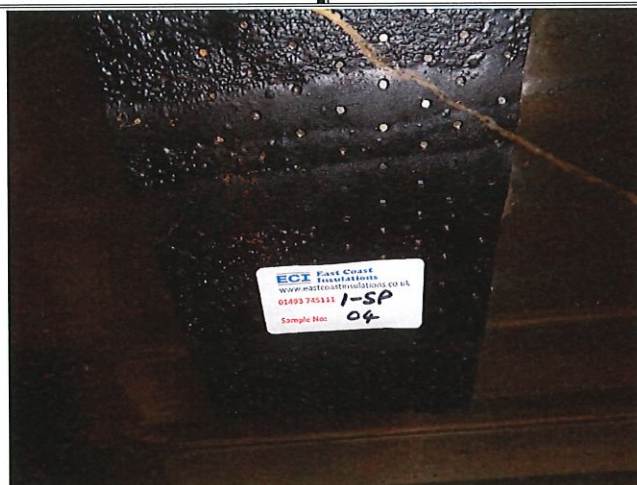
Photograph No:-
04

Accessibility	DIFFICULT 0		MEDIUM 2	<input checked="" type="checkbox"/>	EASY 6		Asbestos	Yes	No
Damaged	NO 0		MINOR 2	<input checked="" type="checkbox"/>	SEVERE 4			<input checked="" type="checkbox"/>	
Friability	LOW 1	<input checked="" type="checkbox"/>	MEDIUM 2		HIGH 4		Amount : X 2		
General Condition	GOOD 0		FAIR 2	<input checked="" type="checkbox"/>	POOR 4		Laboratory Results		
Algorithm Rating	8	Recommended Action: REMOVAL	High		Chrysotile	<input checked="" type="checkbox"/>			
			Medium		Amosite				
			Low	<input checked="" type="checkbox"/>	Crocidolite

SAMPLE /REF NO:-	LOCATION	AREA	QUANTITY	SURFACE COATING TYPE	ACCESSIBILITY	DAMAGE	FRIABILITY	GENERAL CONDITION	ALGORITHM SCORE	ASBESTOS TYPE	COMMENT	RECOMMENDED ACTION
NO BENEATH GROUND EXCAVATION UNDERTAKEN												
1SP-04	Ground Floor – Kitchen	Sink Pad	X 2	Other – 1	Medium – 2	Minor – 2	Low – 1	Fair – 2	Low – 8	Chrysotile (White)		Removal
1SP-06	Ground Floor – Stairs to Basement	Ceiling Board	2m ²	Cement – 2	Easy – 6	Minor – 2	Low – 1	Fair – 2	Medium – 13	Chrysotile (White)		Removal

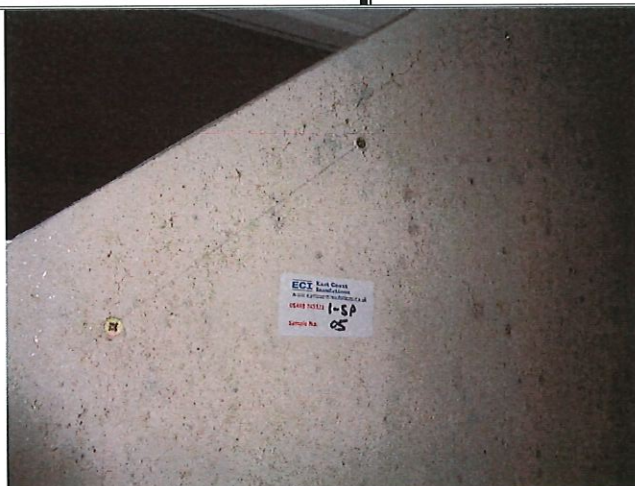
Photograph No:-
05

Accessibility	DIFFICULT 0	MEDIUM 2	EASY 6	Asbestos	Yes	No
Damaged	NO 0	MINOR 2	SEVERE 4			<input checked="" type="checkbox"/>
Friability	LOW 1	MEDIUM 2	HIGH 4	Amount :		
General Condition	GOOD 0	FAIR 2	POOR 4	Laboratory Results N.A.D.I.S.		
Algorithm Rating		Recommended Action:	High	Chrysotile		
			Medium	Amosite		
			Low	Crocidolite

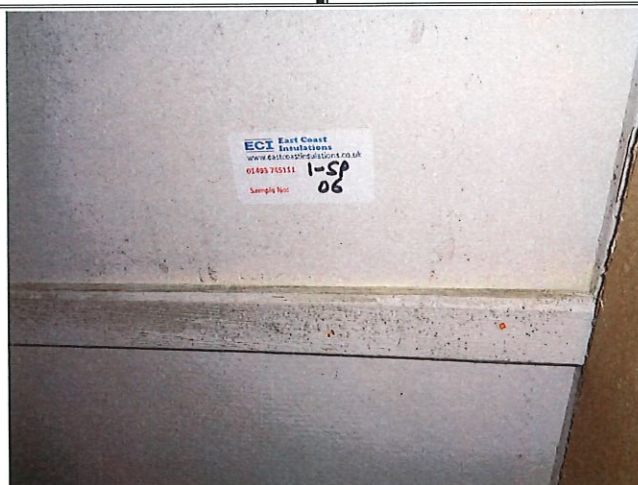
Photograph No:-
06

Accessibility	DIFFICULT 0		MEDIUM 2		EASY 6	<input checked="" type="checkbox"/>	Asbestos	Yes	No
Damaged	NO 0		MINOR 2	<input checked="" type="checkbox"/>	SEVERE 4			<input checked="" type="checkbox"/>	
Friability	LOW 1	<input checked="" type="checkbox"/>	MEDIUM 2		HIGH 4		Amount : 2m²		
General Condition	GOOD 0		FAIR 2	<input checked="" type="checkbox"/>	POOR 4		Laboratory Results		
Algorithm Rating	13	Recommended Action: REMOVAL	High		Chrysotile	<input checked="" type="checkbox"/>			
			Medium	<input checked="" type="checkbox"/>	Amosite				
			Low		Crocidolite

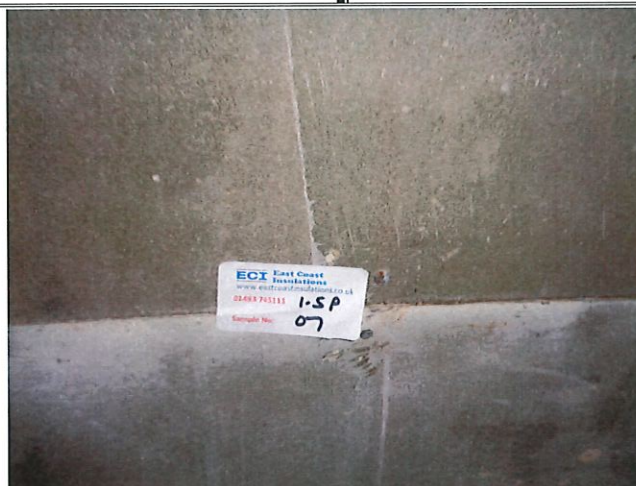
1SP-07

Accessibility	DIFFICULT 0	MEDIUM 2	EASY 6	Asbestos	Yes	No
Damaged	NO 0	MINOR 2	SEVERE 4			✓
Friability	LOW 1	MEDIUM 2	HIGH 4	Amount :		
General Condition	GOOD 0	FAIR 2	POOR 4	Laboratory Results N.A.D.I.S.		
Algorithm Rating		Recommended Action:	High	Chrysotile		
			Medium	Amosite		
			Low	Crocidolite

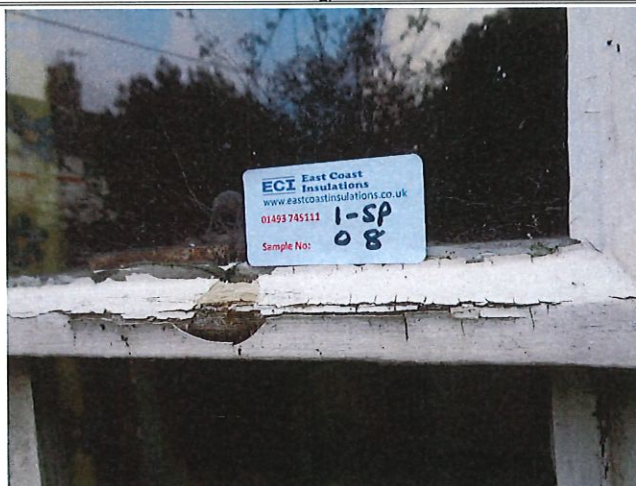
Photograph No:-
08

Accessibility	DIFFICULT 0	MEDIUM 2	EASY 6	Asbestos	Yes	No
Damaged	NO 0	MINOR 2	SEVERE 4			<input checked="" type="checkbox"/>
Friability	LOW 1	MEDIUM 2	HIGH 4	Amount :		
General Condition	GOOD 0	FAIR 2	POOR 4	Laboratory Results N.A.D.I.S.		
Algorithm Rating		Recommended Action:	High	Chrysotile		
			Medium	Amosite		
			Low	Crocidolite

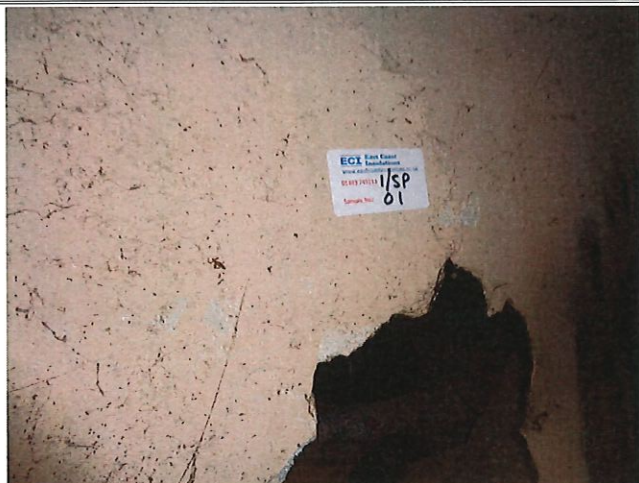
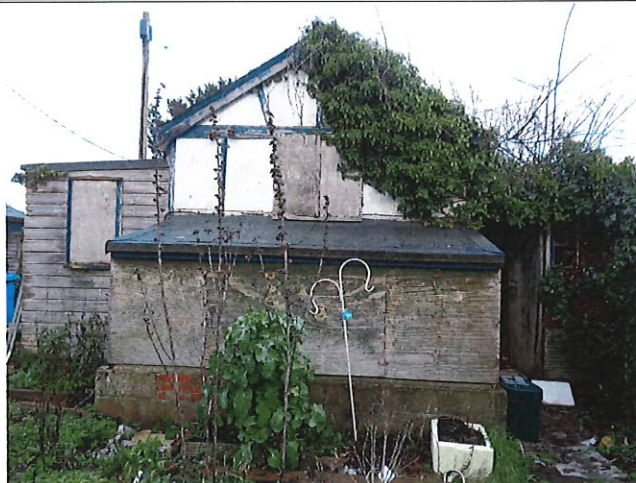
Accessibility	DIFFICULT 0		MEDIUM 2		EASY 6	✓	Asbestos	Yes	No
Damaged	NO 0		MINOR 2		SEVERE 4	✓		✓	
Friability	LOW 1	✓	MEDIUM 2		HIGH 4		Amount : THROUGHOUT		
General Condition	GOOD 0		FAIR 2		POOR 4	✓	Laboratory Results		
Algorithm Rating	17	Recommended Action: Removal		High			Chrysotile	✓	
				Medium	✓		Amosite		
				Low			Crocidolite

SAMPLE /REF NO:-	LOCATION	AREA	QUANTITY	SURFACE COATING TYPE	ACCESSIBILITY	DAMAGE	FRIABILITY	GENERAL CONDITION	ALGORITHM SCORE	ASBESTOS TYPE	COMMENT	RECOMMENDED ACTION
NO BENEATH GROUND EXCAVATION UNDERTAKEN												
2SP-01	Shed	Wall Sheets	Throughout	Cement - 2	Easy - 6	Severe - 4	Low - 1	Poor - 4	Medium - 17	Chrysotile (White)		Removal
