# KENNINGTON BOWL SKATEPARK, LONDON

## Preliminary Tree Assessment

JSL4040\_770

26 APRIL 2021

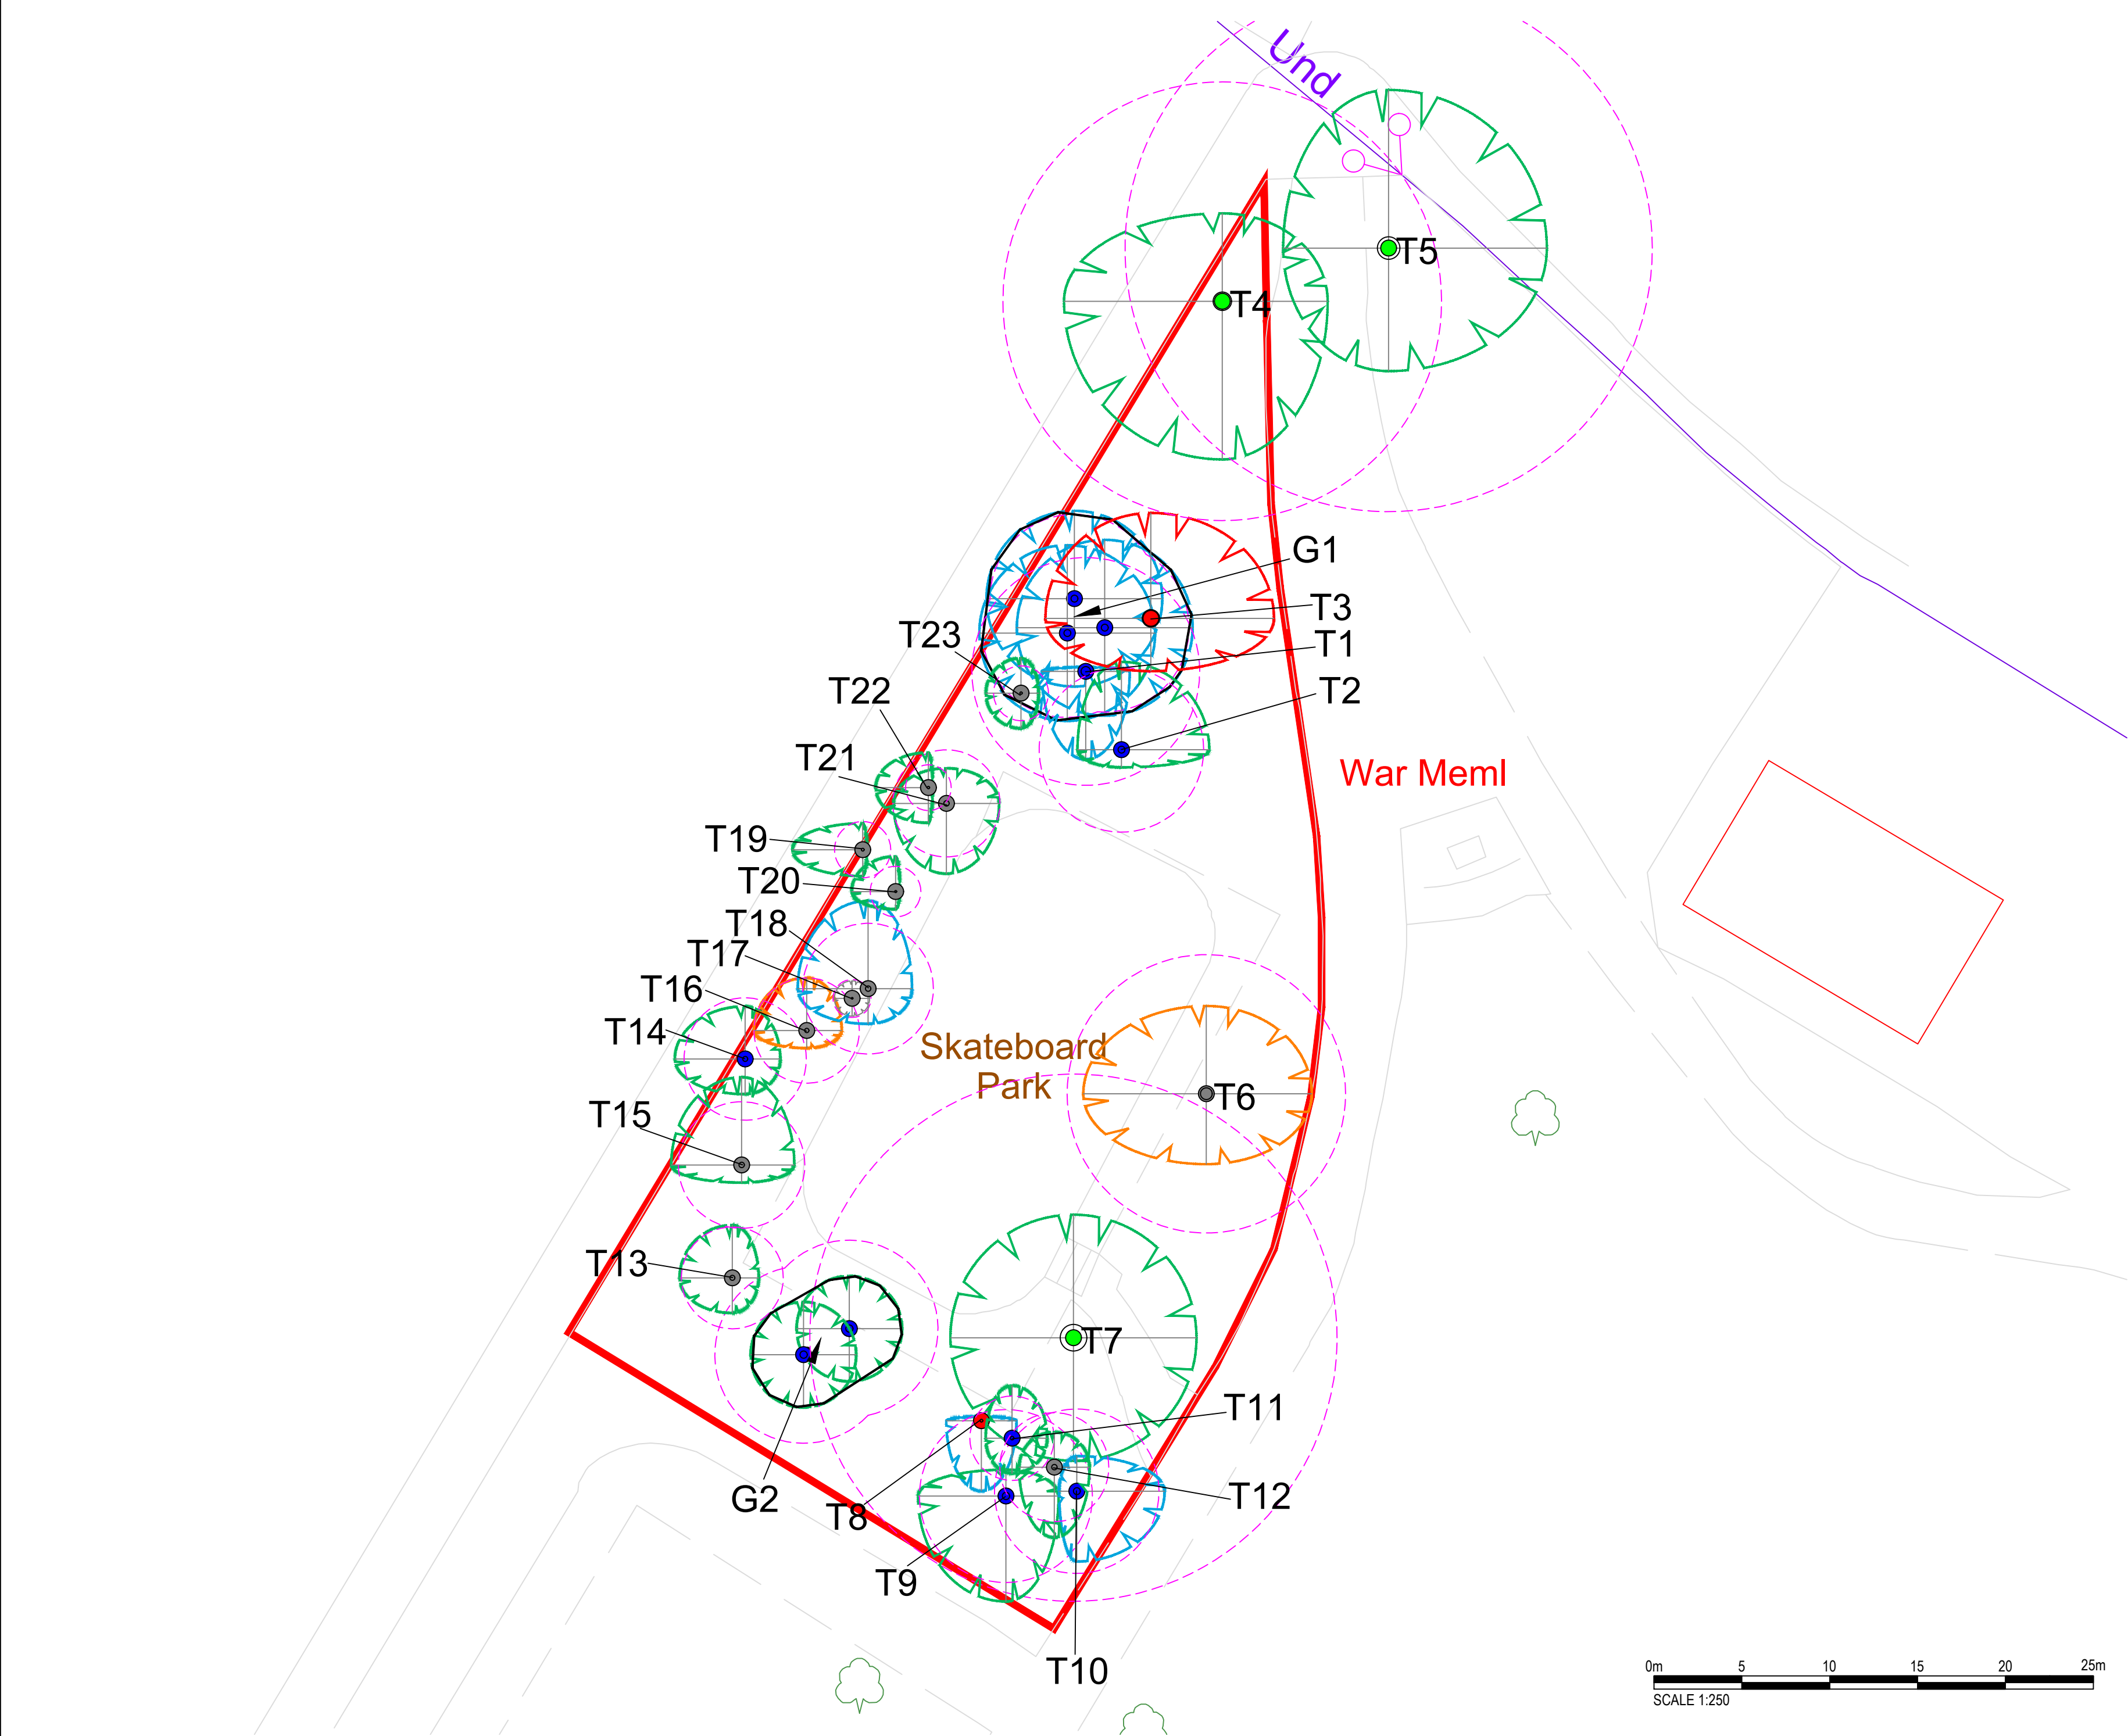
**JSL4040\_700: TREE CONSTRAINTS & WORKS PRIORITY PLAN**

- 4.3 One London plane (T3) was recorded as being affected by an overall decline in physiological health and with a visible infection of Massaria (see Section 2. Site Information, para. 2.4 for more information). It is possible this tree became drought stressed in the past, perhaps due to the false acacia growing adjacent to it competing for available moisture it had previously been accustomed to having for itself. The tree has shed limbs in the past, one of which remains in situ at the base, and this was shed due to Massaria judging by its appearance. This tree is likely to have a limited remaining life expectancy and will probably shed further limbs as Massaria was observed within the crown. It therefore poses a safety concern to the public given the high levels of footfall at Kennington Park. It is recommended that this tree be removed.

- 4.4 The most significant stem defect present is that of T6, a sycamore growing directly adjacent the east side of the structure. This tree has a large tear-shaped opening to its stem where it appears to have lost a limb in the past which has likely torn downward. This has severely exposed the heartwood which is decaying and while there is some occlusion to the edges of the large wound it poses a risk given its size and location. It is recommended that this tree be removed.

- 4.5 A laburnum (*Laburnum anagyroides*), T16, is located along the western side of the structure and this tree has a decay cavity below the point where the crown forks. As is fairly typical for laburnum, it previously developed an inclusion at its fork union which provides an entry point for decay and this is the likely cause of the stem cavity. Unfortunately, the tree has the potential to lose its main limbs due to this and both have potential targets of significance adjacent them. It is recommended this tree be removed to remove the risk it poses.

- 4.6 Of less significance, the removal of the small cotoneaster species (T8) growing close to the south side of the skatepark should be removed under general maintenance as one stem has died and the remaining stem is in poor condition.

- 4.7 All tree works can be found within Tables 3 and 4 attached to this report and can be seen on the Tree Constraints & Works Priority Plan (see drawing JSL4040\_700).

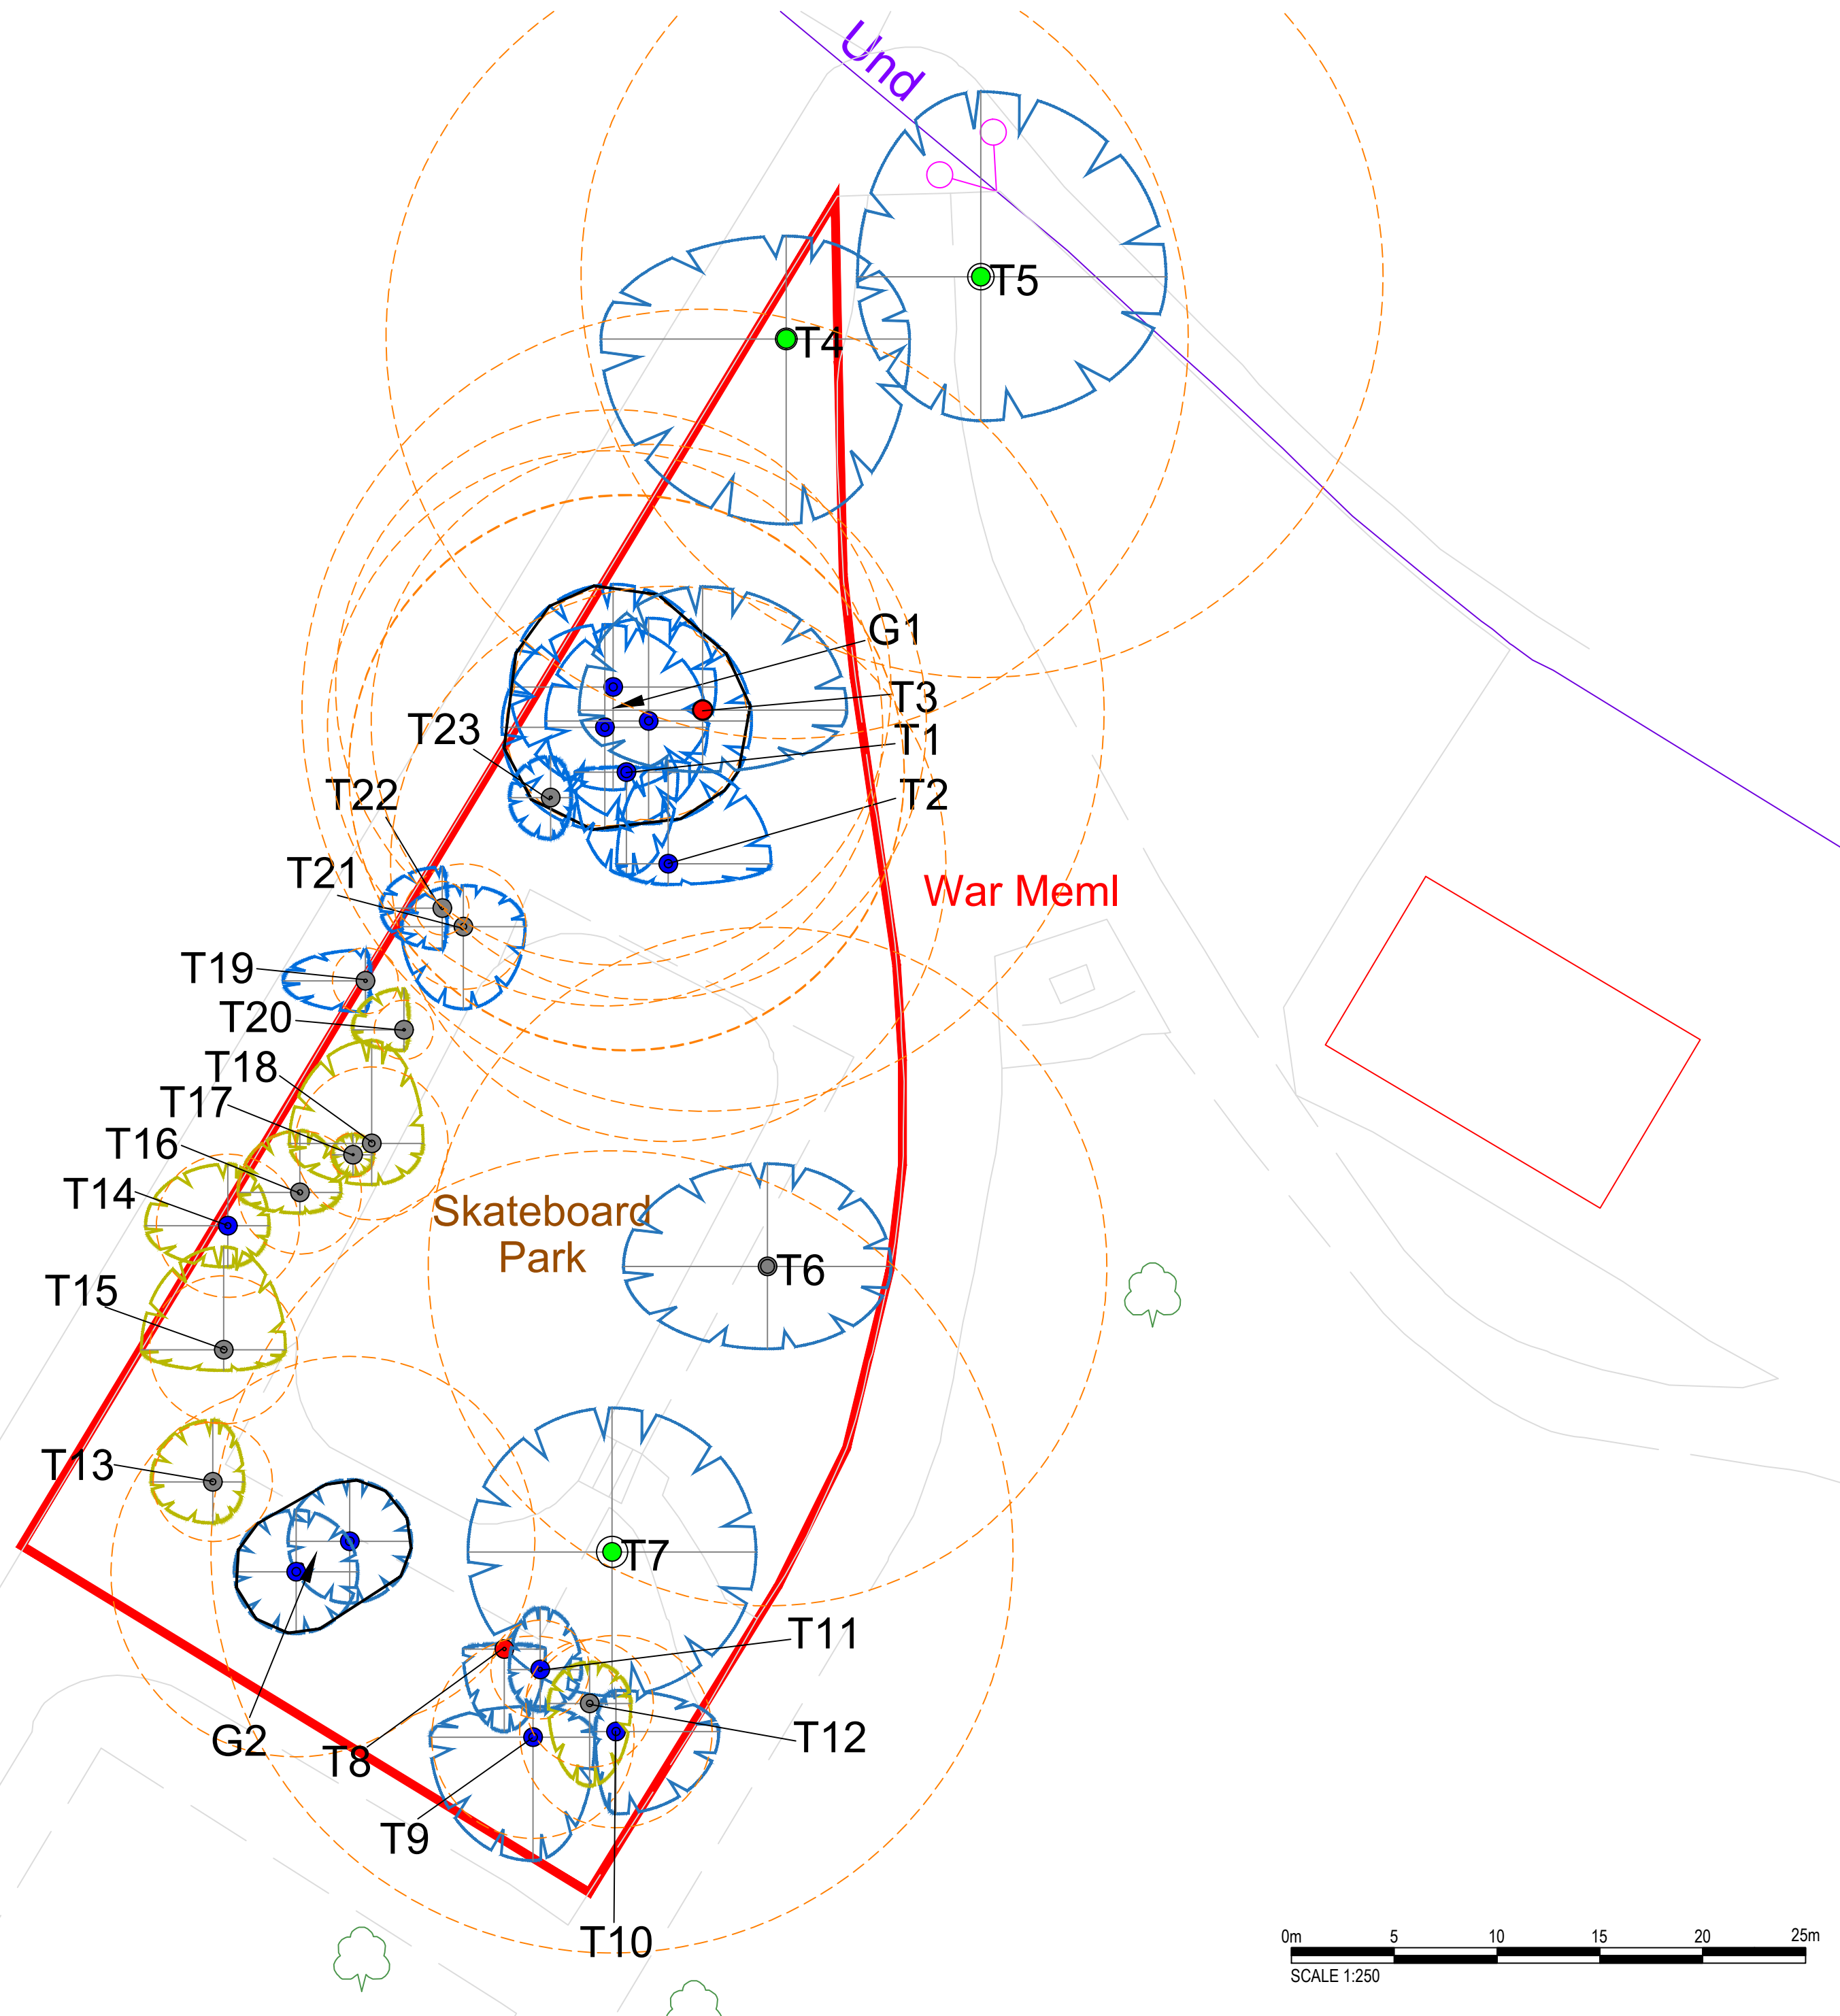
**JSL4040\_701: TREE LOCATION & ANALYSIS PLAN**

- 6.9 The trees shown on the Tree Location & Analysis Plan (see drawing JSL4040\_701) are colour coded based on their species moisture demand.

- 6.10 It can be seen on the Tree Location & Analysis Plan (see drawing JSL4040\_701) that the potential zones of influence are marked as orange dashed circles. These are calculated in accordance with the NHBC Chapter 4.2 guidance based on a tree's height and moisture demand and it indicates the potential range by which a tree has a potential to effect soil moisture levels.

- 6.13 The soils beneath the structure have been confirmed to comprise of clay, likely with a plasticity that would leave it susceptible to shrinkage due to tree roots. It is therefore likely that certain trees at the site, in particular T6 and T7, are likely to be influencing the moisture levels within the clay and causing it to move in correlation with the seasons.
