ARBORICULTURAL SURVEY REPORT AND METHOD STATEMENT

A MULTI USE GAMES AREA

NORMAN SCOTT PARK, CONISTON ROAD, PATCHWAY

Prepared by: Ian Monger *MSc, BSc, (Hons), TechCert, (ArborA) MArborA*
Checked by: Richard Hyett *MSc, MArborA, MICFor*
Reference: N.2864

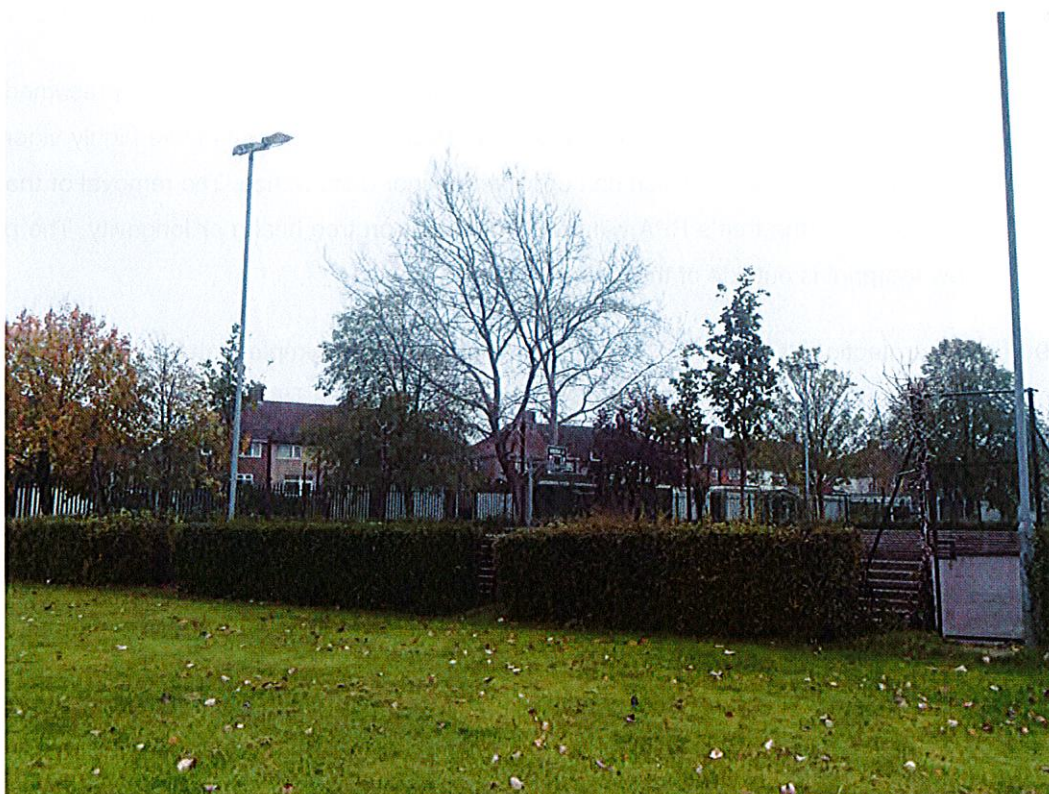
Photo view 1: Picture of site looking south, with White Poplar T6 in centre.

- 3.8 The RPA of White Poplar T6 extends into the existing MUGA footprint. It is presumed that the existing MUGA has a compacted sub-base. Poplar species trees have highly vigorous and adaptable root systems which can cope with minor disturbance. The removal of the existing surface within the tree's RPA will have no impact on tree health or longevity. The proposed new footprint is outside of the tree's RPA.

- 3.9 The protection of tree RPAs during construction will be a simple matter of installing protective barrier fencing in the positions shown and specified on the Tree Protection Plan. For simplicity and continuation of footpath access 'out of hours', the fencing would be installed on the outside edge of the existing tarmac footpath. The footpath is one of the most popular public uses of the site and would allow this use to be maintained when construction work is not taking place. This would mean a small part of the RPA of Lime spp. Tree T9 remains unprotected, but this would have no negative impact on tree health or longevity of this early-mature tree.
