Revised Heritage, Design and Access Statement

Royal Cornwall Museum – Re-roofing, Improvement Works and Repairs

Update 9th October 2022

CGH/7377

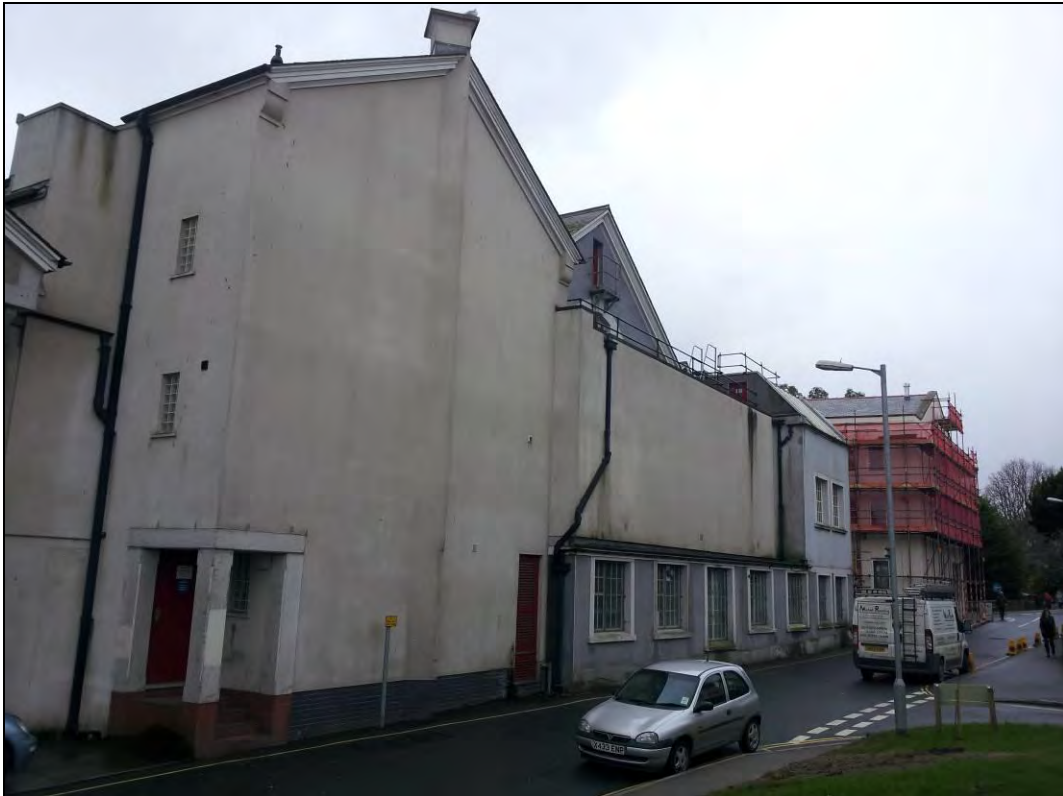
5. View of the rear elevation from the northeast. The downpipes will be replaced.

4.37 All rainwater goods at high level on the roofs, to the east elevation and to the north elevation will be replaced as they are all showing signs of degradation and disrepair. They are all a mixture of UPVC, cast iron and aluminium.

4.38 In the interests of longevity and maintenance new Alumasc Heritage Aluminium rainwater goods will be provided. They will be provided with a black powder coated finish.

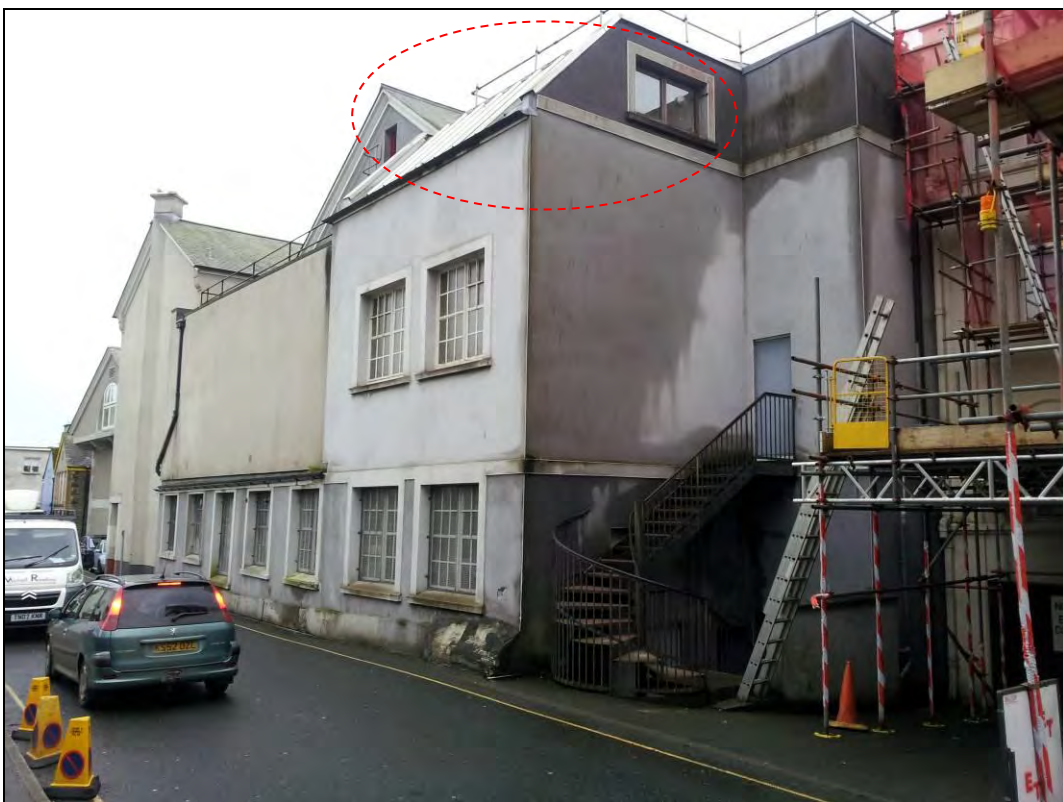
6. View of the rear elevation from the northwest. The windows to the top floor of room 4.01 will be replaced (see 4.22 above).

4.22 A new black aluminium double glazed window of matching style to existing will be provided on the gable wall of the storeroom below on the west elevation

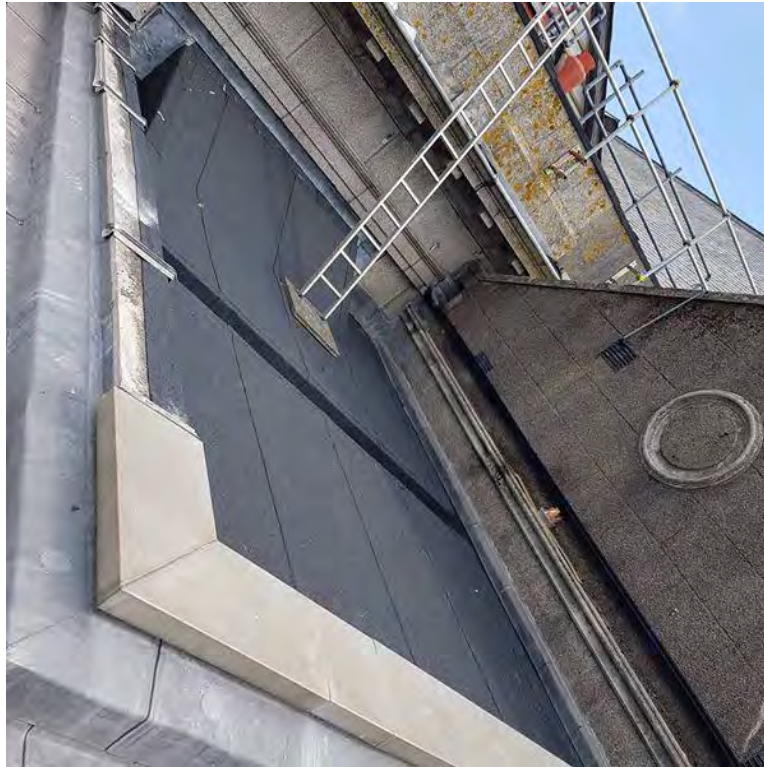
7. View of roof R1. Poor detailing in far corner still leading to water ingress in room below.

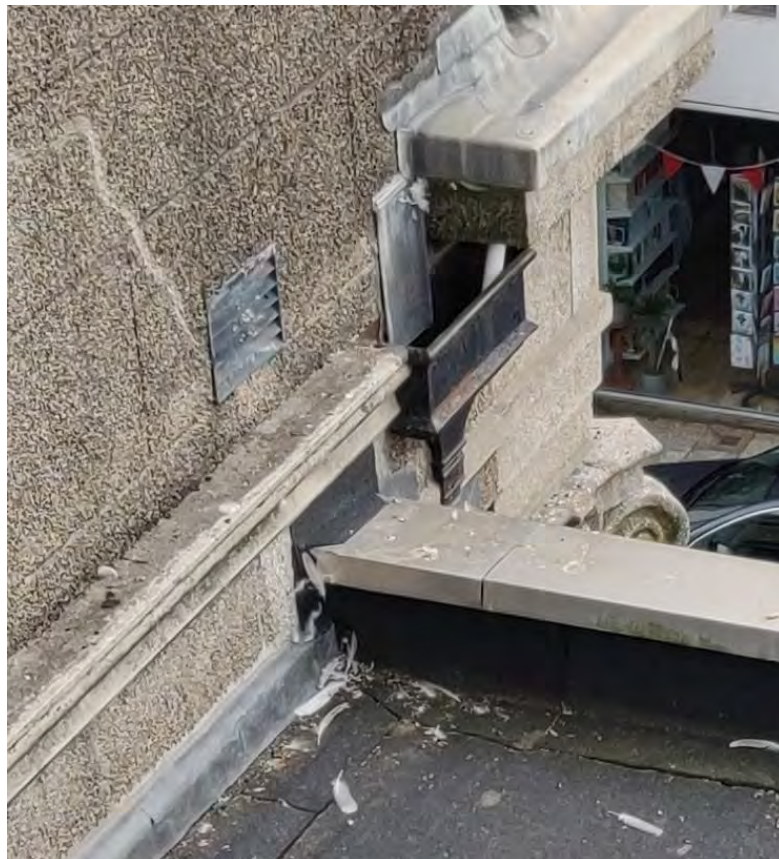
8. Poor detailing around hopper and lead.

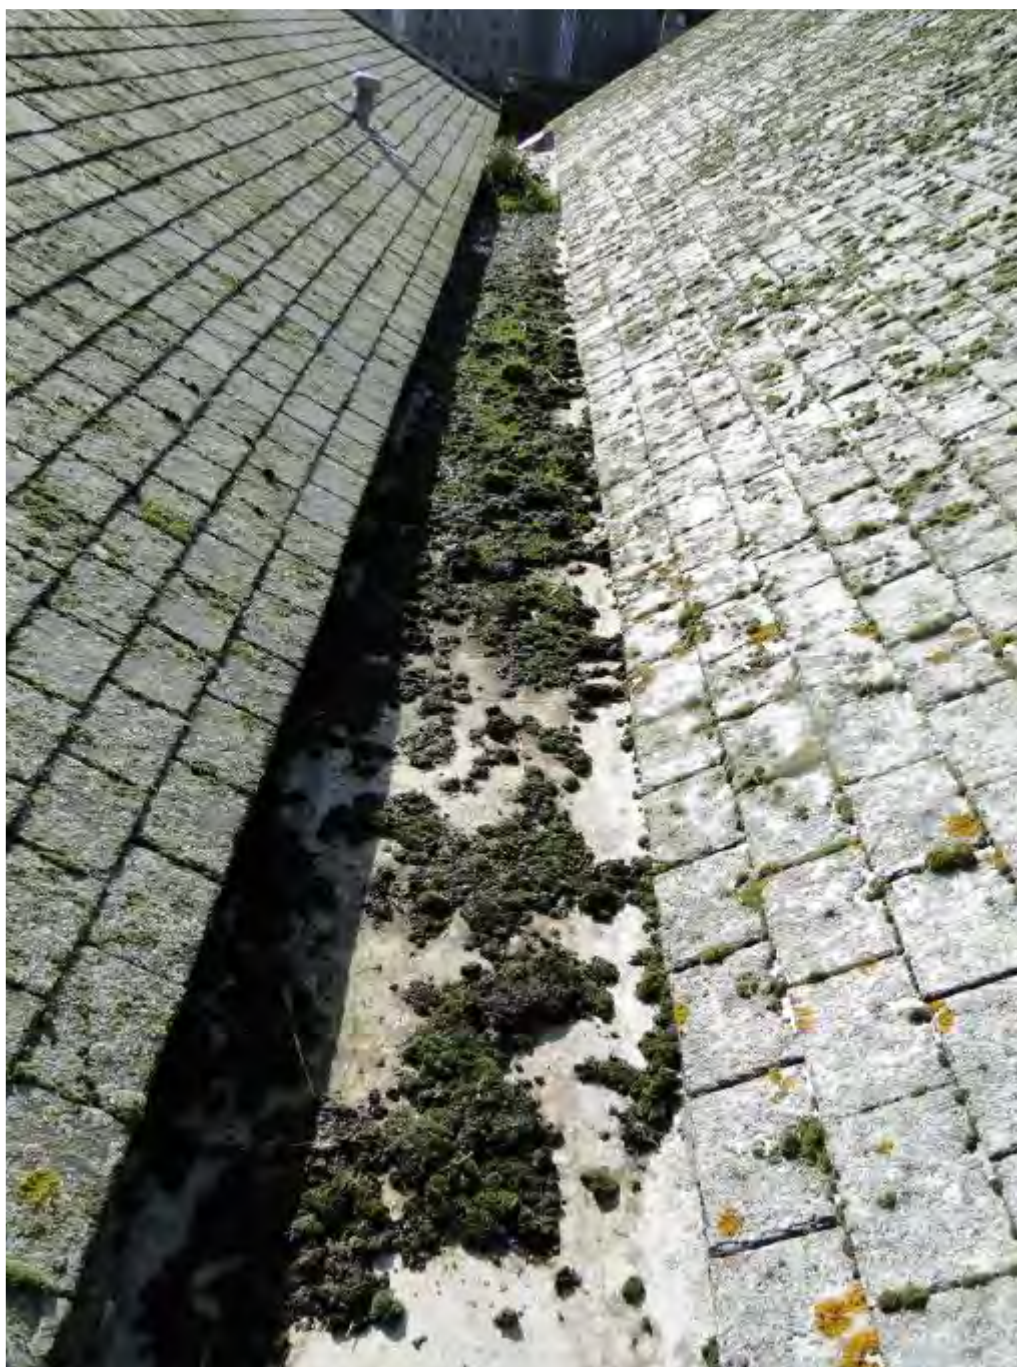
10. View along gully S9 looking towards rear.

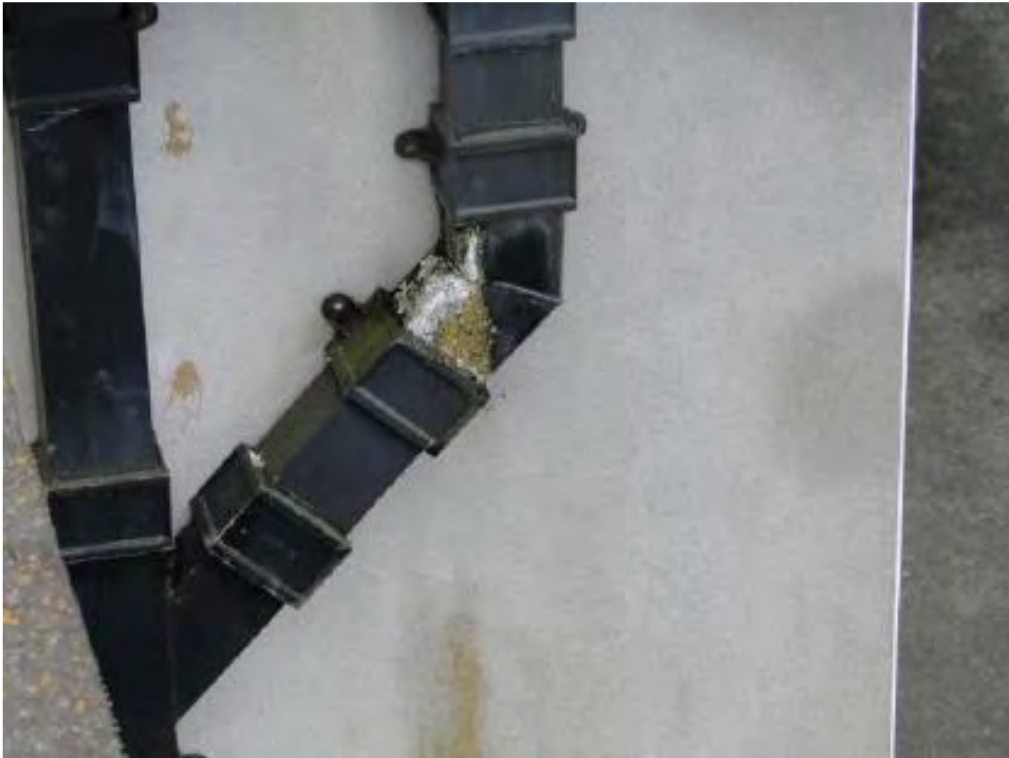
11. Typical defect to rainwater goods along north side.

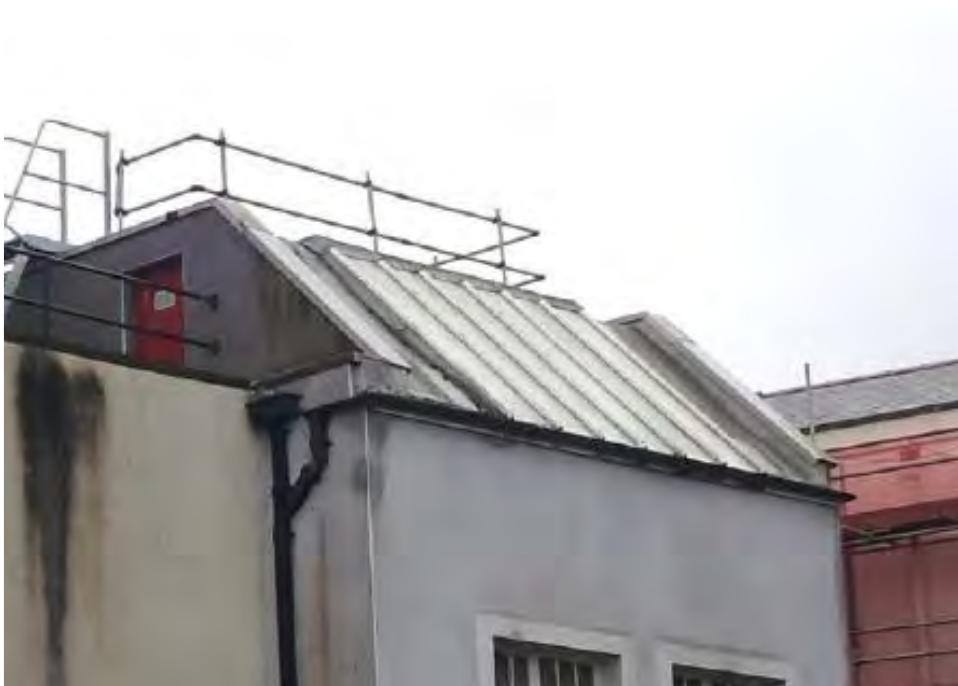
4.20 The roof will be stripped and replaced with a Sarnafil roof on both flat and pitch. The existing lay light LL1 is leaking and in need of replacement. New double glazed panels within aluminium thin section framework will be provided to replace existing. This will provide a more elegant window here in line with roof covering. The new window will have the glazed panels reduced from 6 to 5.

12. View of LL1 to be replaced.

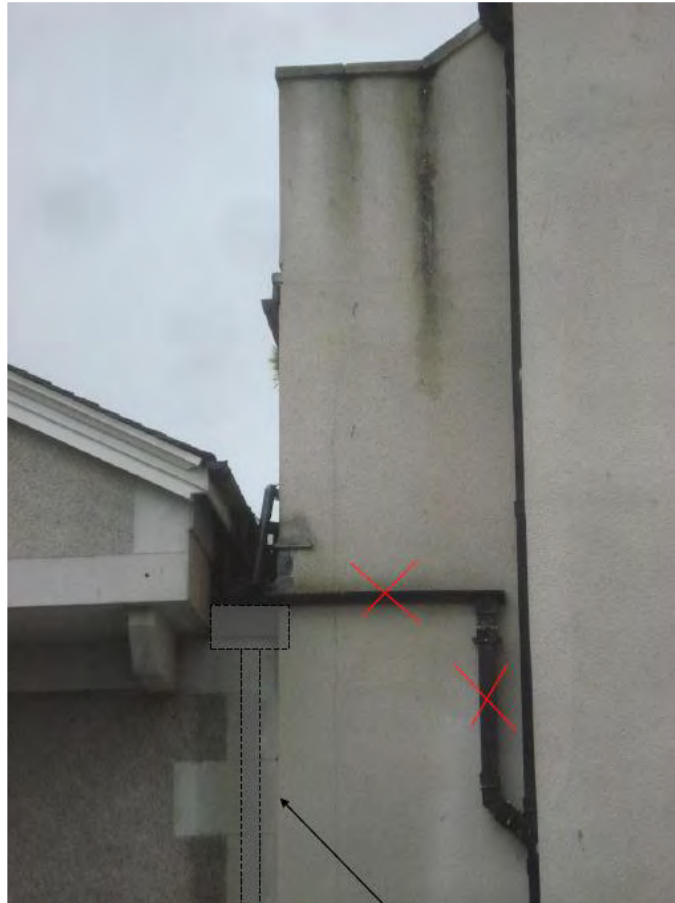
4.30 The rainwater drainage here is very poor with a very inaccessible UPVC gutter between these two elements. This is prone to blockage and over flowing and could lead to eventual water penetration within the building.

13. Location of new rainwater outlet and hopper to replace poor gutter and downpipe arrangement between R5 and R7.

4.31 The removal of the gutter and the stripping of the lower courses of slates to R5 will be undertaken to enable a new lead valley gutter on timber decking to be provided. This will provide an easily accessed area that can be cleared of debris and prevent blockage. The slates will be reset to accommodate the new valley.

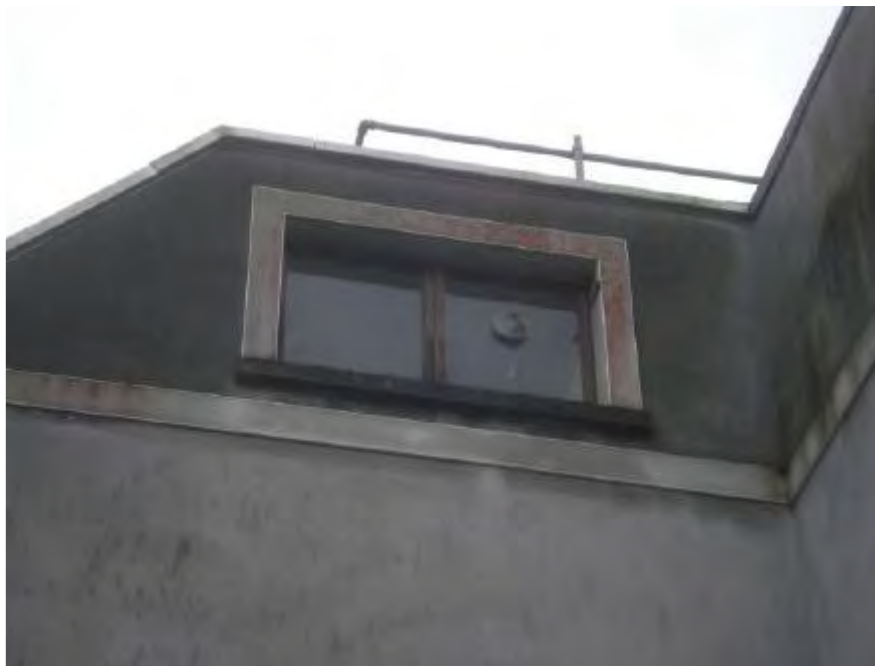
14. View of west window below S3 west side to be replaced with matching timber frame window – C20 window.

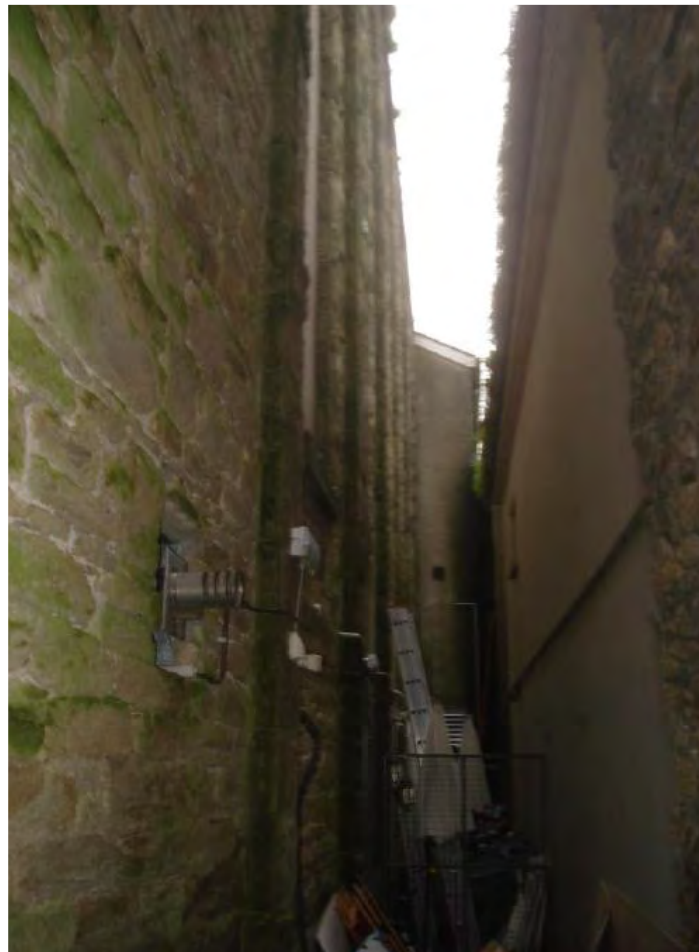
15. View along east elevation to be repointed in lime.

Wall to this elevation to be re-pointed in NHL3.5 lime with CLS25 sand
