PORT OF  
**TILBURY**  
LONDON

1.1. PRS Architects have been appointed by the Tilbury on the Thames Trust as Architects, Lead Designers, Lead Consultants and Specialist Conservation Architects for the Tilbury Riverside Railway Station Back on Track Project. The TTT have secured a delivery phase grant from the NLHF. The Back on Track project is an important step in the TTT's journey to achieve their vision.

## 2. EXISTING CONDITION EXTERNAL

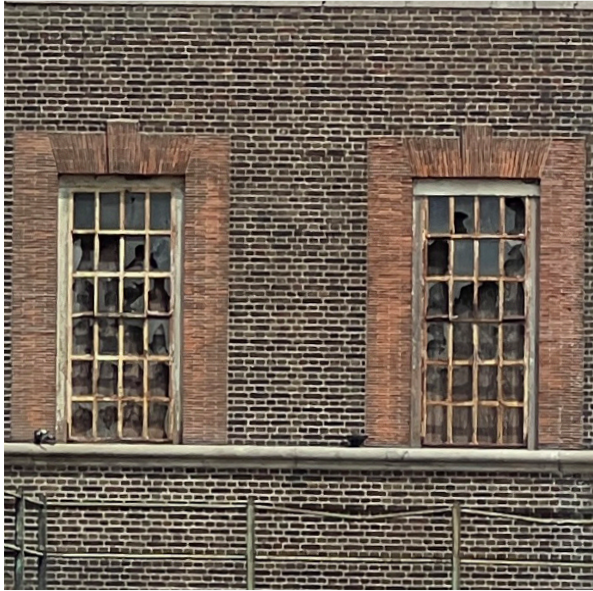
### Crittall Windows

- 2.1. The existing historic external crittall windows are generally in a state of disrepair. The steel work has been ill maintained leading so extensive corrosion and rust. Window pains are smashed. These windows are significant focal points along the main elevation and are in need of replacement or restoration.

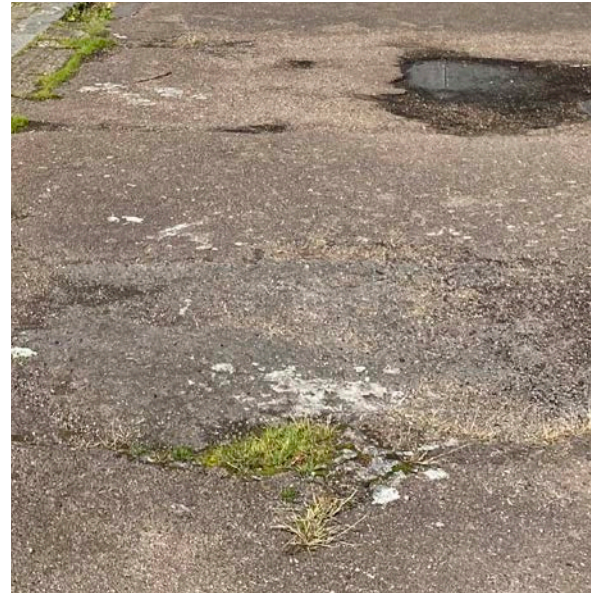
### Hard Landscaping

- 2.4. The Hard Landscaping around the cafe has deteriorated.
- 2.5. Concrete landscaping is cracked and not level leading to plant growth, the formation of puddles and other trip hazards. The hard landscaping therefore needs some attention.

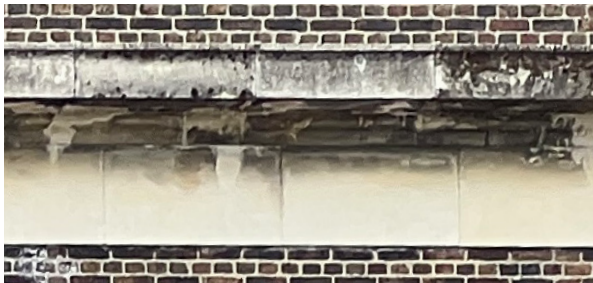
### Concrete Mouldings

- 2.2. At the higher level Cornice stones will need some aesthetic repairs in the future due to the streaking on the elevation.
- 2.3. The string course along the building is in parts badly damaged and broken. Replacement and fixing is necessary.

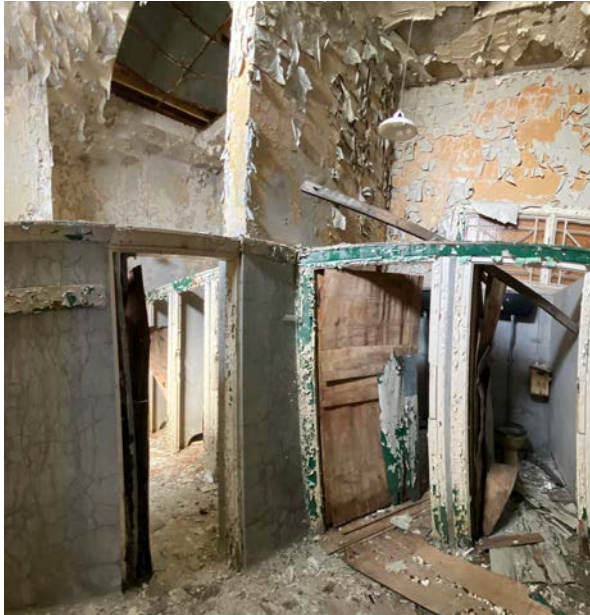
- 2.8. The wide angle image of the existing ladies bathroom on the right shows the condition of the internal rooms. Damaged Crittall rooflights, smashed internal windows and deteriorating wall surfaces are evident.

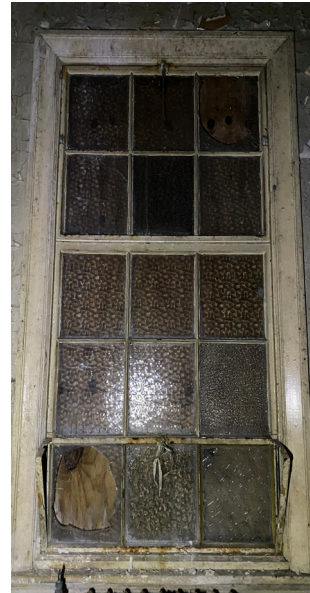
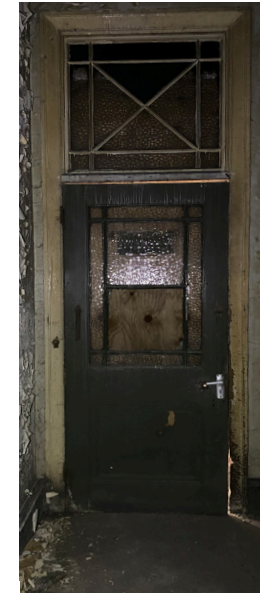
### Internal Crittall Windows and Roof Lights

- 2.10. Internal Crittall glazing and doors are usable but would need repair and restoring. Most of the frosted 'ice effect' glass in them is broken and ironmongery missing.
- 2.11. Historic Crittall roof lights within the internal rooms are in a state of disrepair, the steel work is rusting at some places and the glass is broken, and there might be future risk of glass falling off. These roof lights will be made safe and preserved in current condition.

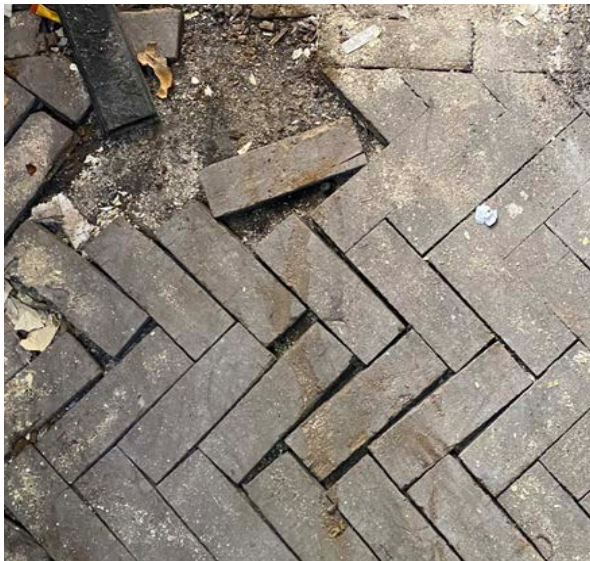
### Flooring

- 2.9. Heritage timber parquet flooring blocks can be found in some of the internal rooms. The flooring is generally in a state of disrepair with many blocks loose and some missing. The flooring will need repairs.
