Domestic Services Risk Assessment & Written Scheme for the Control and Prevention of Legionellosis

**Tendering District Council
Dovercourt Lifestyles Leisure Centre
Wick Lane
Harwich
CO12 3TA**

Date of Assessment: 7th December 2021

Assessment No: 12618SI

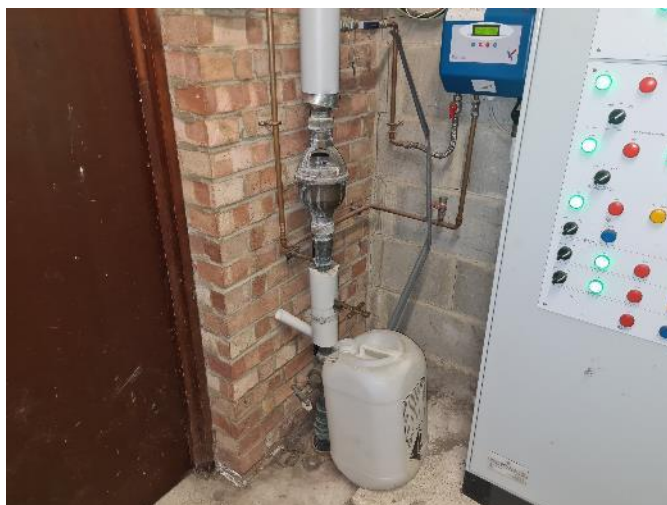
MCW Inlet 1 – Boiler room

General Information	Risk Comment
Asset number	MCW Inlet 1
Location of source	Boiler room
Source of water	Towns mains
Material of construction	Copper
Insulation type	FFFG
Are dead ends present	No
Is unused equipment connected	No
Is scale present on tap outlets	No
Is there a water softener	Yes
Are spray taps present	No
Are strainers fitted	Yes
Are point of use heaters fitted	Yes
Are unvented water heaters fitted	Yes
Temperatures	
Furthest sentinel point location	Staff room
Furthest sentinel point temperature	10.7°C
Nearest sentinel point location	First aid room tap
Nearest sentinel point temperature	10°C
Comments/Actions Required:	
Overall risk rating	0

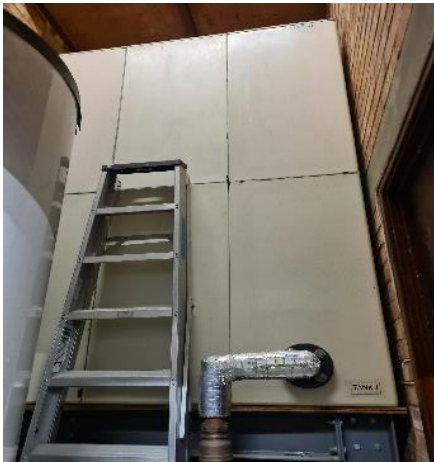
Internally the tank was in good clean condition and had been cleaned in November 2021.

General Information		Risk Comment
Tank title/asset number		CWST 1
Location		Plant room
Size (m) / volume (m ³)		3000 Litres
Materials of construction		GRP
External Photograph of Tank

Source of water supply to tank		Mains cold water
Process served by tanked water		Reception toilets, gym change & wet side change
Is tank easily and safely accessible		Yes,
Configuration		Single tank
If split or duplex, is flow balanced		N/A
Corrosion of internal surfaces		No
Deposits on internal surfaces		No
Scale		No
Flow patterns correct		Yes
Stagnation evident		No
Tank insulation condition		Integral
Distribution insulation condition		Good

Continuation	
Overflow screen fitted	Yes
If no o/f screen – indicate size required and in line or end of line	N/A
Warning pipe fitted	Yes
Lid condition and fit	Good & tight
If no lid – dimensions required	N/A
Lid vent fitted with screen	Yes
Temperature remote from valve - °C	11°C
Temperature inlet - °C	10.7°C
Ambient temperature tank room - °C	18°C
Date of last clean and disinfection	November 2021
Date of last inspection	December 2021
Inlet & Outlet Opposed	Yes
Hot water services vent returns to cold water storage tank	No
Details for re-routing vent: dimensions, length	N/A
Drain size and location	Not seen
Make-up size and location	54mm – Top
Services size and location	54mm – Base
Tank clearly labelled	Yes
Tank nearest sentinel - location & temp °C	First aid room – 11.8°C
Tank furthest sentinel - location & temp °C	Pool change cleaners – 12.4°C
Non-compliances with Water Fittings (Water Supply) Regulations 1999/Water Bylaws 2000, Scotland

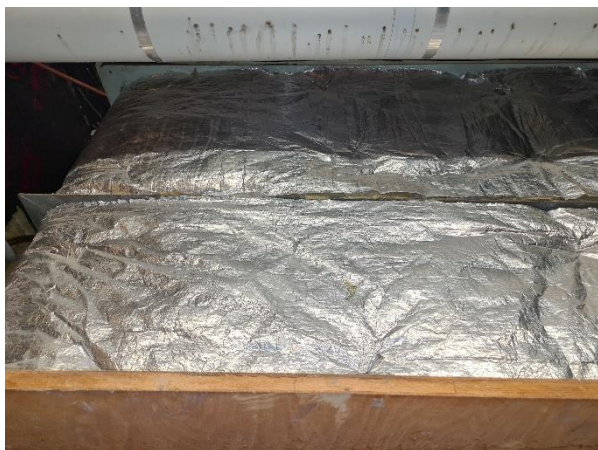
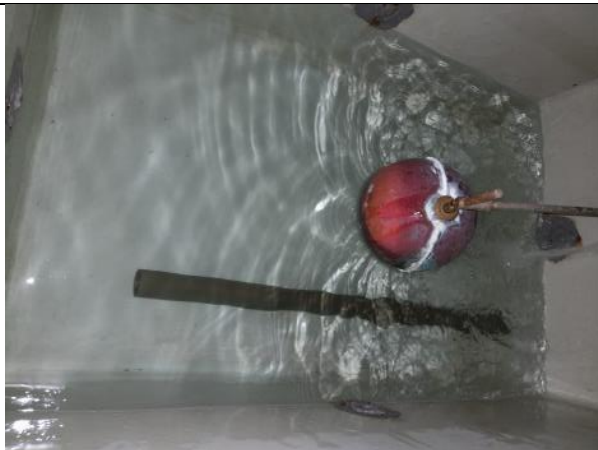
CWST 2 – A second tank was located in the plant room at high level above CWST 1 and supplies CAL 2. The tank is constructed from GRP and has a stored water capacity of 1500 litres. The tank is on a boarded-out area, the tank can be accessed via a long ladder. Access was assessed as being unsafe and as such it is recommended that a fixed vertical ladder is installed to allow safer access (**Remedial action 1 refers**).

General Information	Risk Comment
Tank title/asset number	CWST 2
Location	Plant room – High level
Size (m) / volume (m ³)	1500 Litres
Materials of construction	GRP
External Photograph of Tank

Source of water supply to tank	Mains cold water
Process served by tanked water	CAL 2
Is tank easily and safely accessible	Yes
Configuration	Single tank
If split or duplex, is flow balanced	N/A
Corrosion of internal surfaces	No
Deposits on internal surfaces	No
Scale	No
Flow patterns correct	Yes
Stagnation evident	No
Tank insulation condition	Good - FFFG
Distribution insulation condition	Good

Continuation	
Overflow screen fitted	Yes
If no o/f screen – indicate size required and in line or end of line	N/A
Warning pipe fitted	Yes
Lid condition and fit	Good & tight
If no lid – dimensions required	N/A
Lid vent fitted with screen	Yes
Temperature remote from valve - °C	11°C
Temperature inlet - °C	10.7°C
Ambient temperature tank room - °C	18°C
Date of last clean and disinfection	November 2021
Date of last inspection	December 2021
Inlet & Outlet Opposed	Yes
Hot water services vent returns to cold water storage tank	No
Details for re-routing vent: dimensions, length	N/A
Drain size and location	Not seen
Make-up size and location	28mm – Top
Services size and location	42mm – Base
Tank clearly labelled	Yes
Tank nearest sentinel - location & temp °C	N/A
Tank furthest sentinel - location & temp °C	N/A
Non-compliances with Water Fittings (Water Supply) Regulations 1999/Water Bylaws 2000, Scotland	
Comments/actions required	Provide safer access to the tank, such as a fixed ladder (Remedial action 1 refers) .

Remedial Actions & Recommendations						
No	Inherent Risk	Risk Rating	Time Frame	Action Required	Residual Risk Rating	Signed Off Date & Signature
1	Cold Water Storage Tanks (Page 33/ 34 refers) There is no safe access to the cold water storage tanks at high level in the plant room off the pool plant room.	1	6 months	Install a fixed ladder if possible to the high level tanks to create safer access.	0	
2	Showers (Page 46 refers) The showers in the outdoor change area in the accessible changing rooms have been isolated and are no longer in use.	2	ASAP	Ensure the showers have been isolated as close as possible to the nearest live feed to prevent dead legs and stagnation.	0

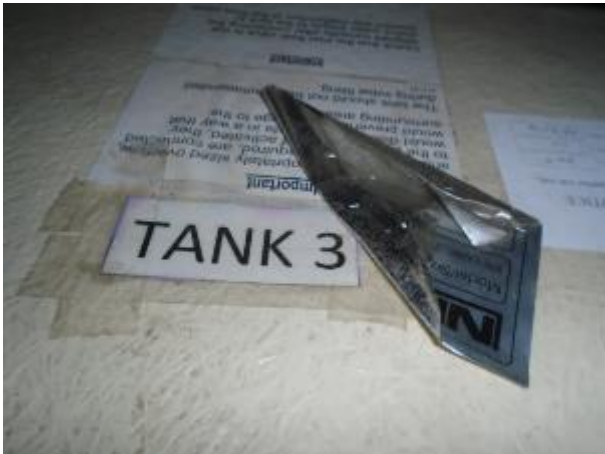
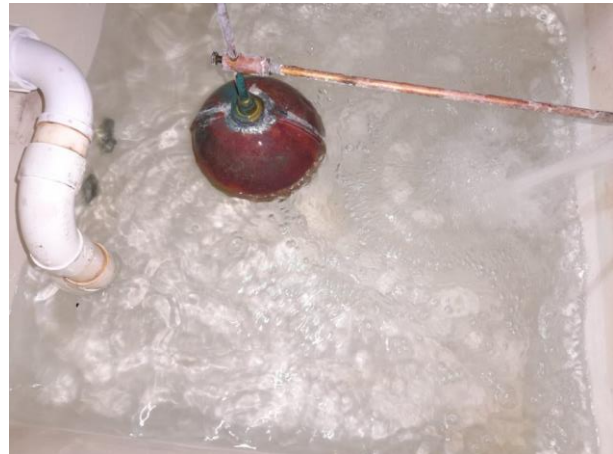
CWST 3 – Internal & external condition

CWST 3 – This tank is constructed from GRP and has a stored water capacity of approximately 180 litres. The tank supplies the make up to the pool chemical plant and a single bib tap. At the time of the survey the tank was found to be in good clean condition and had a stored water temperature of 12°C.

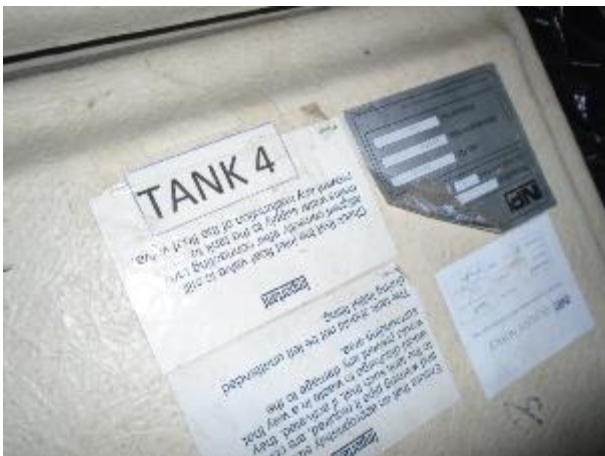
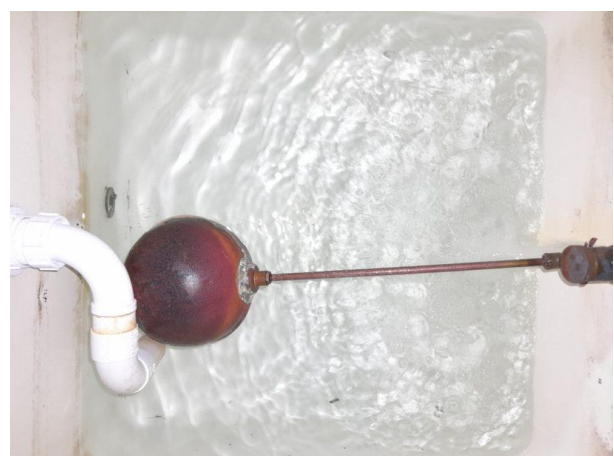
CWST 4 – Internal & external

CWST 4 – This tank is constructed from GRP and has a stored water capacity of approximately 180 litres. The tank provides the top up to the main pool.

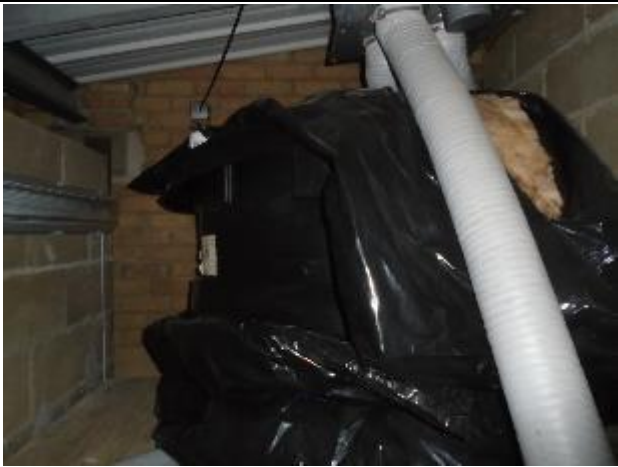
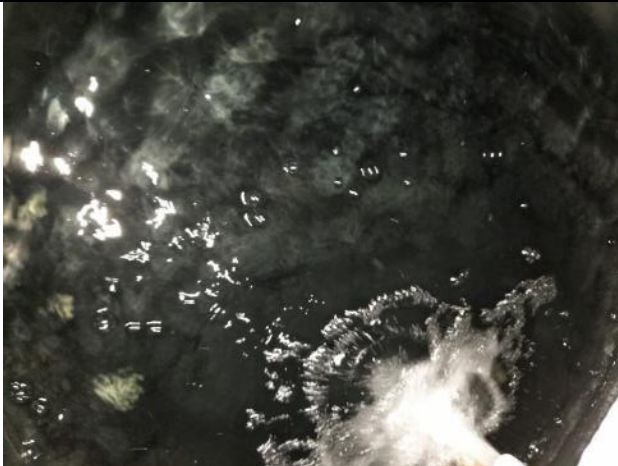
CWST 5 – A further CWST is located above the outdoor changing rooms in the roof void . Accessed via a hatch in changing room number 4.

At the time of the survey the tank was found to be clean internally and was storing water at 13°C which is sufficient to control legionella growth.

General Information		Risk Comment	
Tank title/asset number		CWST 5	
Location		Outdoor changing 4 room roof void	
Size (m) / volume (m ³)		400 - 500 Litres	
Materials of construction		Plastic	
External Photograph of Tank

Source of water supply to tank		Mains cold water	
Process served by tanked water		Outdoor changing rooms	
Is tank easily and safely accessible		Yes	
Configuration		Single tank	
If split or duplex, is flow balanced		N/A	
Corrosion of internal surfaces		No	
Deposits on internal surfaces		No	
Scale		No	
Flow patterns correct		Yes	
Stagnation evident		No	
Tank insulation condition		External jacket – Good	
Distribution insulation condition		Good

Continuation	
Overflow screen fitted	Yes
If no o/f screen – indicate size required and in line or end of line	N/A
Warning pipe fitted	Yes
Lid condition and fit	Good & tight
If no lid – dimensions required	N/A
Lid vent fitted with screen	Yes
Temperature remote from valve - °C	13°C
Temperature inlet - °C	11°C
Ambient temperature tank room - °C	15°C
Date of last clean and disinfection	November 2021
Date of last inspection	December 2021
Inlet & Outlet Opposed	Yes
Hot water services vent returns to cold water storage tank	No
Details for re-routing vent: dimensions, length	N/A
Drain size and location	Not seen
Make-up size and location	28mm – Top
Services size and location	28mm – Base
Tank clearly labelled	Yes
Tank nearest sentinel - location & temp °C	Changing room 4 – 13°C
Tank furthest sentinel - location & temp °C	Changing room 1 – 13°C
Non-compliances with Water Fittings (Water Supply) Regulations 1999/Water Bylaws 2000, Scotland

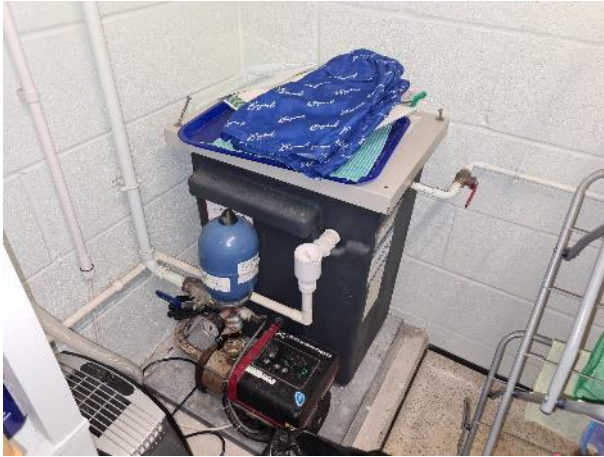
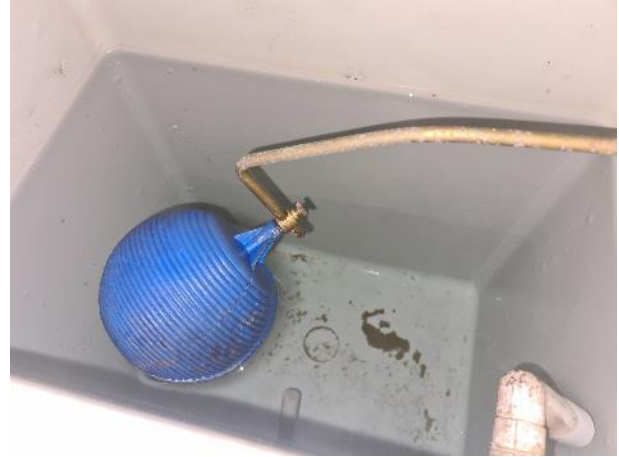
CWST 6 – Pool area cleaners room

CWST 6 – There was one final CWST located in the pool side cleaners room. The tank supplies the bib taps in the pool side changing area and gym changing rooms. The tank is of GRP construction and supplies the outlets via a booster pump.

The tank had a stored water temperature of 13.8°C. Internally the tank contained light sediment at the base.

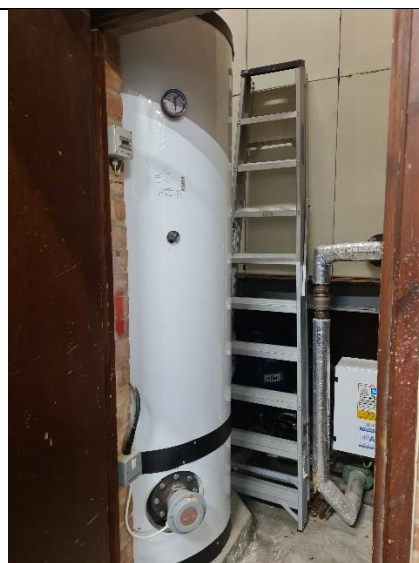
There was a secondary circulation pump noted on the return piping, which feeds into the cold water inlet to the CAL. The unit was fitted with temperature gauges on the flow and return piping which were accurate during the survey. The flow and return piping achieved an acceptable 65°C and 57°C respectively.

General Information		Risk Comment		
Hot water generator title/asset number		CAL 1		
Location		Plant room off pool plant room		
Stored water Volume		473 litres		
Materials of construction		S/ Steel		
Photograph of Hot Water PHE

Accessible inspection hatch		Yes		
Vessel supplied from		CWST 1		
Vessel Feeds		Leisure area		
Accessible drain fitted on lowest point		Yes		
Heat source		LTHW – Immersion		
Vessel insulation condition		Good		
Distribution insulation condition		Good		
Expansion type		Open vent to tundish		
If pressure vessel fitted, can diaphragm be cleaned		Yes		
HWS recirculation pump fitted		Yes		
Timed destratification pump fitted		Yes		
Immersion temperature gauges fitted		Flow - Yes	Storage – No	Ret – Yes
Temperature °C (Digital thermometer with surface probe)		65	65	57
Nearest Sentinel Point Temperature		First aid room (pre TMV) - 68°C		
Furthest Sentinel Point Temperature		Pool area cleaners - 73°C

Overall Risk Rating		0

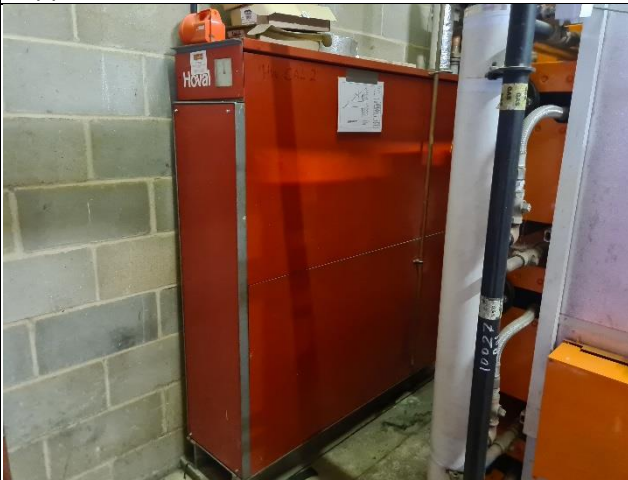
There was a secondary circulation pump noted on the return piping, which feeds into the cold water inlet to the CAL. The unit was fitted with temperature gauges on the flow and return piping which were accurate during the survey. The flow and return piping achieved an acceptable 65°C and 58°C respectively.

General Information		Risk Comment		
Hot water generator title/asset number		CAL 2		
Location		Boiler room		
Stored water Volume		300 litres		
Materials of construction		Copper		
Photograph of Hot Water PHE

Accessible inspection hatch		Yes		
Vessel supplied from		CWST 2		
Vessel Feeds		Outdoor changing area		
Accessible drain fitted on lowest point		Yes		
Heat source		LTHW		
Vessel insulation condition		Good		
Distribution insulation condition		Good		
Expansion type		Open vent to tundish		
If pressure vessel fitted, can diaphragm be cleaned		Yes		
HWS recirculation pump fitted		Yes		
Timed destratification pump fitted		No		
Immersion temperature gauges fitted		Flow - Yes	Storage – No	Ret – Yes
Temperature °C (Digital thermometer with surface probe)		65	65	58
Nearest Sentinel Point Temperature		Changing room 4 (pre TMV) - 62°C		
Furthest Sentinel Point Temperature		Changing room 1 (pre TMV) - 62°C		
Overall Risk Rating		0

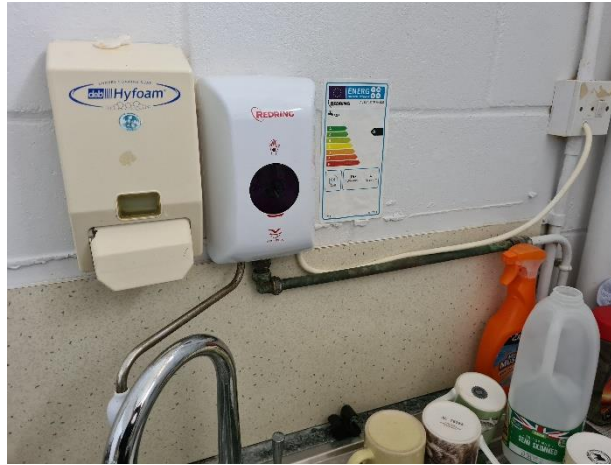
There is one instant electric water heater located in the staff room. The unit is mains fed and supplies the sink only. The unit was online and achieved 46°C.

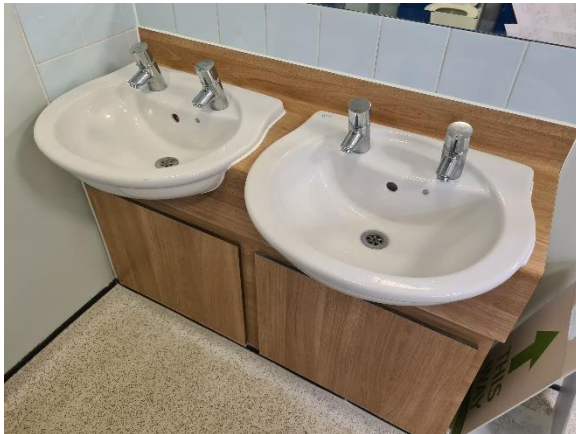
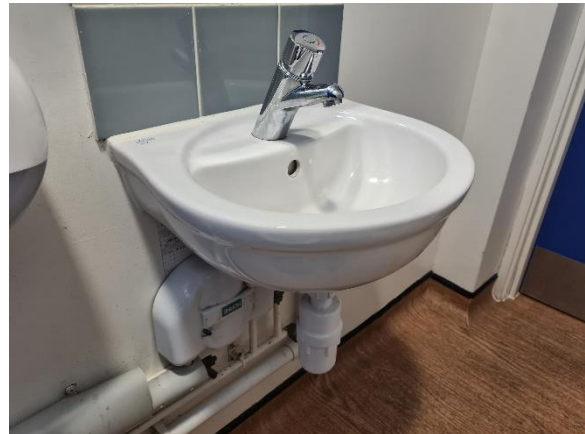
Examples of WHB configuration

All of the outlets were in good working order. All taps were clean and scale free.

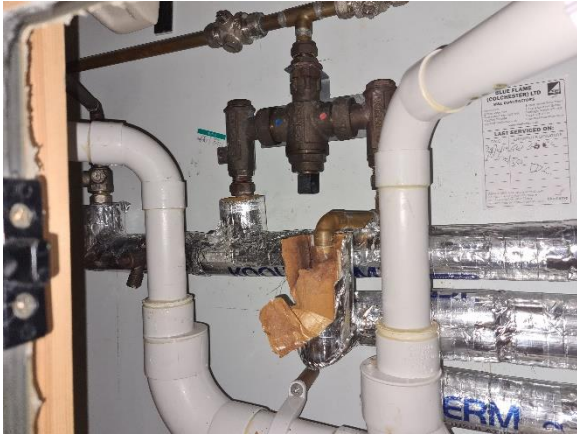
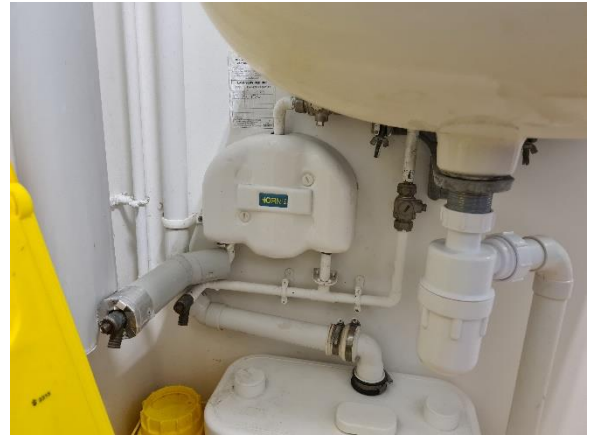
TMV examples around site

TMV's are installed on all toilet washbasins in the building. The recommended temperature for TMV's is between $39-42^{\circ}\text{C}$. All TMV's tested achieved between $39-42^{\circ}\text{C}$. The TMV's are serviced regularly. This action is recorded in the log book.

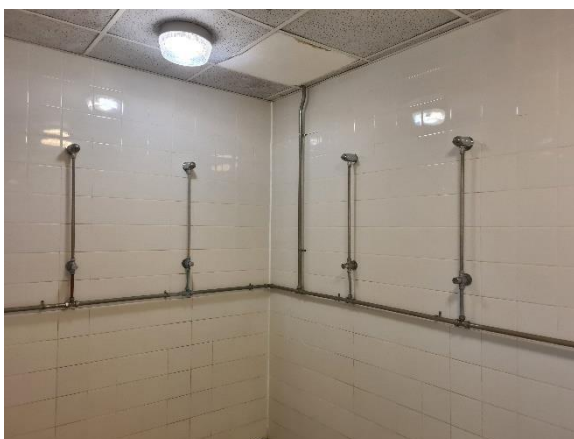
Typical shower configuration

Showers were located in all changing rooms. The showers for the gym and pool changing rooms are mixer controlled. The units in the outdoor changing rooms are thermostatic and are of similar construction and appeared to be operating correctly. There showerheads are clean and scale free.

The showers located in the outdoor accessible changing areas have been isolated. Ensure the showers have been isolated to the nearest live feed to prevent any dead legs and stagnation within the piping (**Remedial action item 2 refers**).

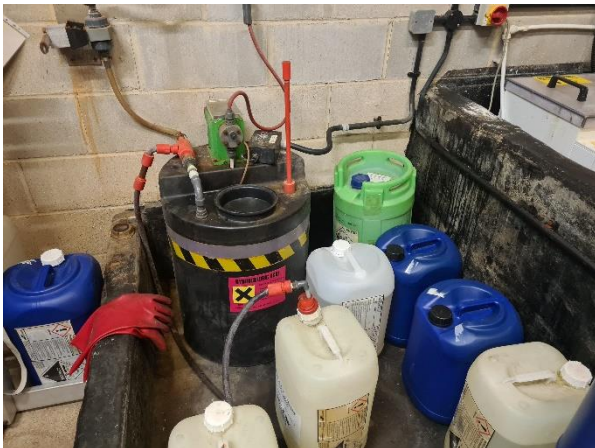
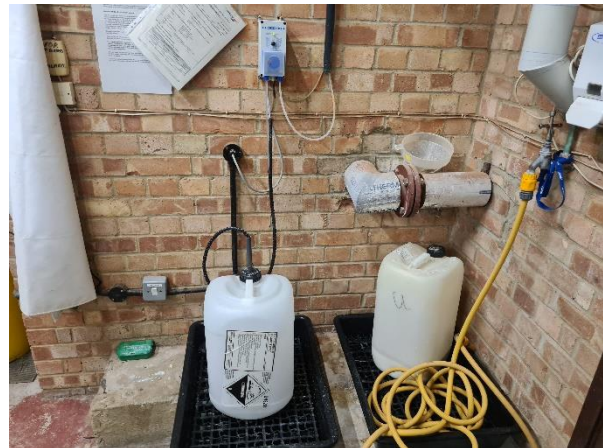
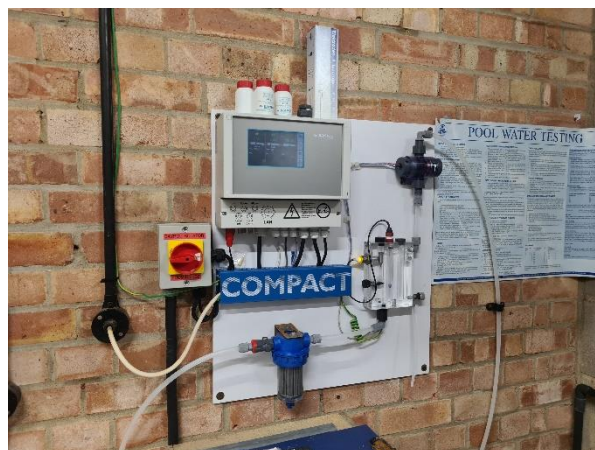
Chemical dosing plants & unit

The chemical plants consist of **Calcium Hypochlorite** for bacteria control and Acid for PH Control. Both plants were operational at the time of inspection and in good condition.

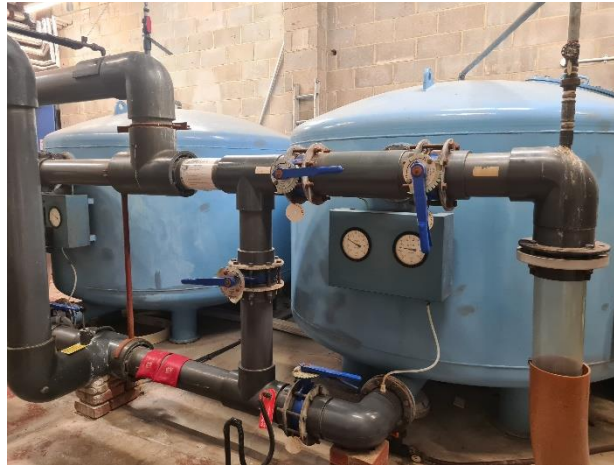
The pool has its own filtration system. Pool Management ensures that all filters are inspected and cleaned if necessary, every 5 years to include media replacement.
