# Whitchurch Town Hall, Hampshire

Vesper Conservation & Ecology Limited

Phase 1 & 2 Bat Surveys:

**Whitchurch Town Hall**

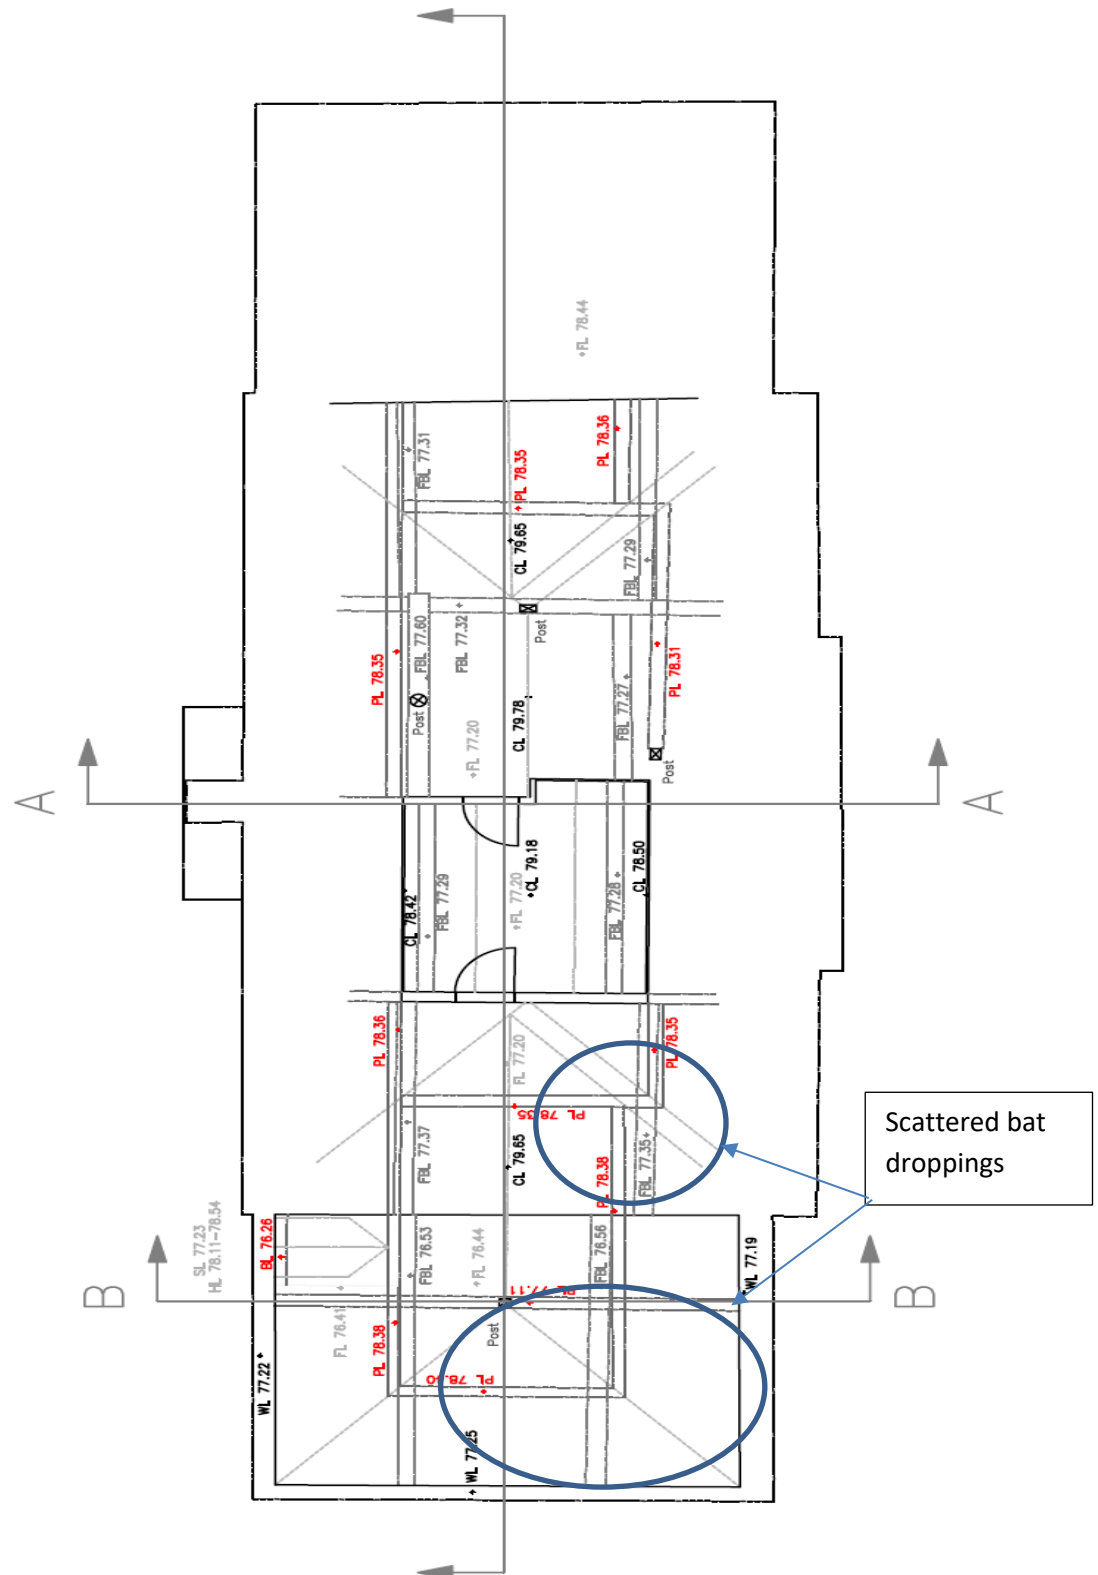
- 2.13 Bat droppings where seen on top of cross beam (nearest the enclosed area) and on the fibre glass insulation at the southern end of the roof, these look like small to medium size droppings from a although no bats where seen during the internal inspection. Droppings were collected and sent for DNA analysis, the analysis should that they were from Brown Long-eared bats.

**Figure 1:** Showing areas bat droppings where found

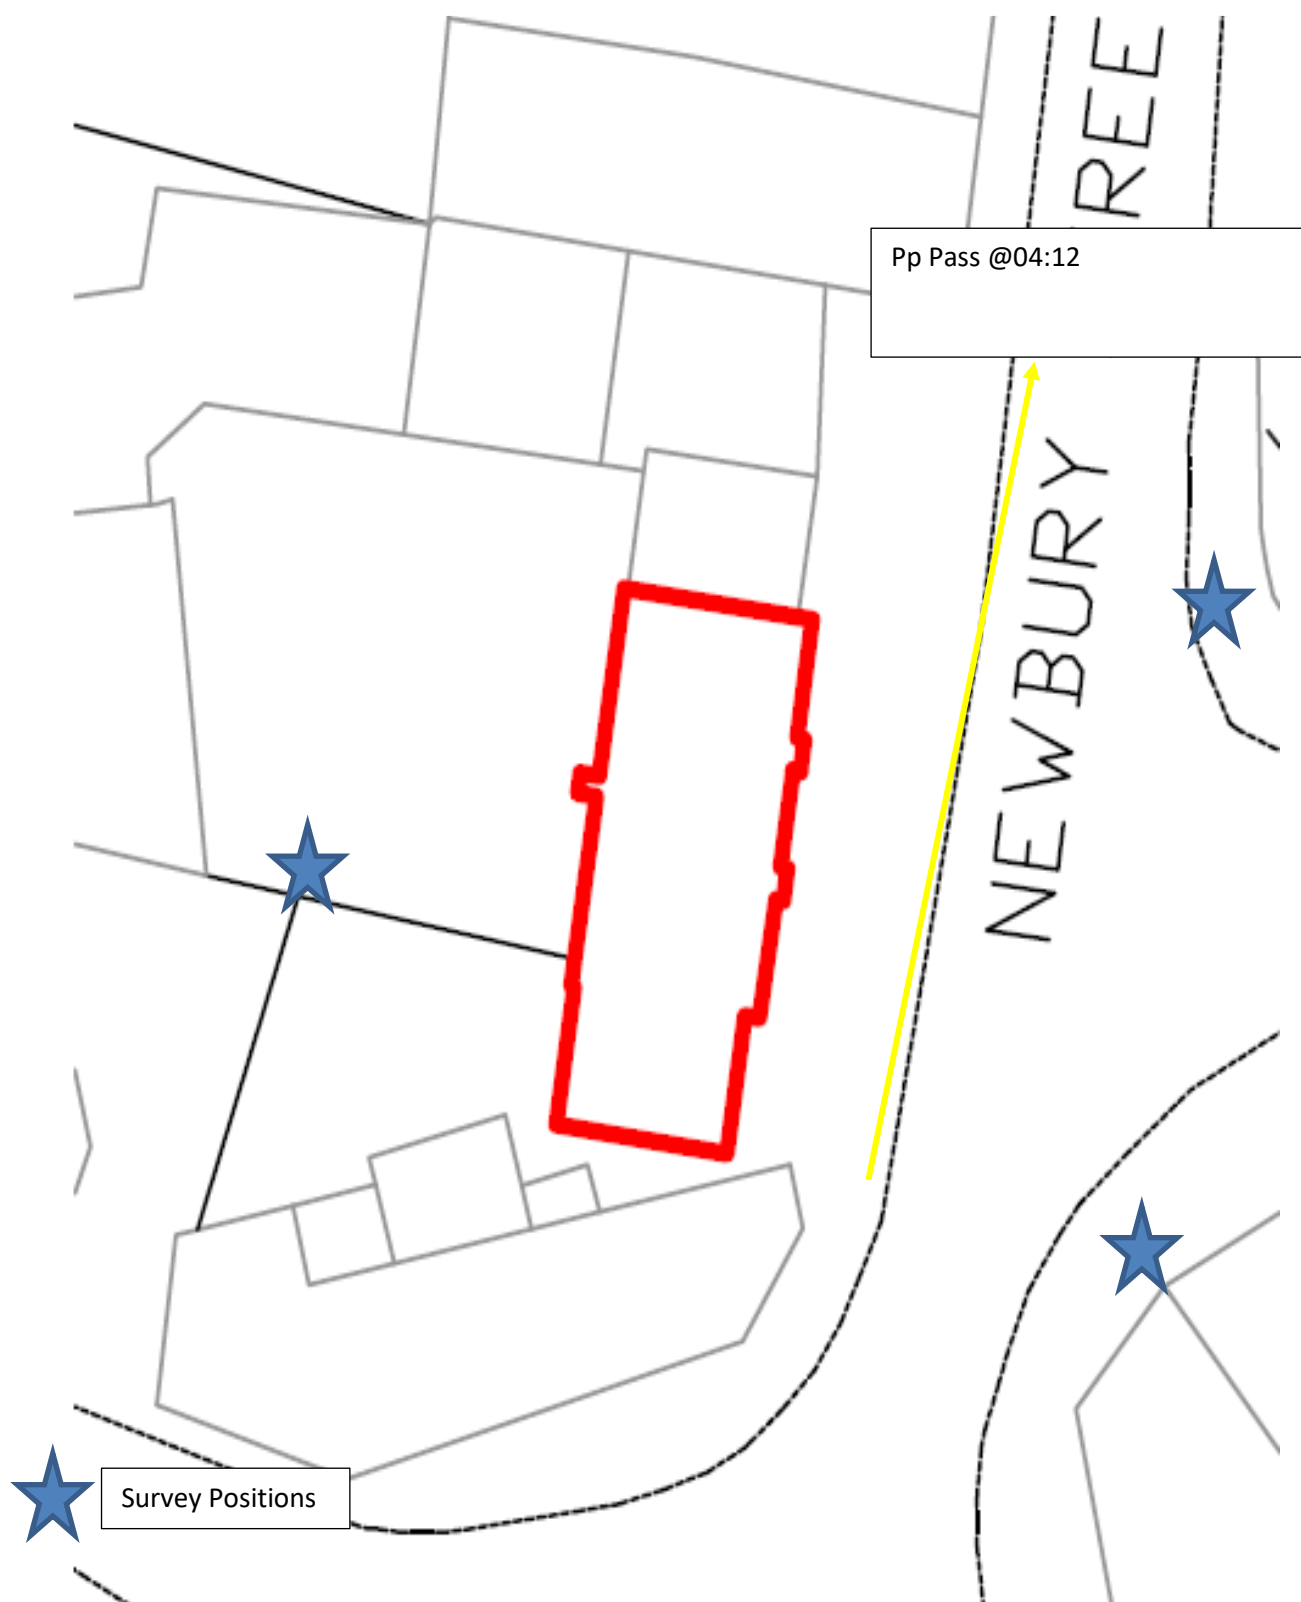
3.6 During the dawn survey (30/06/20) A single species was recorded during the survey (Common pipistrelle). No bats were seen emerging from the building there was only a single bat recorded passing during the survey (See Figure 4) (Rob West, Jake Cousins, Des Purdy).

**Figure 3: Dawn Survey summary map (for the activity surveys 30/06/2020)**

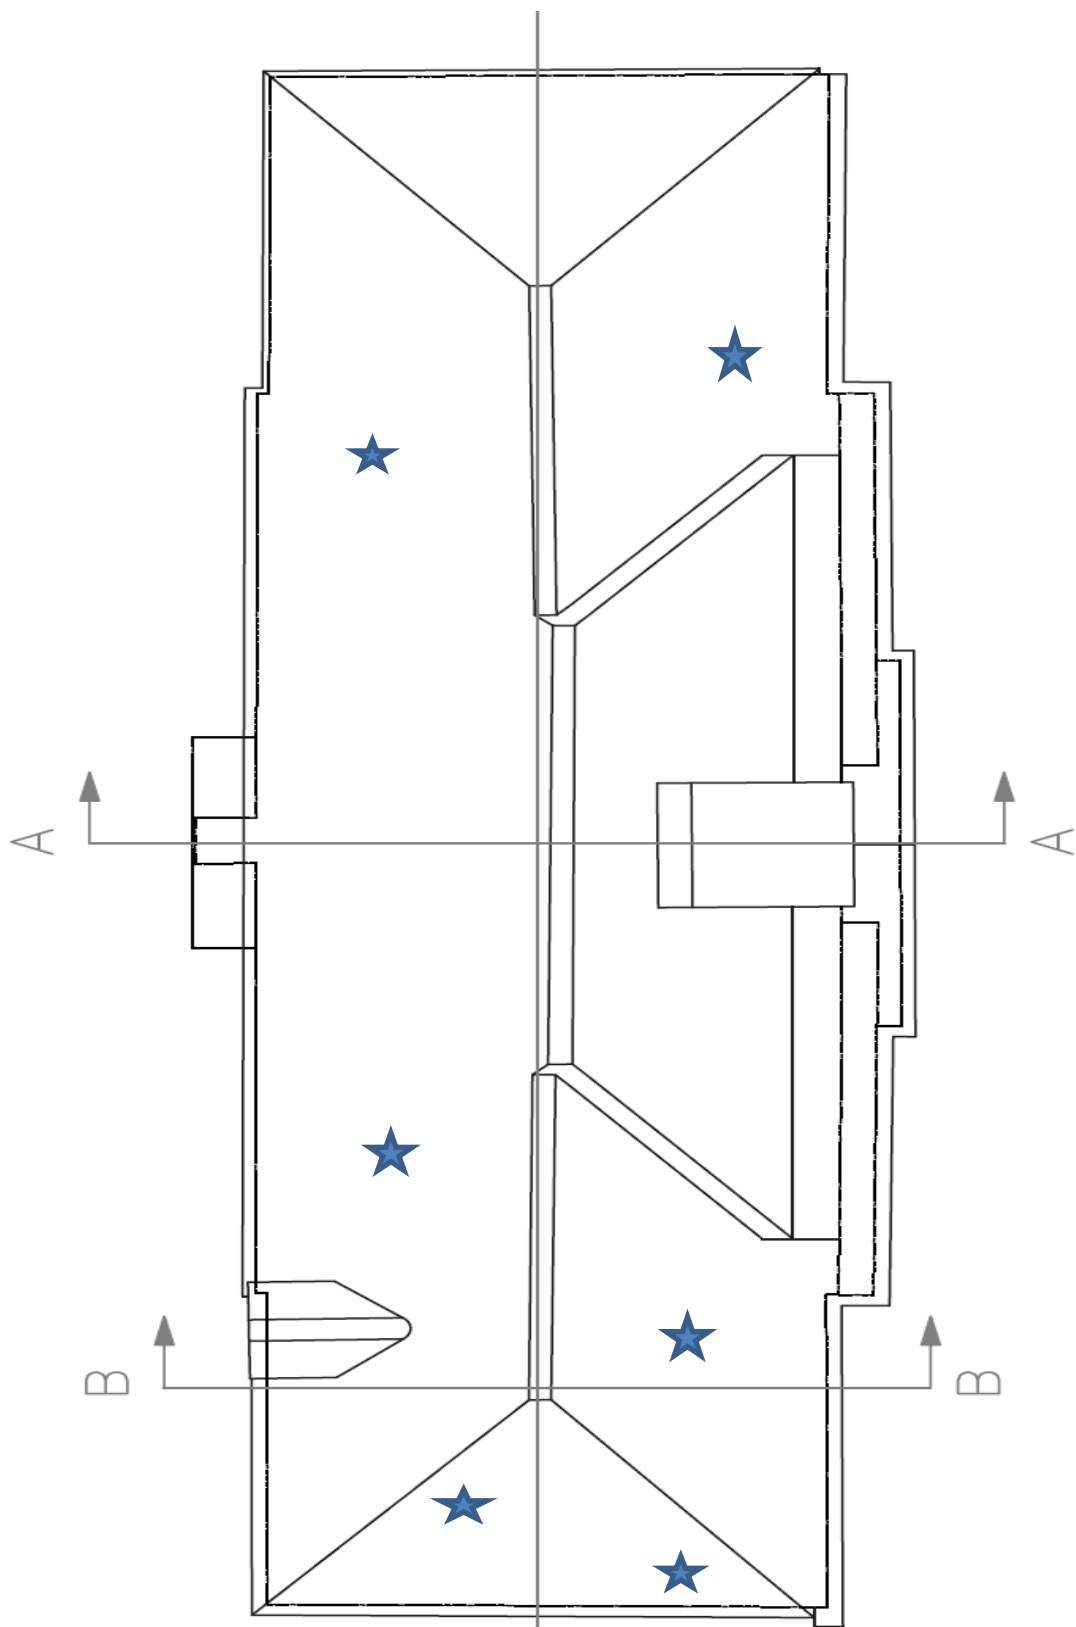
**Figure 4:** Proposed area of bat access tiles

Recommendations	A bat mitigation License <b>will be needed</b> and can only be applied for once full planning has been granted. The addition of bat access tiles is needed to maintain the local populations.

- 4.6 Due to the evidence of bat roosting within the building from the internal inspection, it is considered that the bats using the building, the internal evidence showed that there is plenty flying within the roof space. Consequently, the proposed redevelopment of the property will disturb the roosting of the bats in the short term.
- 4.7 The following inclusions are therefore recommended for incorporation into the redeveloped building to keep and improve roosting opportunities:
  - The addition of 6 bats access tiles 2 on both the eastern and western elevations and 2 on the southern elevation, these should have access to the internal space of the roof. (figure 4)
  - During the works a suitable alternative roost will need to be supplied so that any bats found during the destructive search/tile strip of the

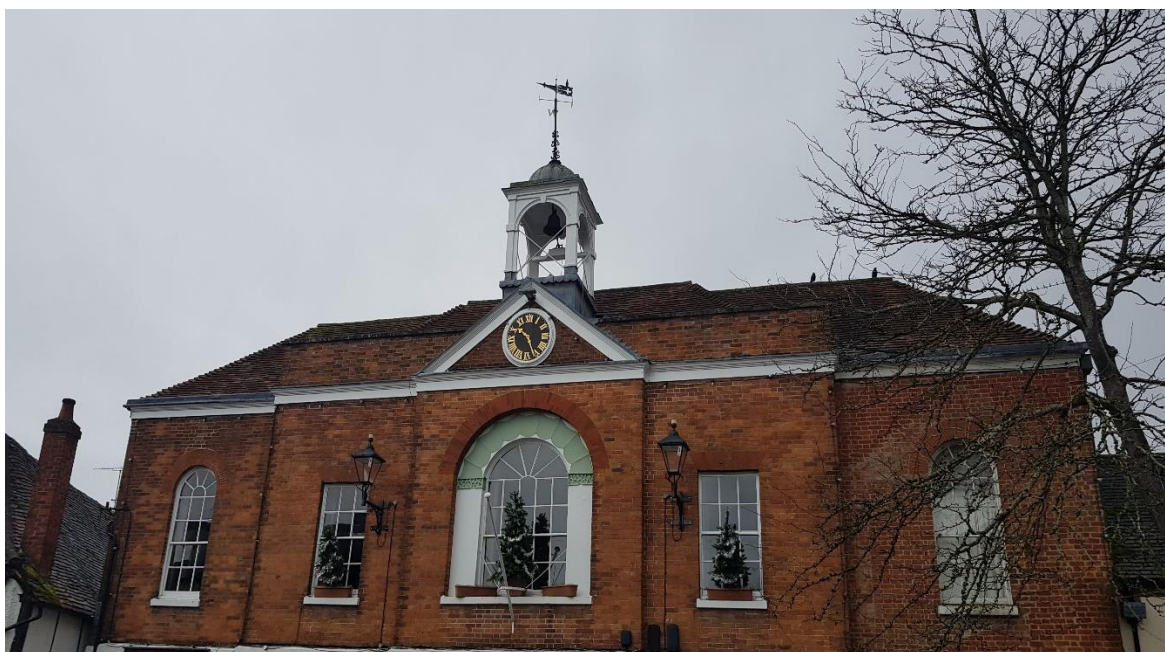
- 2.6 There is a large ornate clock and bell tower on the eastern elevation of the roof which is in good order and the lead work around it seems intact and tight

**Picture 1:** The eastern elevation showing clock and bell tower

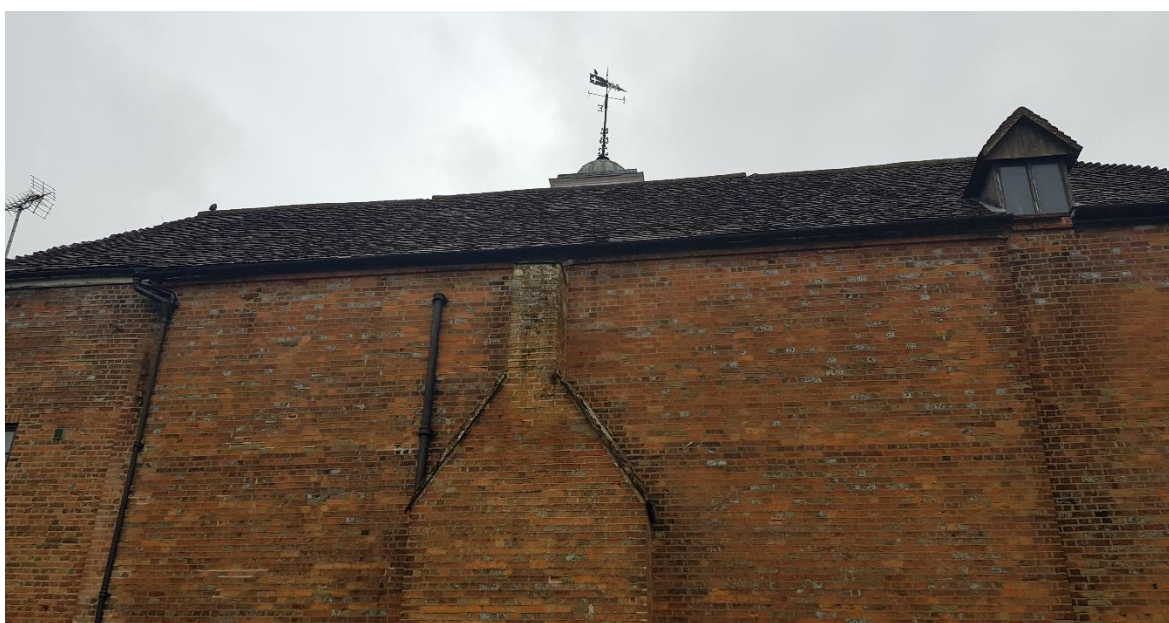
- 2.7 There is a small dormer type window on the western elevation, which has wooden cladding on the front and is clad in the same tiles on the roof, the pugging is all intact and there are no obvious holes or gaps that would allow ingress into the building.

**Picture 2:** Showing the western elevation, small dormer type window

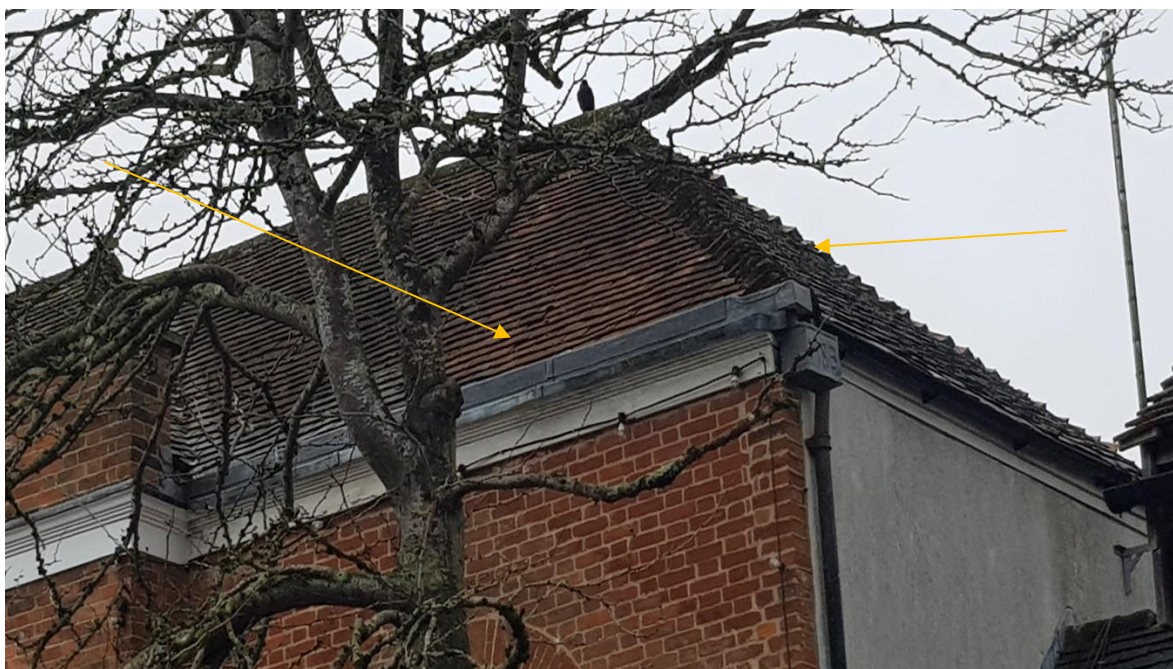
- 2.5 There are numerous gaps and lifted tiles on all elevations of the building that would allow ingress into the building, the hip tiles have numerous gaps and missing cement which could allow ingress into the building.

**Picture 3:** The a close-up of the northern elevation showing gaps under tiles (arrowed)

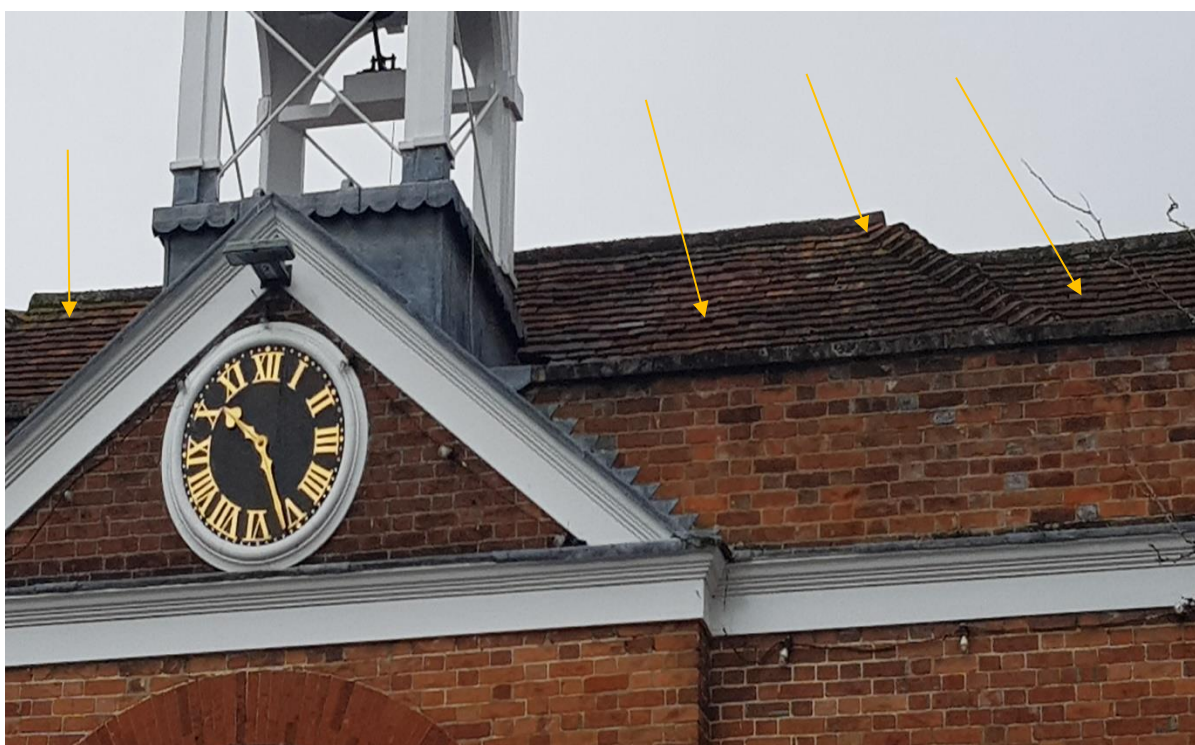
**Picture 4:** Showing a close-up of the eastern elevation and gaps under the tiles (arrowed)

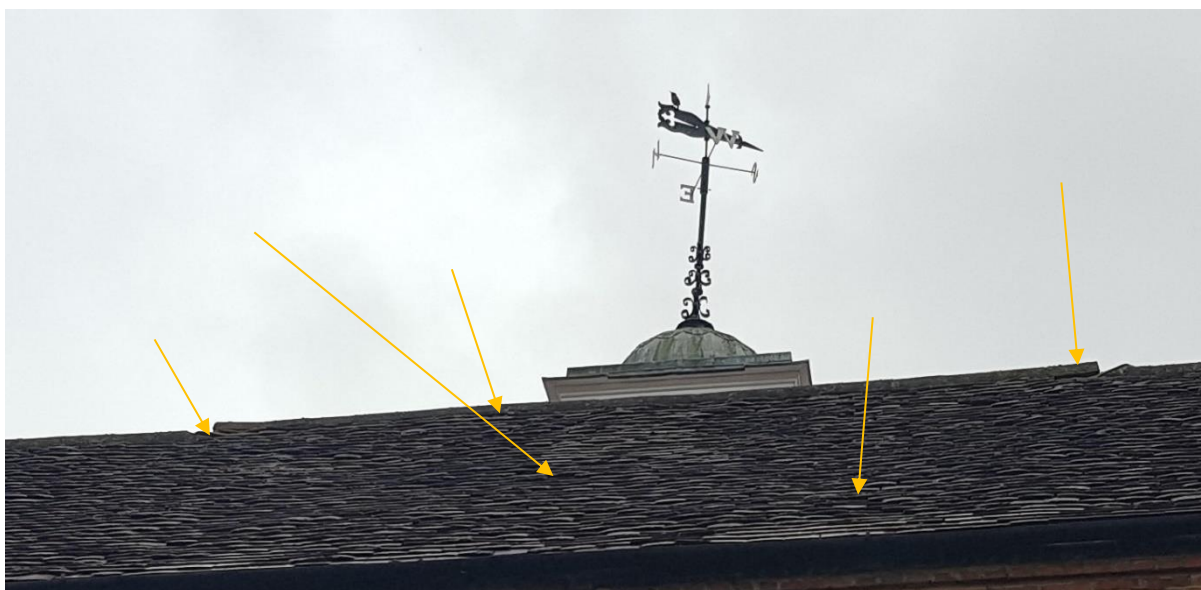
**Picture 5:** Showing a close-up of the western elevation some of the gas arrows

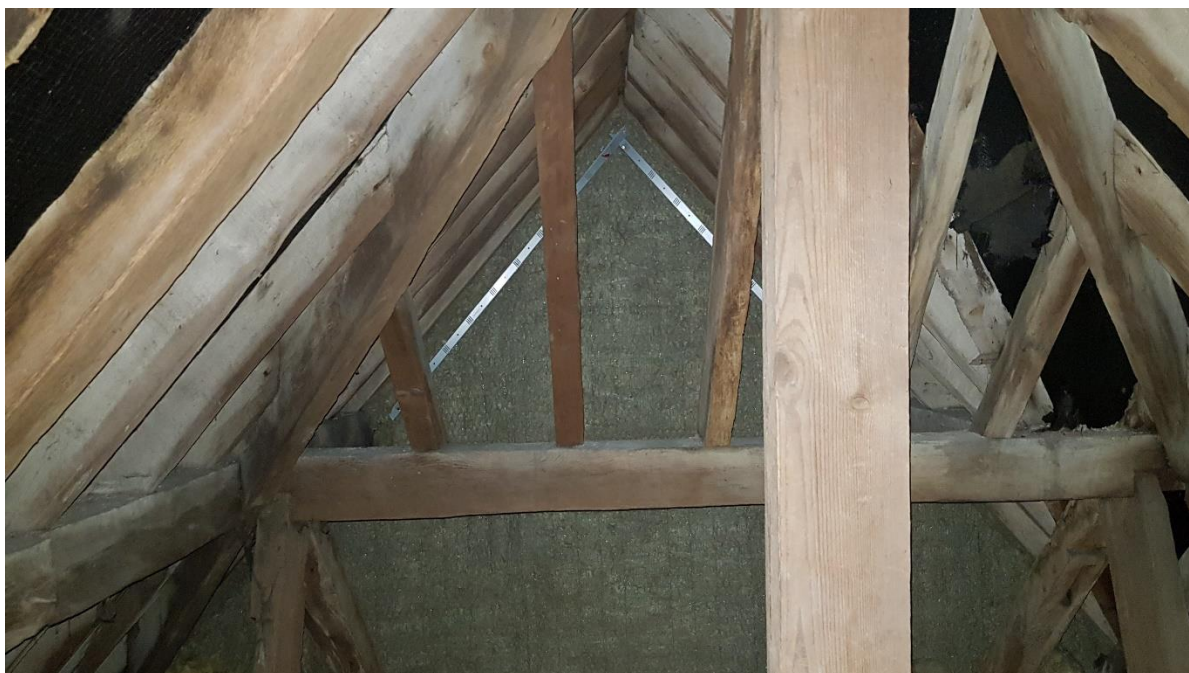
- 2.12 The northern most wall has had new fire wall protection placed on it, there are no obvious signs of bats at the northern end of the building, access beyond the fire wall is not possible.

**Picture 6:** Showing the new fire wall at the northern end of the roof space

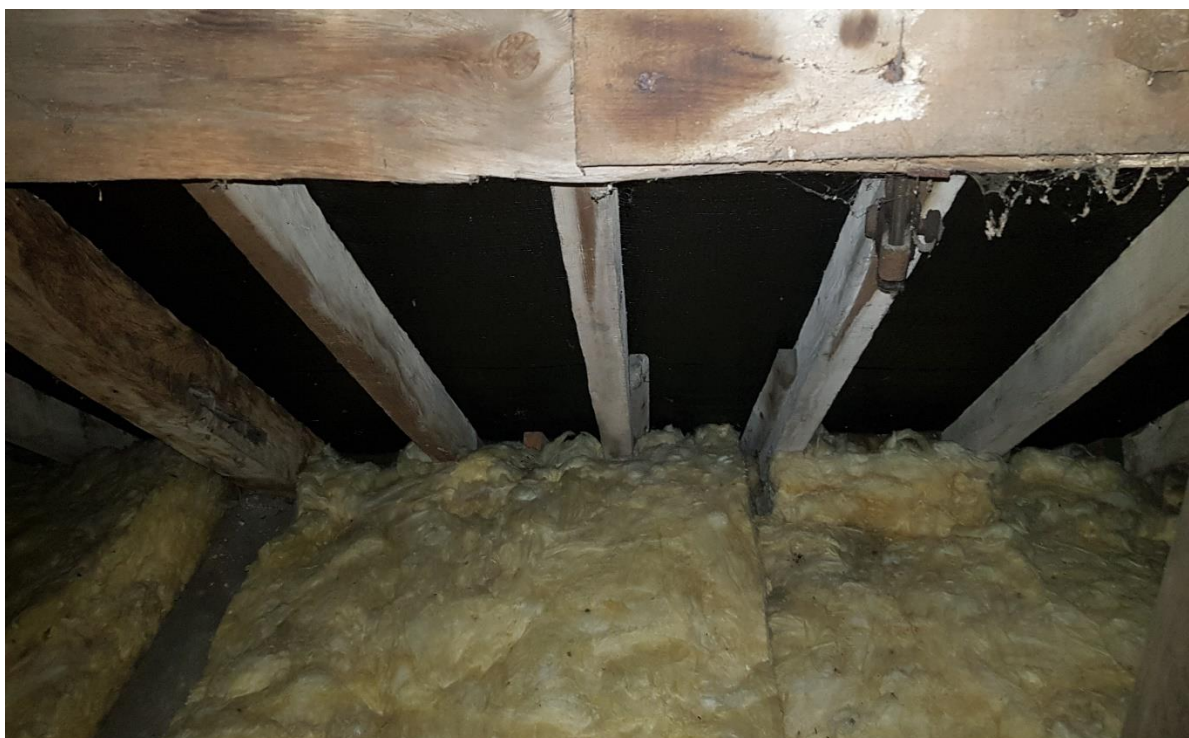
- 2.10 The tiles are backed with a bitumen type felt, there are areas where it overlaps and flops out into the roof space there are no obvious tears or holes in it, the felt looks relatively new.

**Picture 7:** Showing the insulation tucked into the eaves and the bitumen type felt that backs the tiles

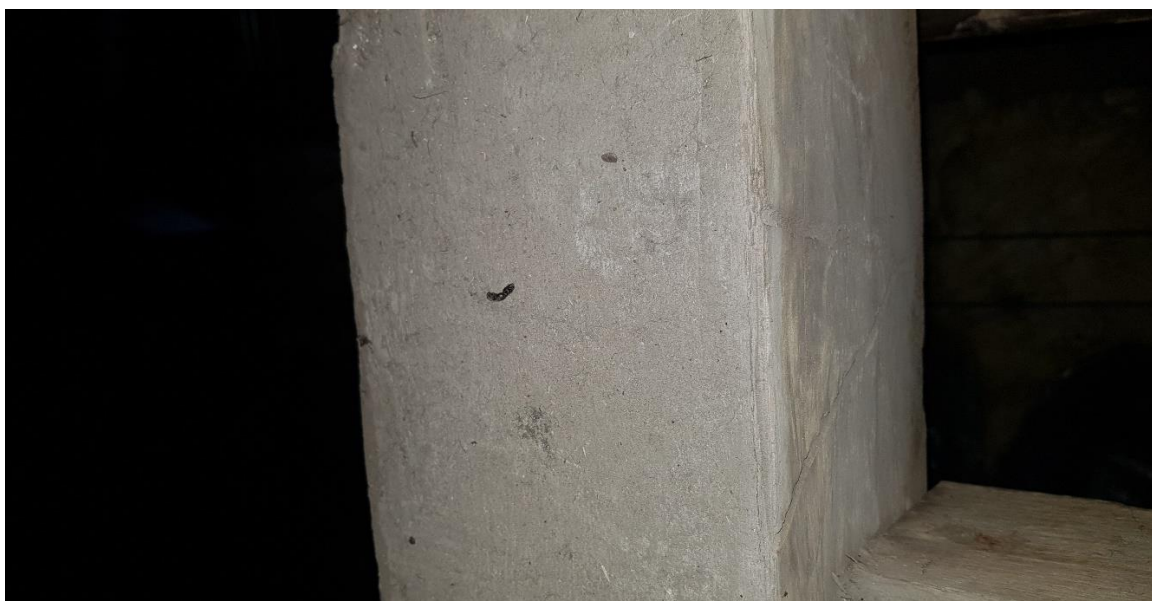
**Picture 8:** Showing a bat dropping on a beam at the southern end of the building

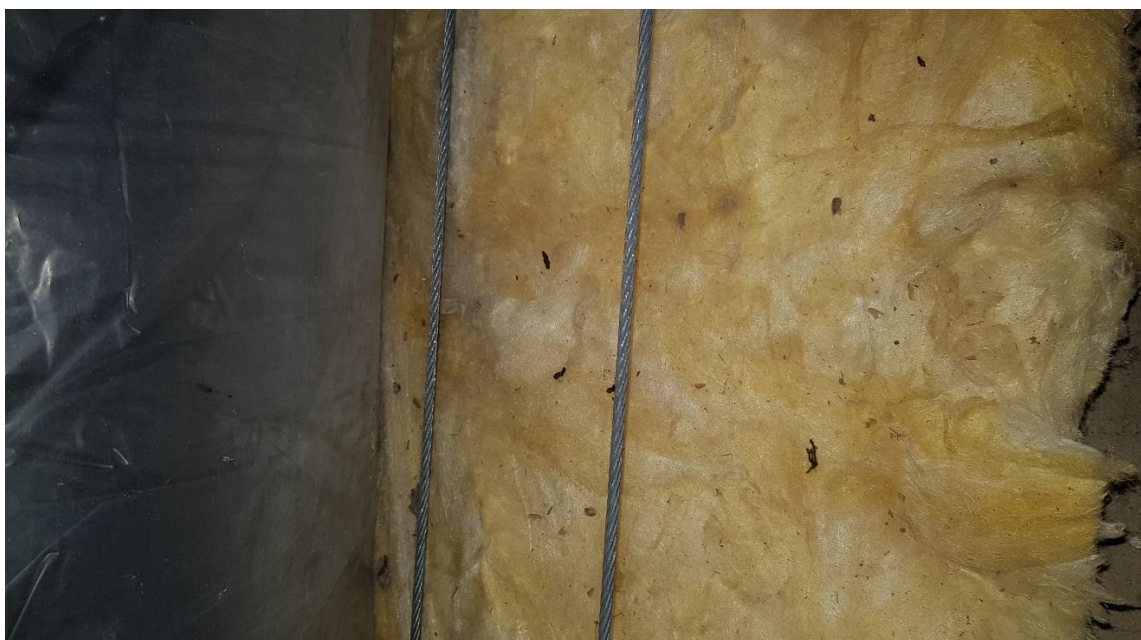
**Picture 9:** Showing bat droppings on the roof insulation at the southern end of the building
