Location : Area 2 - A30 Rawridge MP 243.7 to 240.9 Pavement Investigation  
 Northbound, Lane 1 (CL1), Lane Centre, Offset from Nearside line 1.2m  
 Survey Ch. 418m  
 HAPMS Ch. 7025A30/47+88m  
 OSGR: ST 191611, 04560  
 Notes: Rutting

# DYNAMIC CONE PENETROMETER RESULTS

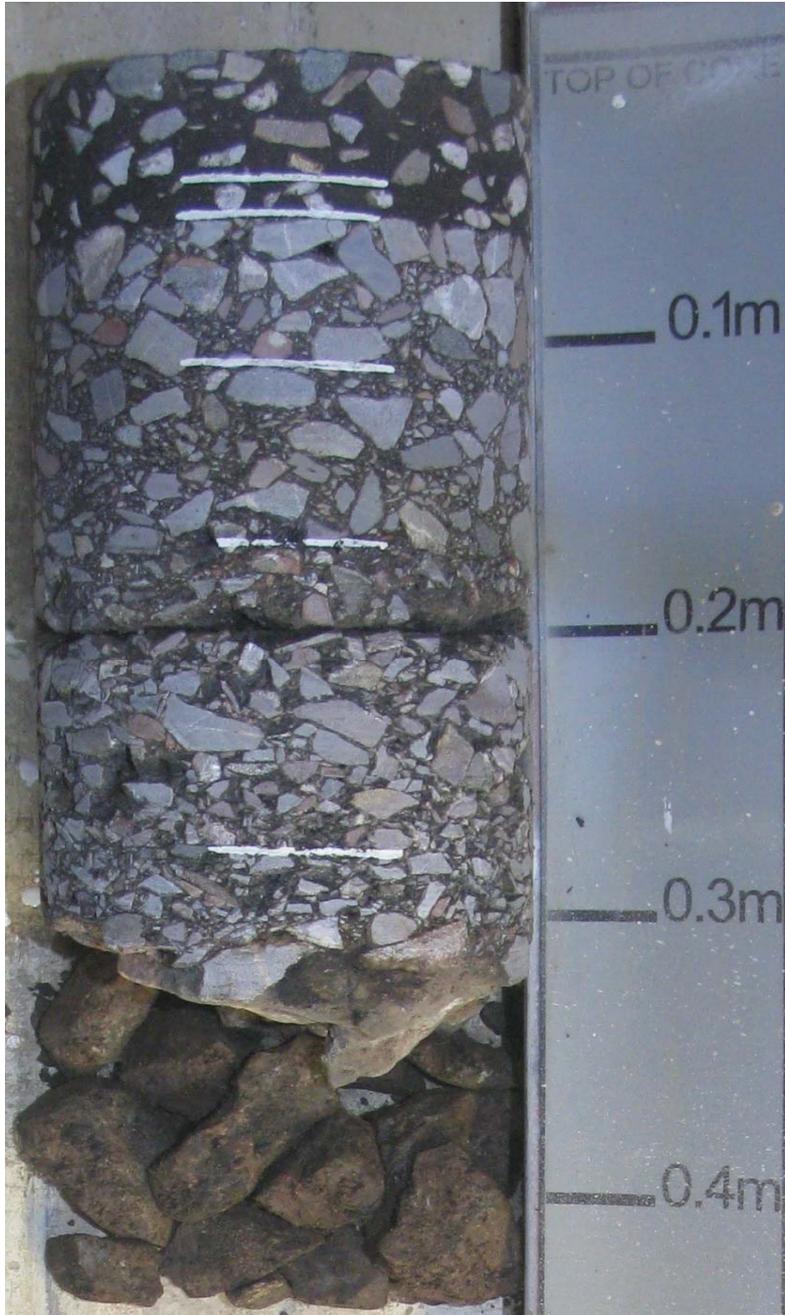
Job Number : 47072436  
 Sample Number : CR0738  
 Core Number : 2C  
 Cored / Logged By : MB / BT  
 Date Cored / Logged : 12-Nov-15 / 17-Nov-15  
 Nominal Diameter : 150

Layer	Depth		Thickness (mm)	Material description	Suitable for NAT/CS Testing (Yes/No)	PAK-Marker Result (+ve/-ve or n/a)	Binder	Aggregate	
	From	To						Size	Type
1	0	40	40	Hot Rolled Asphalt + PCC	Yes	-ve	Bitumen	14	Crushed Rock
2	40	51	11	Hot Rolled Asphalt	No	-ve	Bitumen	14	Crushed Rock
3	51	100	49	Asphalt Concrete	Yes	-ve	Bitumen	20	Crushed Rock
4	100	157	57	Asphalt Concrete	Yes	-ve	Bitumen	20	Crushed Rock
5	157	185	28	Asphalt Concrete (damage to face and voided)	No	-ve	Bitumen	14	Crushed Rock
				Layers 5 & 6 Not Bonded					
6	185	258	73	Asphalt Concrete (damage to face and voided)	No	+ve	Tar	20	Crushed Rock
7	258	300	42	Asphalt Concrete (broken @ base and damage to face)	No	+ve	Tar	20	Crushed Rock
				Loose Granular Material

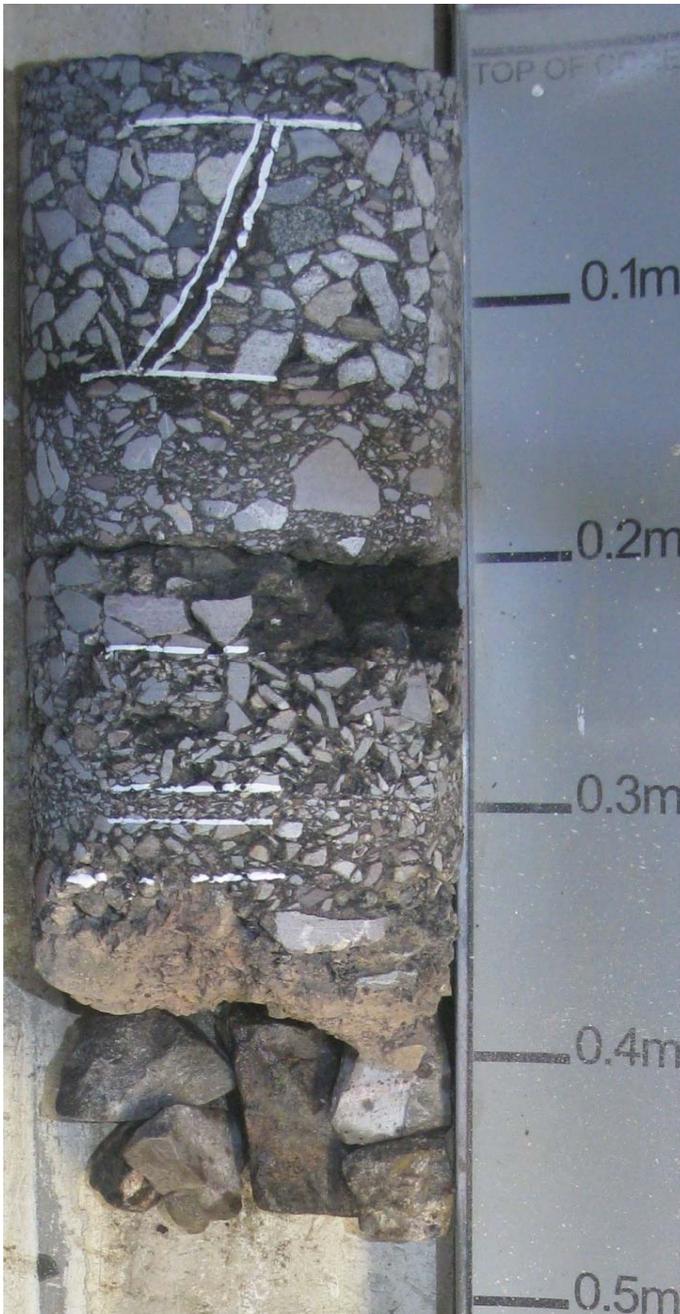
Job Number : 47072436  
 Sample Number : CR0738  
 Core Number : 04  
 Cored / Logged By : MB / BT  
 Date Cored / Logged : 12-Nov-15 / 17-Nov-15  
 Nominal Diameter : 150

Location : Area 2 - A30 Rawridge MP 243.7 to 240.9 Pavement Investigation  
 Southbound, Lane 1 (CR1), NSWP, Offset from Nearside line 0.8m  
 Survey Ch. 827m  
 HAPMS Ch. 7025A30/51+207m  
 OSGR: ST 19804, 04901  
 Notes: N/A

Layer	Depth		Thickness (mm)	Material description	Suitable for NAT/CS Testing (Yes/No)	PAK-Marker Result (+ve/-ve or n/a)	Binder	Aggregate	
	From	To						Size	Type
1	0	24	24	Asphalt Surfacing (voided)	No	-ve	Bitumen	14	Crushed Rock
2	24	116	92	Asphalt Concrete (full depth crack)	No	-ve	Bitumen	20	Crushed Rock
3	116	182	66	Asphalt Concrete	Yes	-ve	Bitumen	32	Crushed Rock
				Layers 3 & 4 Not Bonded					
4	182	218	36	Asphalt Concrete (damage to face and highly voided)	No	+ve	Tar	32	Crushed Rock
5	218	270	52	Asphalt Concrete (damage to face and highly voided)	No	+ve	Tar	14	Crushed Rock
6	270	282	12	Asphalt Concrete (voided)	No	-ve	Bitumen	10	Crushed Rock
7	282	302	20	Asphalt Concrete (damage to face and voided)	No	-ve	Bitumen	14	Crushed Rock
8	302	365	63	Asphalt Concrete (damage to face)	No	-ve	Bitumen	32	Crushed Rock
				Loose Granular Material

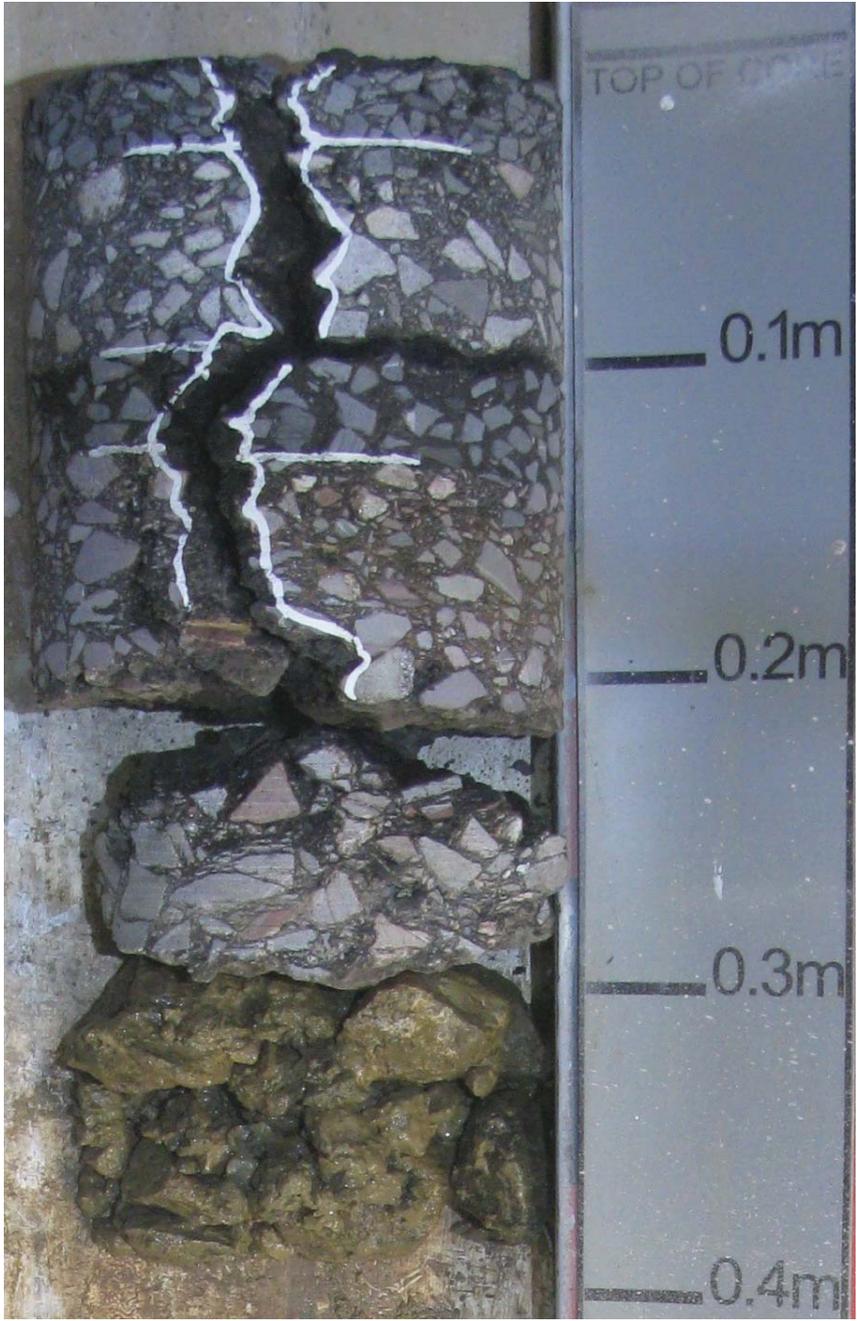
Job Number : 47072436  
 Sample Number : CR0738  
 Core Number : 06  
 Cored / Logged By : MB / BT  
 Date Cored / Logged : 12-Nov-15 / 17-Nov-15  
 Nominal Diameter : 150

Location : Area 2 - A30 Rawridge MP 243.7 to 240.9 Pavement Investigation  
 Northbound, Lane 1 (CL1), Lane Centre, Offset from Nearside line 1.45m  
 Survey Ch. 1886m  
 HAPMS Ch. 7025A30/51+1266m  
 OSGR: ST 20346, 05769  
 Notes: Longitudinal Crack

Layer	Depth		Thickness (mm)	Material description	Suitable for NAT/CS Testing (Yes/No)	PAK-Marker Result (+ve/-ve or n/a)	Binder	Aggregate	
	From	To						Size	Type
1	0	27	27	Asphalt Surfacing (in half and voided)	No	-ve	Bitumen	14	Crushed Rock
2	27	85	58	Asphalt Concrete (in half)	No	-ve	Bitumen	20	Crushed Rock
3	85	117	32	Hot Rolled Asphalt (in half)	No	-ve	Bitumen	14	Crushed Rock
4	117	200	83	Asphalt Concrete (broken @ base and in half)	No	-ve	Bitumen	20	Crushed Rock
				Layers 4 & 5 Not Bonded					
5	200	265	65	Asphalt Concrete (broken up)	No	-ve	Bitumen	20	Crushed Rock
				Loose Granular Material

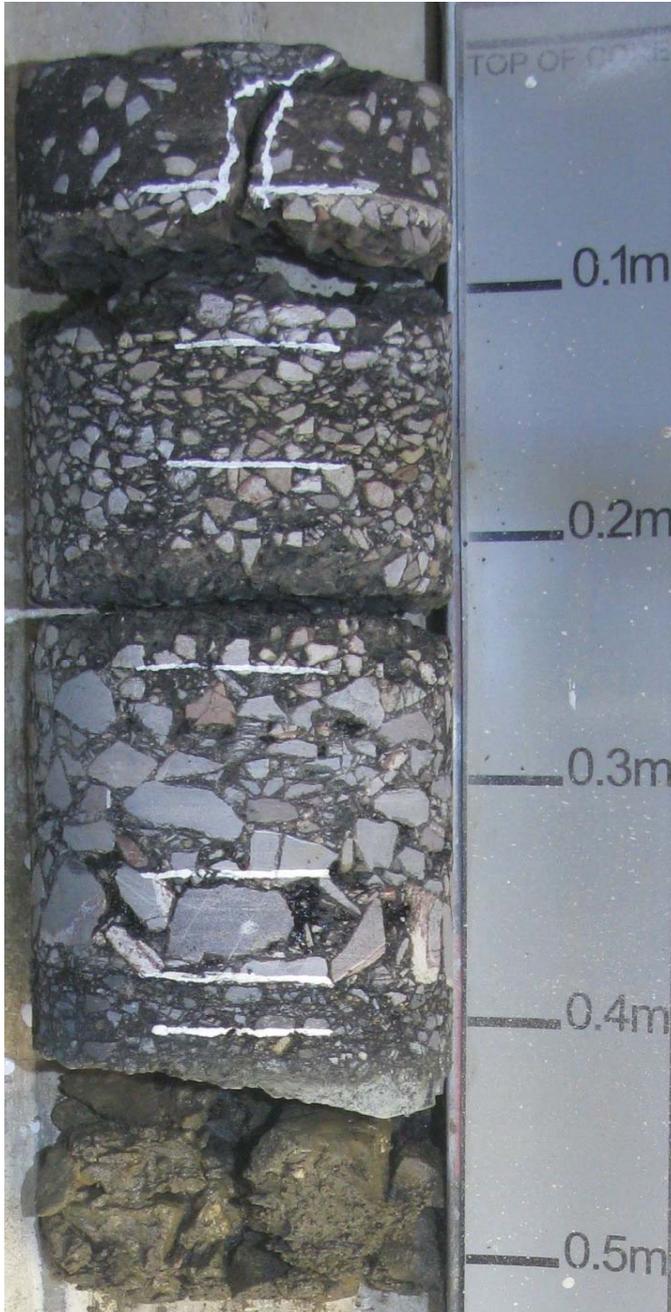
Job Number : 47072436  
 Sample Number : CR0738  
 Core Number : 09  
 Cored / Logged By : MB / BT  
 Date Cored / Logged : 12-Nov-15 / 17-Nov-15  
 Nominal Diameter : 150

Location : Area 2 - A30 Rawridge MP 243.7 to 240.9 Pavement Investigation  
 Southbound, Layby, Lane 1 (CL1), OSWP, Offset from Offside edge 1.1m  
 Markerpost 245/8  
 HAPMS Ch. 7025A30/98+40m  
 OSGR: ST 18216, 02567  
 Notes: Surface Deterioration

Layer	Depth		Thickness (mm)	Material description	Suitable for NAT/CS Testing (Yes/No)	PAK-Marker Result (+ve/-ve or n/a)	Binder	Aggregate	
	From	To						Size	Type
1	0	55	55	Hot Rolled Asphalt + Surface Dressing (in half)	No	-ve	Bitumen	14	Crushed Rock
2	55	80	25	Asphalt Concrete (damage to face and in half)	No	-ve	Bitumen	14	Crushed Rock
				Layers 2 & 3 Not Bonded					
3	80	112	32	Asphalt Concrete (broken @ top and voided)	No	-ve	Bitumen	14	Crushed Rock
4	112	157	45	Asphalt Concrete (voided)	Yes	-ve	Bitumen	14	Crushed Rock
5	157	210	53	Asphalt Concrete (broken @ base and damage to face)	No	-ve	Bitumen	14	Crushed Rock
				Layers 5 & 6 Not Bonded					
6	210	236	26	Asphalt Concrete (damage to face and voided)	No	-ve	Bitumen	14	Crushed Rock
7	236	315	79	Asphalt Concrete (voided)	Yes	+ve	Tar	32	Crushed Rock
8	315	356	41	Asphalt Concrete (voided)	Yes	+ve	Tar	32	Crushed Rock
9	356	376	20	Asphalt Concrete	No	-ve	Bitumen	10	Crushed Rock

10	376	405	29	Asphalt Concrete	No	+ve	Tar	10	Crushed Rock
				Loose Granular Material

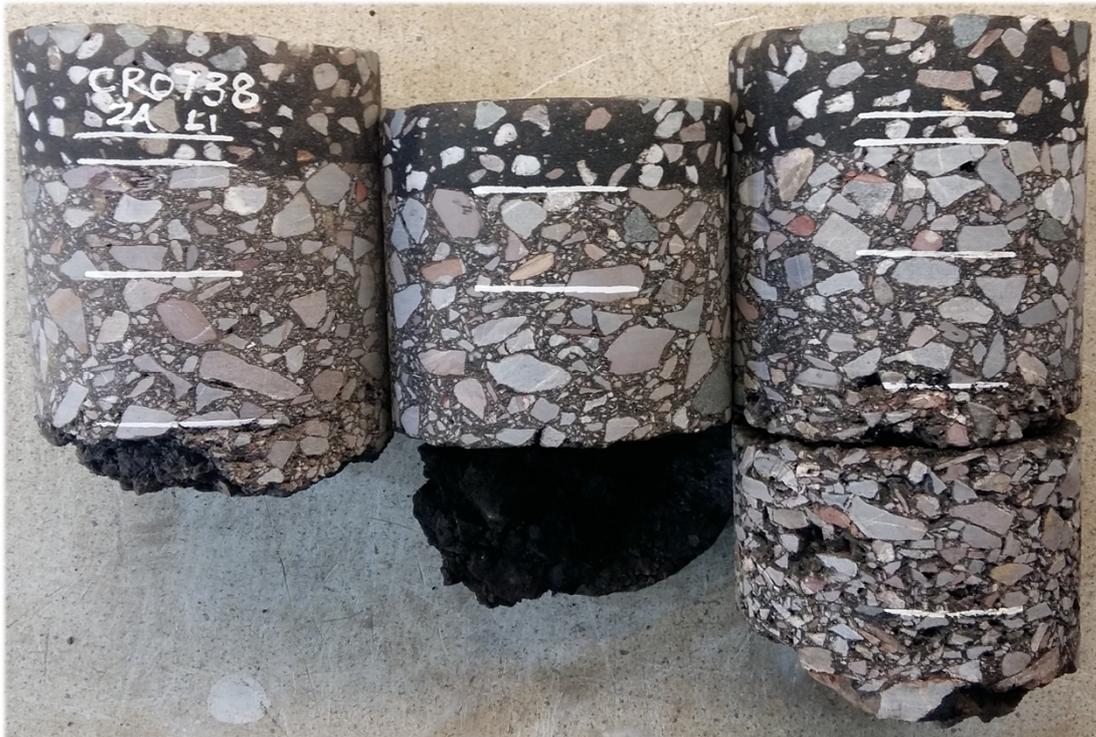
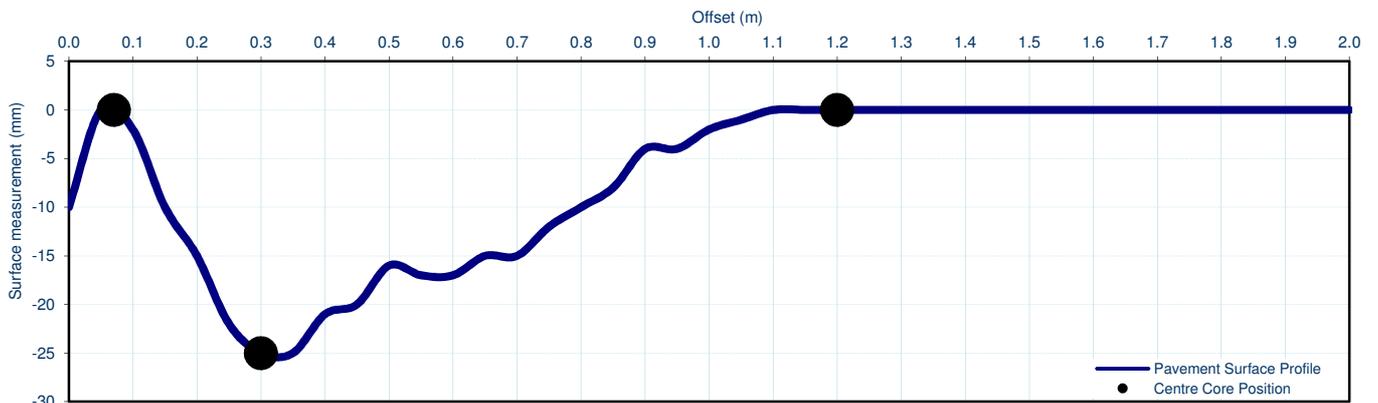
Job Number : 47072027  
 Sample Number : CR0738  
 Core Number : 2 (ABC)  
 Cored / Logged By : MB / BT  
 Date Cored / Logged : 11/11/15 - 17/11/15  
 Nominal Diameter : 150

Location : Area 2 - A30 Rawridge MP 243.7 to 240.9 Pavement Investigation  
 Northbound, Lane 1 (CL1), NSW, Offset from Nearside line 0.07, 0.3 and 1.2m  
 Survey Ch. 418m  
 HAPMS Ch. 7025A30/47+88m  
 OSGR: ST 191611, 04560  
 Notes: Rutting

Material Description	Layer	A			B			C		
		Cumulative Depth inc. Rut	Cumulative Thickness	Layer Thickness	Cumulative Depth inc. Rut	Cumulative Thickness	Layer Thickness	Cumulative Depth inc. Rut	Cumulative Thickness	Layer Thickness
		(mm)			(mm)			(mm)		
HRA	1	45	45	45				40	40	40
HRA	2	57	57	12	63	38	38	51	51	11
Asphalt Concrete	3	105	105	48	106	81	43	100	100	49
Asphalt Concrete	4	171	171	66	175	150	69	157	157	57
Asphalt Concrete	5	210	210	39	275	250	100	185	185	28
Asphalt Concrete	6							258	258	73
Asphalt Concrete	7							300	300	42

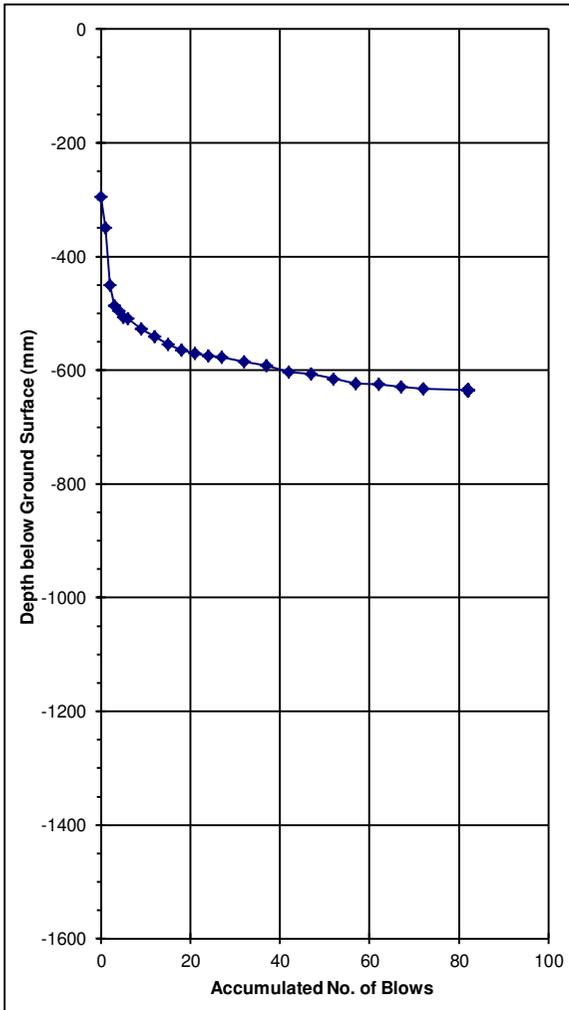
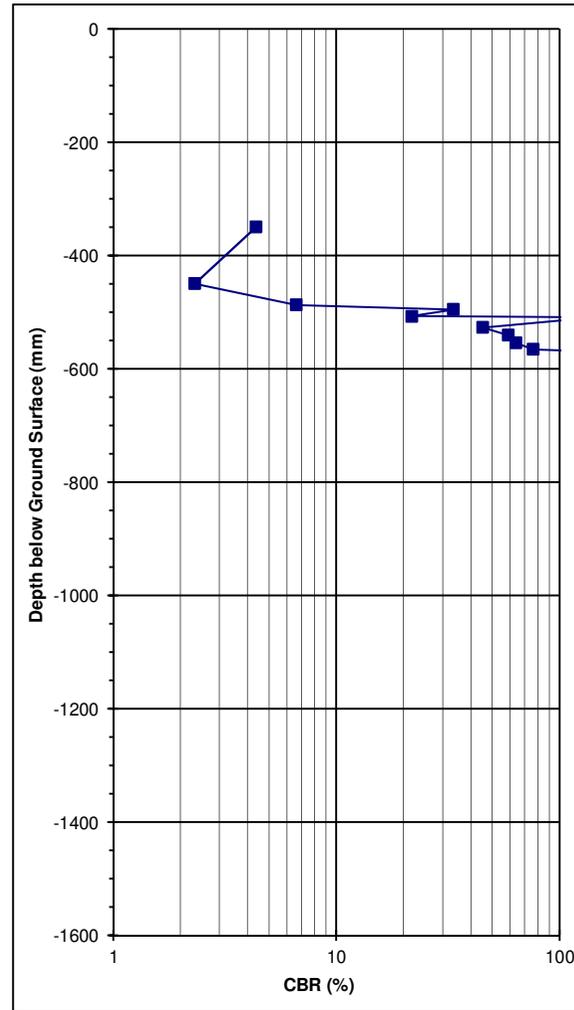
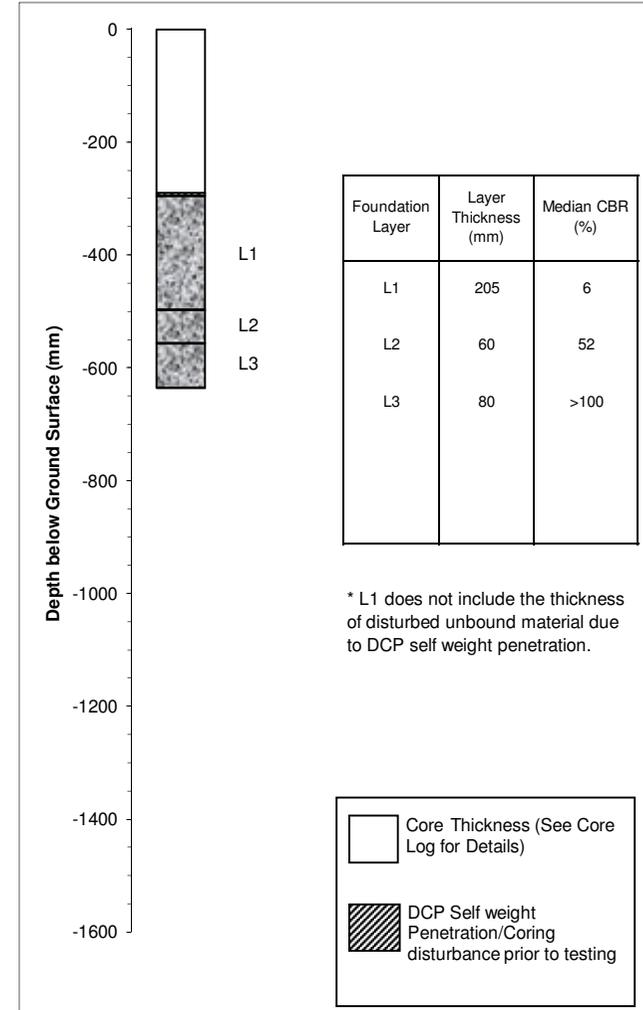
Job Number :	47072436	Location :	Area 2 - A30 Rawridge MP 243.7 to 240.9 Pavement Investigation
DCP/Core Number :	2B		Northbound, Lane 1 (CL1), NSWP, Offset from Nearside line 0.3m
DCP Operator :	MB/PM		Survey Ch. 418m
Date Tested :	11/11/15		HAPMS Ch. 7025A30/47+88m
Plot Prepared By :	JB		OSGR: ST 191611, 04560
Plot Checked By :	TJ		Notes: Rutting
Date Prepared :	24/11/15

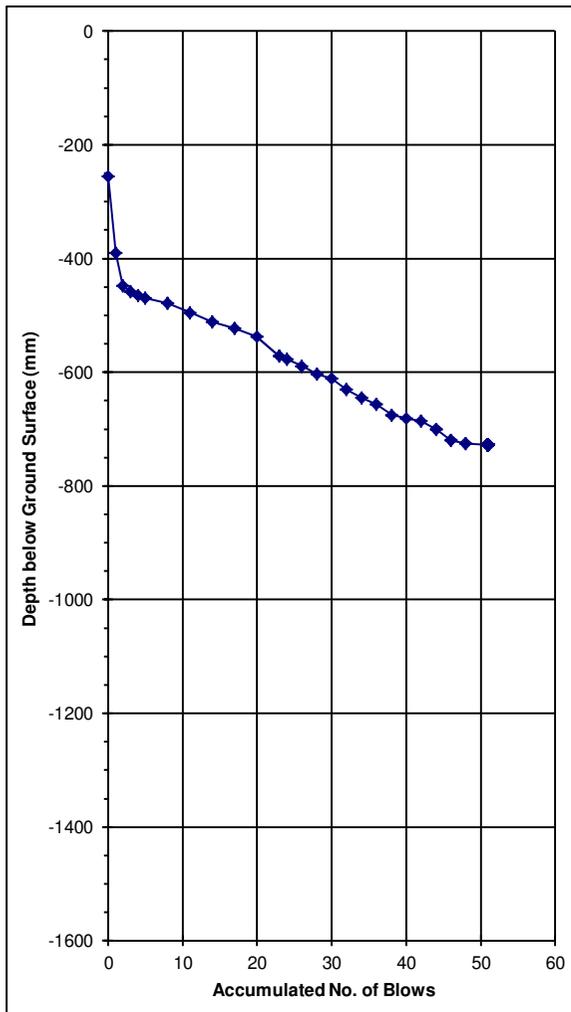
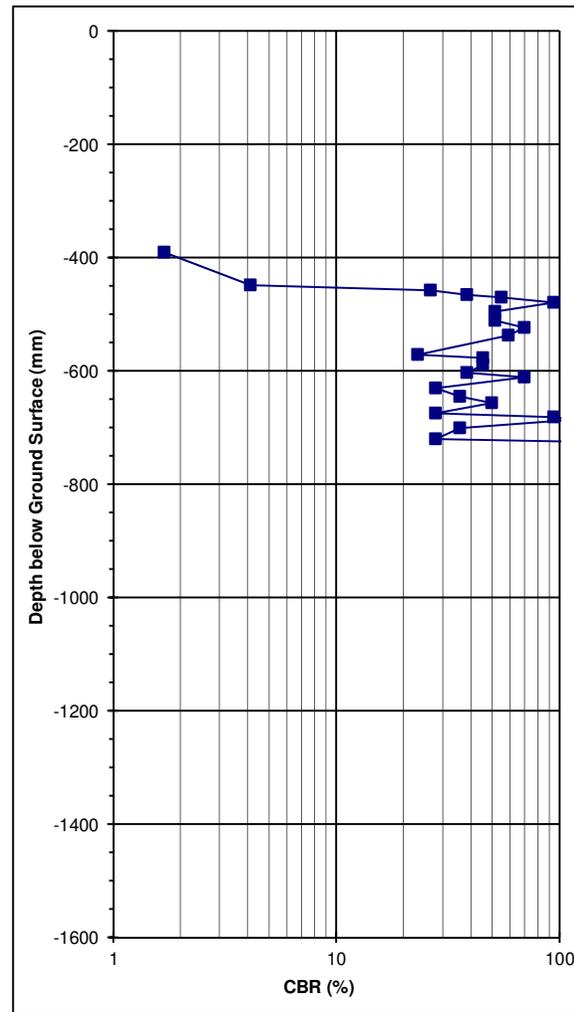
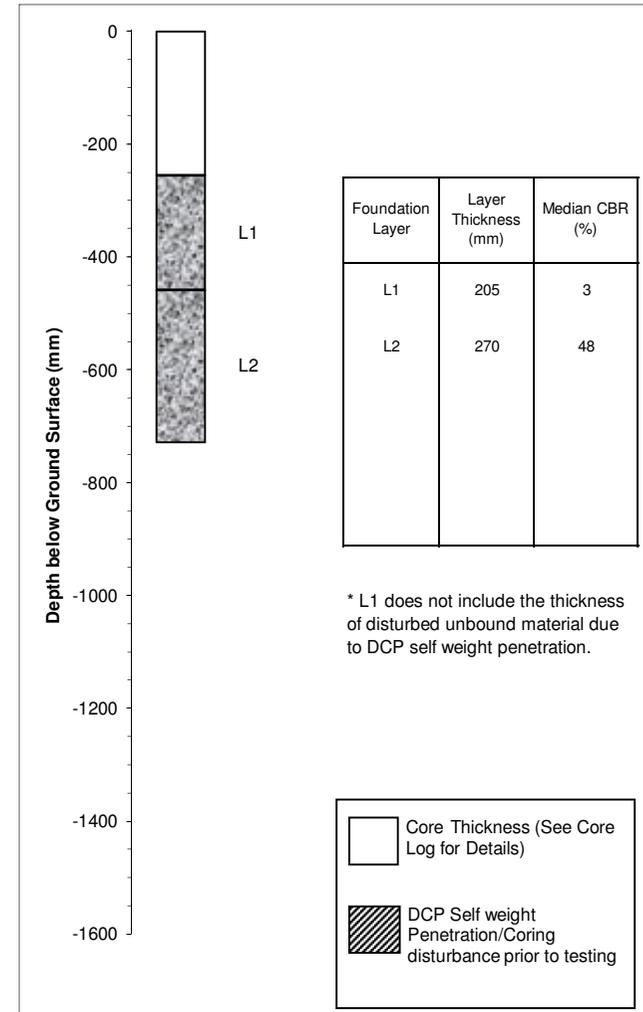
Job Number :	47072436	Location :	Area 2 - A30 Rawridge MP 243.7 to 240.9 Pavement Investigation
DCP/Core Number :	3		Southbound, Lane 1 (CR1), NSW, Offset from Nearside line 0.56m
DCP Operator :	MB/PM		Survey Ch. 523m
Date Tested :	12/11/15		HAPMS Ch. 7025A30/47+193m
Plot Prepared By :	JB		OSGR: ST 19673, 04640
Plot Checked By :	TJ		Notes: Longitudinal Crack
Date Prepared :	24/11/15

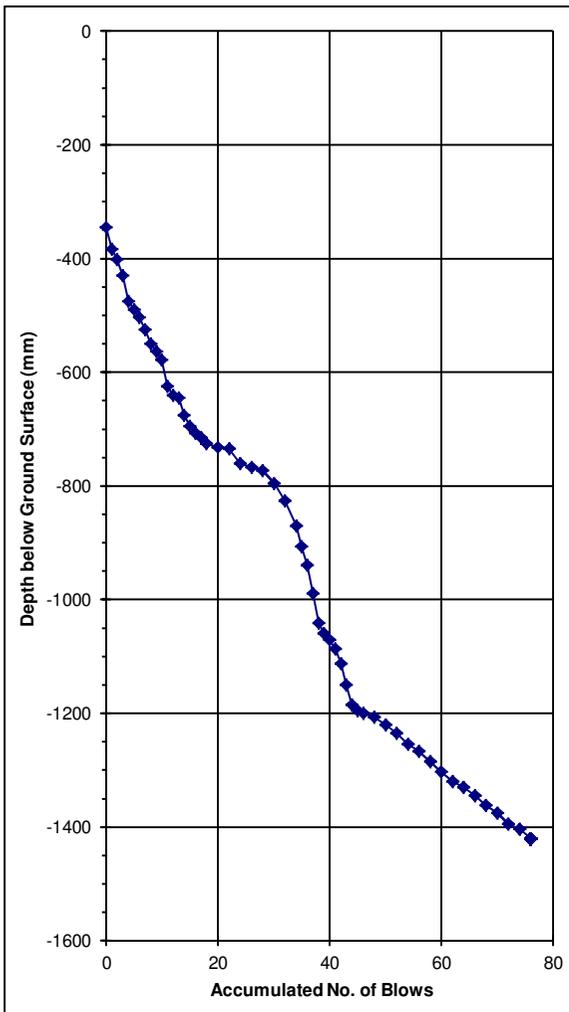
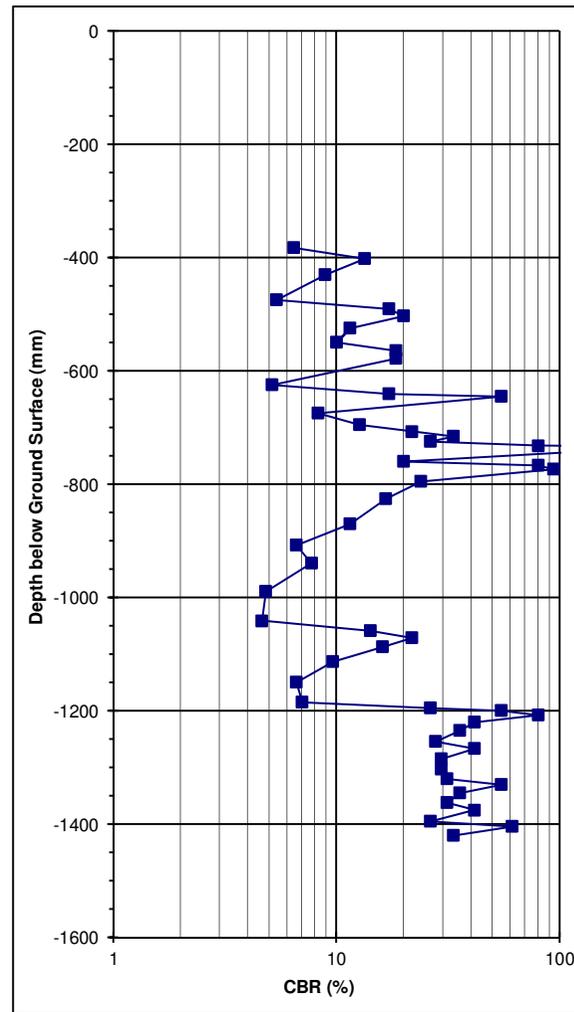
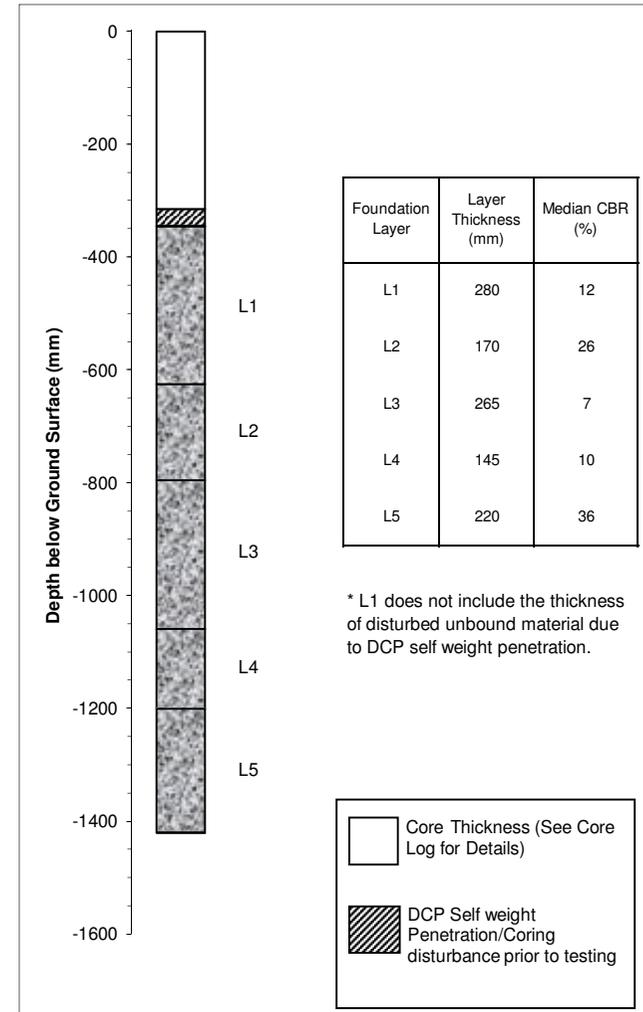
Job Number :	47072436	Location :	Area 2 - A30 Rawridge MP 243.7 to 240.9 Pavement Investigation
DCP/Core Number :	5		Northbound, Lane 1 (CL1), NSWP, Offset from Nearside line 0.92m
DCP Operator :	MB/PM		Survey Ch. 1868m
Date Tested :	12/11/15		HAPMS Ch. 7025A30/51+1248m
Plot Prepared By :	JB		OSGR: ST 20337, 05753
Plot Checked By :	TJ		Notes: No crack identified on site
Date Prepared :	24/11/15

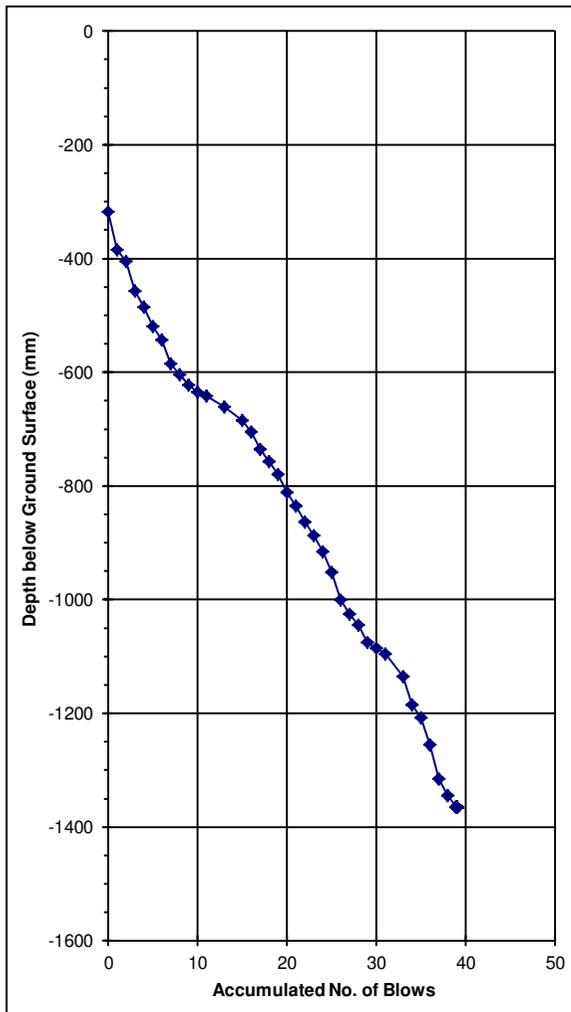
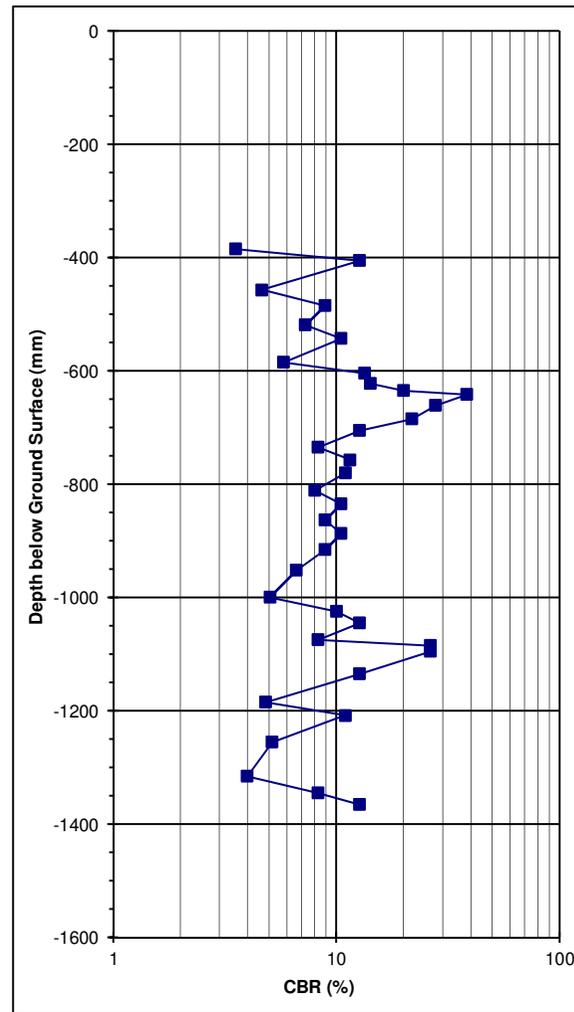
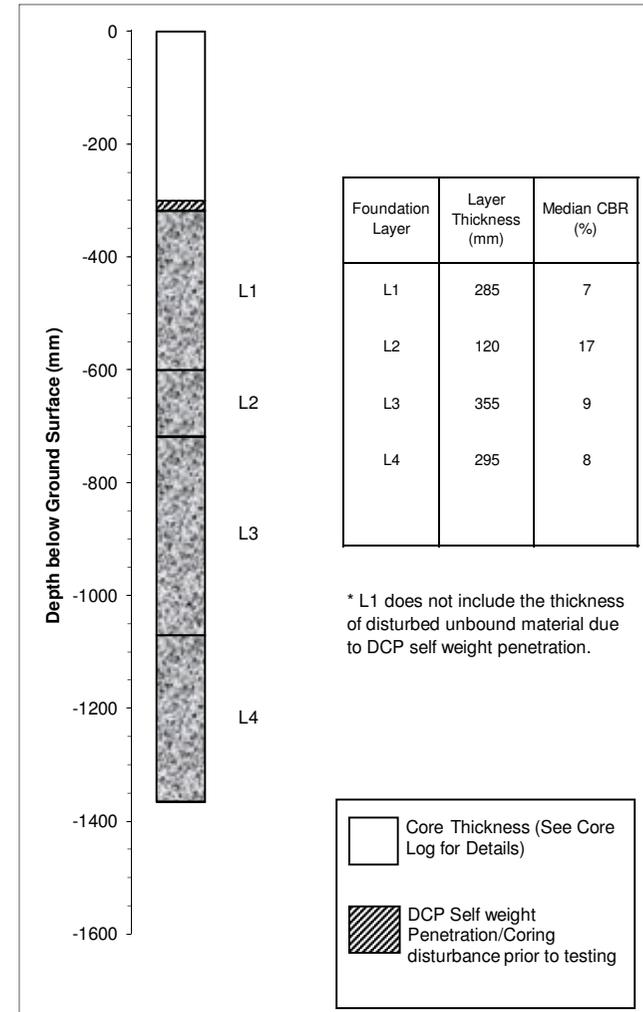
Job Number :	47072436	Location :	Area 2 - A30 Rawridge MP 243.7 to 240.9 Pavement Investigation
DCP/Core Number :	6		Northbound, Lane 1 (CL1), Lane Centre, Offset from Nearside line 1.45m
DCP Operator :	MB/PM		Survey Ch. 1886m
Date Tested :	12/11/15		HAPMS Ch. 7025A30/51+1266m
Plot Prepared By :	JB		OSGR: ST 20346, 05769
Plot Checked By :	TJ		Notes: Longitudinal Crack
Date Prepared :	24/11/15

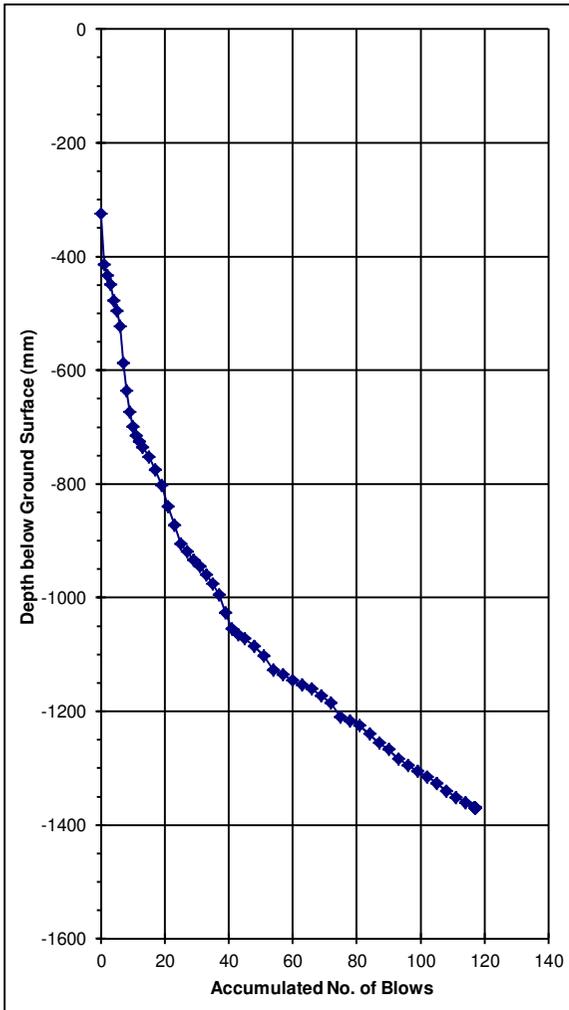
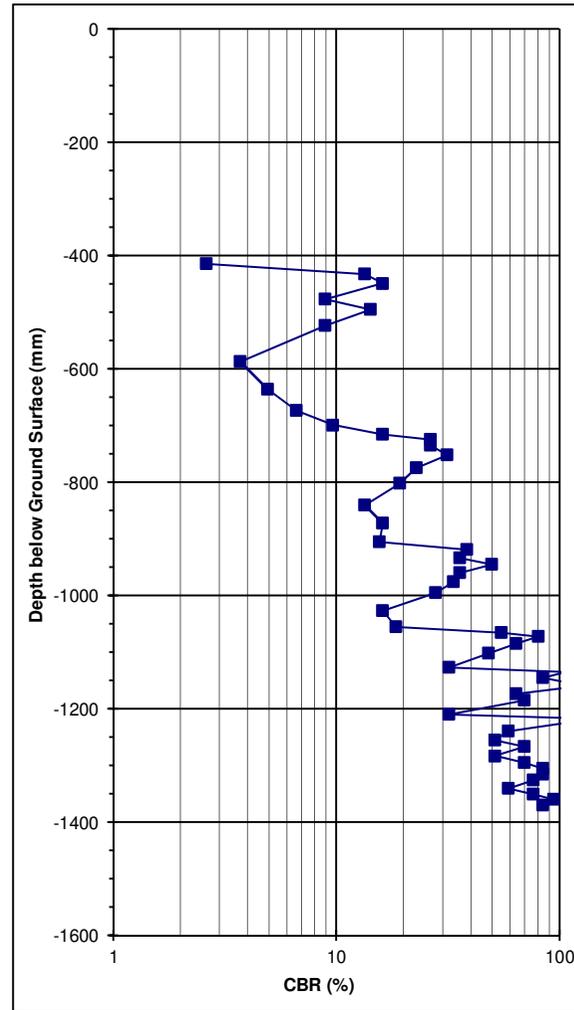
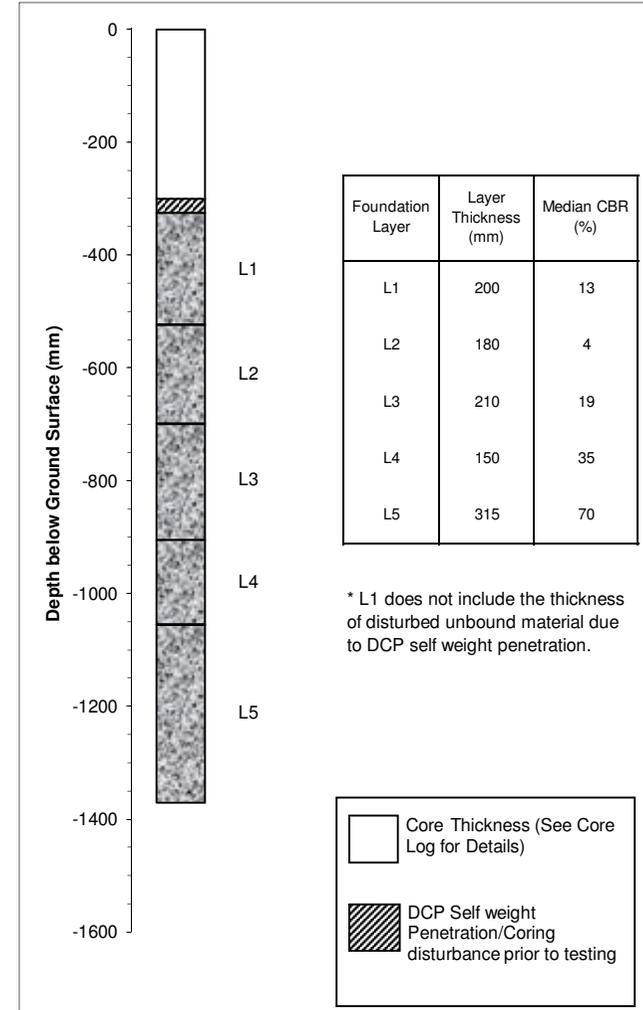
Job Number :	47072436	Location :	Area 2 - A30 Rawridge MP 243.7 to 240.9 Pavement Investigation
DCP/Core Number :	9		Southbound, Layby, Lane 1 (CL1), OSWP, Offset from Offside edge 1.1m
DCP Operator :	MB/PM		Markerpost 245/8
Date Tested :	12/11/15		HAPMS Ch. 7025A30/98+40m
Plot Prepared By :	JB		OSGR: ST 18216, 02567
Plot Checked By :	TJ		Notes: Surface Deterioration
Date Prepared :	24/11/15
