# Mechanical Services Report

Public Toilet Block – High Street, Westbury, BA13 3BW

Prepared for: Information and Refurbishment Recommendations

Date: Tuesday 30<sup>th</sup> September 2025

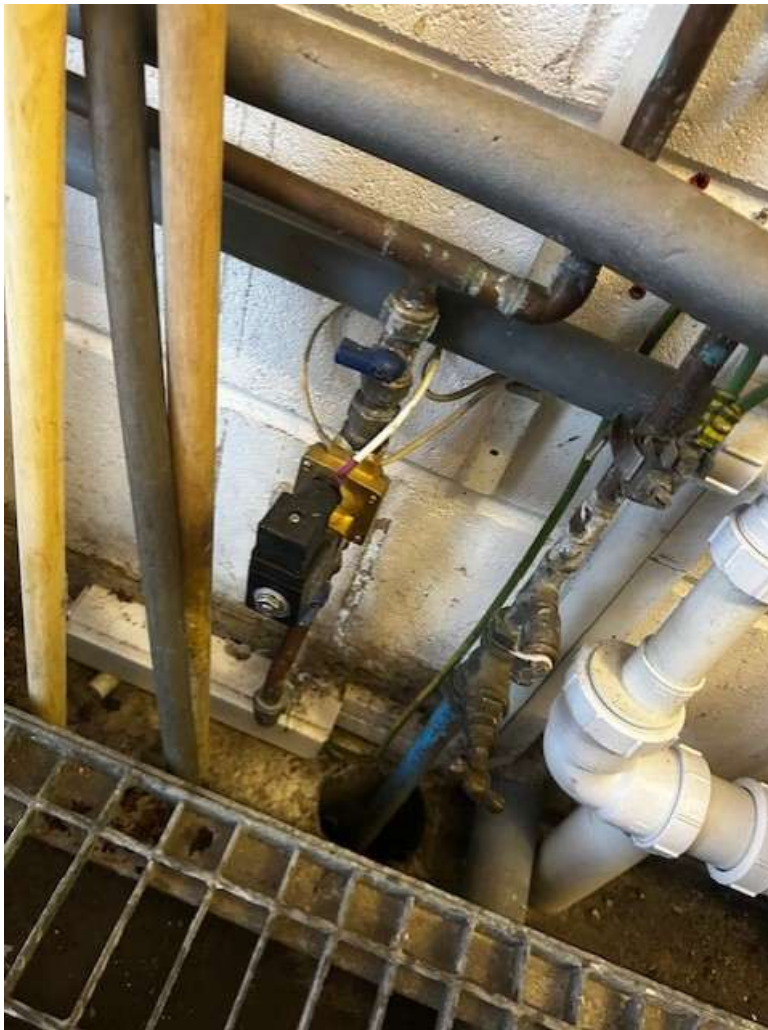
Ref 1.

Incoming 20mm MDPE mains supply observed. No double check valve (DCV) or backflow prevention device(s) installed. This presents a compliance issue under the Water Supply (Water Fittings) Regulations 1999.

[Photo(s) Ref. 1 Incoming mains pipework]

Recommendation: Install appropriate DCV or break tank arrangement.

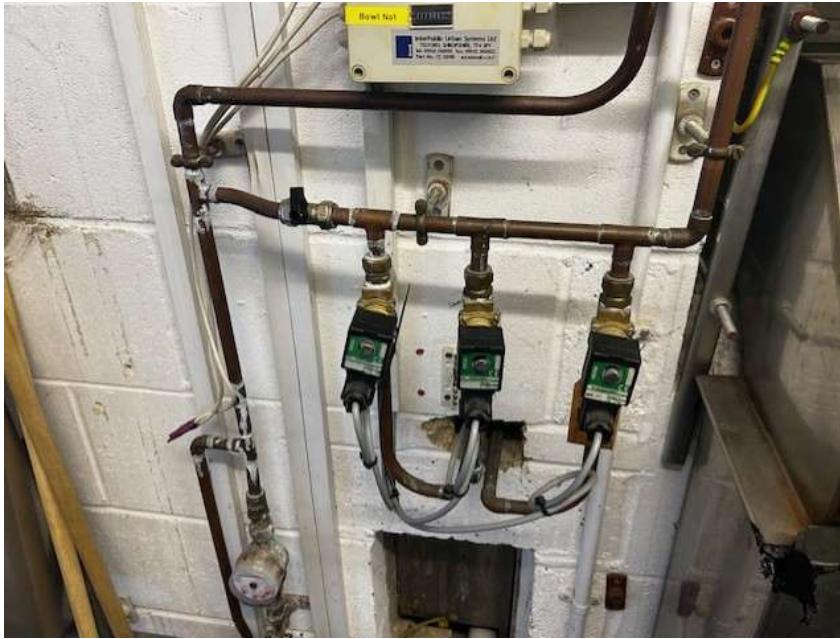
Ref 2.

Urinals are directly fed from mains water without pipe interrupter or Cat 5 break tank for backflow prevention. This is non-compliant due to Fluid Category 5 risk.

[Photo(s) Ref. 2 Urinal water feed]

Recommendation: Install Cat 5 break tank with solenoid valve and timing controls, or if direct flush is preferred a Type DC pipe interrupter.

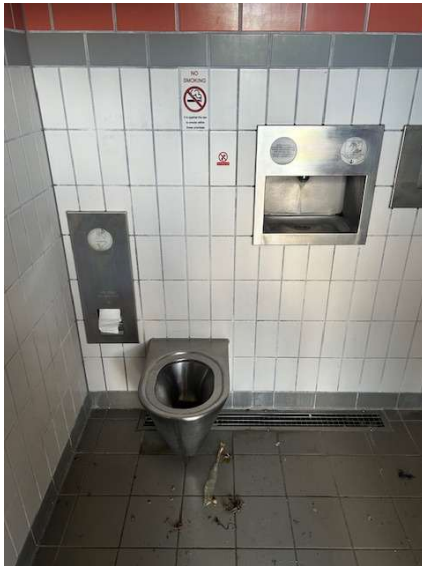
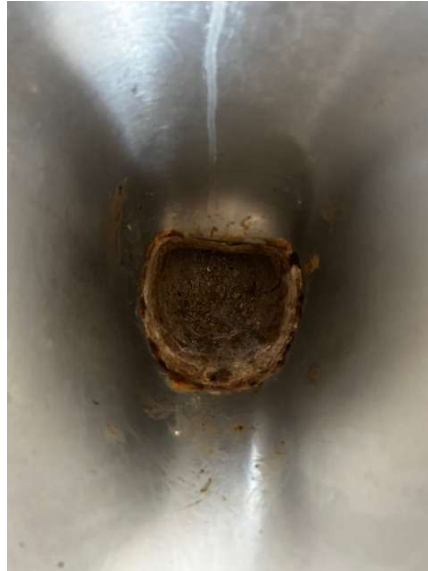
Ref 3.

All sanitaryware and fittings show significant signs of age. Retrofit repairs and mismatched fittings are evident. Microwave sensor flush controls and automatic taps are outdated, with some removed entirely.

[Photo(s) Ref. 3 Sanitaryware]

Recommendation: Replace all sanitaryware and sensor controls.

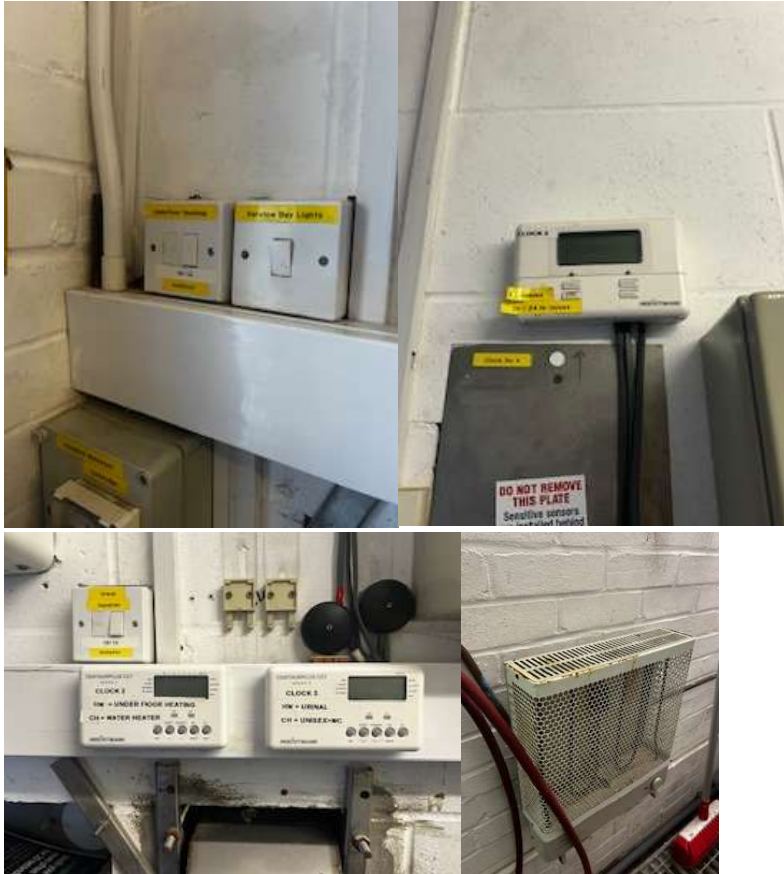
Ref 5.

Electric underfloor heating and wall mounted heaters present but dated.

[Photo(s) Ref. 5 Heating]

Recommendation: Replace controls and heaters.

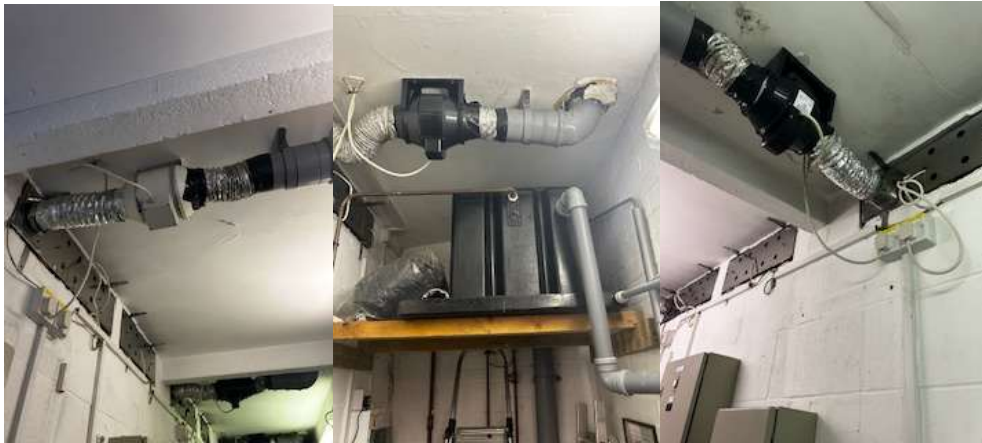
Ref 6.

Fans and ductwork dated, with excess flex.

[Photo(s) Ref. 6 – Ventilation]

Recommendation: Replace with efficient inline fans with rigid ducting

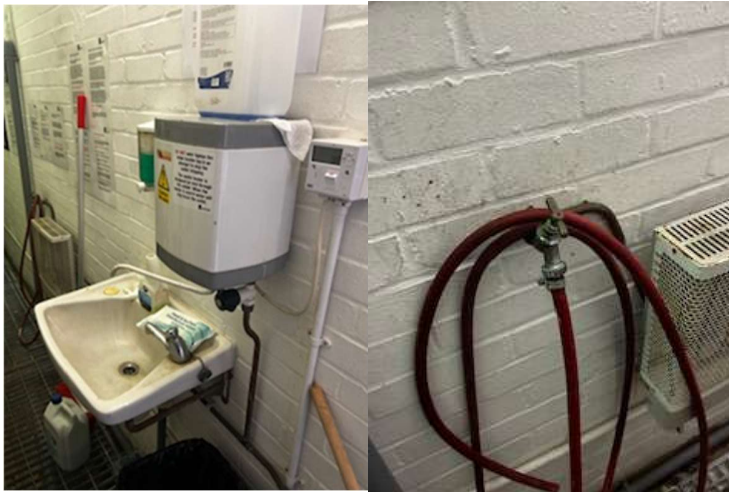
Ref 8.

Mains cold water also serves the cleaner's sink within the service corridor. A 6-litre point-of-use over-sink water heater provides hot water. A bib tap with hose is also present. Whilst not in use, the hose should be disconnected to prevent backflow contamination.

[Photo(s) Ref. 8 Cleaner's sink and bib tap]

Recommendation: Provide dedicated hose storage and consider installing a Cat 5 mini booster set depending on intended use.

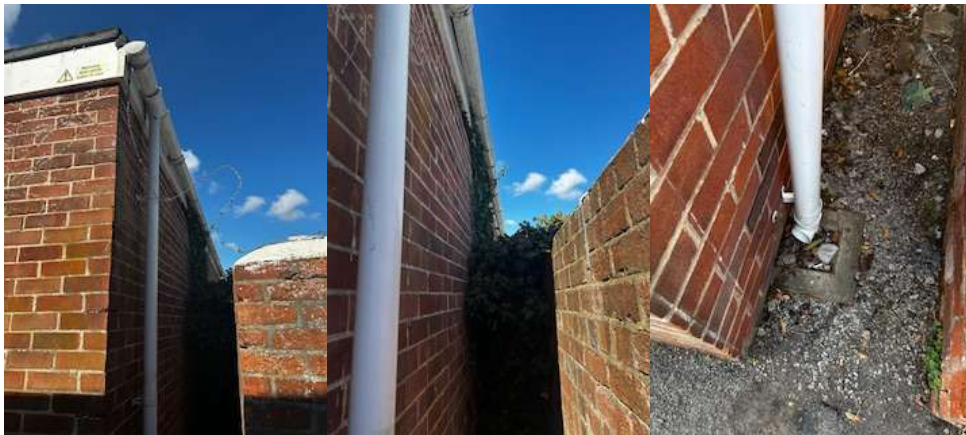
Ref 9.

Rainwater goods are installed on the rear elevation. Downpipes show damage and clips are missing.

[Photo Ref. 9 Rainwater downpipe]

Recommendation: Replace damaged rainwater downpipes and clips.
