Medmerry Islands

Detailed Unexploded Ordnance (UXO) Threat and Risk Assessment with Risk Mitigation Strategy

Project No.: 11444

10th September 2024

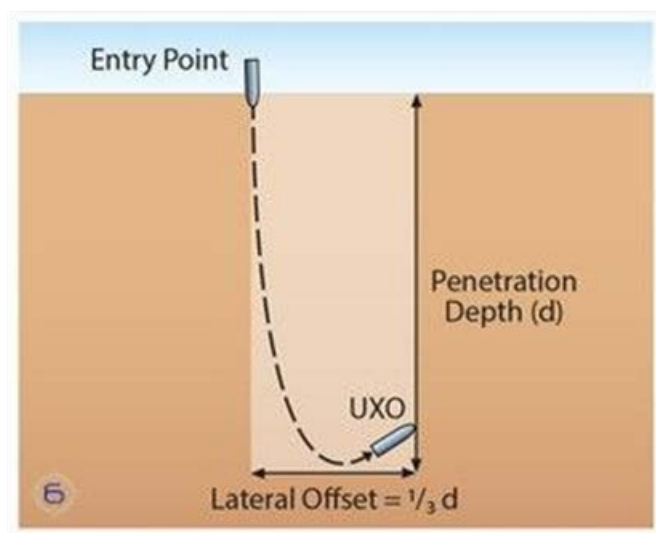
Figure 1: The “J Curve” Effect

As a UXB penetrated the ground, it's velocity naturally slowed where it either came to an abrupt stop (e.g., against foundations) or would continue along a route of least resistance – which often resulted in a curving of the trajectory back towards the surface. This is known as the “J Curve” effect and often resulted in a considerable horizontal off-set from the point of entry. This explains why UXBs have been discovered against or under the foundations of buildings which were present during WWII, or many meters from their entry holes. A diagrammatical representation of the “J Curve” effect is presented at Figure 1.

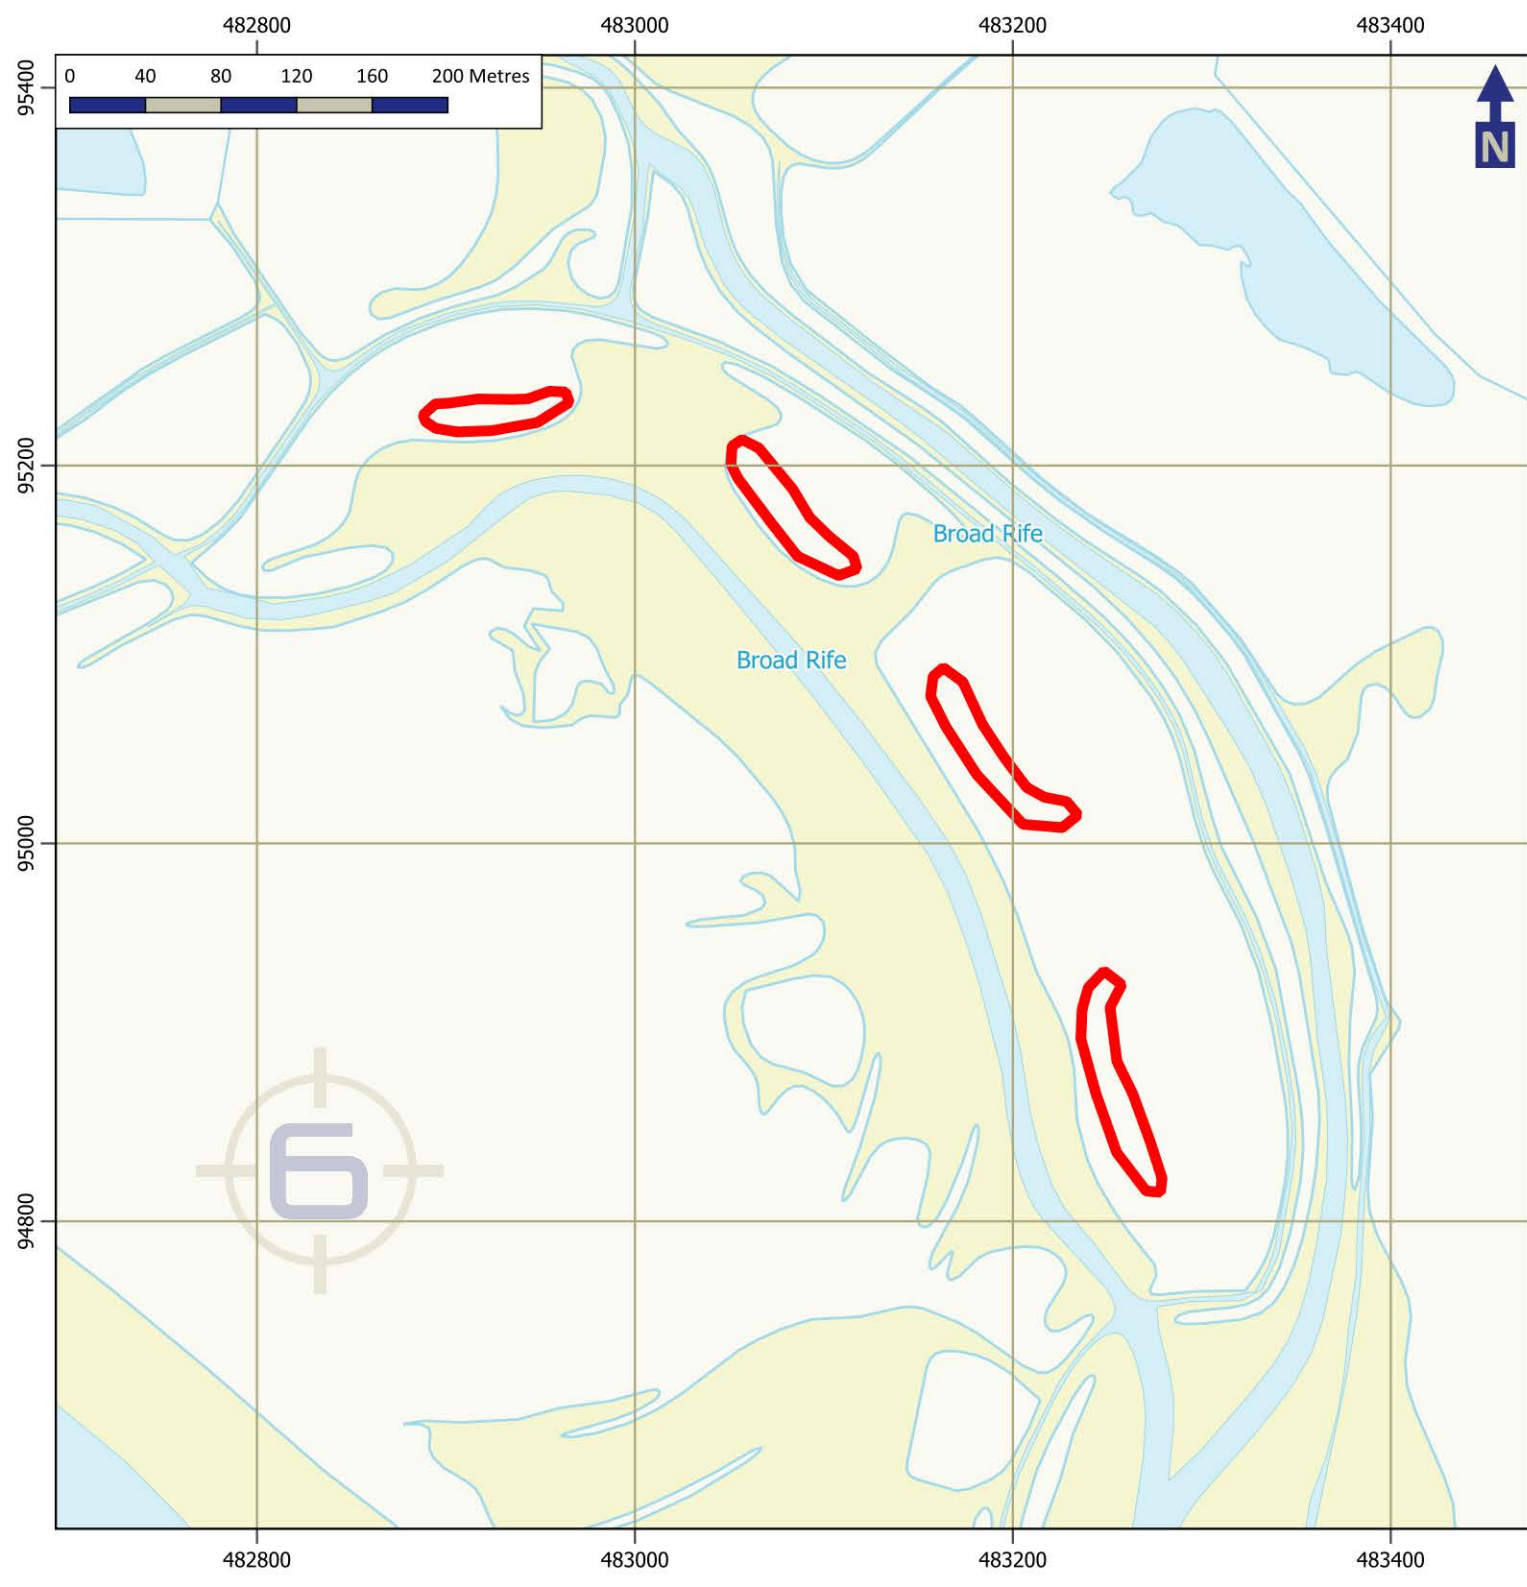
Appendix 2 – Site Boundary

Site Boundary

The Site’s Location and Site Boundary is depicted at Appendices 1 and 2, with aerial photography of the Study Site presented at Appendix 3.

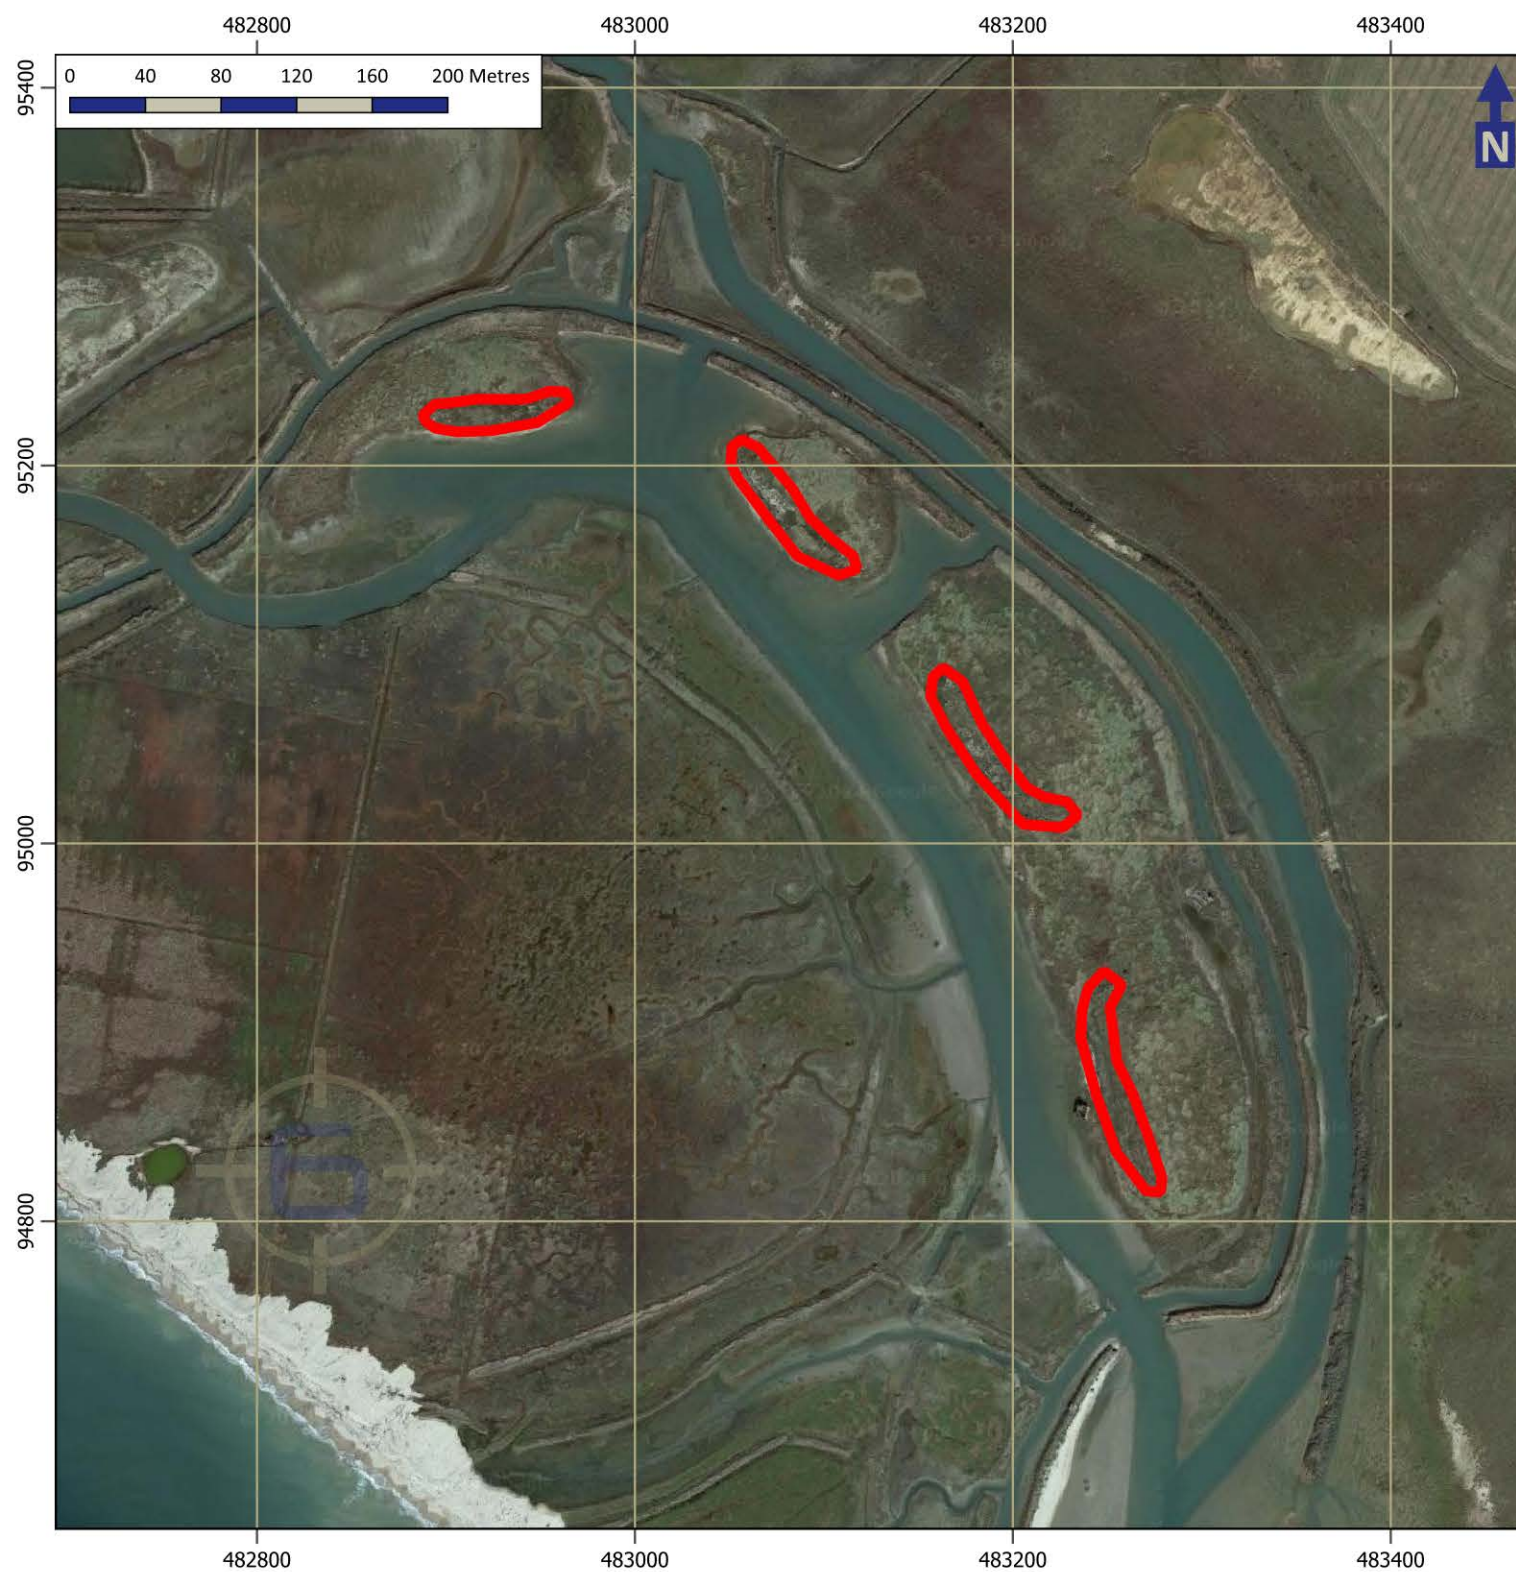
Appendix 3 – Modern Aerial Photography

Modern Aerial Photography

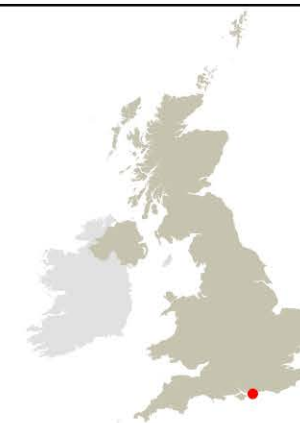
High Explosive Bomb Density

- Less than 15 bombs per 100 hectares
- 16-25 bombs per 100 hectares
- 26-35 bombs per 100 hectares
- 36-45 bombs per 100 hectares
- Over 46 bombs per 100 hectares

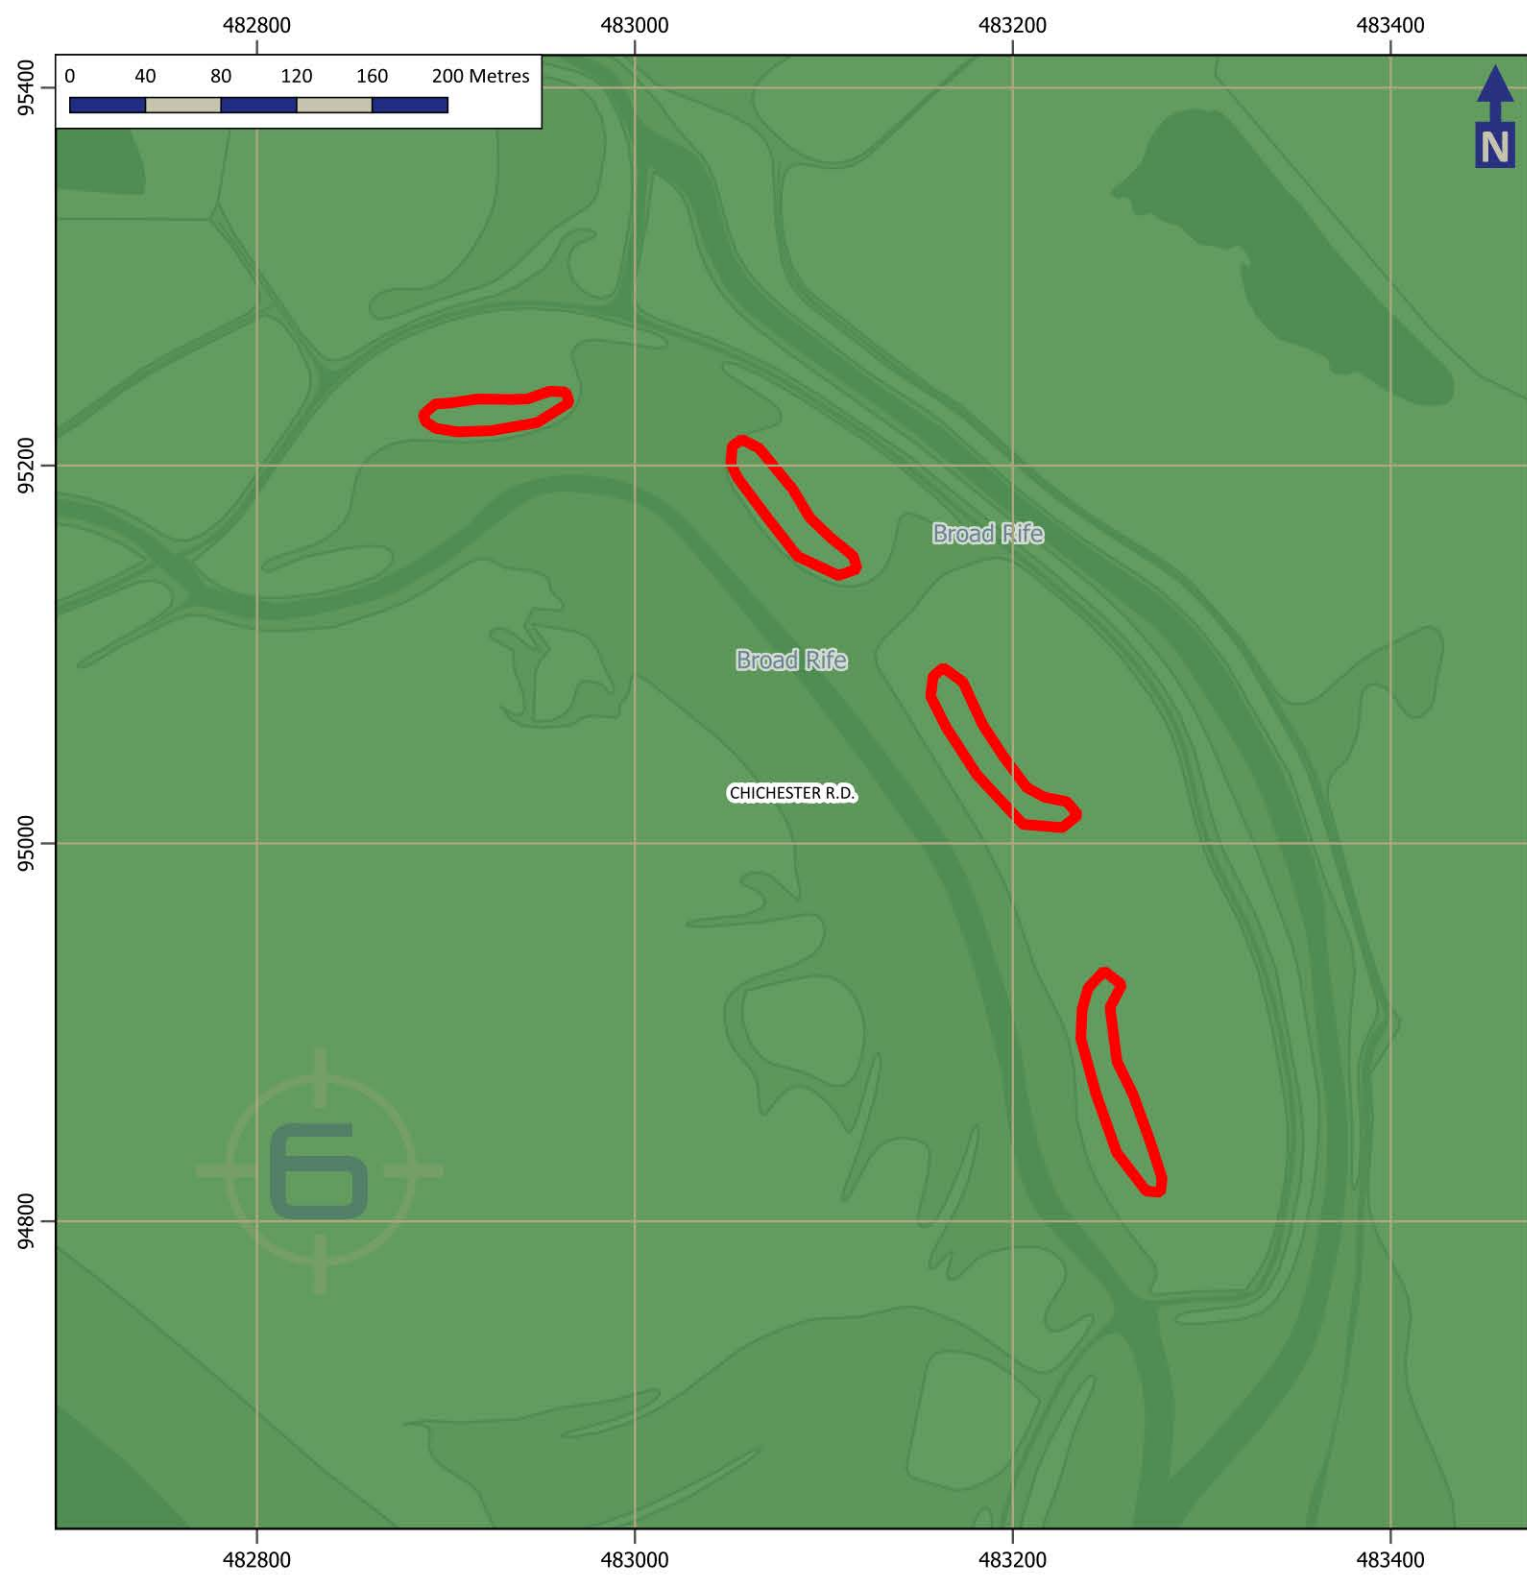
Appendix 4 – WWII High Explosive Bomb Density

WWII High Explosive Bomb Density

The Study Site was located within *Chichester Rural District*, as presented at Appendix 4. This region recorded one HE bomb strike per 100 hectares, a “very low” level of bombing. However, further site-specific data has been considered regarding the potential bombing of the Site during WWII.

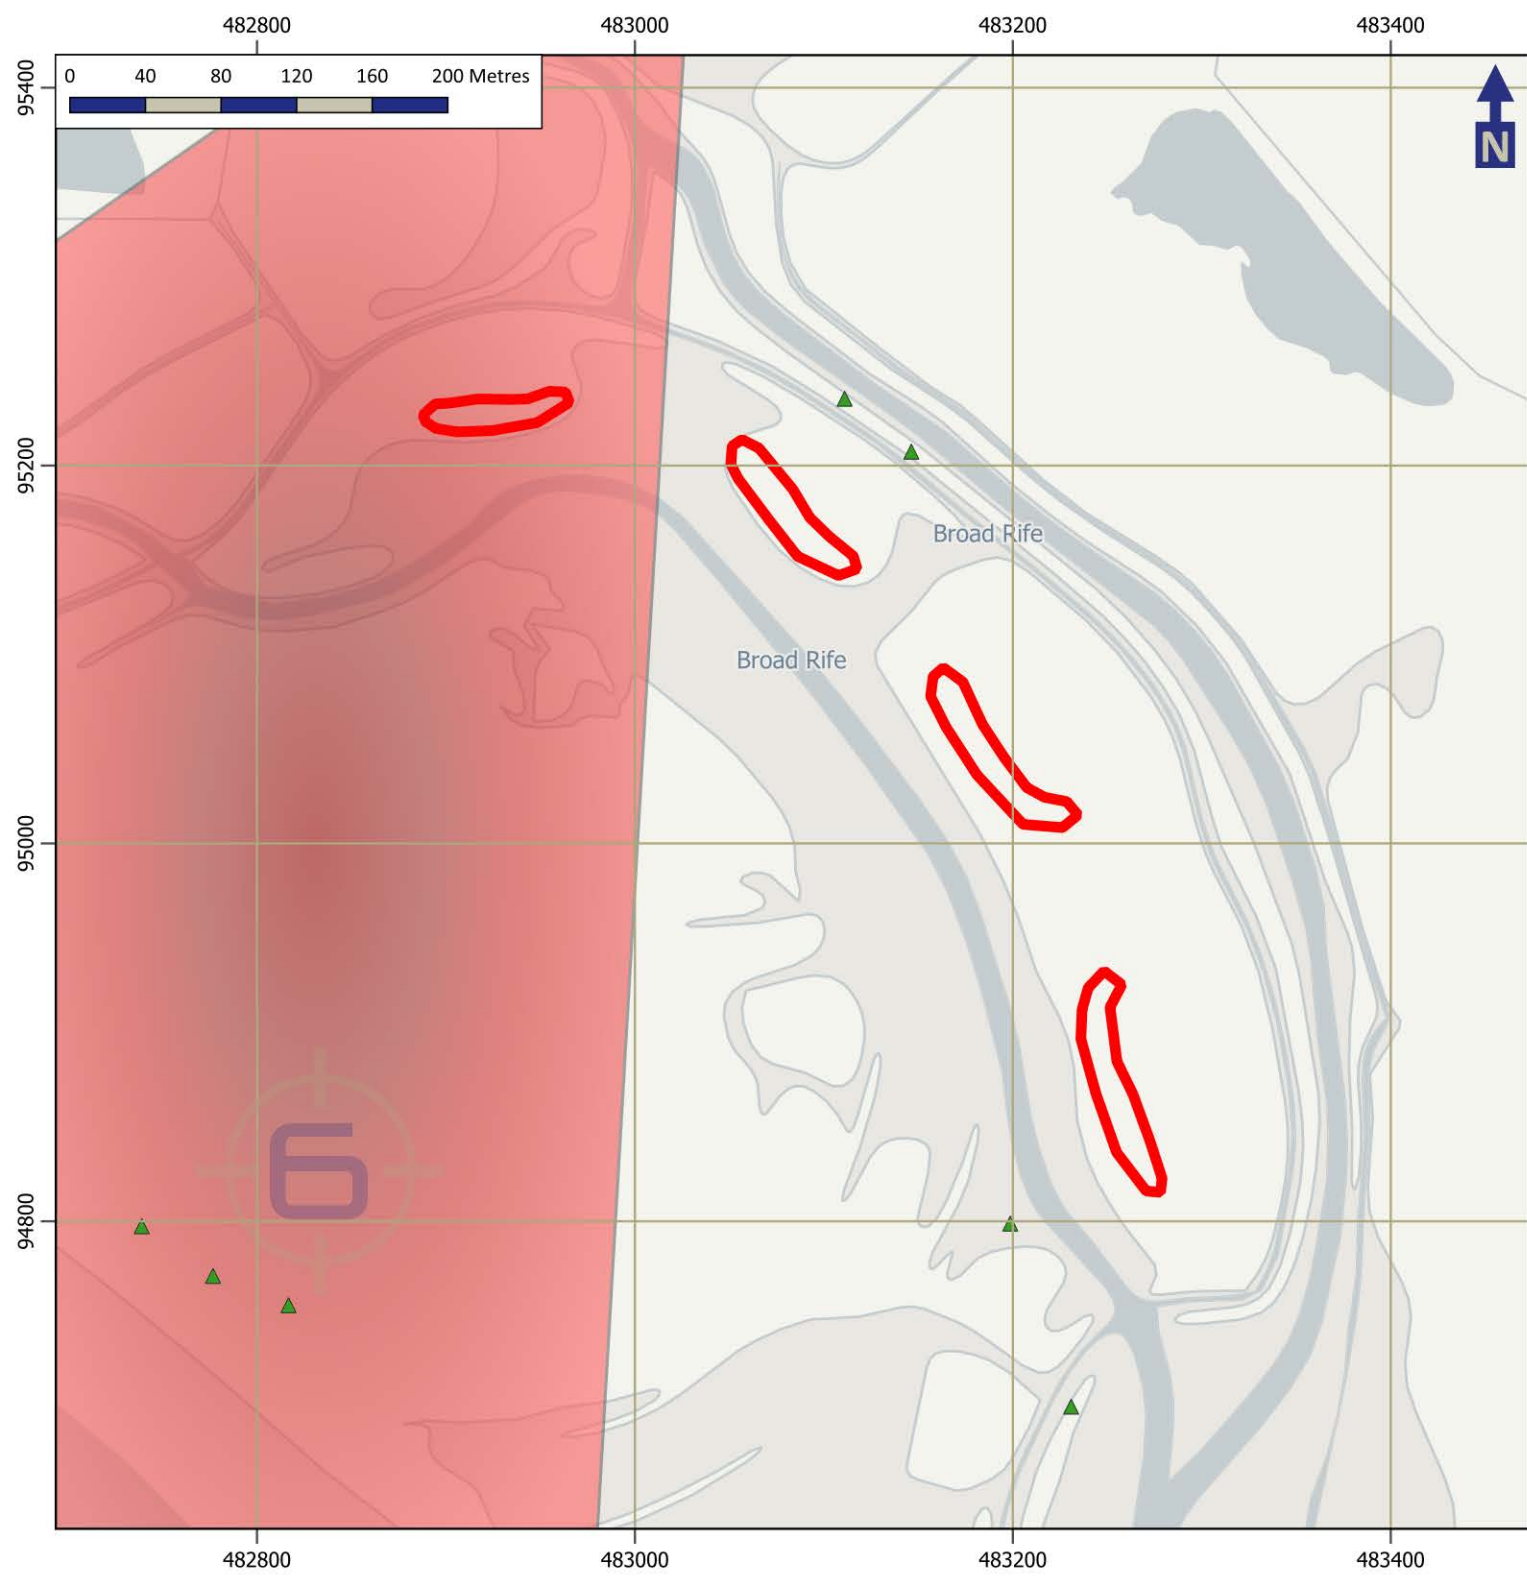
Appendix 5 – Historical Military Activity

Historical Military Activity

- Site Boundary
- Defensive Structures
- Historic Military Training Areas

The Study Site was partially located within the *Selsey Range* (designated as A26) during WWII. Originally developed in 1941, the range was first operated as an *RAF* (and potentially a *Fleet Air Arm*, the *Royal Navy's* flying contingent) air-to-air firing range. However, it was expanded in 1943 to include air-to-ground bombing practice, including low-level and dive-bombing practice, with an additional extension in 1944, when rocket projectile training was added. By the end of 1944, the following ranges were documented at *Selsey*: live bombing, dive bombing, rocket projectile, live fire against tank targets, a tactical range against convoy targets, and air-to-ground gunnery targets.

In addition, other military activity has been noted in the wider area – including extensive WWII-era defensive installation. This includes four machine gun emplacements (located 50m to the north-east, 60m to the north-east, 120m to the south-west and 210m to the south-west of the Site), eight pillboxes (the closest located 440m to the south-west), and two onshore minefields (situated 535m to the south-west and 610m to the south-west).
