Photographic Log - Identification of External Cladding to 2Nr high rise Blocks  
in Castle Vale  
Pioneer Group - 8165

## Identification of External Cladding to 2Nr high rise Blocks in Castle Vale

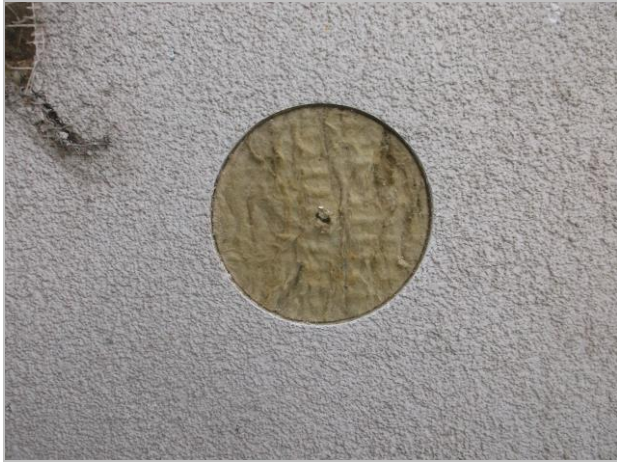
Photograph: 5

### Topcliffe House – Sample LHE-GF-MID-EWI

External render removed showing mineral wool insulation beneath.

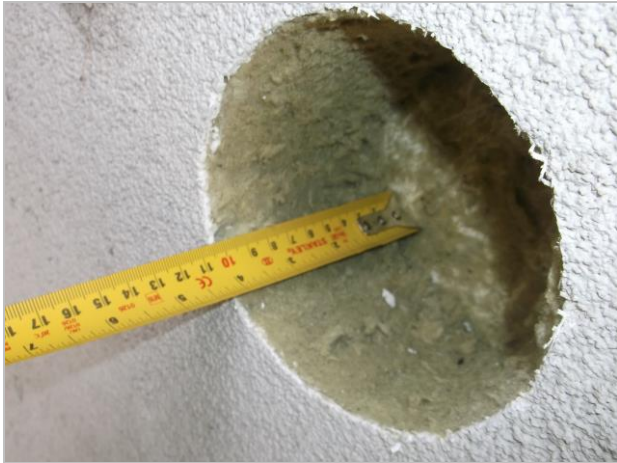
Photograph: 6

### Topcliffe House – Sample LHE-GF-MID-EWI

Exposed location using a 130mm core drill, showing the original wall substrate and 100mm thick mineral wool insulation behind the 5mm external render.

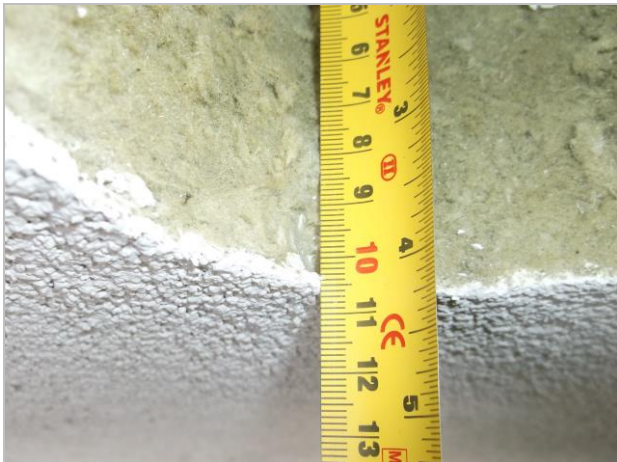
Photograph: 7

### Topcliffe House – Sample LHE-GF-MID-EWI

5mm of external wall finish built up of base coat render, reinforcement (Scrim), primer and decorative finish.

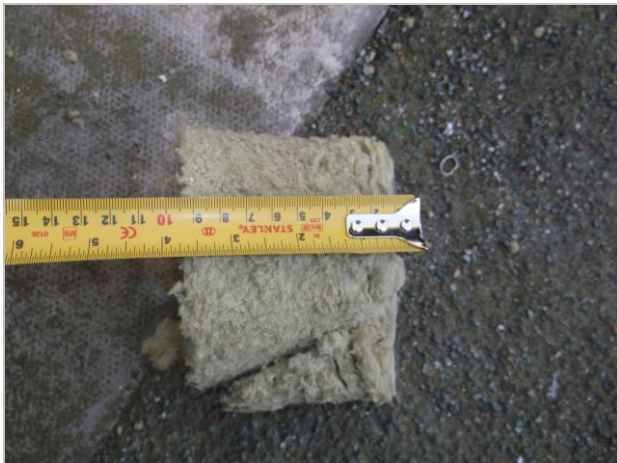
Photograph: 8

### Topcliffe House – Sample LHE-GF-MID-EWI

100mm thick mineral wool insulation removed from core hole location.

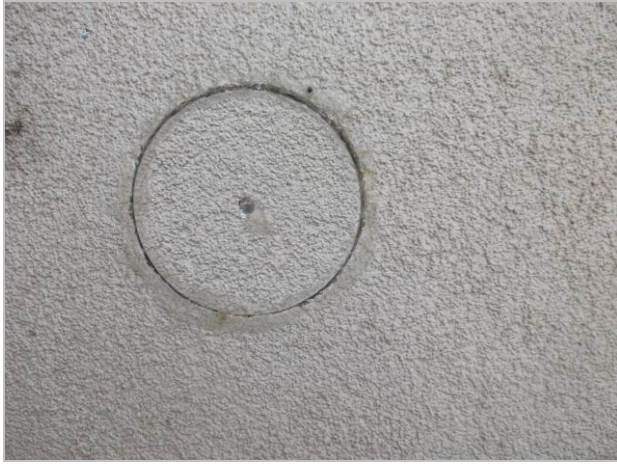
Photograph: 9

### Topcliffe House – Sample LHE-GF-MID-EWI

Core hole made good using adequate mastic sealant.

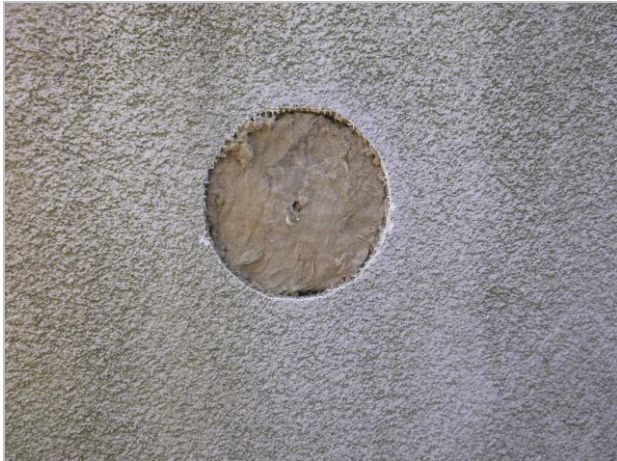
Photograph: 10

### Topcliffe House – Sample FE-GF-LH-EWI

External render removed showing mineral wool insulation beneath.

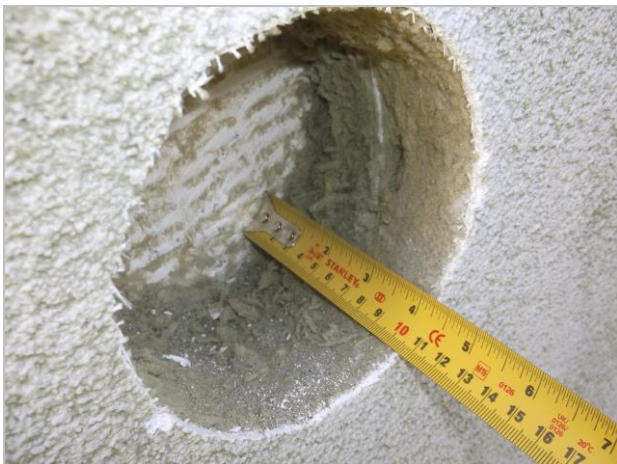
Photograph: 11

### Topcliffe House – Sample FE-GF-LH-EWI

Exposed location using a 130mm core drill, showing the original wall substrate and 100mm thick mineral wool insulation behind the 5mm external render.

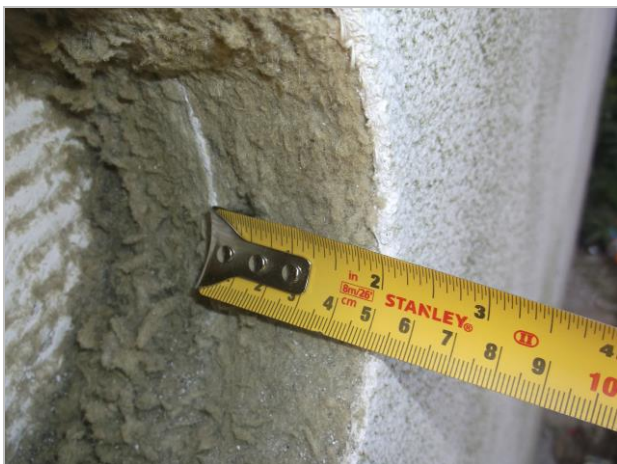
Photograph: 12

### Topcliffe House – Sample FE-GF-LH-EWI

Two layers of 50mm thick mineral wool insulation separated by a layer of adhesive or the like.

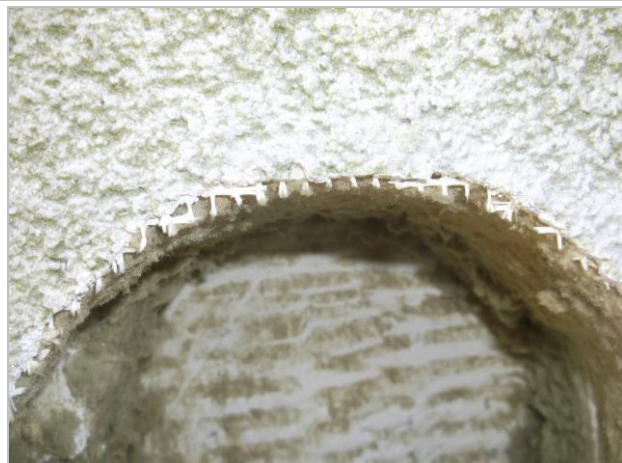
Photograph: 13

**Topcliffe House – Sample FE-GF-LH-EWI**

Evidence of reinforcement scrim.

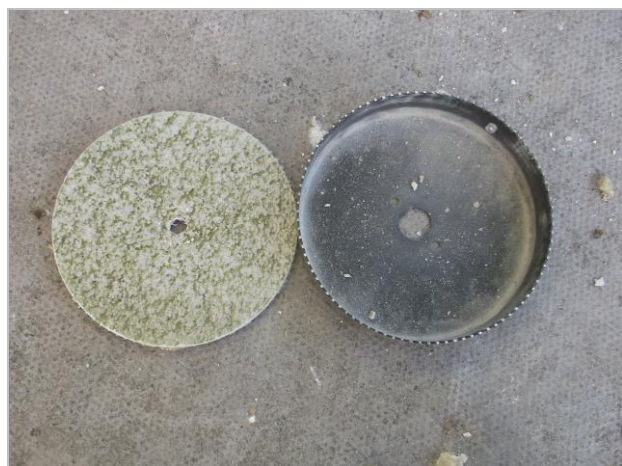
Photograph: 14

**Topcliffe House – Sample FE-GF-LH-EWI**

130mmx130mm external render.

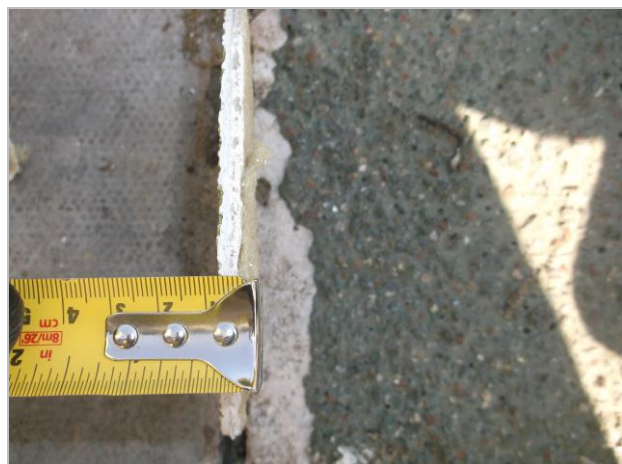
Photograph: 15

**Topcliffe House – Sample FE-GF-LH-EWI**

5mm of external wall finish built up of base coat render, reinforcement (Scrim), primer and decorative finish.

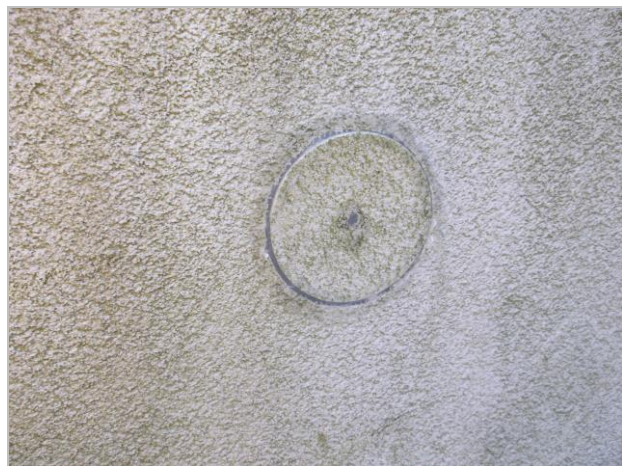
Photograph: 16

**Topcliffe House – Sample FE-GF-LH-EWI**

Core hole made good using adequate mastic sealant.

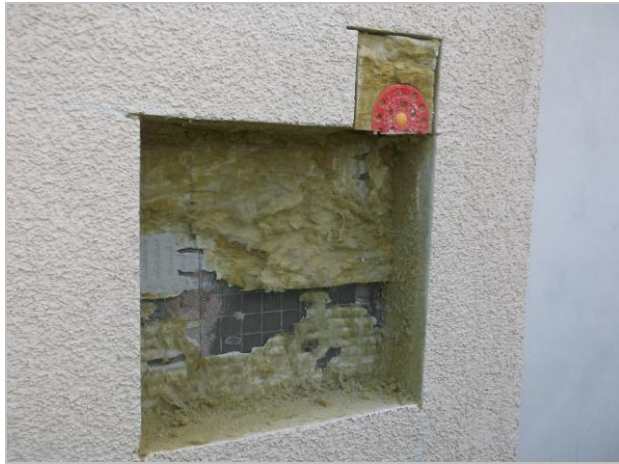
Photograph: 21

### Chivenor House – Sample RHE-GF-MID-EWI

Sample taken approx. 250mmx250mm exposing EWI system and fixing details.

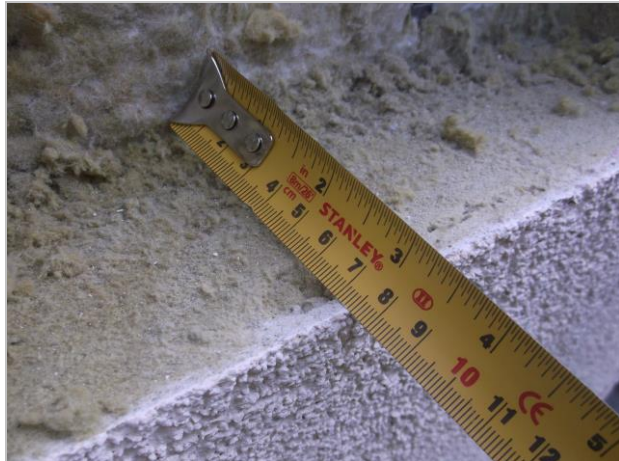
Photograph: 22

### Chivenor House – Sample RHE-GF-MID-EWI

Exposed location showing the original wall substrate and 70mm thick mineral wool insulation behind the 5mm external decorative render.

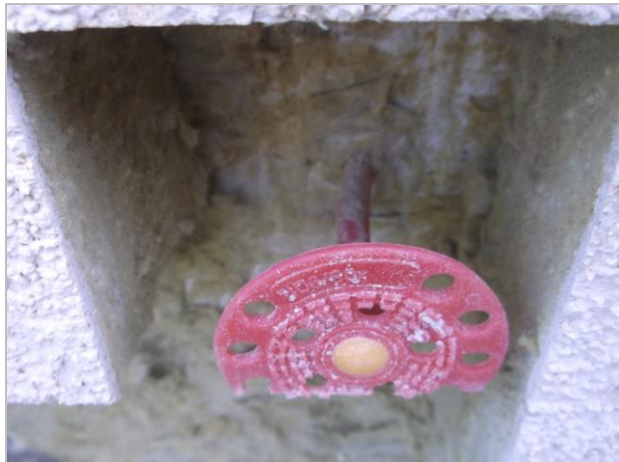
Photograph: 23

### Chivenor House – Sample RHE-GF-MID-EWI

Anchoring fixing located, adequately fixed.

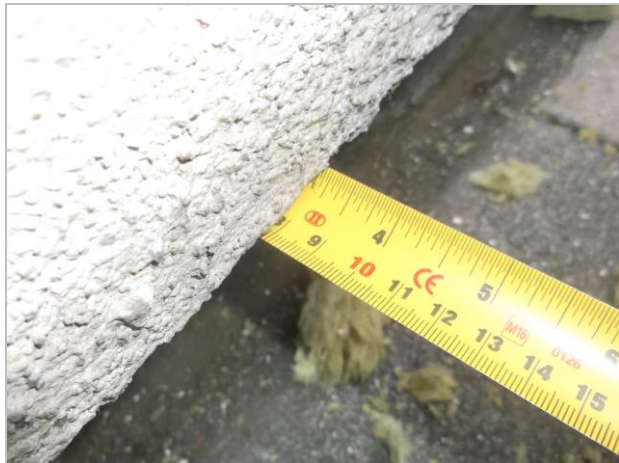
Photograph: 24

### Chivenor House – Sample RHE-GF-MID-EWI

EWI system at Damp proof course (DPC) level proud 80mm from original substrate.

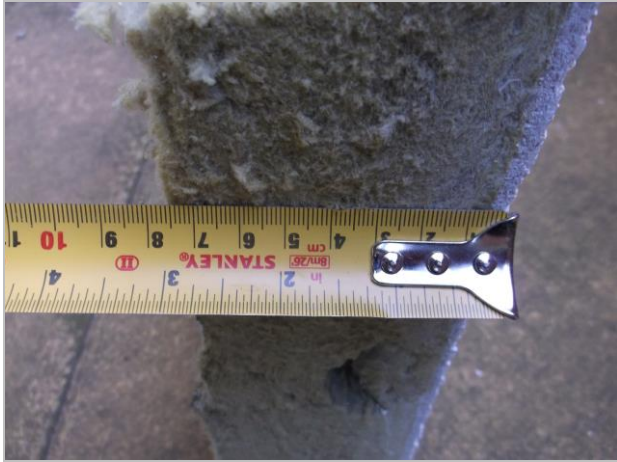
Photograph: 25

### Chivenor House – Sample RHE-GF-MID-EWI

70mm thick mineral wool insulation and 5mm decorative external wall finish removed from location.

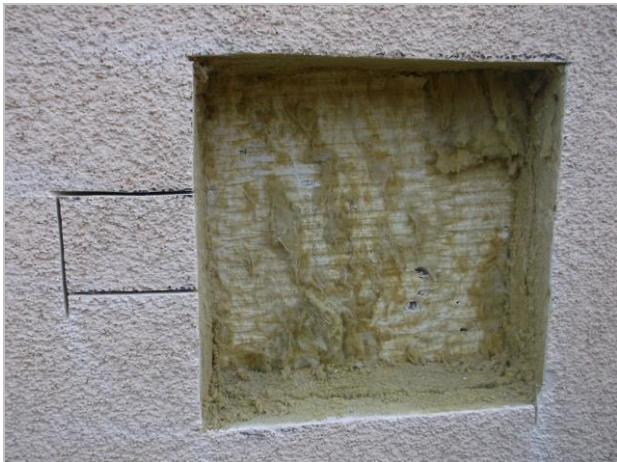
Photograph: 27

### Chivenor House – Sample FE-GF-RH-EWI

Sample taken approx. 250mmx250mm exposing EWI system and fixing details.

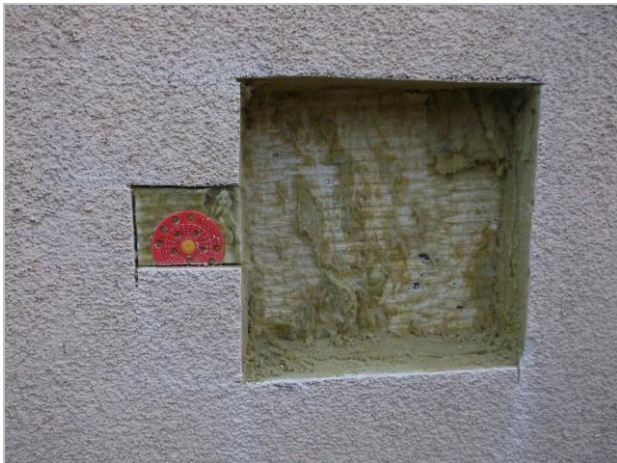
Photograph: 28

### Chivenor House – Sample FE-GF-RH-EWI

Additional 100mm approx. sample taken exposing anchor fixing.

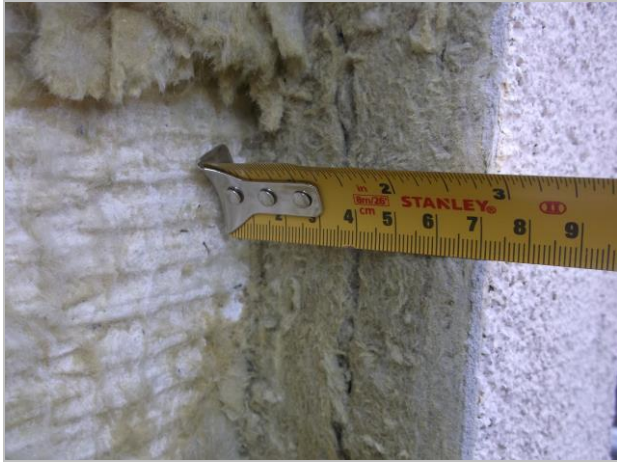
Photograph: 29

### Chivenor House – Sample FE-GF-RH-EWI

Exposed location showing the original wall substrate and 70mm thick mineral wool insulation behind the 5mm external decorative render.

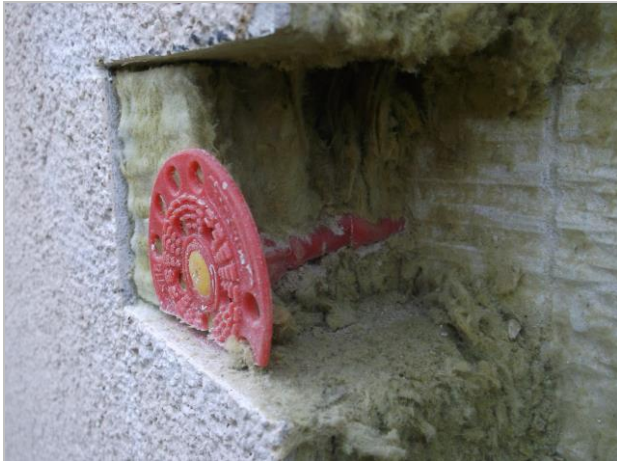
Photograph: 30

### Chivenor House – Sample FE-GF-RH-EWI

Anchoring fixing located, adequately fixed.

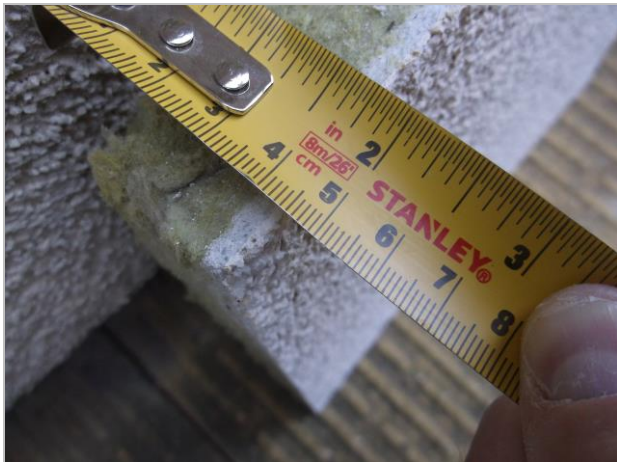
Photograph: 31

### Chivenor House – Sample FE-GF-RH-EWI

5mm thick base coat and external render.

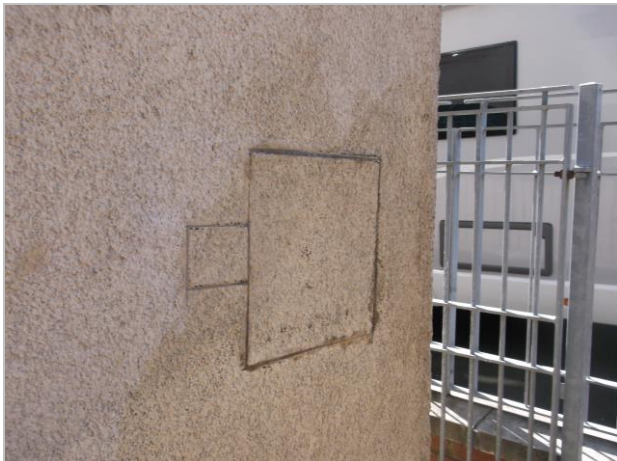
Photograph: 32

### Chivenor House – Sample FE-GF-RH-EWI

Exposed area made good using adequate mastic sealant.
