HOLTON HEATH (NORTH) – STRUCTURAL OPENINGS AUDIT

All measurements are approximate (brick work to brick work) & in mm.

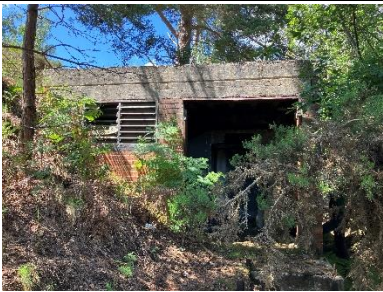
BUILDING ID: <b>F6</b> DATE: 17/06/2024	LOCATION:
MEASUREMENTS:	NOTES:
1. Door (north) – 2040x1620. 2. Louvre (north) – 670x1850. 3. X2 openings with metal work still present (see photo). Opening in the metal work measured – 800x940. 4. Door (south) – 2040x1610. 5. Louvre (south) – 700x1185.	<ul style="list-style-type: none"><li>• Access restricted due to vegetation.</li><li>• Partially cleared of vegetation.</li><li>• Metal work present in building.</li><li>• [REDACTED]</li></ul>

Door; Louvre (south).

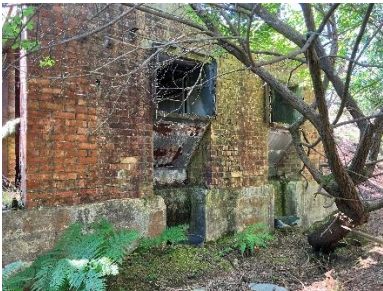
Door; Louvre (north).

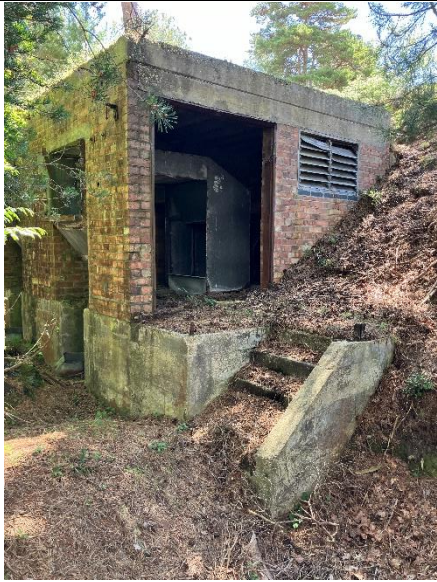
Access.

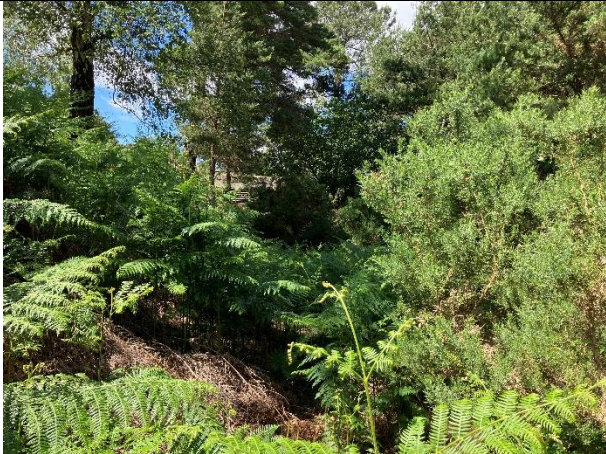
Openings with metal work (east). All photos are ©Natural England.

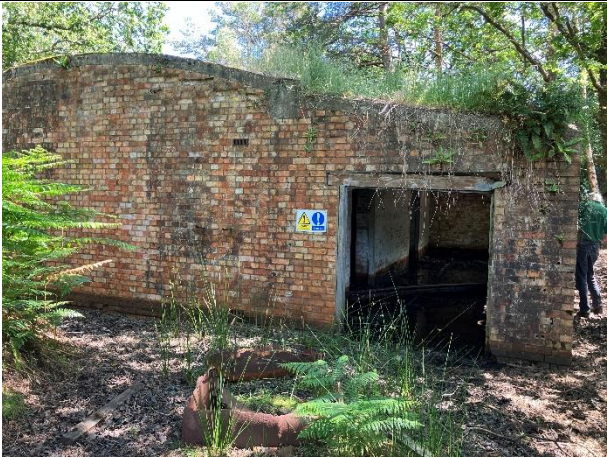
BUILDING ID: <b>K3</b> DATE: 17/06/2024	LOCATION:
MEASUREMENTS: 1. Door (north) – 1980x1670. 2. X4 windows (west) – 920x1720.	NOTES: <ul style="list-style-type: none"><li>• Cleared of vegetation.</li><li>• Access restricted due to rough/wet ground and vegetation.</li></ul>

Door (north).  
All photos are ©Natural England.

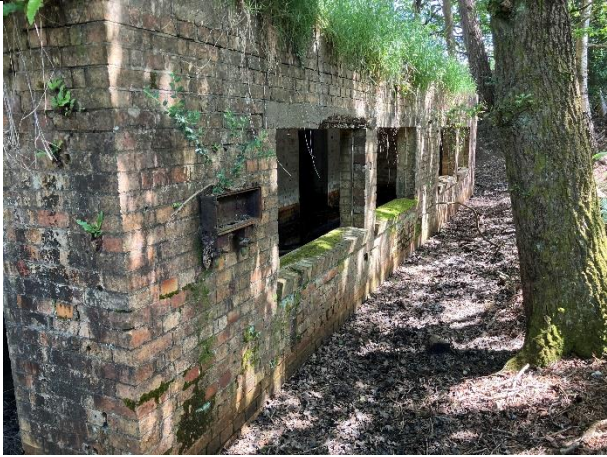
Windows (west).

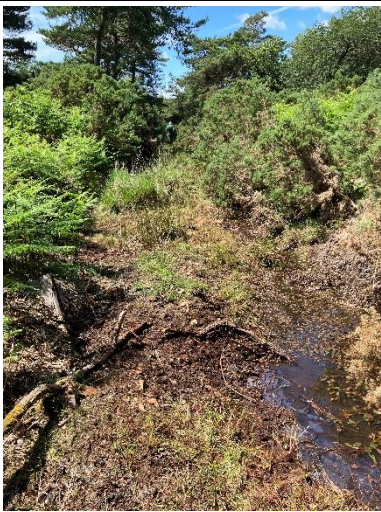
Access.

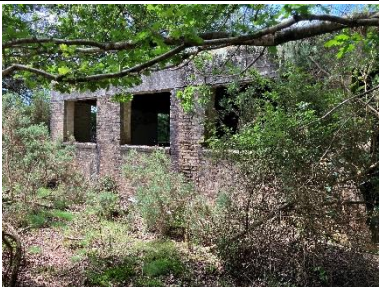
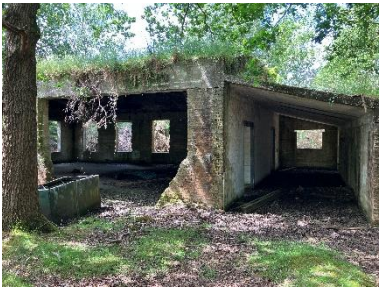
BUILDING ID: <b>K4</b> DATE: 17/06/2024	LOCATION:
MEASUREMENTS:	NOTES:
<ol style="list-style-type: none"><li>1. Window (annex) (north) – 1060x1320.</li><li>2. X5 windows (north) – 2120x1330.</li><li>3. Window (west) – 2100x1330.</li><li>4. X2 windows (west) – 1400x1820.</li><li>5. Door (annex) (south) – 2900&amp;2200x2990.</li><li>6. Knocked through windows (south) – 2900x4650.</li><li>7. X3 windows (south) – 1400x1820.</li><li>8. Door (annex) (east) – 2050x1050.</li></ol>	<ul style="list-style-type: none"><li>• Access restricted due to vegetation.</li><li>• Partial clearance of vegetation.</li></ul>

Windows (south).  
Openings (south)

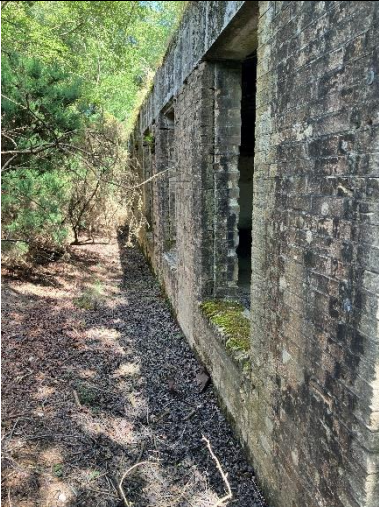
Windows (north).

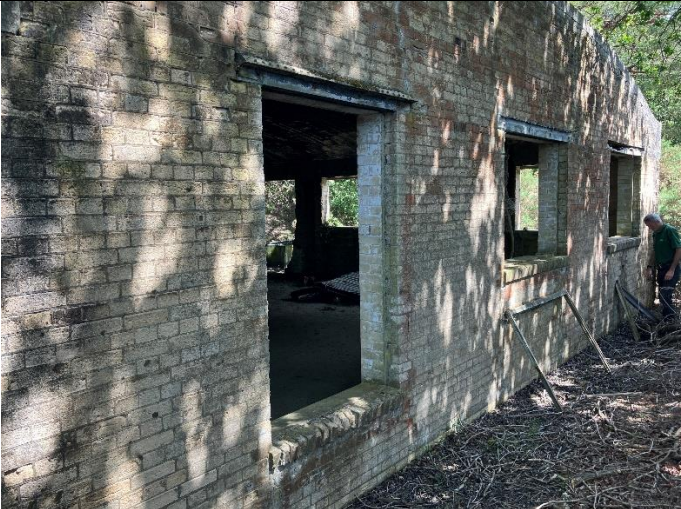
Windows (west).

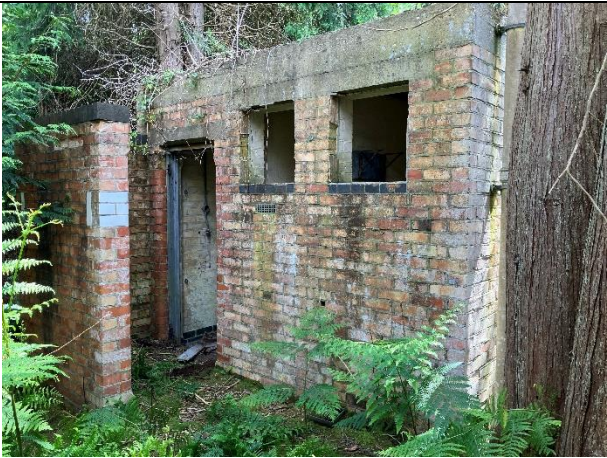
BUILDING ID: <b>LATRINE 28</b> DATE: 17/06/2024	LOCATION: locate.dress.danger
MEASUREMENTS:  1. Door (west) – 2020x840. 2. X2 window (west) – 620x620. 3. Window (east) – 630x1240.	NOTES:  • Restricted access due to vegetation. • <span style="background-color: black; color: black;">[REDACTED]</span>

Door; Windows (west).  
All photos are ©Natural England.

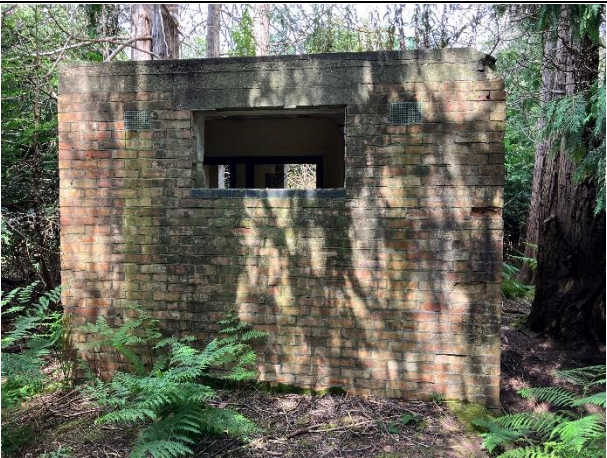
Window (east).

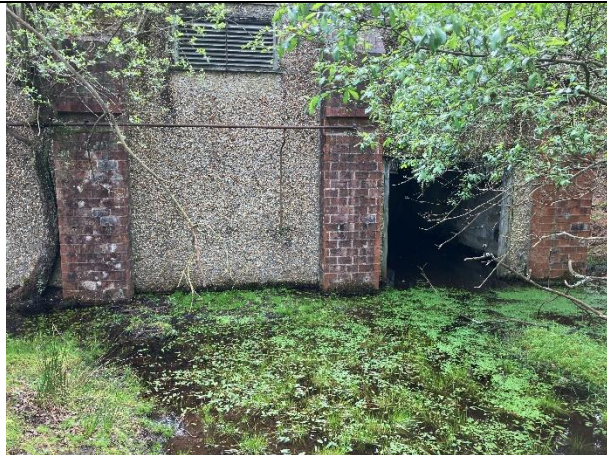
BUILDING ID: <b>N5</b> DATE: 24/05/2024	LOCATION:
MEASUREMENTS:	NOTES:
1. Not measured due to flooding.	<ul style="list-style-type: none"> <li>• Not cleared of vegetation.</li> <li>• Not accessible due to vegetation and water levels.</li> <li>• Barn owls present.</li> </ul>

N5 Flooded.  
 All photos are ©Natural England.

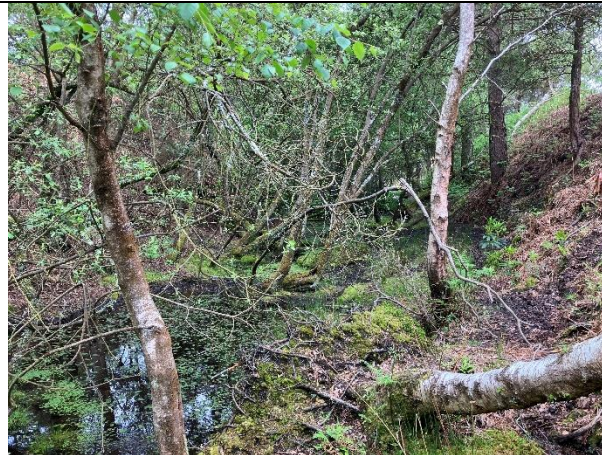
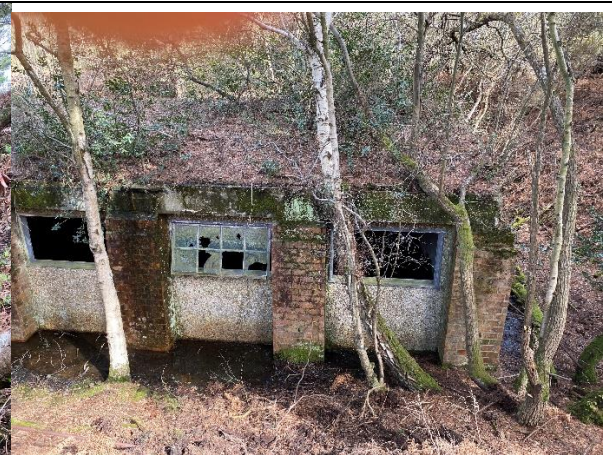
Access.

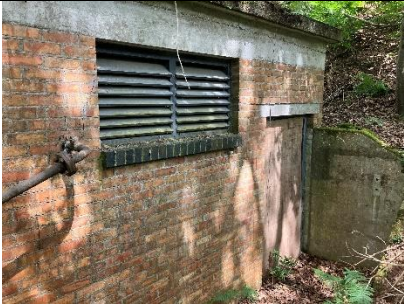
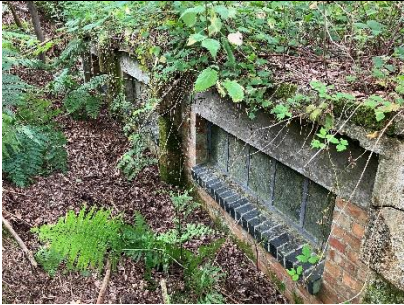
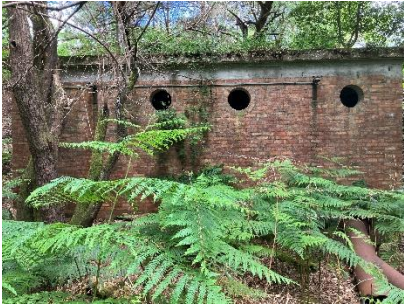
BUILDING ID: <b>N7</b> DATE: 17/06/2024	LOCATION: stages.oddly.finest
MEASUREMENTS:	NOTES:
1. X3 windows (glazed) (north) – 500x1610. 2. Door (west) – 2140x1220. 3. Louvre (west) – 765x1590. 4. X4 circular openings (south) – 460 diameter. 5. Door (east) – 2140x1220. 6. Louvre (east) – 765x1590.	<ul style="list-style-type: none"><li>• Mostly cleared of vegetation.</li><li>• Access restricted due to vegetation.</li><li>• Scrap metal present.</li></ul>

Door; Louvre (east).  
Circular openings (south). All photos are ©Natural England.

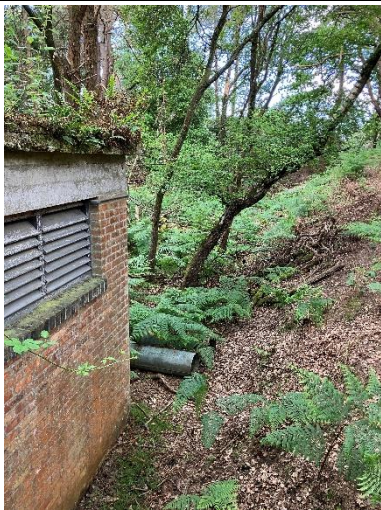
Access.

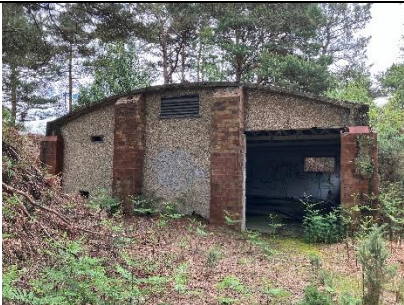
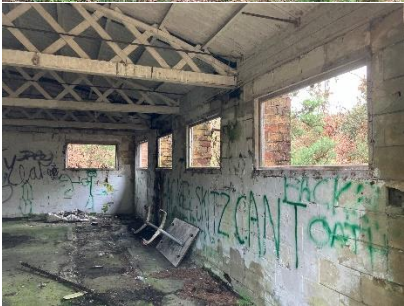
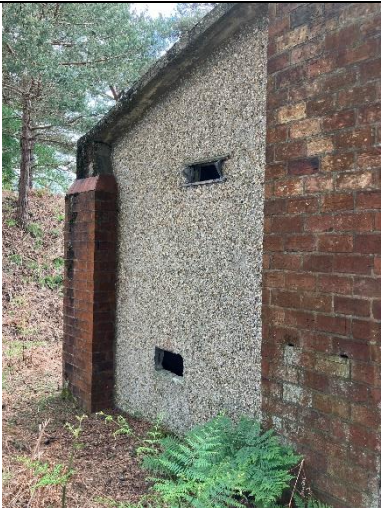
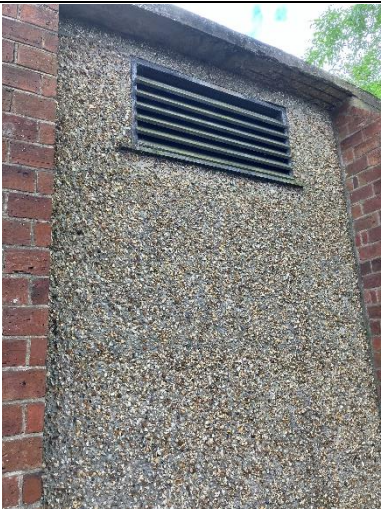
BUILDING ID: <b>M2</b> DATE: 24/05/2024	LOCATION:
MEASUREMENTS:	NOTES:
<ol style="list-style-type: none"><li>1. Door (north) - 2770x2460.</li><li>2. Lower hole (north) - 250x460.</li><li>3. X4 window openings (west) - 1010x1780.</li><li>4. X1 window opening (south) - 1010x1780.</li><li>5. X2 louvre (north)(south) - ~ 670x1260.</li><li>6. Distance between external pillars (west) from N to S:<ol style="list-style-type: none"><li>6.1. – 1940.</li><li>6.2. – 1890.</li><li>6.3. – 1890.</li><li>6.4. – 1950.</li></ol></li><li>7. Distance between external pillars (south) – 2480.</li></ol>	<ul style="list-style-type: none"><li>• Mostly cleared of vegetation.</li><li>• Access restricted due to single windblown tree.</li><li>• Obvious signs of previous public usage.</li><li>• Large amounts of detritus.</li></ul>

Door; Louvre; Holes (north).      Holes (north).      Louvre (south).  
Window openings (west)(south). All photos are ©Natural England.

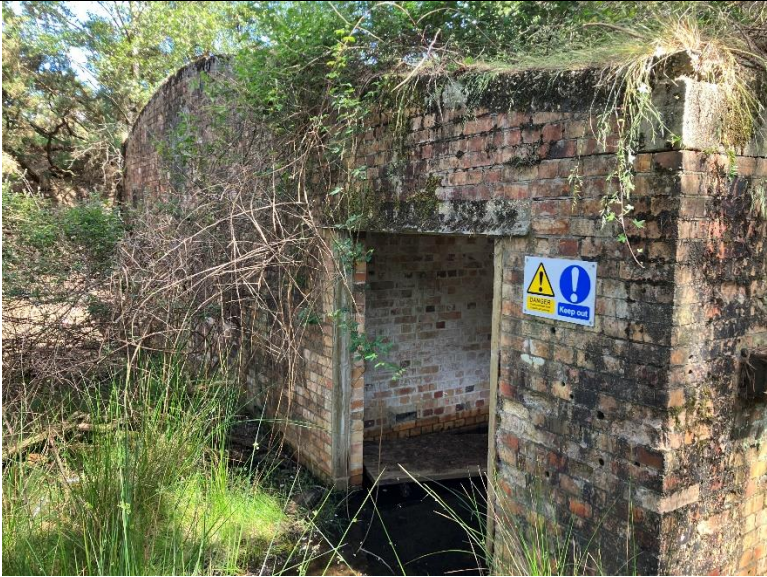
<b>BUILDING ID: M3</b> <b>DATE: 17/06/2024</b>	<b>LOCATION:</b>
<b>MEASUREMENTS:</b>	<b>NOTES:</b>
1. Door (north) – 1980x1670. 2. X4 windows (west) – 920x1720.	<ul style="list-style-type: none"><li>• Restricted access due to vegetation.</li></ul>

Door (north).  
All photos are ©Natural England.

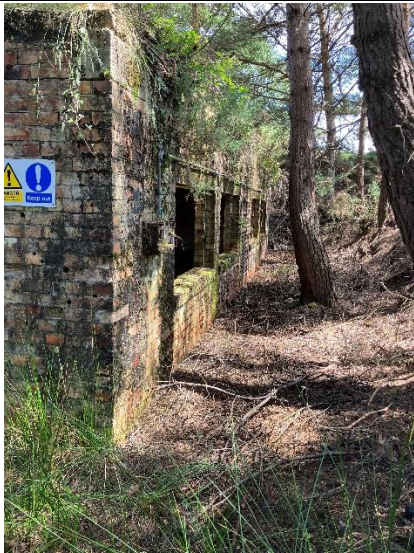
Windows (west).

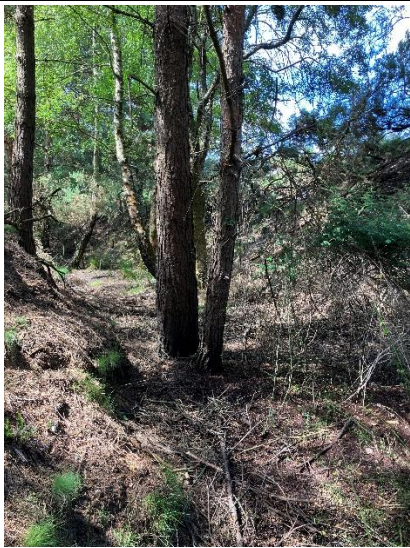
Access.

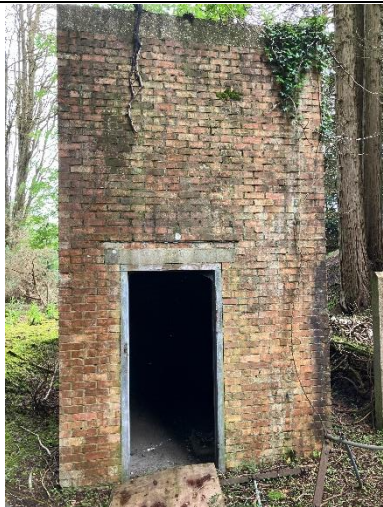
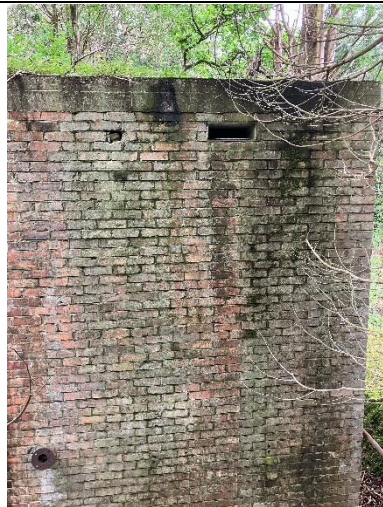
BUILDING ID: <b>S17</b> DATE: 24/05/2024	LOCATION:
MEASUREMENTS:	NOTES:
1. Door (west) – 2210x1070.	<ul style="list-style-type: none"> <li>• Clear of vegetation.</li> <li>• Access clear.</li> <li>• Previous door shuttering removed.</li> <li>• Barn owls present.</li> </ul>

Door opening (west).      Barn owl entrance.  
 All photos are ©Natural England.

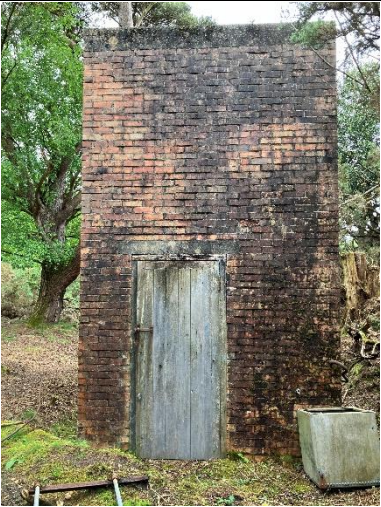
BUILDING ID: <b>S18</b> DATE: 24/05/2024	LOCATION:
MEASUREMENTS:	NOTES:
1. Door (west) – 2230x1070.	<ul style="list-style-type: none"><li>• Clear of vegetation.</li><li>• Access clear.</li></ul>

Door (west).  
All photos are ©Natural England.

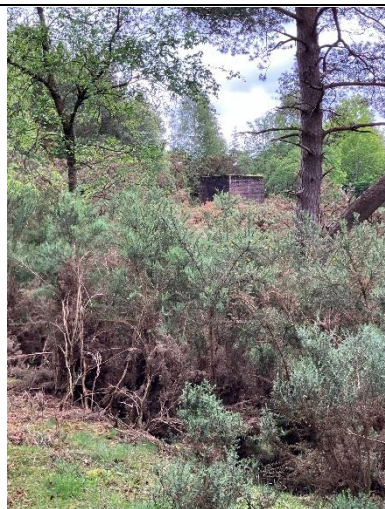
BUILDING ID: <b>S19</b> DATE: 24/05/2024	LOCATION:
MEASUREMENTS:	NOTES:
1. Door (west) – unmeasured due to vegetation (appears standard).	<ul style="list-style-type: none"> <li>• Not cleared of vegetation.</li> <li>• Not accessible.</li> <li>• Presumed un-swept?</li> <li>• Barn owls present.</li> </ul>

Access. Door (west).  
 All photos are ©Natural England.

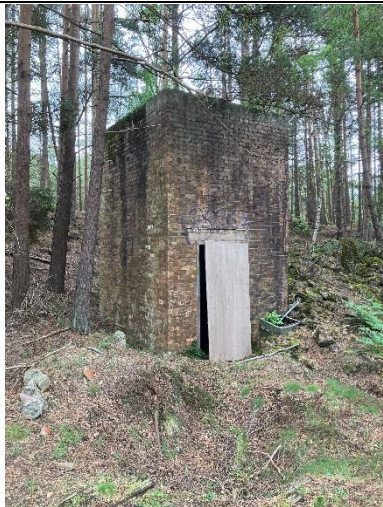
BUILDING ID: <b>S21</b> DATE: 24/05/2024	LOCATION:
MEASUREMENTS:	NOTES:
1. Door opening (west) – 2220x1060.	<ul style="list-style-type: none"> <li>• Mostly cleared of vegetation.</li> <li>• Access restricted due to vegetation.</li> <li>• Previous door shuttering removed.</li> </ul>

Door opening (west).  
All photos are ©Natural England.

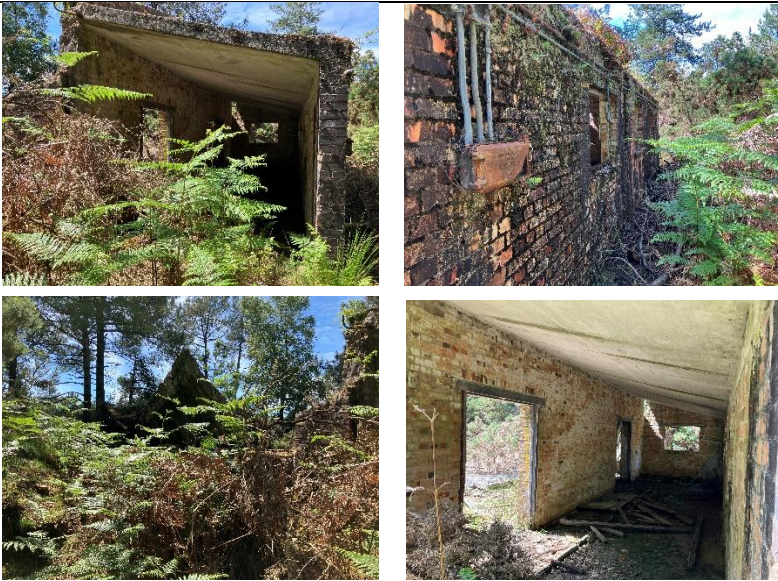
BUILDING ID: <b>M6 (ANNEX)</b> DATE: 17/06/2024	LOCATION:
MEASUREMENTS:	NOTES:
1.	<div></div> <ul style="list-style-type: none"><li>• Restricted access due to vegetation.</li></ul>
