Appendix D. Geotechnical Investigation

Archival (Desktop) Mining Search

Ground Investigation

Trewirgie Junior School

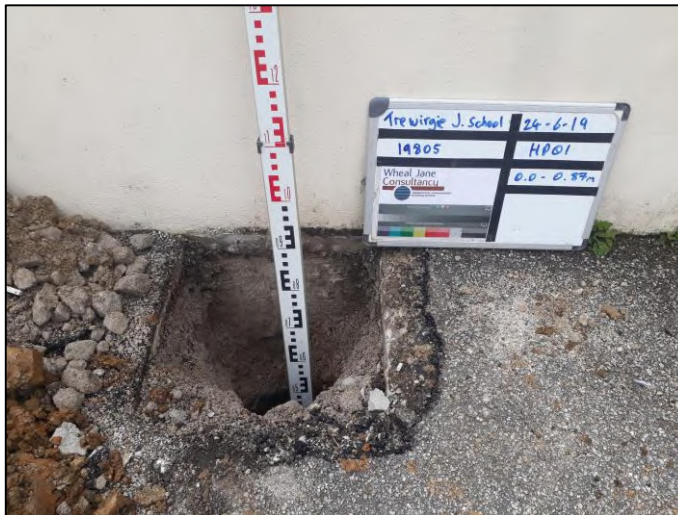
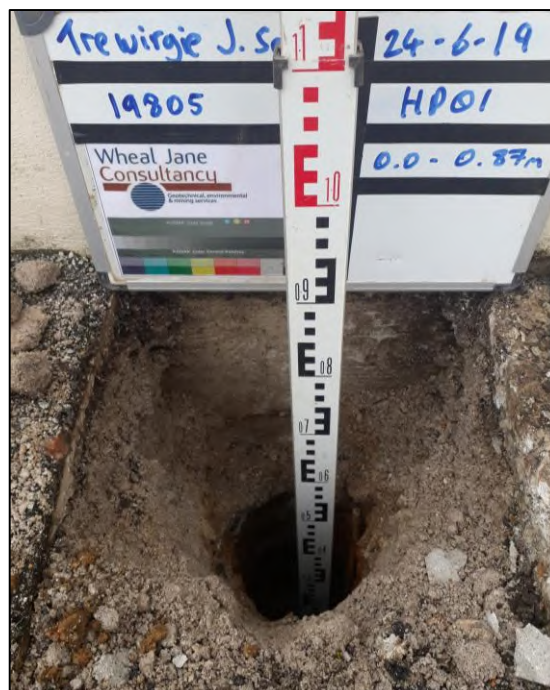
Exploratory Hole Type	Exploratory Hole ID	Hole Depths (mBGL)	Comments
Windowless Sample Borehole	WS01 – WS05	3.00 – 3.50	Undertaken across the site to determine nature of ground conditions
Machine Excavated Trial Pit	TP01 – TP03	1.70 – 2.20	Undertaken to enable infiltration testing and to identify retaining wall structure (TP03).
Hand Excavated Trial Pit	HP01 – HP02	0.31 – 0.87	Undertaken to identify retaining wall foundation structure.

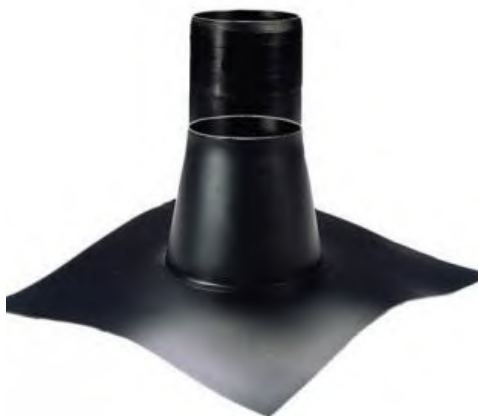
Top Hat Unit

- Provides an effective seal around service pipe penetrations

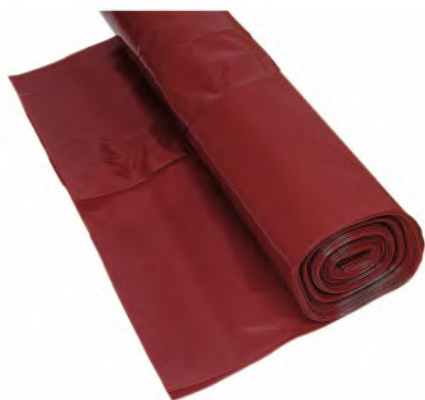
- **Independently tested for radon resistance**
- **BBA Certified**
- **High resistance to puncture**
- **Also acts as a Damp Proof Membrane**
- **Complies with BR 211: 2015**

Visqueen Radon Membrane is manufactured from an enhanced blend of polymer films that is suitable for use in the protection of buildings from the ingress of radon gas.

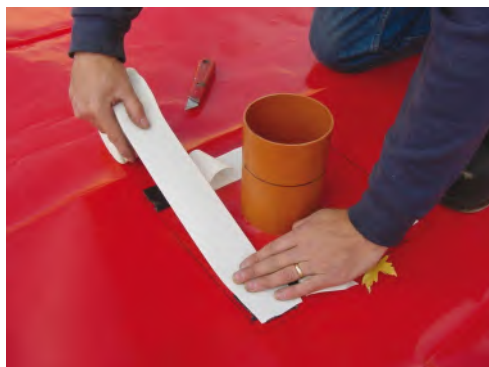
Visqueen Radon Membrane also acts as a damp proof membrane, but is not intended for use where there is the risk of hydrostatic pressure. It is approved for use in Ireland. Visqueen Radon Membrane and ancillary components must be used in accordance with the recommendations in the most recent edition of Building Research Establishment Report BR 211:2015. Visqueen Radon Membrane can be used in most common floor constructions. It is installed in a similar way to a damp proof membrane, but with much greater attention paid to workmanship and detailing in order to achieve effective sealing at all locations.

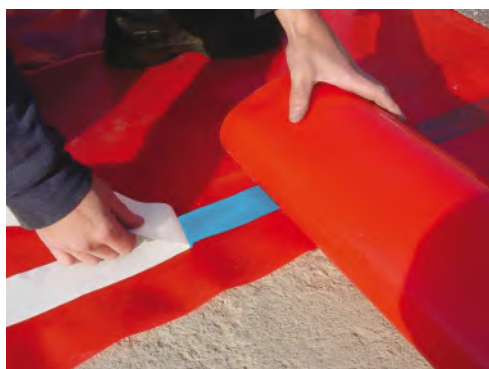
Basic Radon Protection

For “basic” protection, you need to provide an airtight barrier covering the entire ground floor of the building, linked to the damp proof course using cavity trays which prevent radon moving through the wall cavity and into the building. All junctions between the floor membrane and cavity trays should be sealed. You can achieve “basic” protection with both ground supported and suspended (ventilated) concrete ground floors by installing a radon-proof membrane system. With a suspended concrete slab, the space beneath the floor is available to ventilate radon safely away should “full” protection be required.
