Our Ref: CP/15924/Geotechnical Letter Report

GEOTECHNICAL SITE INVESTIGATION: DRACAENA CENTRE, FALMOUTH

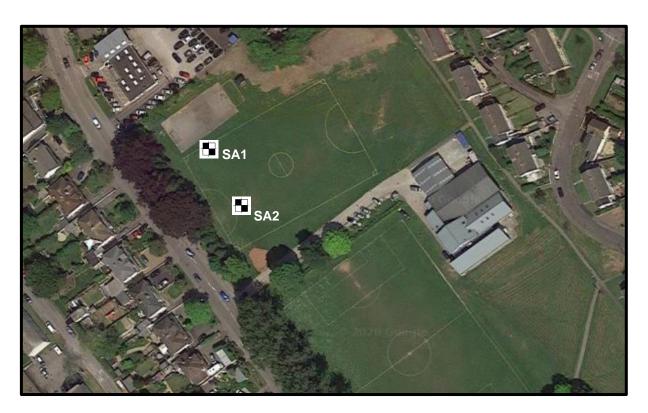
Figure 01 - Site Layout

The location of the trial pits are shown on **Figure 01** and the trial pit logs are presented in **Annex A**.

The fieldwork was supervised by Terra Firma (Wales) Limited, who logged the exploratory holes to the requirements of BS5930:2015. Test locations were chosen in advance by Maverick Industries, as seen in **Drawing 01**.
