**Asbestos Management Survey for**  
**Wiltshire Council**  
**at**  
**Westbury Warminster Road Public Convenience**  
**Wiltshire**

Project Number: 20307S1-2012

# Asbestos Register and Survey / Inspection Report

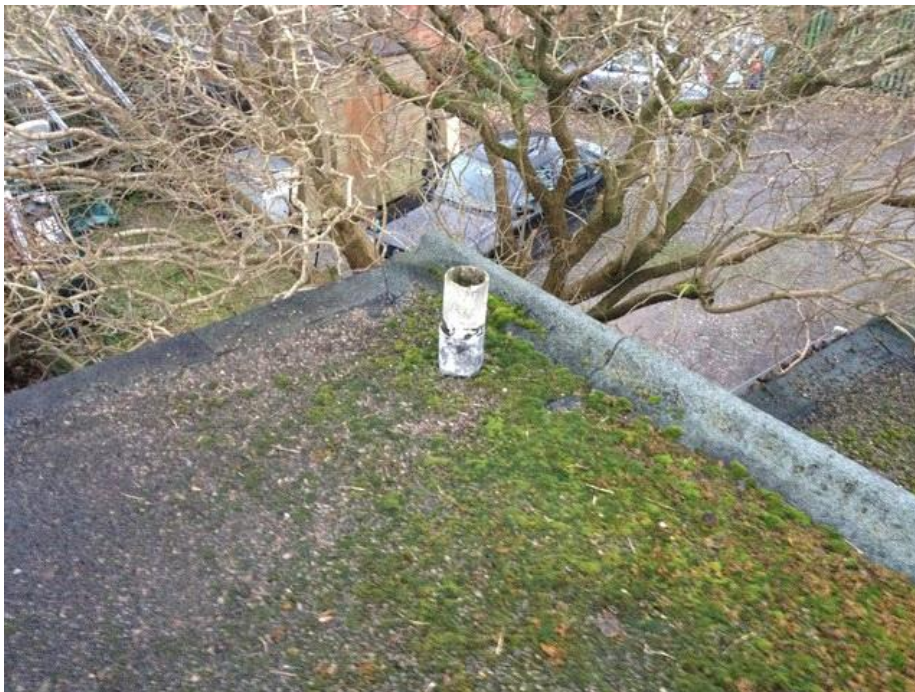
| Sample no | Location | Product type and name | | Extent | Accessibility | Condition | Surface treatment | Asbestos Type | Sample | Material Risk Score | Priority Risk Score | Action Category |
|---|---|---|---|---|---|---|---|---|---|---|---|---|
| 03 | Ground Floor, External | Cement Product | Cement Stench Pipe | 10 Linear Metres or Less | Diffcult Accessibility | Low Damage | Unsealed Asbestos Cement | Chrysotile | Identified | 4 | 1 | 4 |

| Area: | Block 01 | Damage: | Low Damage |

Material Comments: Asbestos Cement Stench Pipe (on flat roof)

**Action  
Category  
4**

Priority Room Type: External (General)  
Action: Apply warning labels and monitor annually.

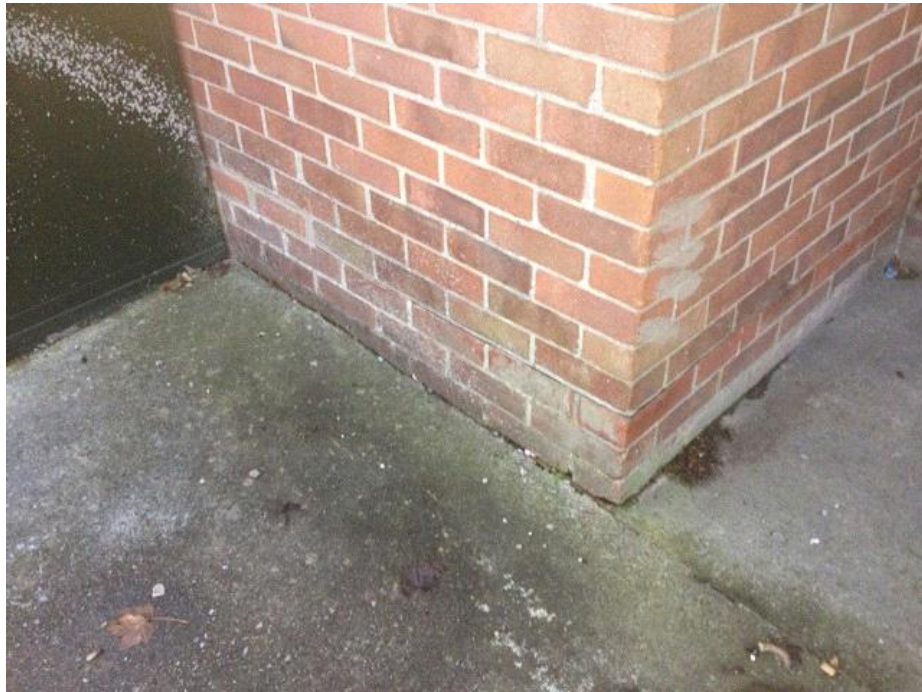
| Area: | Block 01 | Damage: | No Asbestos Detected |

Material Comments: Non Asbestos Bitumen (damp proof course to brickwork)

**No Action Required**

Action: No Action Required
