Detailed Unexploded Ordnance Risk Assessment

Site: **Liskeard Cattle Market**

Client: **Mace Limited**

Ref: **8458 RA**

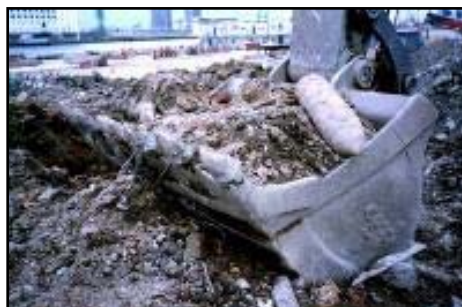
SC 50

Use: Against lightly damageable materials, hangars, railway rolling stock, ammunition depots, light bridges and buildings up to three stories.

Remarks: The smallest and most common conventional German bomb. Nearly 70% of bombs dropped on the UK were 50kg.

50kg bomb, London Docklands

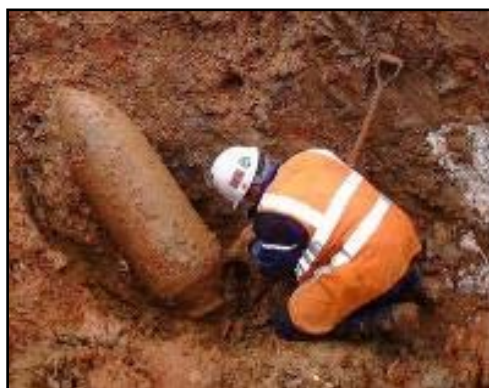
250kg bomb, Hawkinge

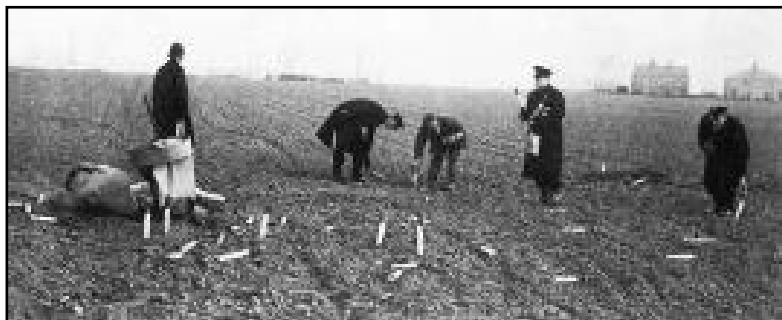
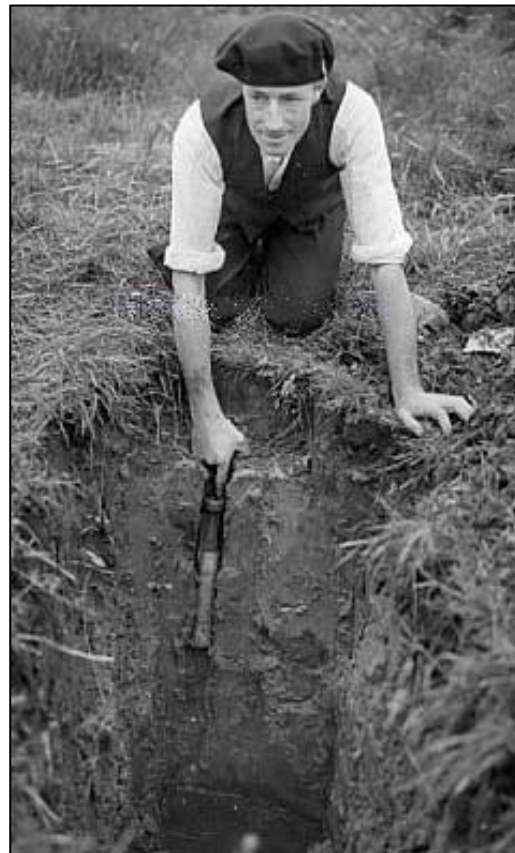
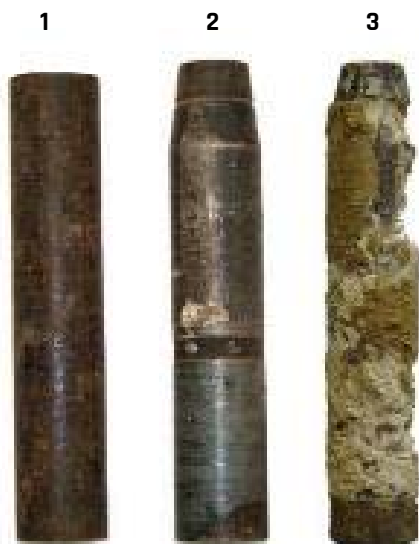
Use: As incendiary - dropped in clusters against towns and industrial complexes

Remarks: Jettisoned from air-dropped containers. Magnesium alloy case. Sometimes fitted with high explosive charge

1. Ordinary scaffold pipe
2. 1kg incendiary bomb
3. Incendiary bomb recently found on site in UK

- **1kg Incendiary Bombs (IB):** These bombs, which were jettisoned from air-dropped containers, were just over 30cm in size and therefore highly likely to go unnoticed. They had the potential to penetrate soft ground and left a very small entry hole. Furthermore, if bombs did not initiate and fell in water or dense vegetation or became mixed with rubble in bomb damaged areas, they could have remained hidden to this day. Some variants had explosive heads, and these present a risk of detonation during intrusive works, particularly due to their shape, which leads them to often be misidentified.

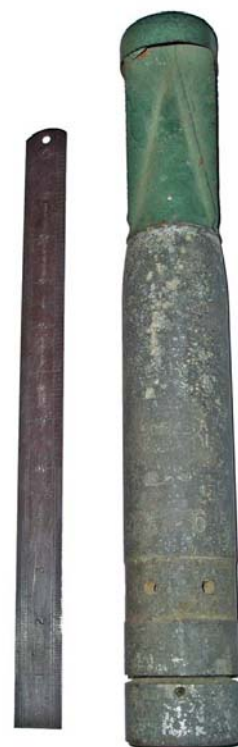
1kg German Incendiary Bomb next to a 30cm ruler

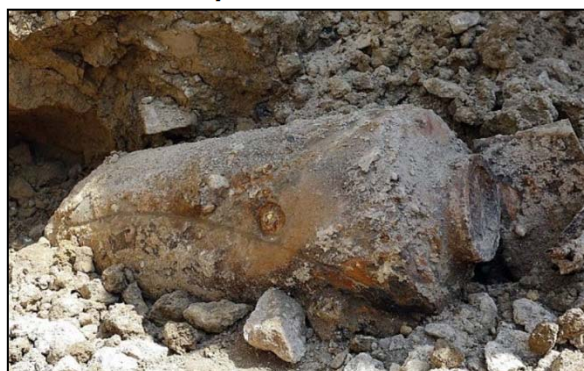
Path of UXB in soft ground

1. **Ricochet resulting from low level attack:** UXB stays perpendicular to ground and rests at surface.
2. **Buried UXB with J-Curve:** Bomb curves horizontally and rests perpendicular to surface.
3. **UXB returning to surface due to J-Curve:** Bomb points towards surface but may remain partially or completely below ground level.
4. **UXB deflected by buried objects:** Results in unpredictable path and unusual shaft.

Below: UXB can come to rest beneath undamaged buildings due to the J-Curve effect if it lands in nearby soft ground.

The location of the bomb is thus “offset” from the hole of entry. This “offset” from vertical is generally understood to be about one third of the penetration depth but can reach up to (and have been found at) 15m/50 ft from point of entry, dependent on ground conditions and the bomb's angle of impact.

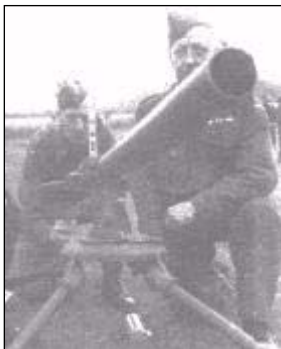
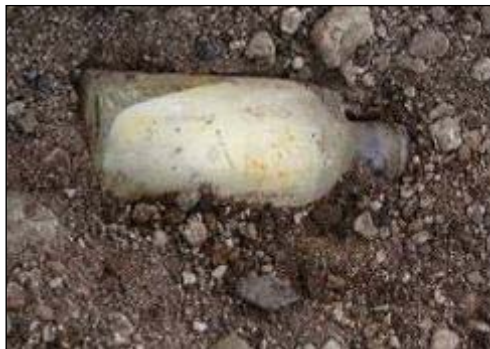
Self Igniting Phosphorous (SIP) Grenades

The grenade comprised a glass bottle with a total volume of approximately one pint. It was filled with White Phosphorus, benzene, a piece of rubber and water. Over time the rubber dissolved to create a sticky fluid which would self ignite when the bottle broke. Fired by hand or Northover Projector. Sometimes called the "A & W" (Albright & Wilson) grenade.

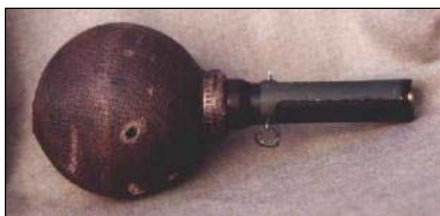
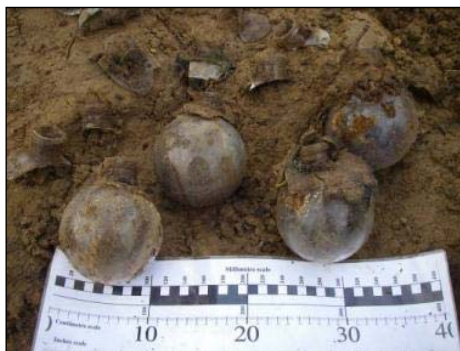
No 74 Grenade (Sticky Bomb)

Designed as an anti-tank grenade and used by the Home Guard. The grenade consisted of a glass ball on the end of a Bakelite (plastic) handle. Inside the glass ball was an explosive filling whilst on the outside was a very sticky adhesive covering. Until used, this adhesive covering was encased in a metal outer casing.

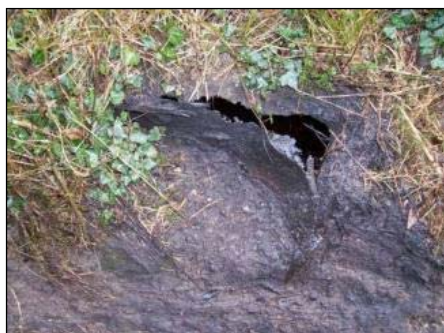
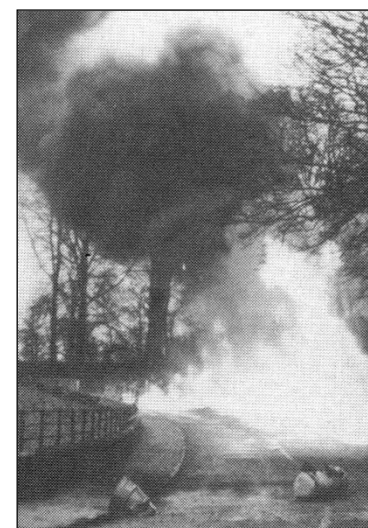
Flame Fougasse Bomb

A Flame Fougasse was a weapon in which the projectile was a flammable liquid, typically a mixture of petrol and oil. It was usually constructed from a 40-gallon drum dug into the roadside and camouflaged. Ammonal provided the propellant charge which, when triggered, caused the weapon to shoot a flame 3m (10ft) wide and 27m (30 yards) long. Initially a mixture of 40% petrol and 60% gas oil was used, this was later replaced by an adhesive gel of tar, lime and petrol known as 5B.

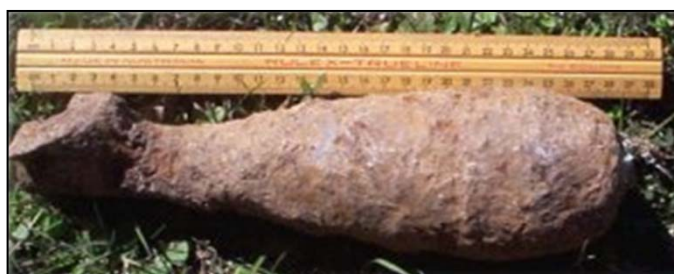
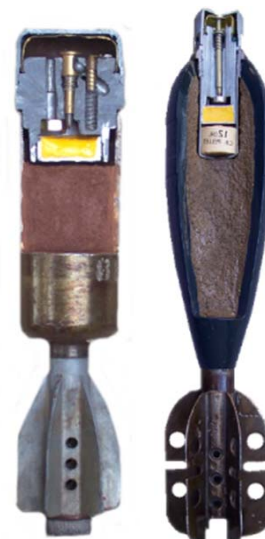
Typical 3 inch Smoke Mortar

Type: Smoke
 Dimensions: c490 x 76mm (19.3in x 3in)
 Filling: Typically white phosphorous
 Maximum Range: 2515m (2,750yds)
 Remarks: On impact, the fuze functions and initiates the bursting charge. The bursting charge ruptures the mortar bomb body and disperses the white phosphorous filler. The white phosphorous produces smoke upon exposure to the air.

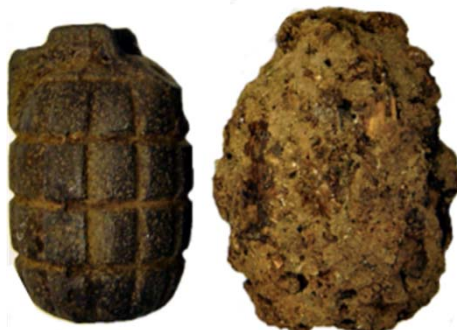
No. 36 'Mills' Grenade

Weight: 0.7kg filled (1lb 6oz)
Type: Hand or discharger, fragmentation
Dimensions: 95 x 61mm (3.7 x 2.4in)
Filling: Alumatol, Amatol 2 or TNT
Remarks: 4 second hand-throwing fuse with approximate 30m range. First introduced May 1918.

Grenade, .303 inch rifle, No. 36M, Mark I.

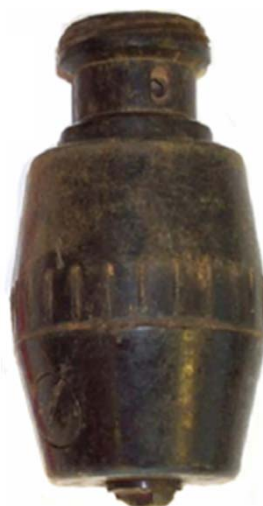
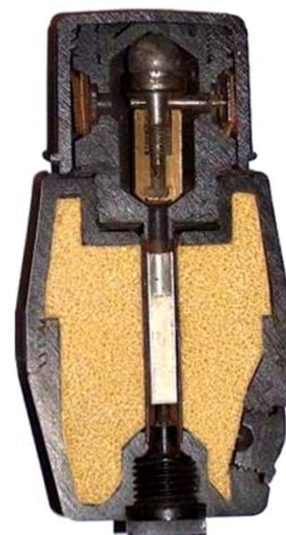
No. 69 Grenade

Weight: 0.38kg filled (0.8lb)
Type: Percussion/Blast
Date Introduced: December 1940
Remarks: Black Bakelite body. Blast rather than fragmentation type. After unscrewing the safety cap, a tape is held when throwing the grenade releasing the safety bolt in the throwing motion. Detection is problematic due to its very low metal content.

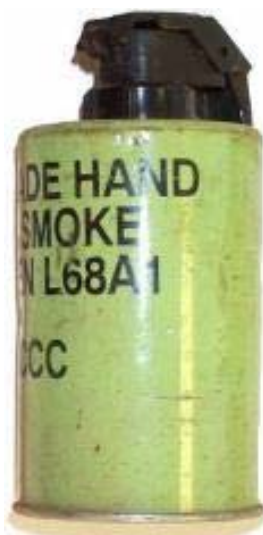
Typical Smoke Grenade

Dimensions: Approx. 65 x 115mm (2.5 x 4.5in)
Type: Smoke
Date Introduced: Current MoD issue
Remarks: Smoke grenades are used as ground-to-ground or ground-to-air signalling devices, or landing zone marking devices, and screening devices for unit movement.
target

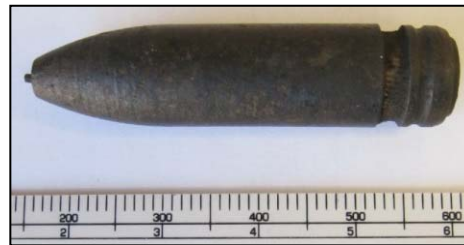
20mm Hispano HEI Ammunition

Type:	Live canon round
Markings:	Upper half of projectile painted 'buff' colour, lower half is red.
Cartridge Weight:	256 grams
Dimensions:	Total cartridge / projectile length - 182mm
Fuzed:	Contact fuze - No.253, No.254 or No.917
Filling:	108 grains of contact explosive + 68 grains of SR.379 incendiary composition.
Threat:	Explosives within unspent cartridge as well as the projectile.
Deployment:	Royal Navy, RAF and British Army Light Anti- Aircraft guns. Also RAF aircraft canons.
Remarks:	Cartridges are belted or supplied lose in cartons.

COLOUR IDENTIFICATION		
BRITISH		
NATURE OF SHELL	H.E. FILLING	COLOUR
H.E. TRACER	T.N.T.	Blue
H.E.	T.N.T.	Orange
PROJ. PRACTICE		Purple
PROJ. TRACER		Green
H.E. INCENDIARY	T.N.T.	Red
H.E. INCENDIARY TRACER	T.N.T.	Green

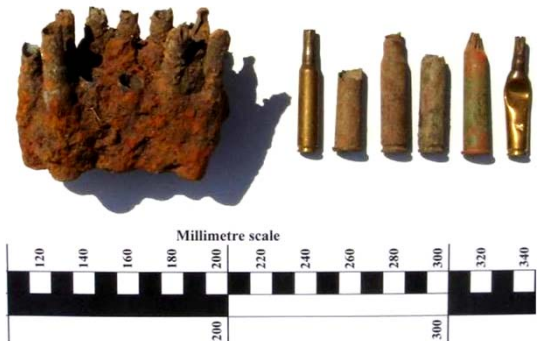
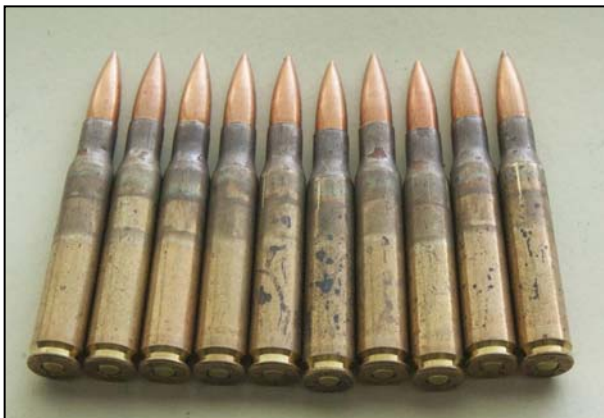
.303" Ammunition

Type:	Rifle / machine gun round
Markings:	Regular round - none. Tracer round - red Primer
Bullet Weight:	150 - 180 grams
Dimensions:	Total cartridge /projectile length - 78mm
Filling:	Regular round - none. Tracer round - small incendiary fill
Threat:	Explosive cordite within unspent cartridge
Deployment:	Royal Navy, RAF and British Army Light Anti-Aircraft guns, machine guns and rifles. Standard British and Commonwealth military cartridge from 1889 until the 1950s.
Remarks:	Cartridges are belted or supplied lose in cartons.

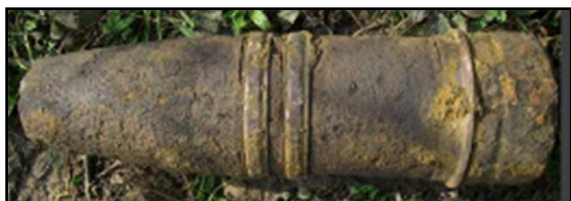
3.7 inch AA Projectile, Minus Fuze.
