**National Asset Delivery  
Technical Surveys and Testing**

**Site Information for M5 J11/A40 EB  
Onslip Ground Investigation**

The contract is M5 J11/A40 EB Onslip.

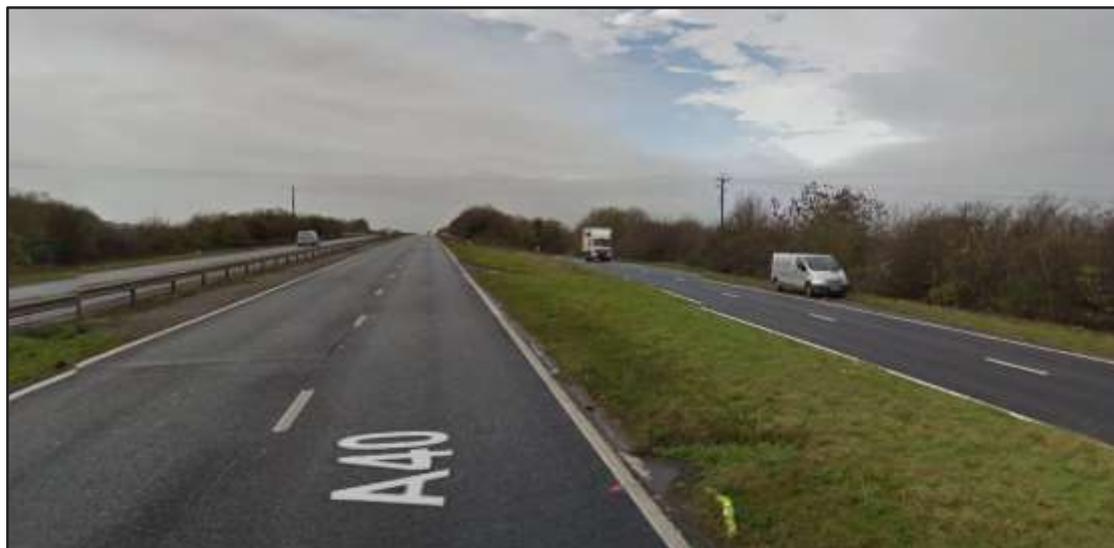
Figure 2: Site View

The defective section of carriageway is identified on the Highways Agency Geotechnical Data Management System as Earthwork 63685 on the A40 eastbound embankment, adjacent to the M5 J11/A40 interchange EB on-slip between:

The site is located on an embankment and according to the information held on HAGDMS the maximum slope angle of the embankment is recorded as 13° at a height of 4.4m.

The location of the site is shown in Figure 1 and Figure 2 shows the site in detail.

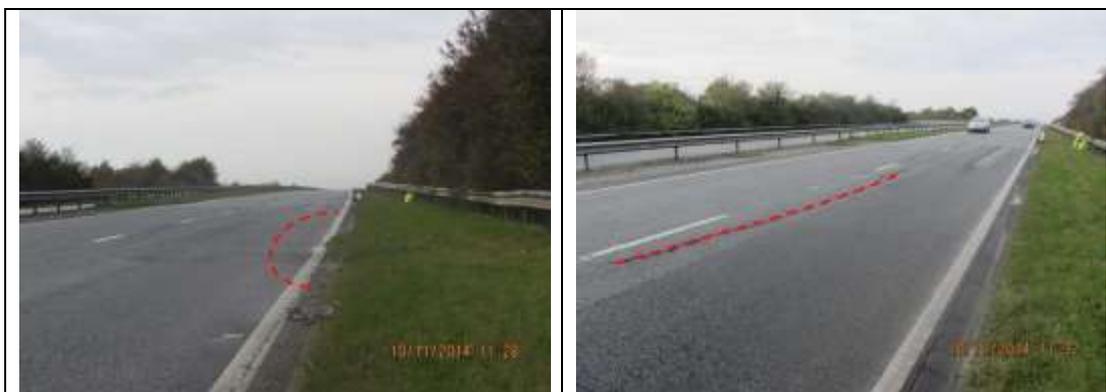
Figure 3: Photographs of Defect

Slope angles of up to 34 degrees are considered too steep for an embankment comprising reworked Lias Clays. Hence, the likely cause of the defect is an over steep slope possibly exacerbated by poor or defective drainage at the crest of the slope.

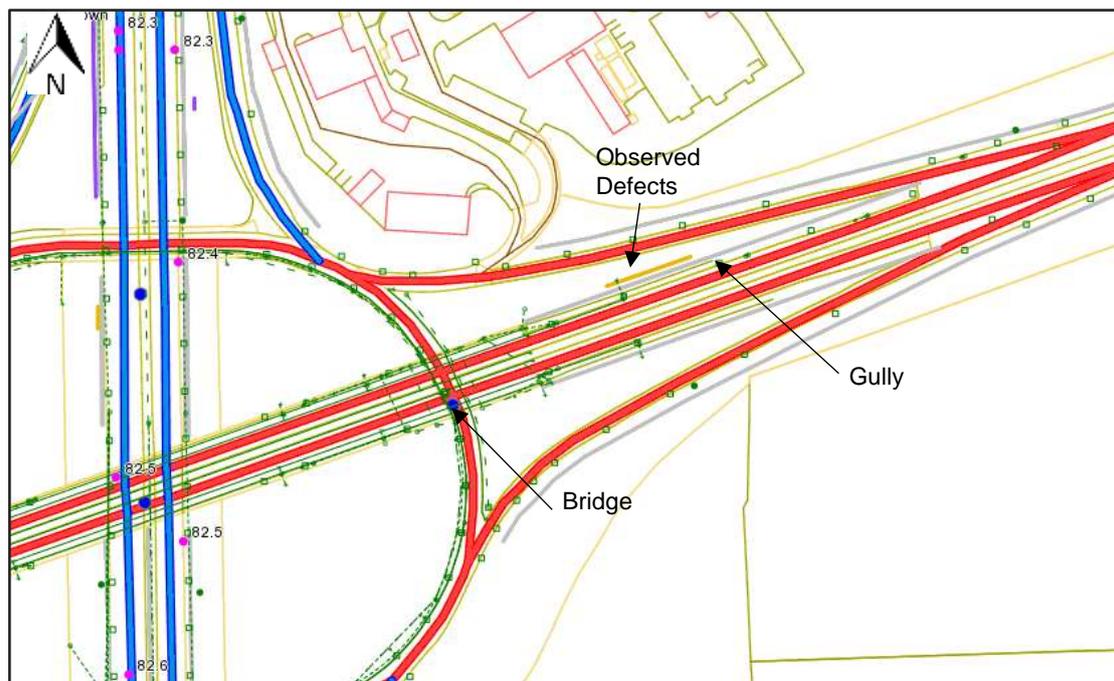
Figure 4: Structure and Drainage Locations

A bridge is shown in Figure 4, west of the observed defect.

- Structure ID: 6687
- Structure name: Golden Valley I/C East

Site drainage includes highways drainage near the defects. The HADDMS drainage inventory indicates the carriageway surface water drainage is by kerb and gully systems. The full extent of the carrier pipework is not recorded.
