**Refurbishing of Print Workshops and Studios  
The Penwith Gallery  
Back Road West  
St.Ives  
TR26 1NL**

**OUTLINE SCHEDULE OF WORK**

October 2023

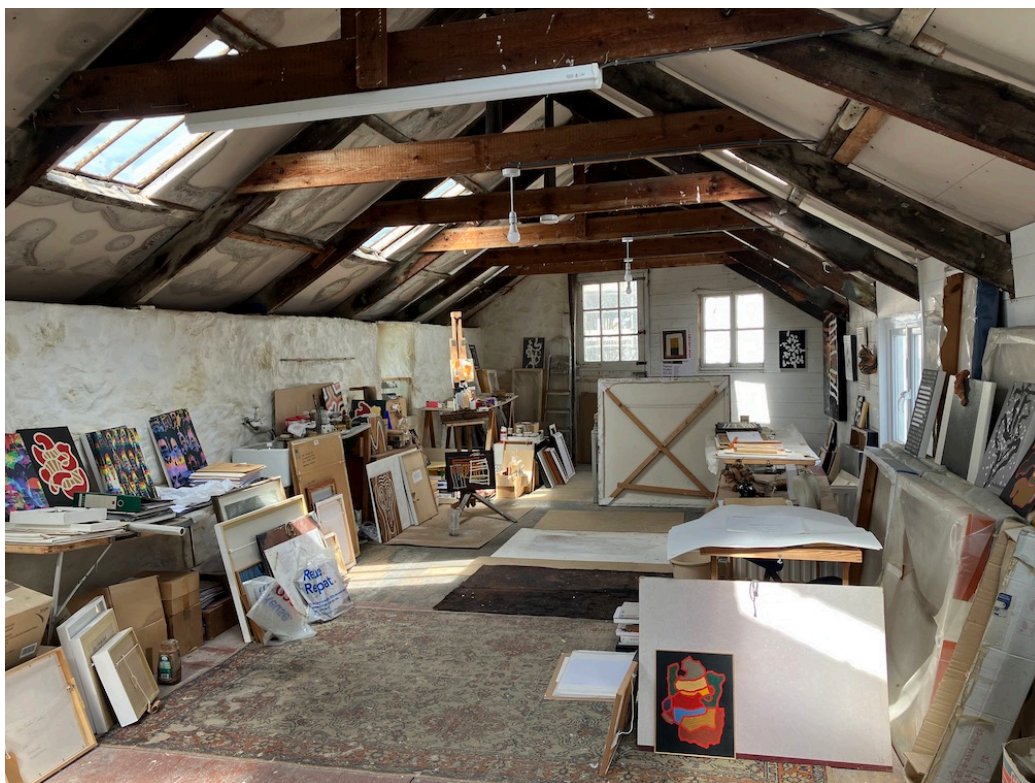
Above: Studio 1 looking North towards the original first floor fire exit

1. Asbestos Removal: Before building works commence carry out the safe removal of any asbestos products identified in the survey by a specialist licenced company.
2. Stripping Out: Inspect electrical installation and isolate any electrical fittings that are likely to be affected by the works. In Studio 1 (photos below) remove all existing plasterboard ceilings on both roof slopes exposing rafters above. Take care not to disturb existing purlins and 'A' frame trusses as these are to be retained. Remove the non-structural timber framed partition separating Studio 1 from the print workshops.

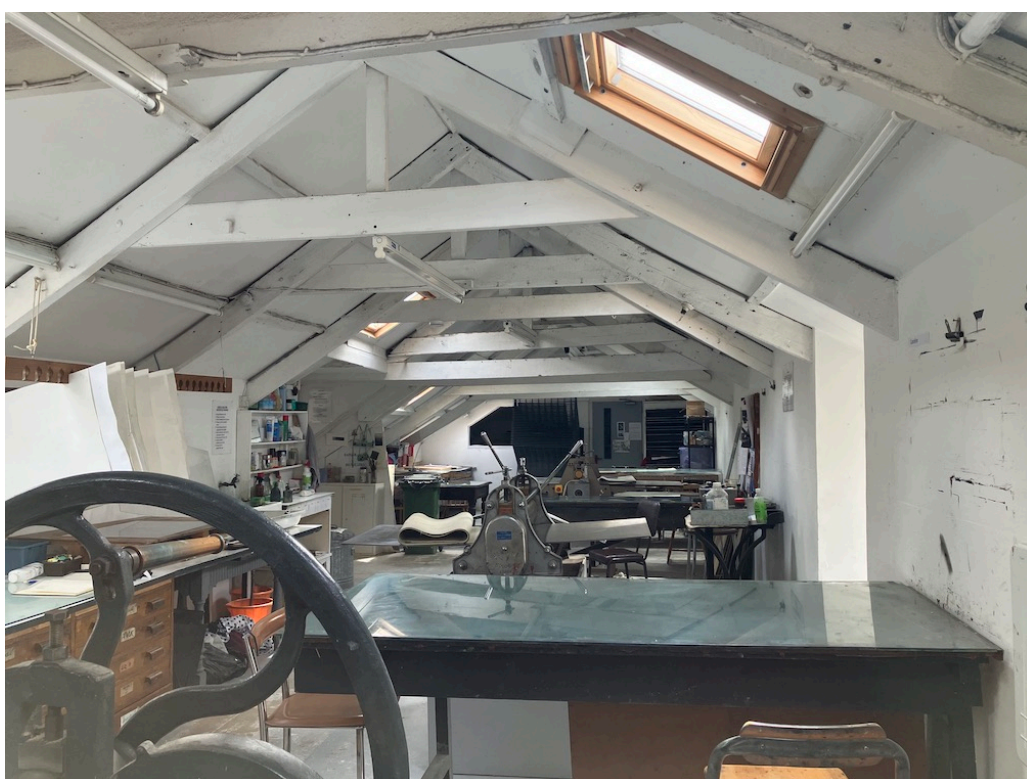
Above: Looking down the main print workshop towards the back office

In the Print Workshop, dismantle the non-structural timber partitions between the workshop and the inner office complete with the part-glazed fire door and frame. Retain the fire door and frame for later re-use (see below). Throughout the workshops and the small Studio 2 remove the fibre-board ceilings. Note that any fire or smoke alarms on the ceilings are to be removed beforehand and retained for re-use.
