Specification:
West Bergholt Village Hall
Roofing Works
Job No: 500899 - Date: March 2019

Orpen Memorial Hall Roof Replacement Works
West Bergholt Parish Council
Job No. 500899

Pre-Construction Information
(CDM Regulations 2015)

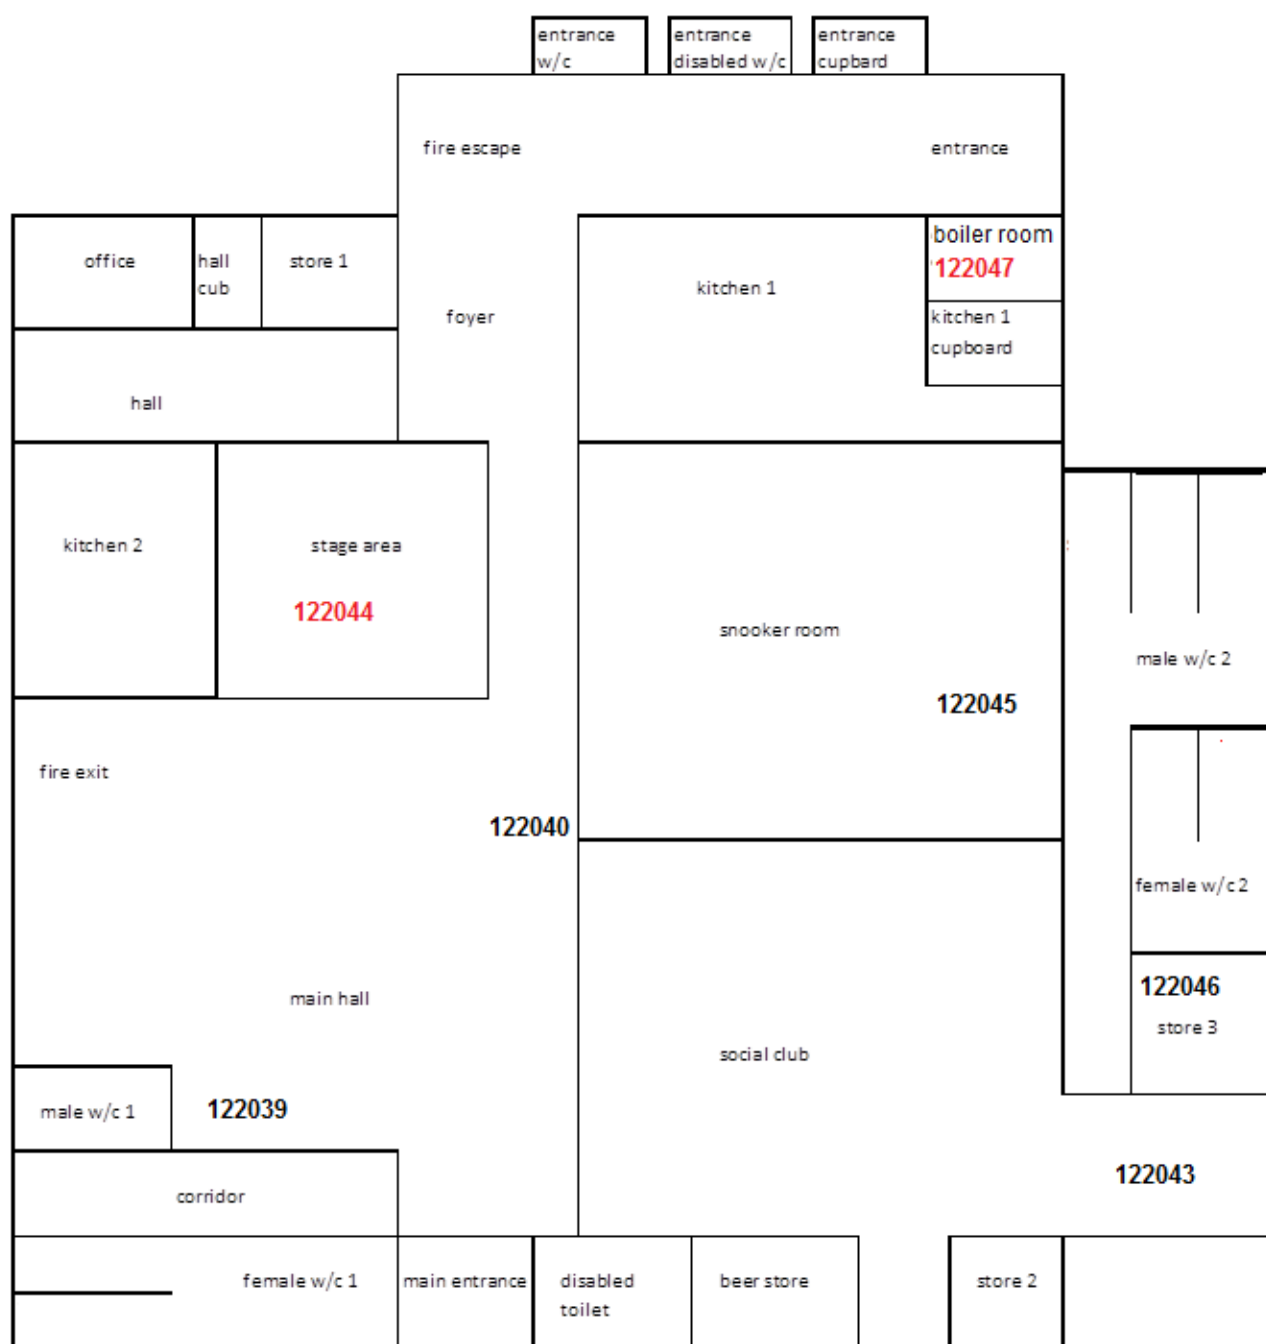
5 Marked drawings

122039-ceiling NAD
 122040-ceiling NAD
 122041-roof felt NAD
 122042-pipe lagging NAD
 122043-artex coating to ceiling NAD
 122044-ceiling
 122045-artex coating to ceiling NAD
 122046-ceiling NAD
 122047-ceiling
 NAD=No asbestos detected

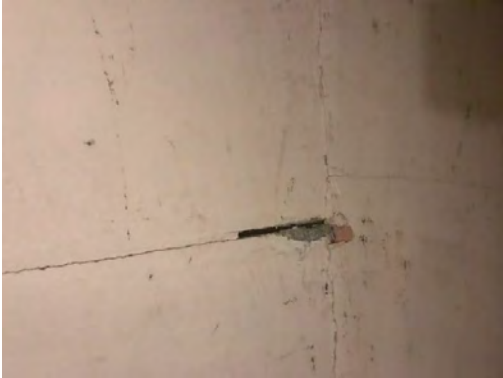
Photo 1

Location	Risk Assessment	Recommendations
Stage-ceiling	Low	Repair/remove

SN1-Slight damage to ceiling. Recommend repair/removal

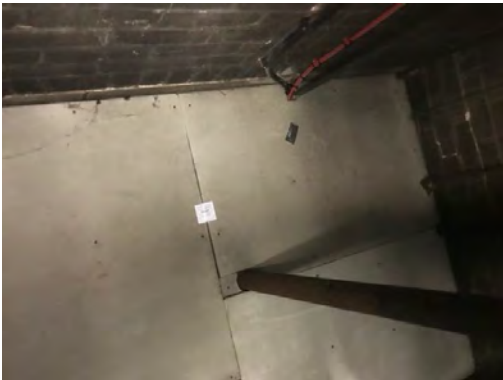
Photo 2

Location	Risk Assessment	Recommendations
Boiler room-ceiling	Low	Manage/remove if impeding works
