TASK NO.	TASK/DESCRIPTION	NOTES
	H8 INTERNAL DECKS, DOORS AND LADDERS	
H8.04	<p data-bbox="411 389 1062 421">Stbd Troop Accommodation Compartment Deck</p> <div data-bbox="408 443 1166 808">

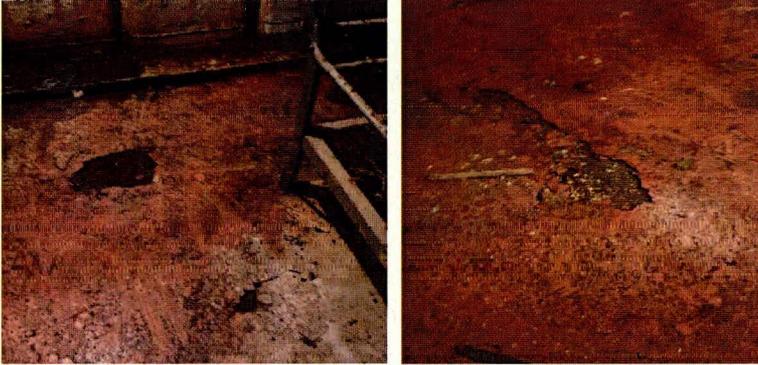
</div> <p data-bbox="411 824 1214 936">Following a compartment flood, the deck screed has broken down in certain areas. Damaged screed to be removed to SURVEY steel deck below. Compartment requires confirmed dry (possible dehumidifiers required) with screed RENEWED and REPRESENTED on completion.</p> <p data-bbox="411 969 1214 1025">ALLOW for 6m² screed RENEWAL. ALLOW for 6m² REPRESENTATION.</p>	<p data-bbox="1249 394 1449 562">Adequate ventilation to be arranged before work commences IAW General 3.2.</p> <p data-bbox="1249 595 1449 707">IAW Paint scheme -General 12 and Annex B refer.</p>

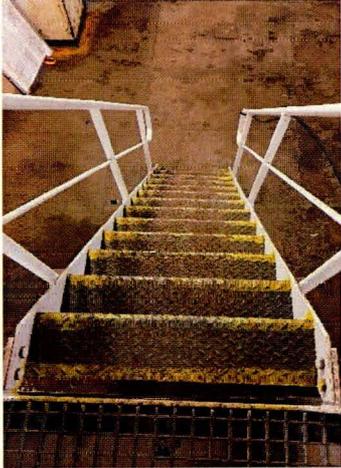
TASK NO.	TASK/DESCRIPTION	NOTES
H8.05	<p data-bbox="517 327 1114 353">H8 INTERNAL DECKS, DOORS AND LADDERS</p> <p data-bbox="397 387 855 421">Tank Deck Training Area Ladders</p>

<p data-bbox="397 920 1209 1021">Both tank deck gantry access ladders showing breakdown of paint coverings. REPRESENT both ladders. ALLOW for 5m² REPRESENTATION.</p>	<p data-bbox="1246 387 1447 506">IAW Paint scheme -General 12 and Annex B refer.</p>

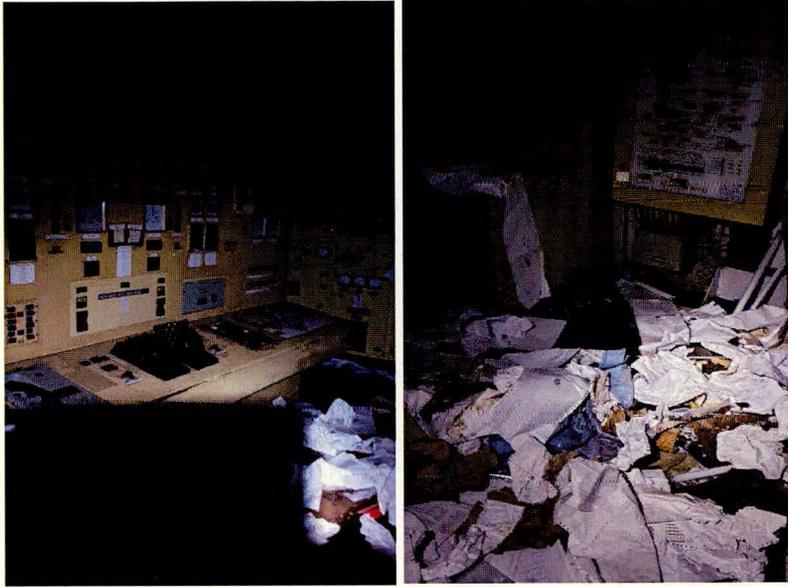
TASK NO.	TASK/DESCRIPTION	NOTES
H8.07	<p data-bbox="512 360 1114 389">H8 INTERNAL DECKS, DOORS AND LADDERS</p> <p data-bbox="397 421 742 454">Machinery Control Room</p> <div data-bbox="397 468 1185 1055">

</div> <p data-bbox="397 1070 1214 1182">The Machinery Control Room (MCR) is currently not used for training purposes and contains a large amount of unused material. Contractor is to remove and dispose of all loose material to allow it to become a the training zone.</p>	<p data-bbox="1246 427 1425 551">To be done in conjunction with L1.02 – Training Zone Lighting</p>
