Cattle Market, Liskeard – Regeneration

Desk Study Report
Project No: 64570

Report Title Desk Study Report

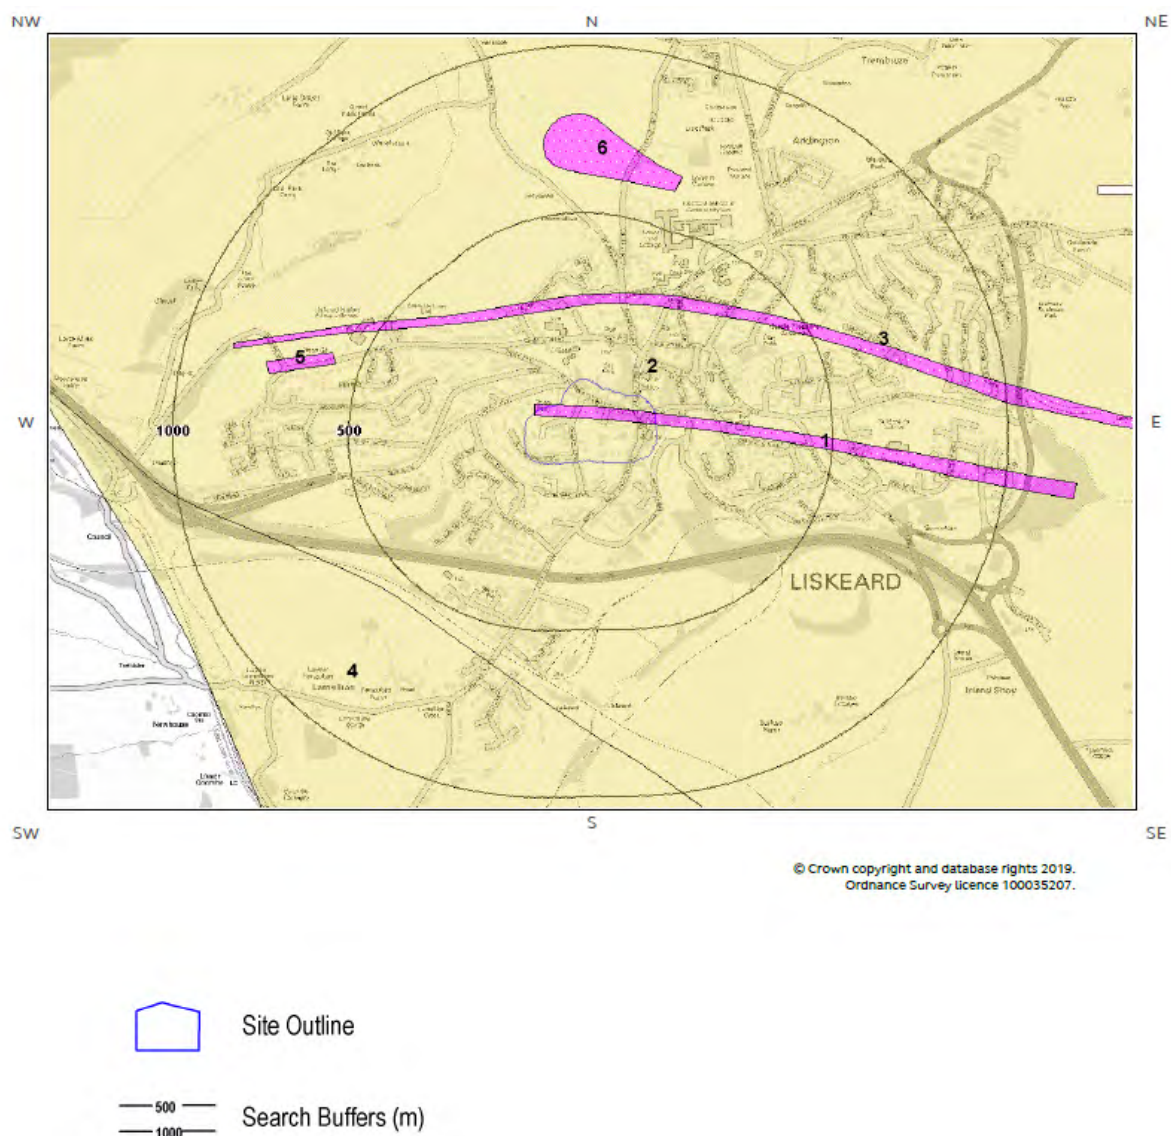
Figure 5: Geological map showing records of bedrock and linear features map. The site is underlain by the Saltash Formation with an unnamed igneous intrusion.

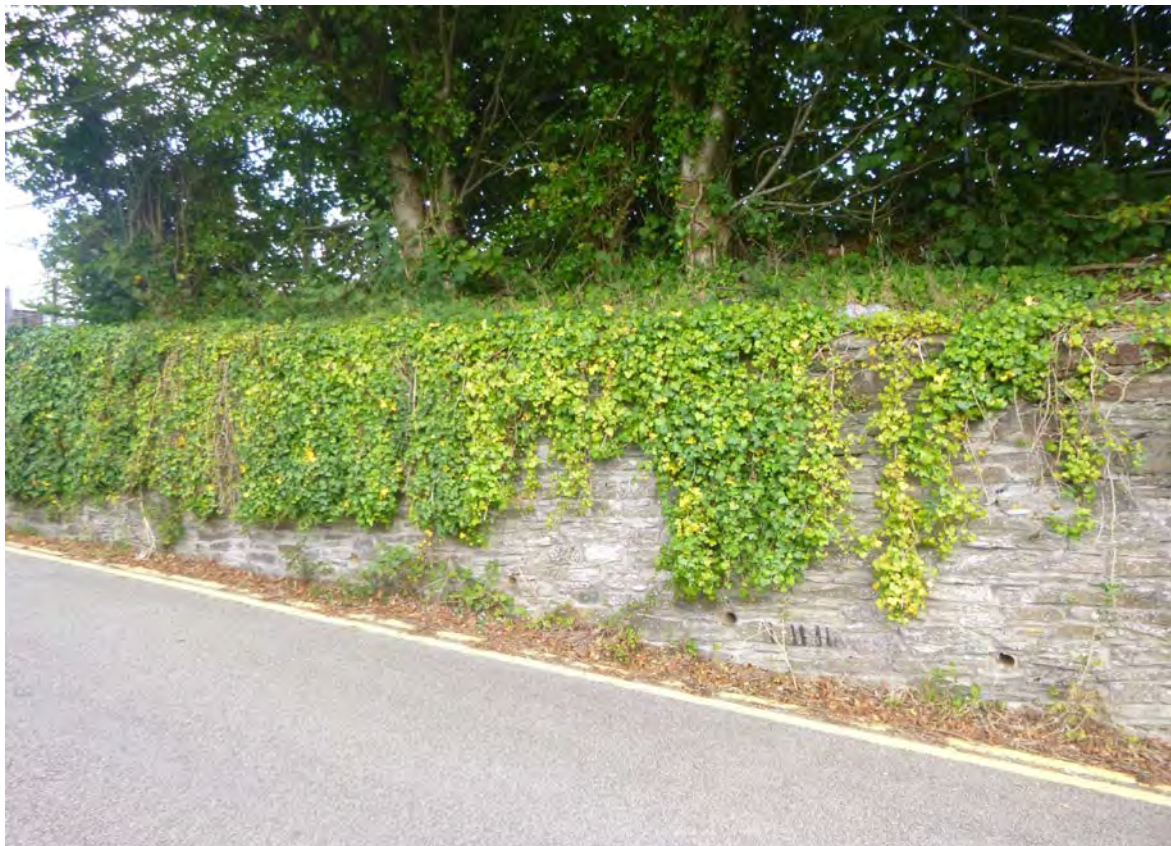
Photograph 20: Western boundary wall between NGR 224924, 064377 and NGR 224930, 064350.

4. Between NGR 224922, 064417 and NGR 224924, 064377 the western site boundary is demarcated by a low north-south trending retaining wall that varies between 0.25m and 0.85m in height which was observed to be in good condition. From NGR 224924, 064377 and 224930, 064350 the boundary retaining wall increases in height to a maximum height of 2.20m. This section of wall was observed to be leaning off-vertical (approximately 5 degrees), locally heavily vegetated with ivy and with local cracking of rendering. A detailed inspection is recommended.

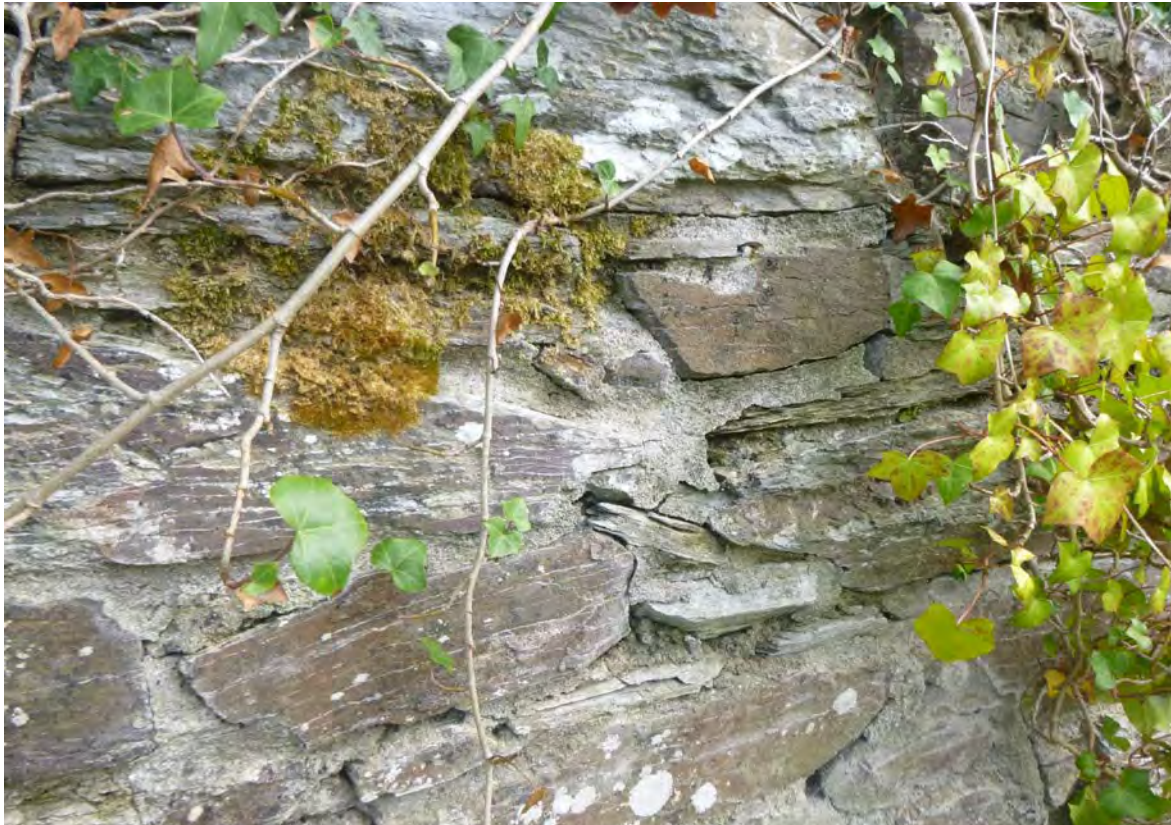
Photograph 21: Cracking of rendering observed in western boundary retaining wall.

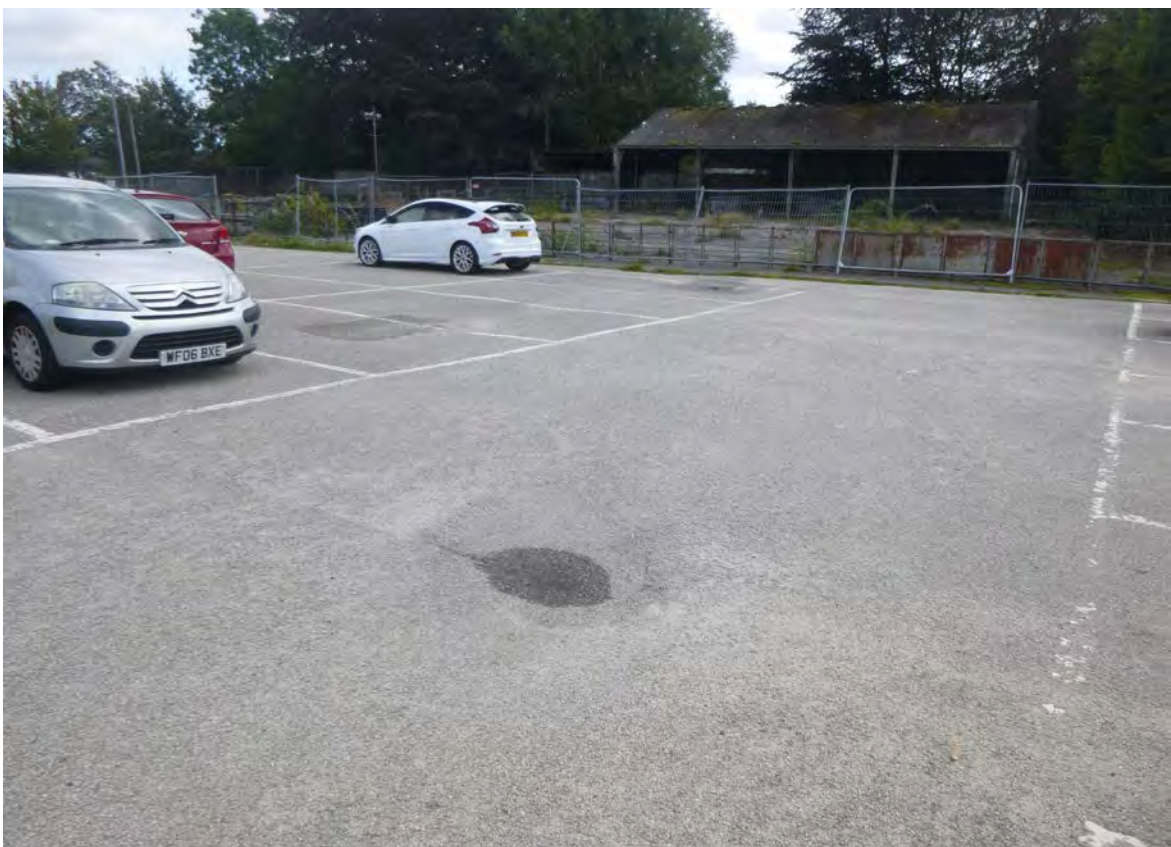
Photograph 22: Localised shallow depressions, western car park surface.

9. Three shallow depressions approximately measuring 0.50 x 0.50m were observed in the asphalt surface in the western portion of the car park (approximate NGR 224941, 064397) and may represent localised weaker ground conditions which warrant further investigation.

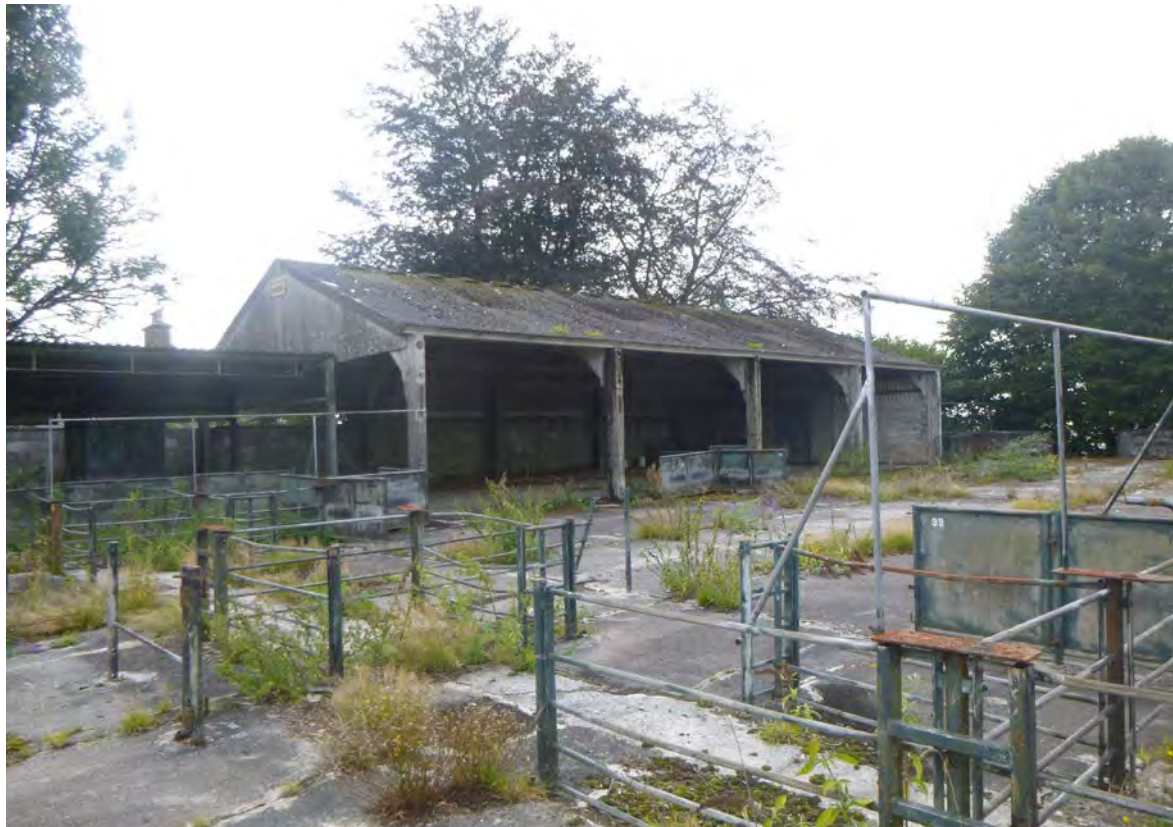
Photograph 23: Sheep yard (NGR 224943, 064359), suspected asbestos roof.

064359 consists of a shed approximately 10m x 25m and 5 to 6m high with suspected asbestos roof and concrete slab floor. To the east, a historical vehicle and livestock container washing facility was observed comprising a raised, sloping concrete slab area with an observed thickness of approximately 0.1-0.25m in addition to rusted steel water hose columns, approximately 10m in height. The founding depth of the concrete slab is unknown and should be investigated further.

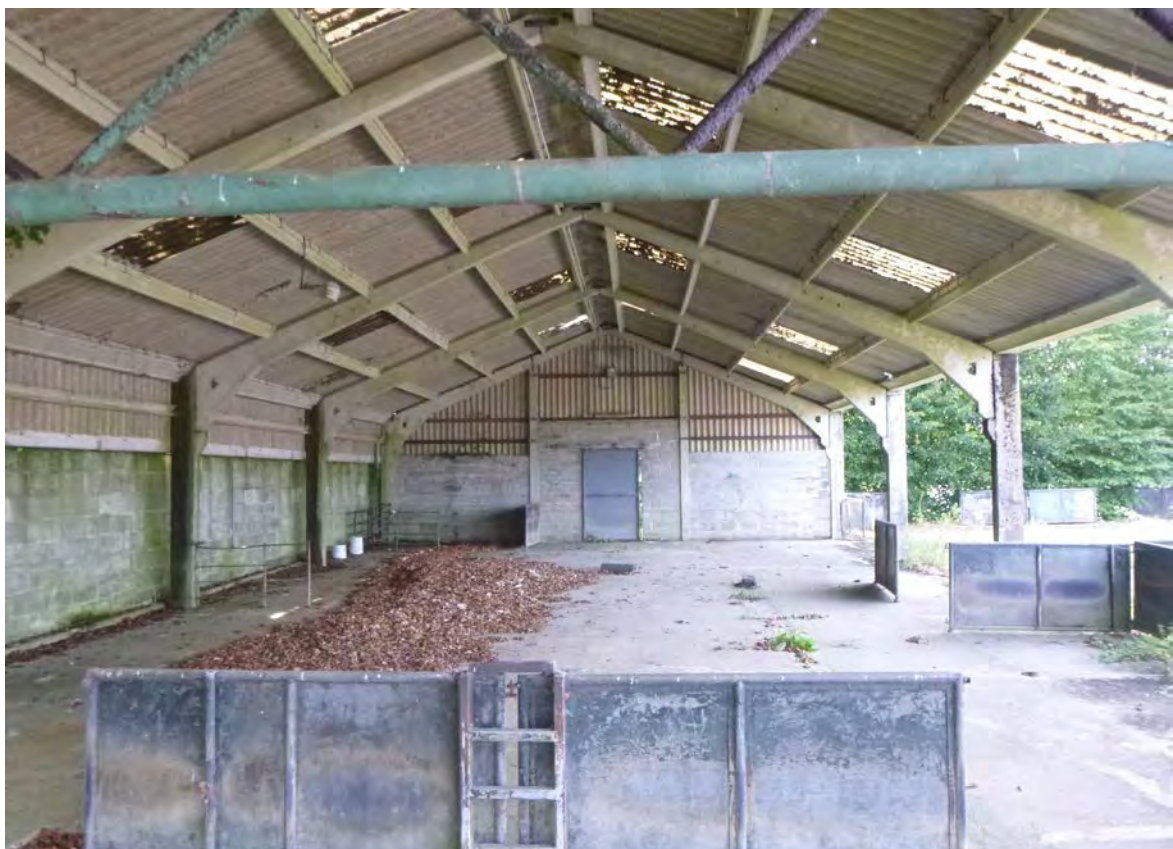
Photograph 24: Sheep yard (NGR 224943, 064359), note concrete floor and steel frame.

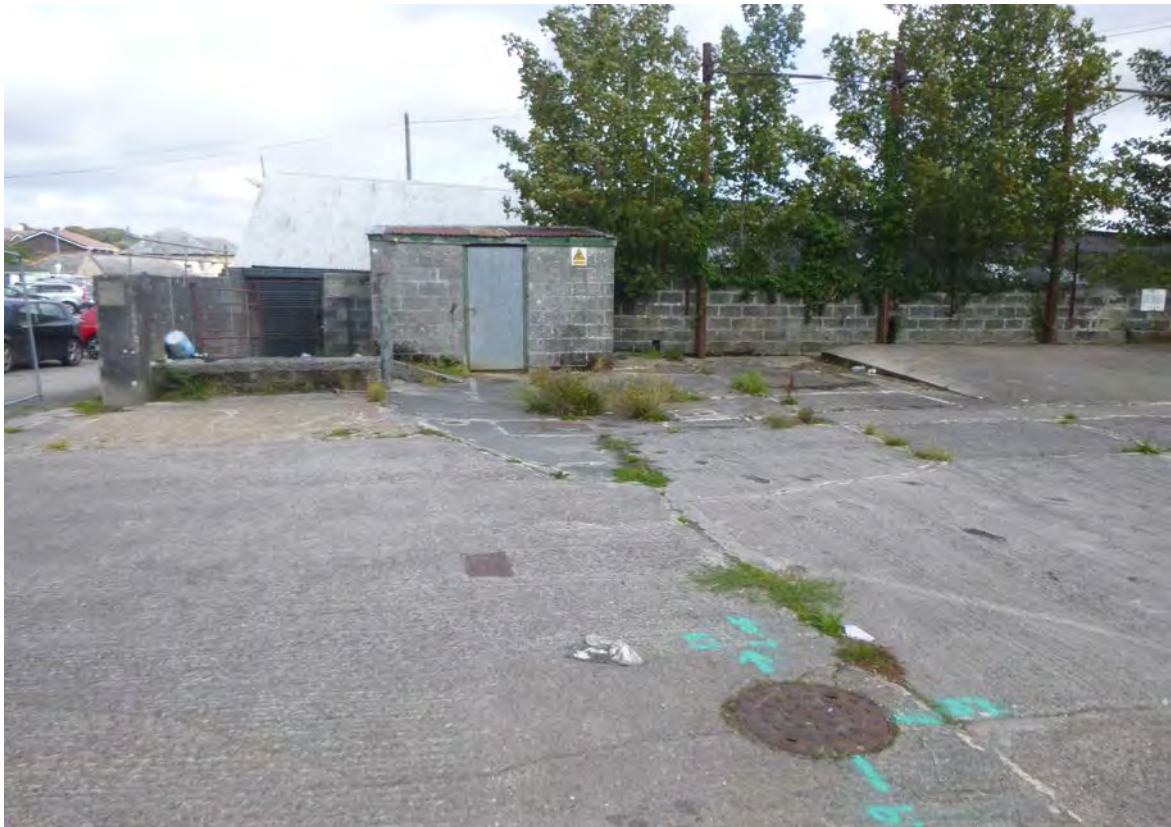
Photograph 25: Vehicle and stock container washing facility, note raised concrete platform, underground services and oxidised metal wash posts.

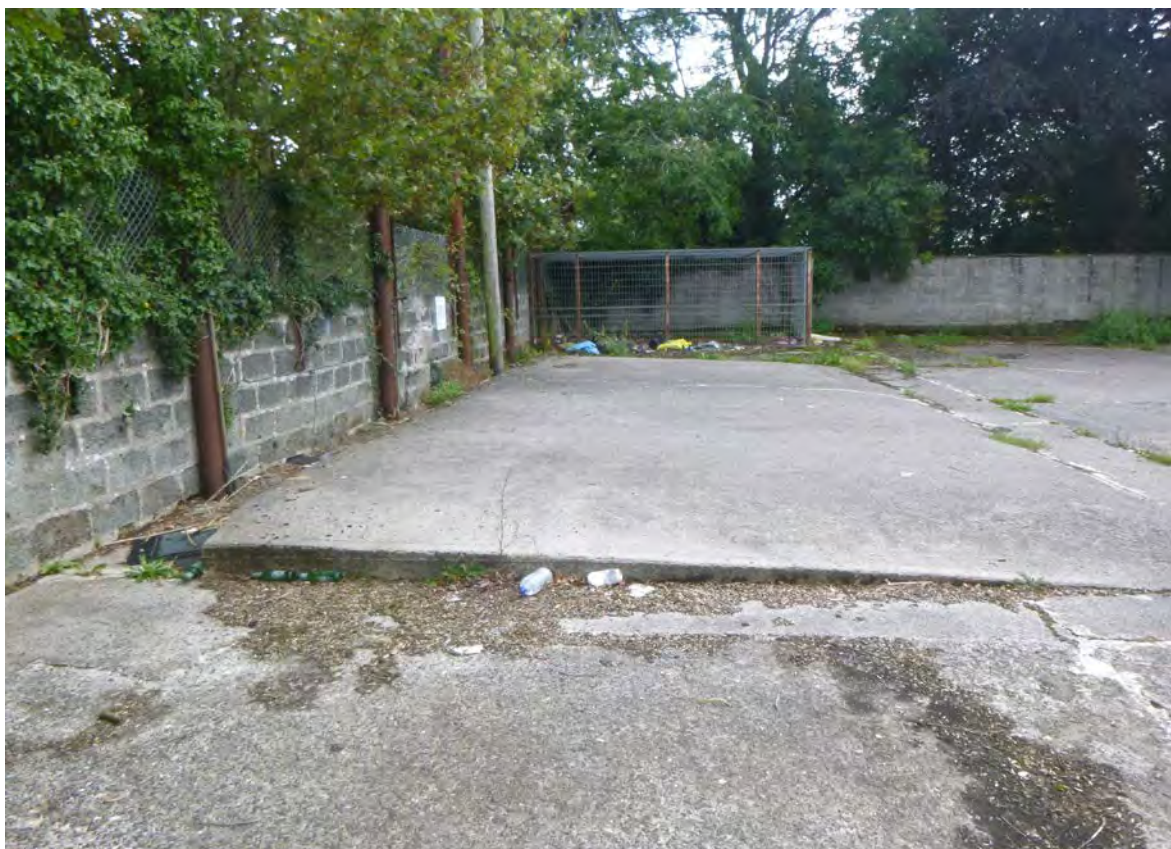
Photograph 26: Stock container washing facility, raised concrete platform.

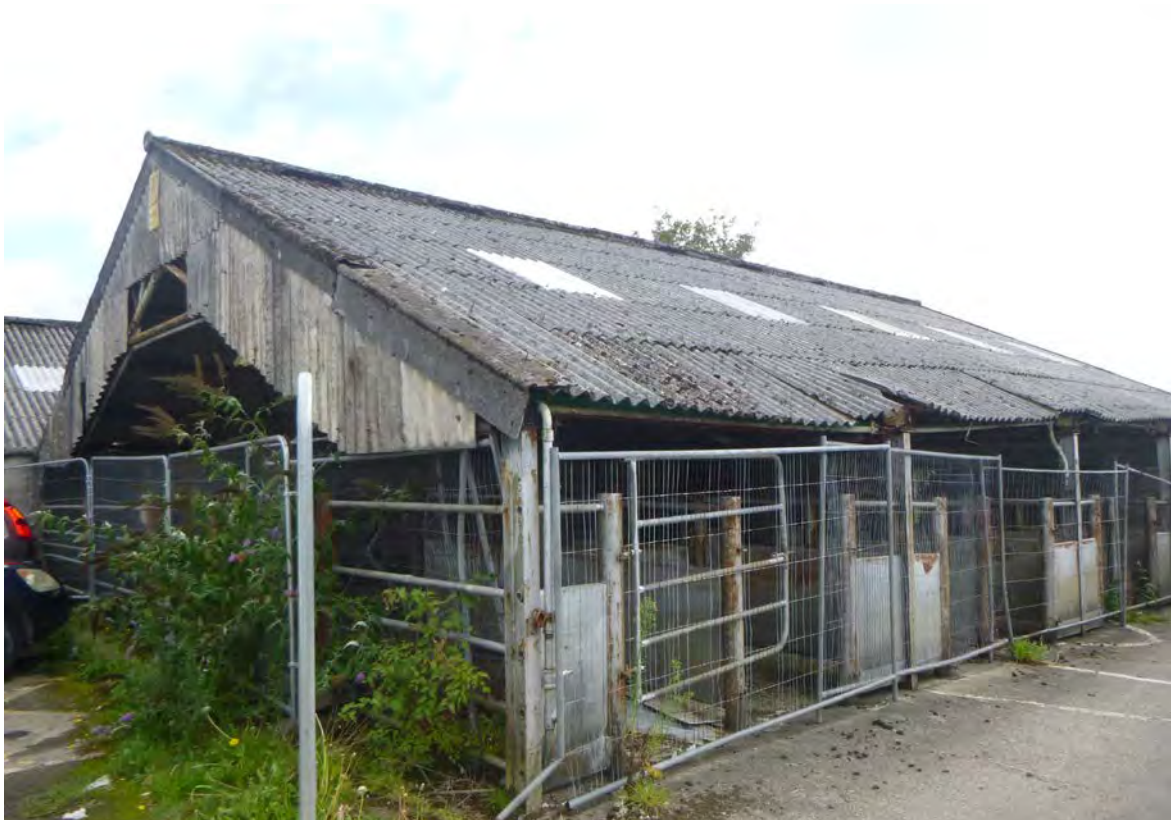
Photograph 29: Cattle yard barn, note suspected asbestos roof (NGR 225055, 064377).

11. Continuing east the cattle yard complex at NGR 225026, 064363 covers an area approximately 70m x 40m and currently consists of five shed structures that are considered unstable. Shed structures are open walled, steel framed with suspected roof asbestos and have concrete slab floors. Steel shed frames were observed to be largely corroded, considerably reducing structural strength, this should be taken into account during the dismantling process. Given the presence of historical concrete and asbestos, appropriate disposal measures should also be taken into account by the designer.

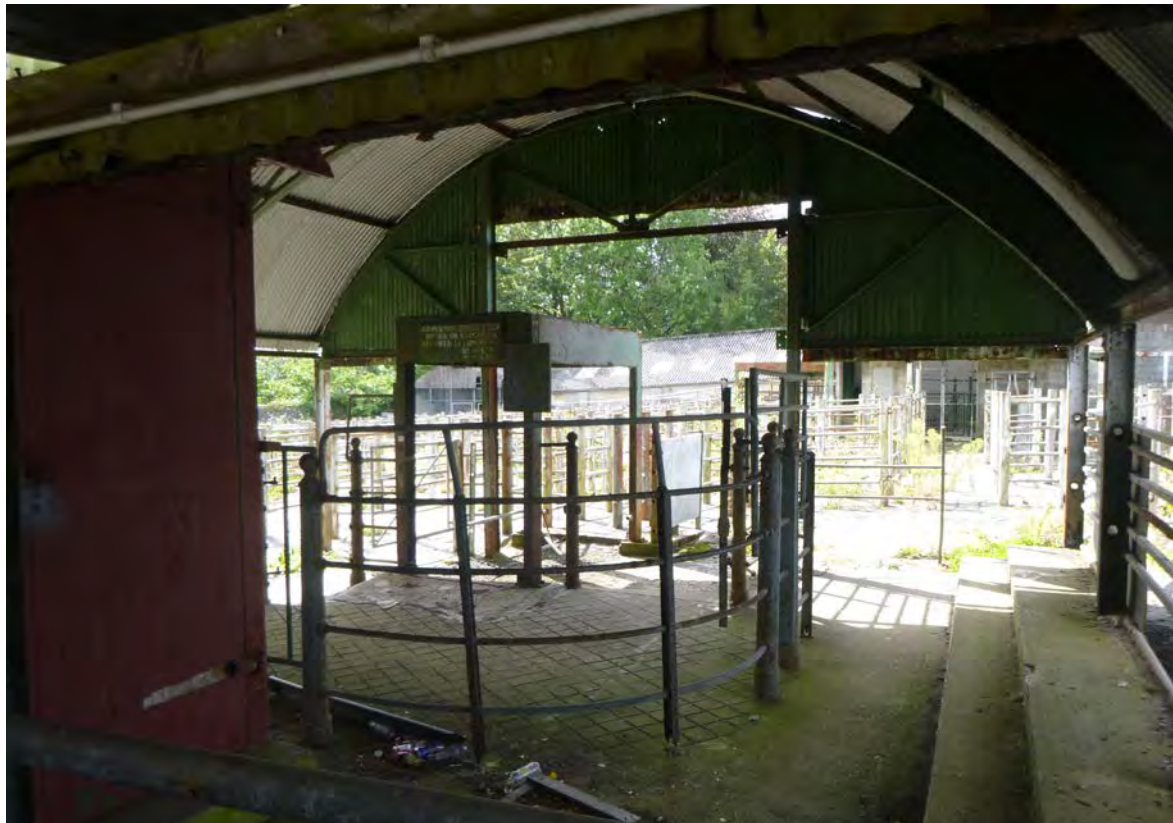
Photograph 33: Outbuilding, cattle yard. Note corroded steel supporting beam and suspected asbestos roof.

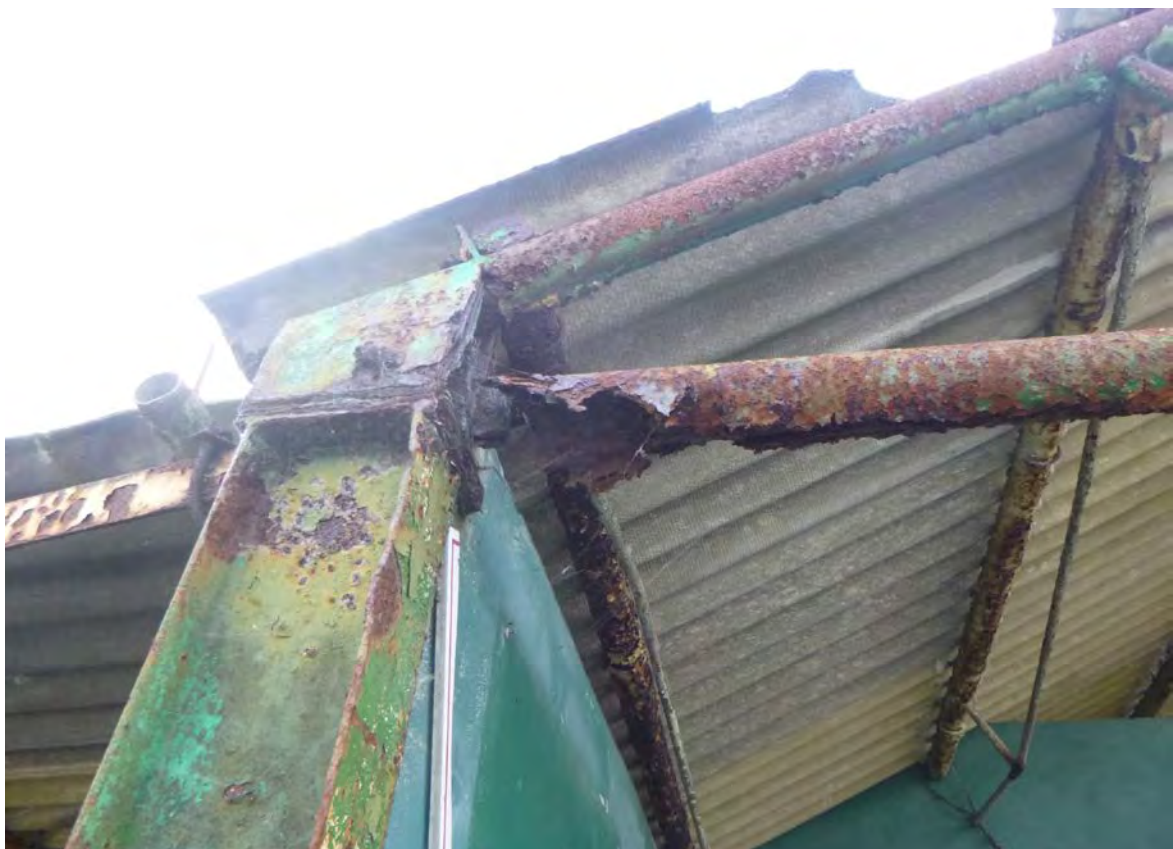
Photograph 34: Cattle yard. Note corroded steel frame. NGR 225040, 064368.

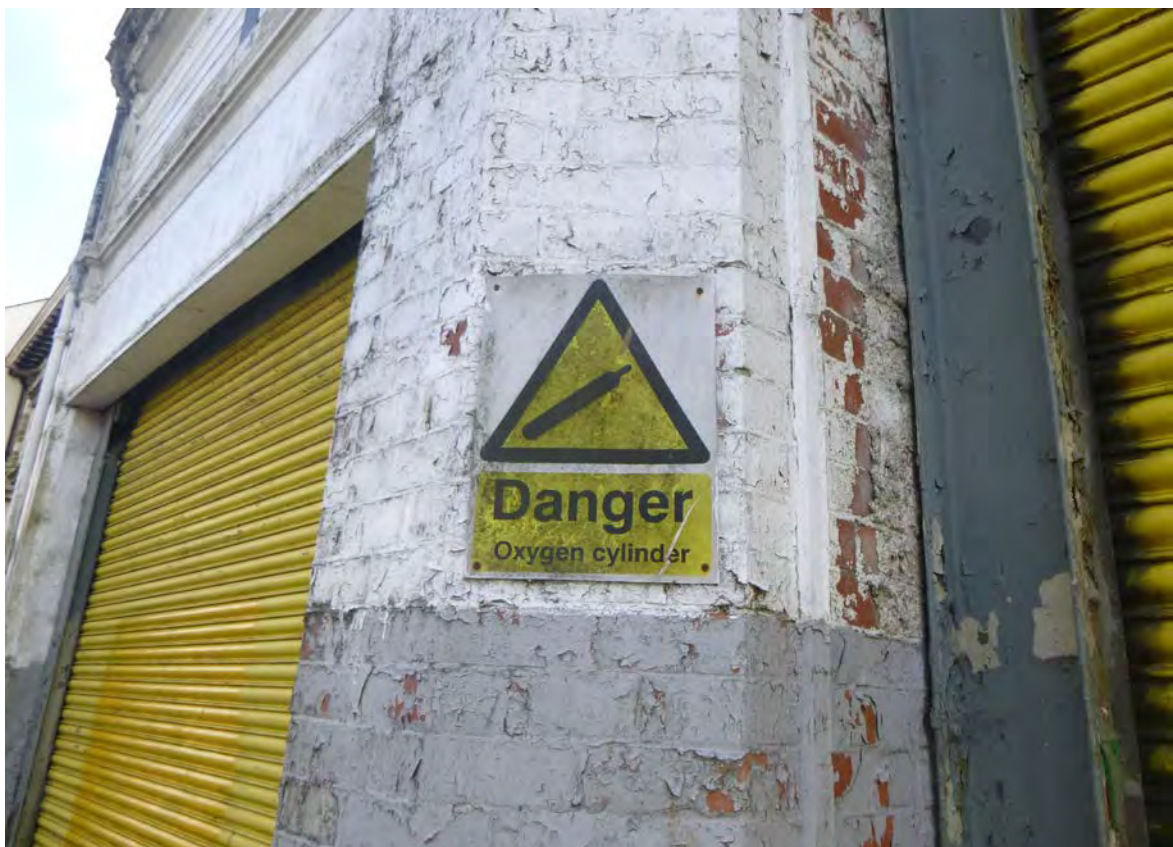
Photograph 38: Disused workshop on Dean Street, oxygen cylinder warning sign.

14. A disused workshop was observed at NGR 225032, 064452 running from Dean Street to the Cattle Market. Suspected asbestos roofing as well as warning signs advising the possible presence of oxygen cylinders were observed.

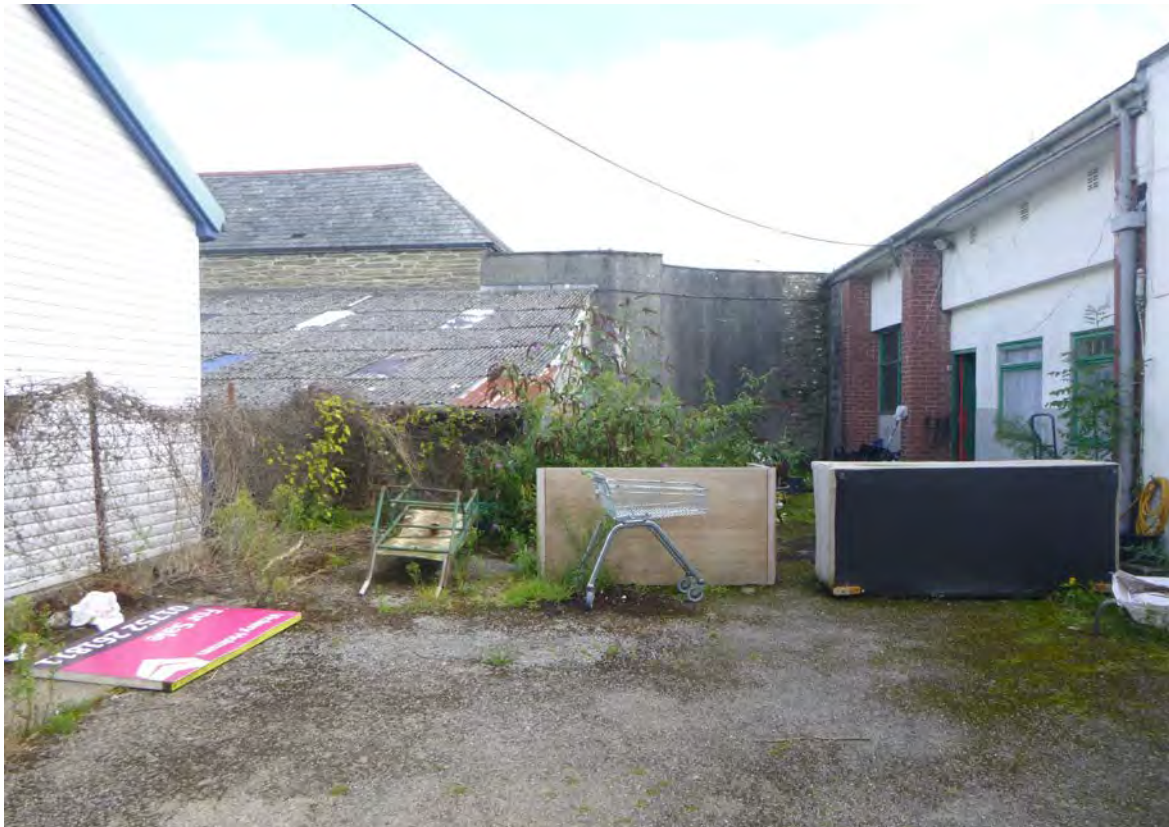
Photograph 39: Suspected asbestos roof at the rear of disused workshop at NGR 225032, 064432.

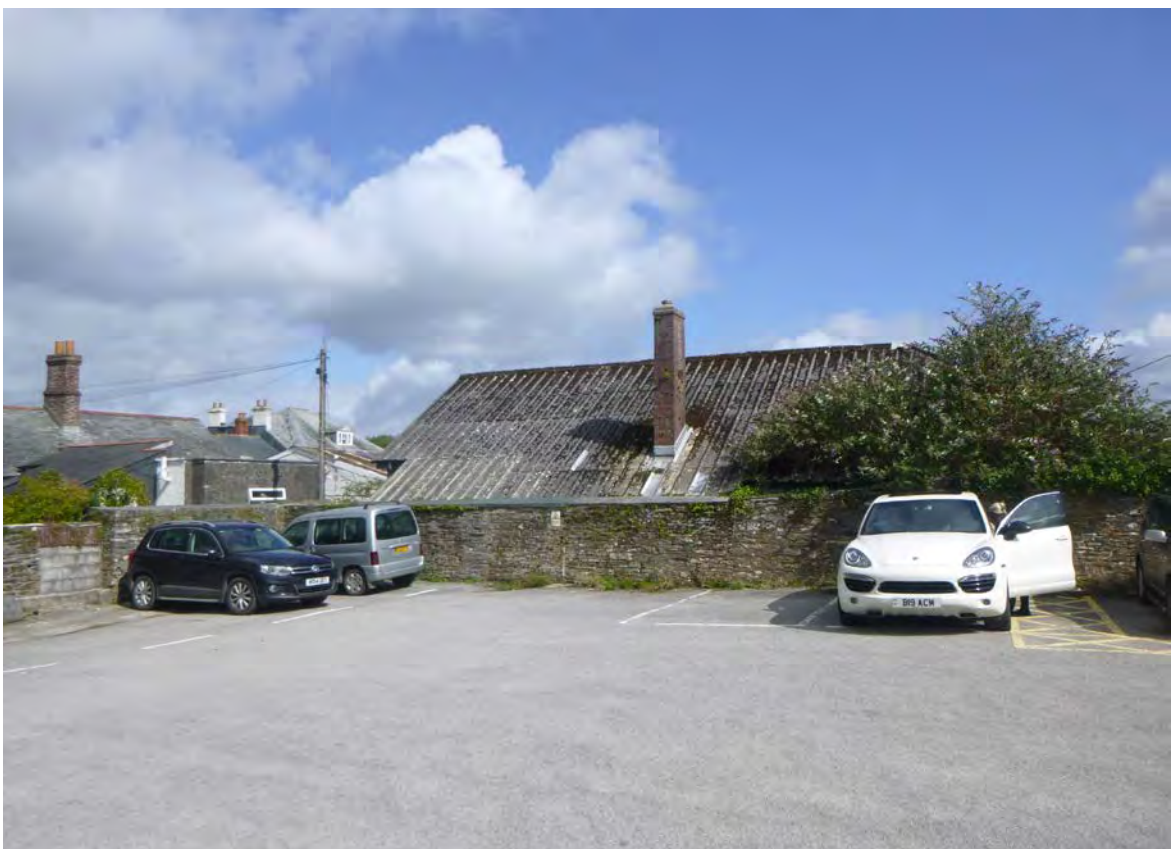
Photograph 42: Suspected asbestos roof at NGR 225003, 064430.

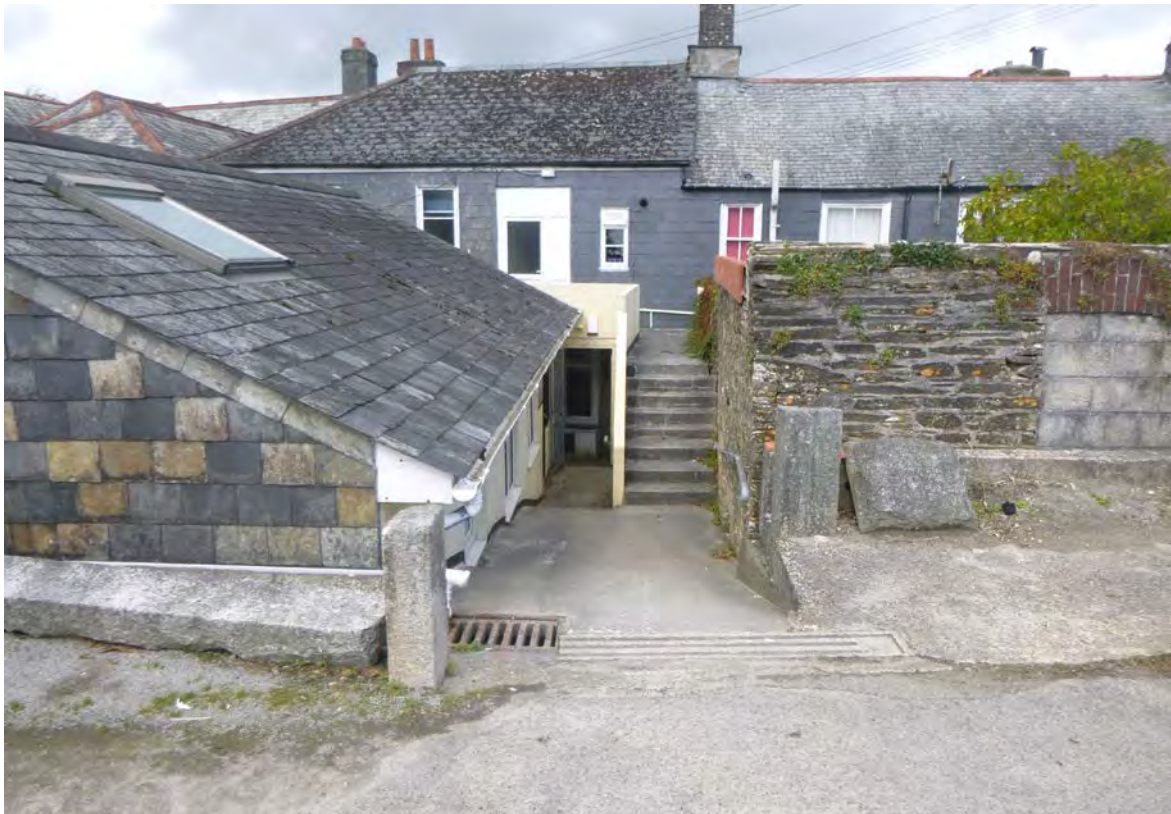
Photograph 43: North-west car park boundary, note small drain and sloping concrete ramp giving rise to potential localised flooding events.

15. Along the north-west boundary of the site, between NGR 224999, 064440 and NGR 224954, 064451, the ground level slopes gently northwards. At this location a number of business premises and residential properties back on to the car park and are connected by means of steep paths. Obvious drainage measures were not observed in this area with high levels of surface run-off during seasonally high levels of precipitation likely to contribute towards localised flooding events. Additional drainage measures should be considered by the designer at this location.

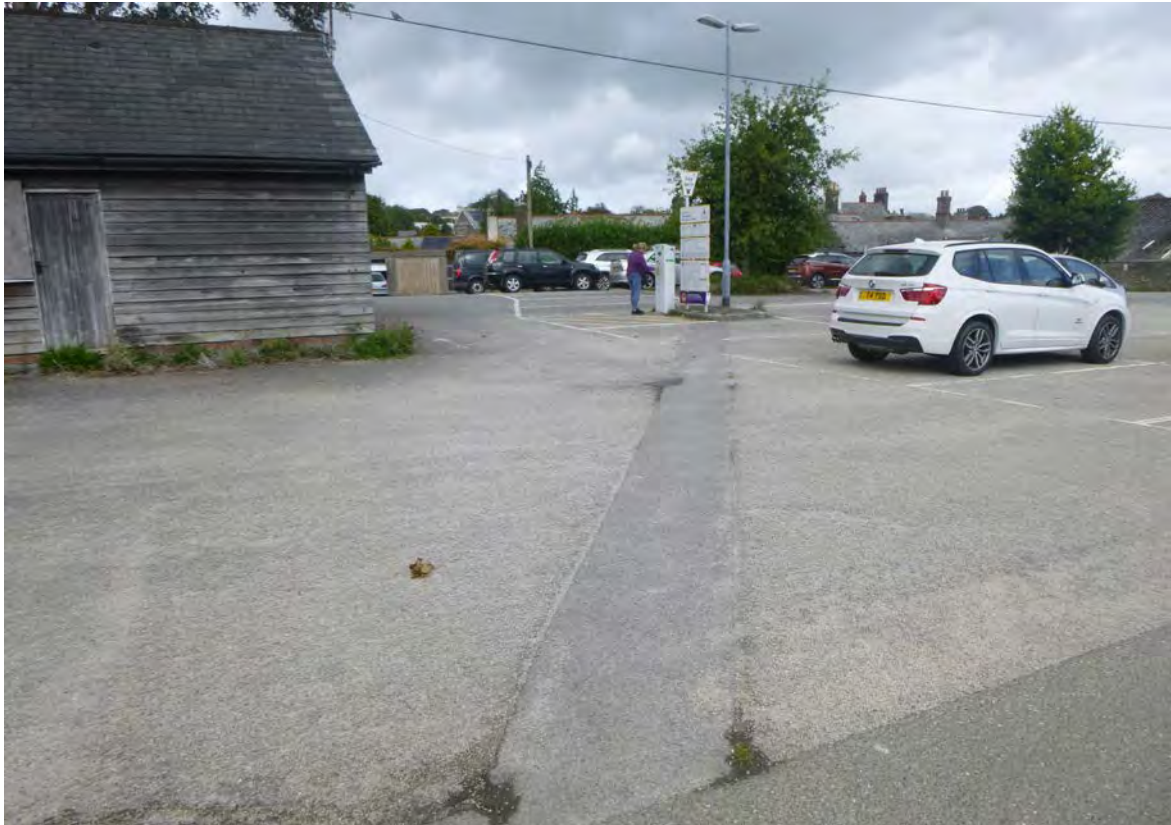
Photograph 45: Reinstatement scar illustrating abundance of buried services.

6. An electricity substation was observed at NGR 224925, 064420.
7. The surface of the cattle market site is gently undulating and consists of asphalt with frequent service reinstatement surface scarring, occasional scouring and localised depressions. The presence of asphalt products should be taken into account by the designer and may warrant geochemical testing to explore disposal options should the material contain tar, and the level hazard exposed to site workers.

8. Utilities observed during the walkover survey included overhead telegraph lines, utility covers corresponding with mains water, gas and electricity. The exact location of utilities should be confirmed by a full utility survey.

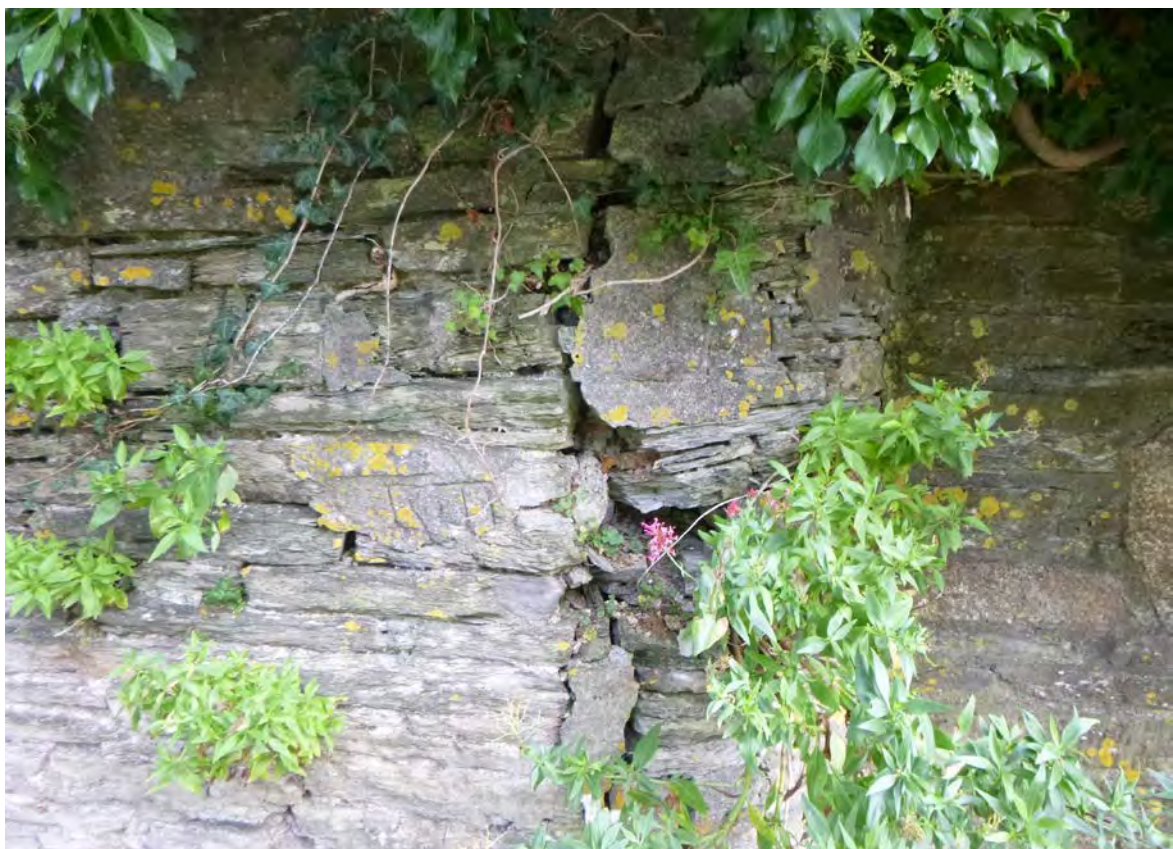
Photograph 48: Wall render cracking along Varley lane approximate NGR 224925, 064426.

5. Between NGR 224925, 064424 and 224950, 064485 Varley Lane narrows into a single lane. Residential properties are located immediately to the west whilst a semi-continuous stone boundary wall was observed to the east. The proximity of residential properties may have implications with regards to potential working hours and noise restrictions and should be considered by the designer. Localised cracking of wall rendering was also observed at this location.

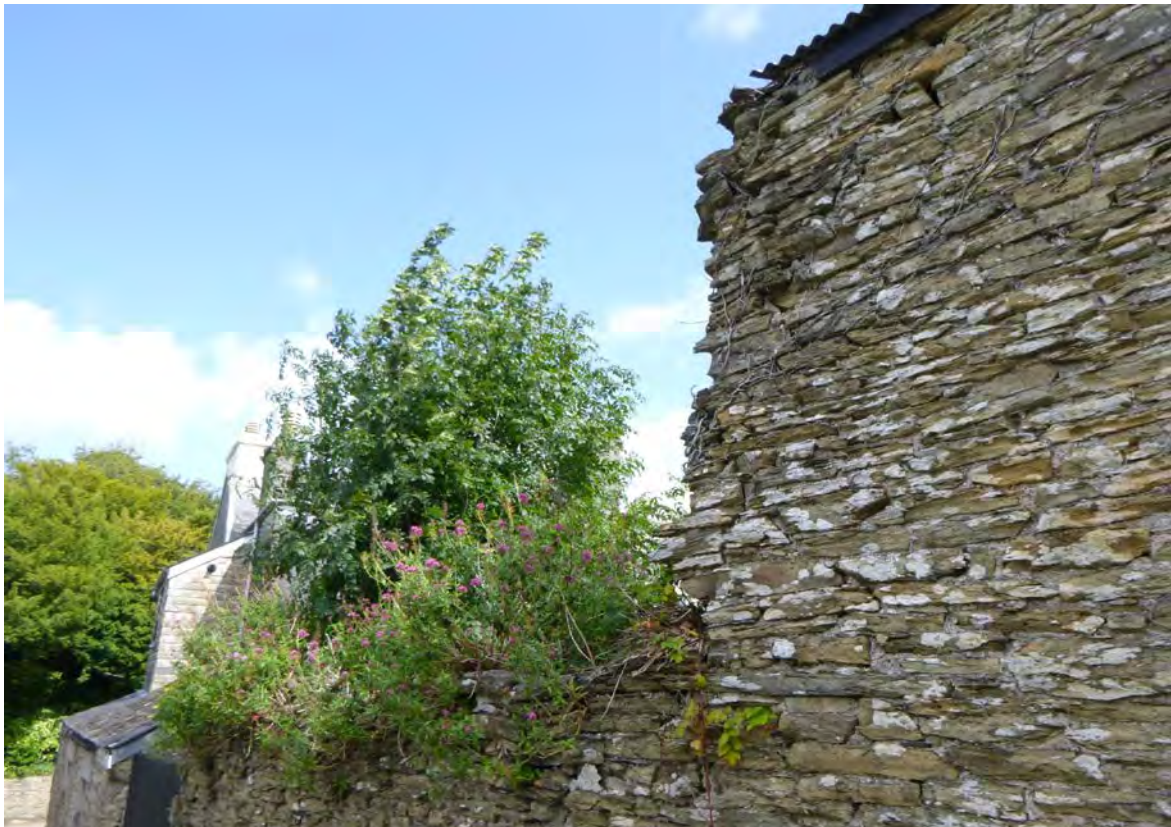
Photograph 49: Unstable boundary wall along Varley Lane approximate NGR 224943, 064470.

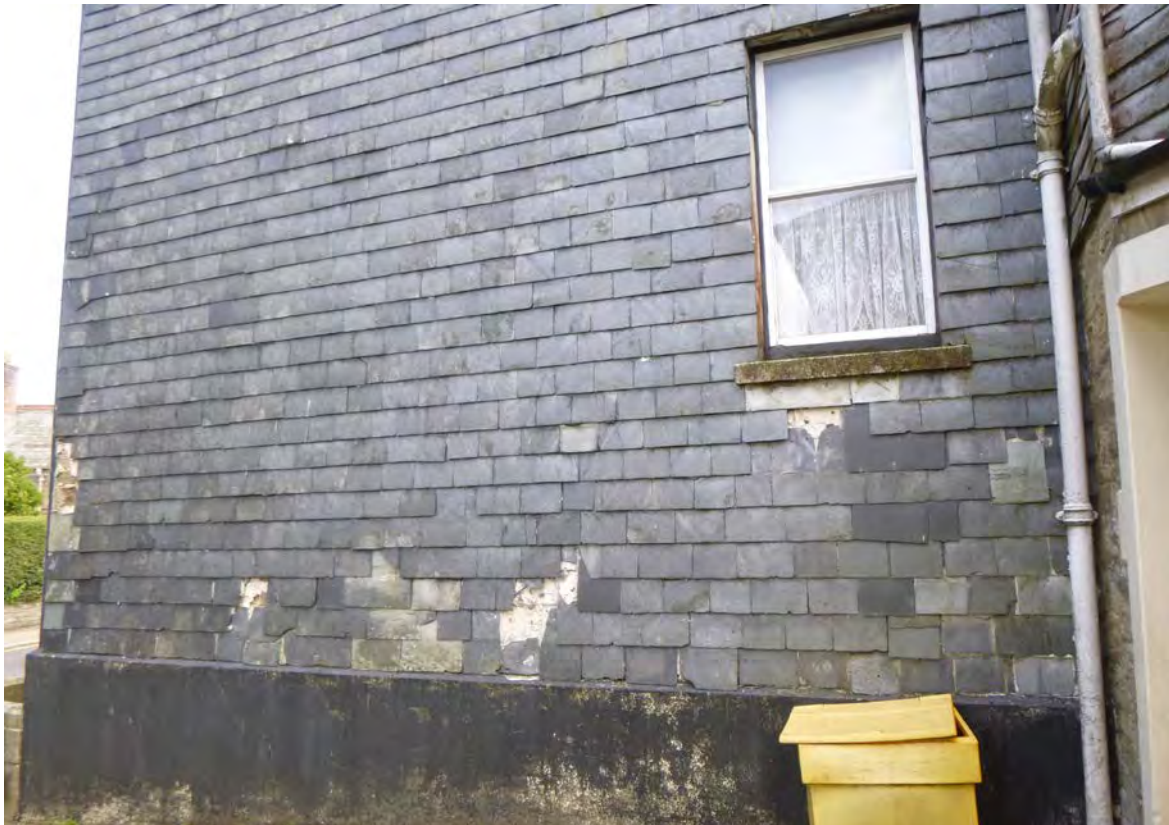
Photograph 51: Existing damage to wall of property at NGR 224955, 064491.

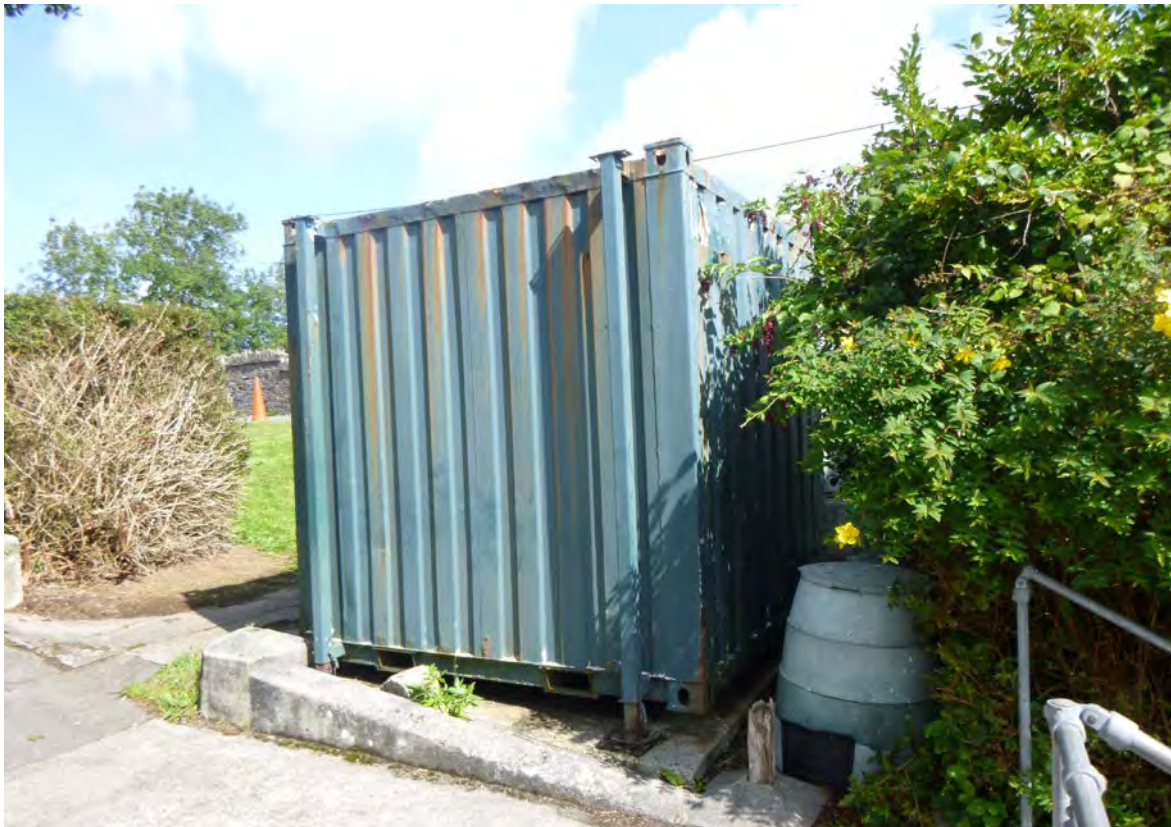
Photograph 5: Steel container of unknown contents, NGR 224904, 064388.

6. A 6-10ft capacity steel shipping container of unknown contents was observed at approximate NGR 224906, 064385. An empty water tank was reportedly present in the water tower at NGR 224894,064366 whilst a gas fuelled boiler was reportedly located in the main school building at NGR 224890, 064402, neither tank was observed during the site walkover.

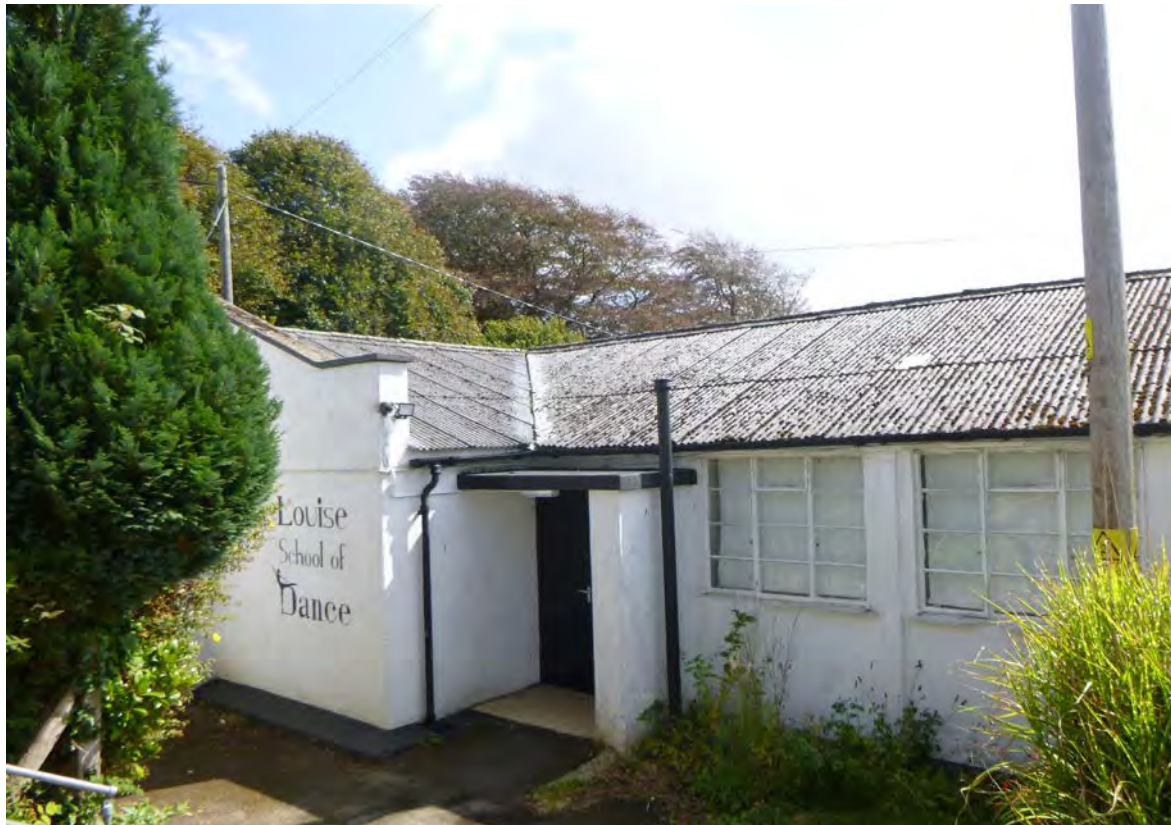
Photograph 7: Outbuilding (NGR 224910, 064370), note suspected asbestos roof.

5. Suspected asbestos roofing was observed at a number of locations across this area these included the school outbuilding at NGR 224880, 064378 and the water tower at NGR 224894, 064366.
