Cattle Market, Liskeard – Regeneration

Desk Study Report
Project No: 64570

Report Title Desk Study Report

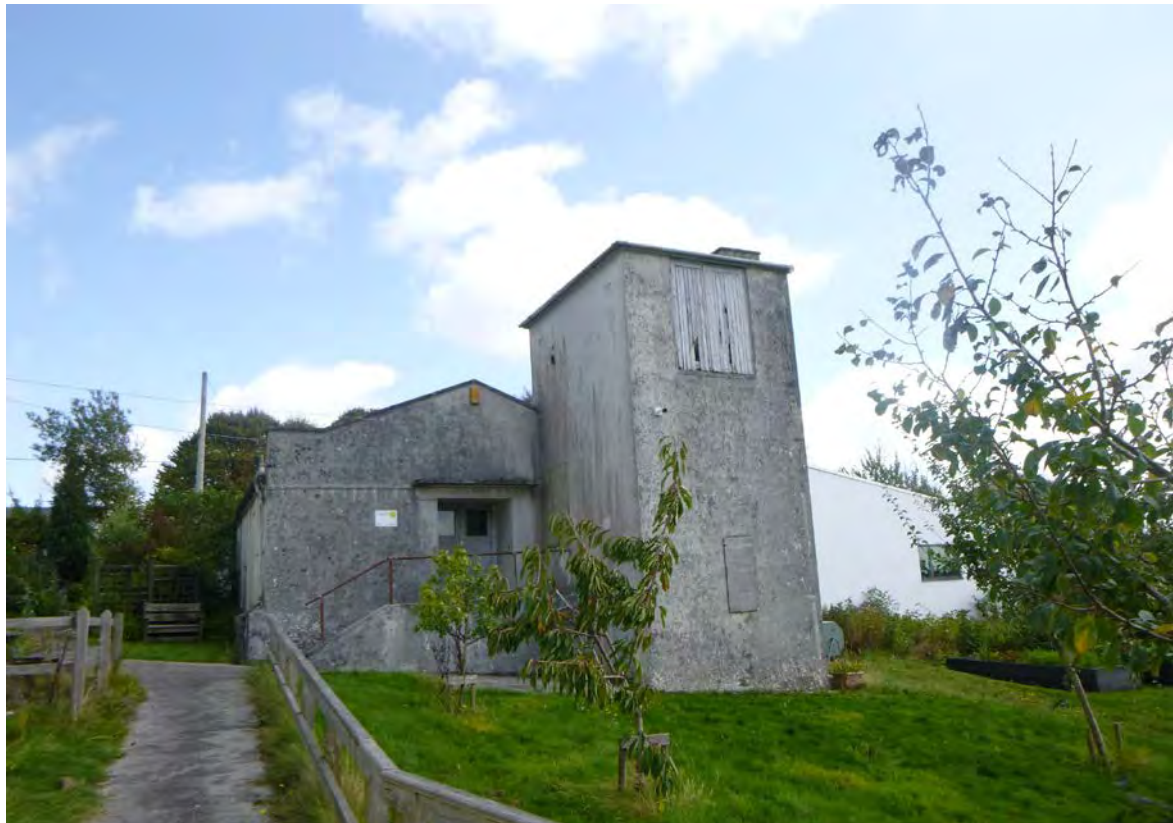
Photograph 9: Water tower (NGR 224894, 064366), suspected asbestos roof and anecdotal evidence of gas powered boiler inside.

5. Suspected asbestos roofing was observed at a number of locations across this area these included the school outbuilding at NGR 224880, 064378 and the water tower at NGR 224894, 064366.

6. A 6-10ft capacity steel shipping container of unknown contents was observed at approximate NGR 224906, 064385. An empty water tank was reportedly present in the water tower at NGR 224894,064366 whilst a gas fuelled boiler was reportedly located in the main school building at NGR 224890, 064402, neither tank was observed during the site walkover.

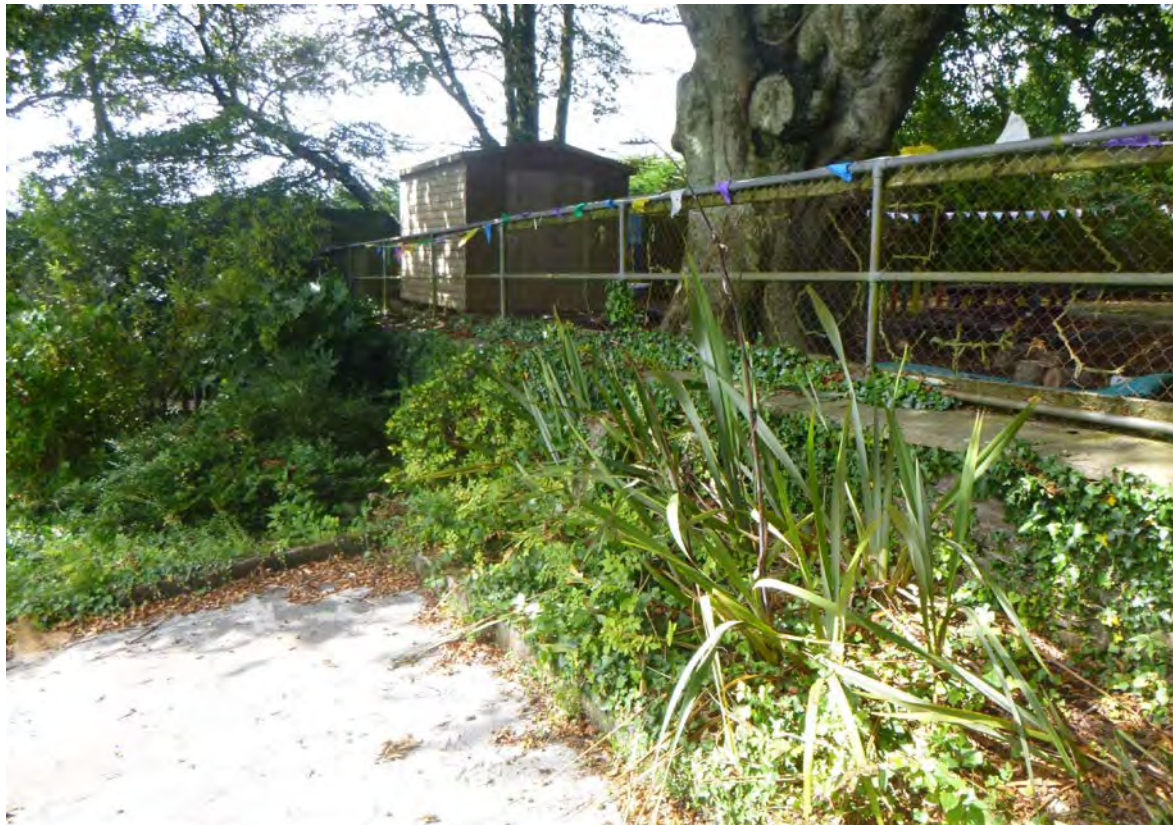
Photograph 11: Benched terrace and mature oak tree, NGR 224846, 064382.

4. East of the school building at NGR 224852,064392 is a children's play area. A large, mature oak tree approximately one metre in diameter was observed in this area at approximate NGR 224846,064382. The tree is situated immediately above a benched retaining wall that accommodates the south-easterly fall in elevation characteristic of the site. The designer should take into account the potential presence of a mature root network which may have a destabilising effect on the current retaining wall. Signs of ongoing instability in this area were not observed.

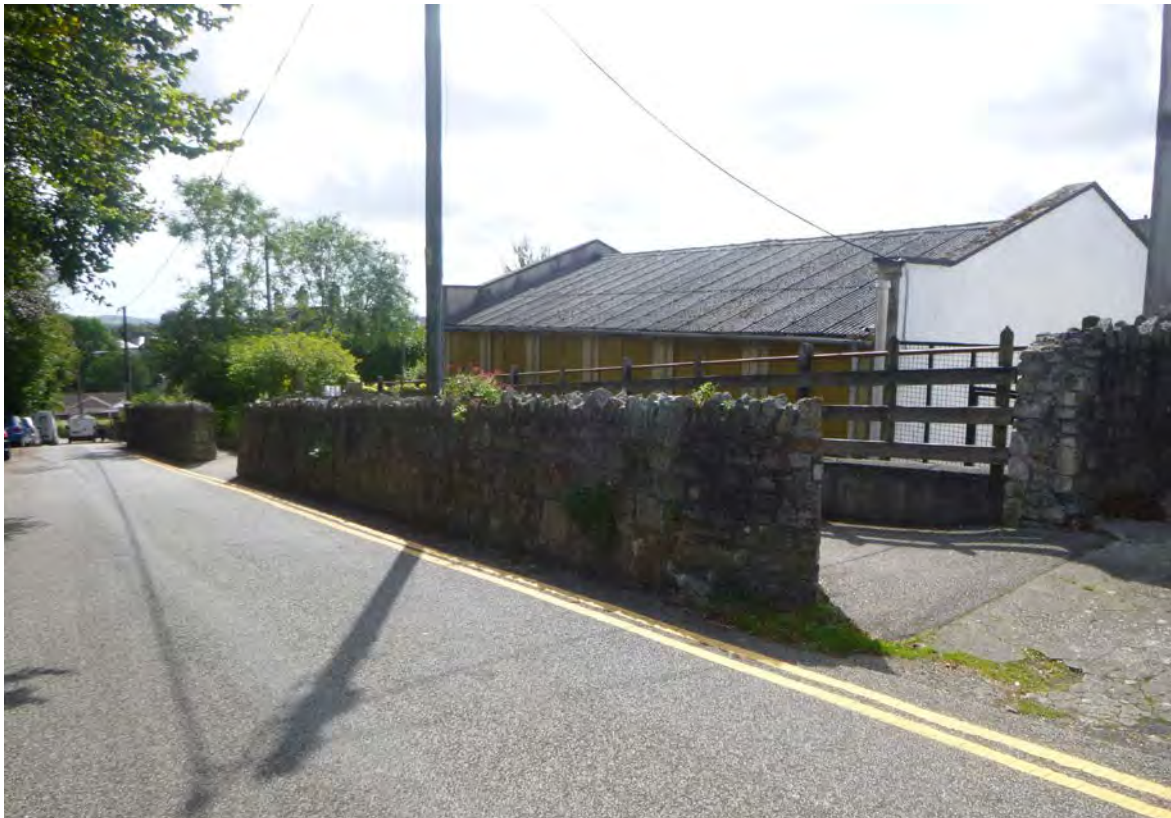
Photograph 13: Historical granite wall, note outbuilding with suspected asbestos roofing (NGR 224912, 064368).

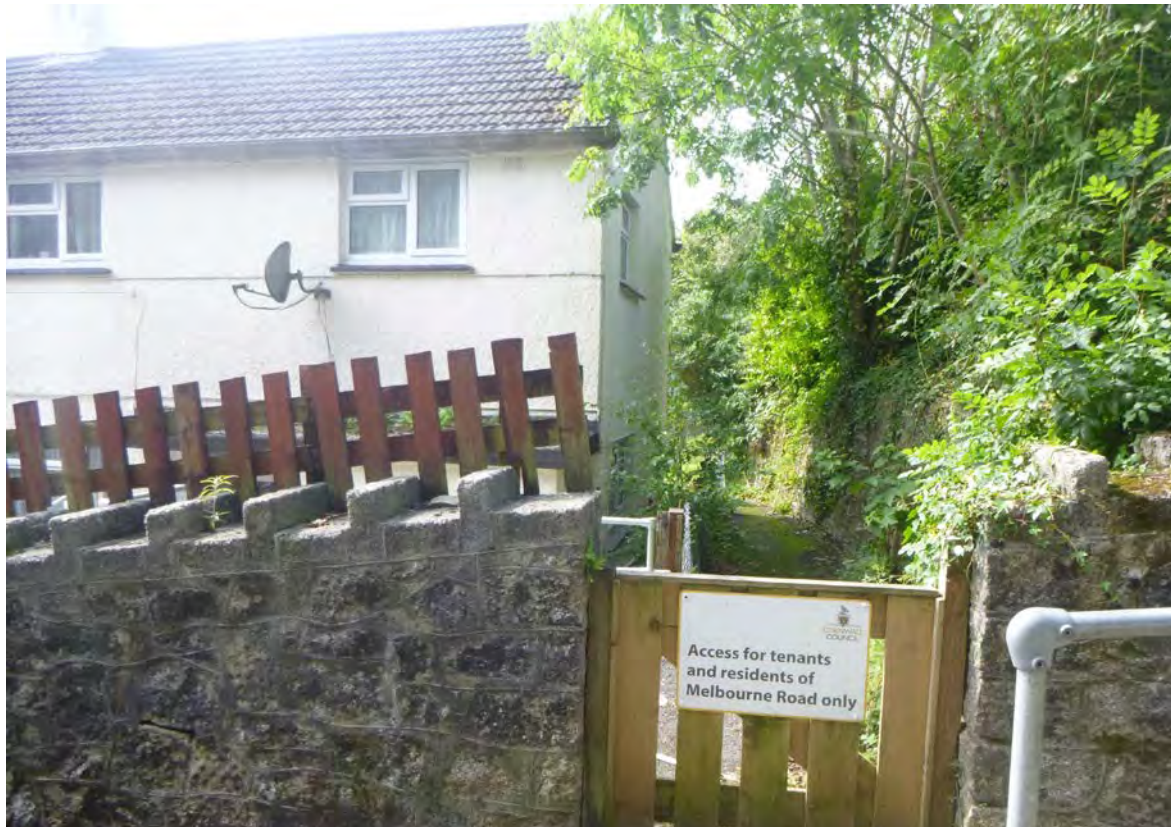
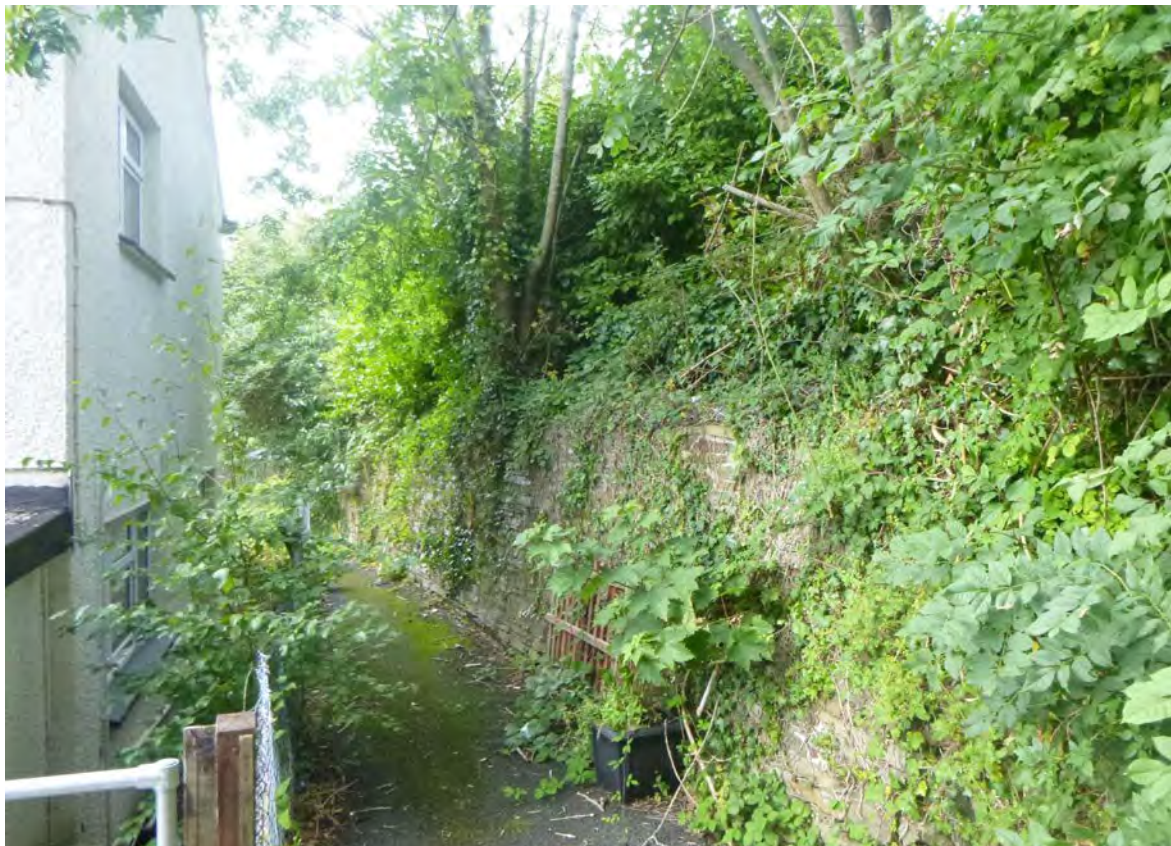
Photograph 15: Southern stone retaining wall bordering local authority housing (NGR 224918, 064341).

Photograph 16: Southern stone retaining wall (NGR 224918, 064341).

8. A retaining wall separating the southern boundary of the Liskeritt Community Centre premises and housing within a local authority housing estate was observed at NGR 224916, 064341. Permission was not obtained for inspection of the retaining wall therefore a detailed inspection was not completed during the walkover. The implications of additional loading of the current retaining wall should be taken into account by the designer.
