National Asset Delivery
Technical Surveys and Testing

Site Information for Clifton Bridge –
Concrete Testing

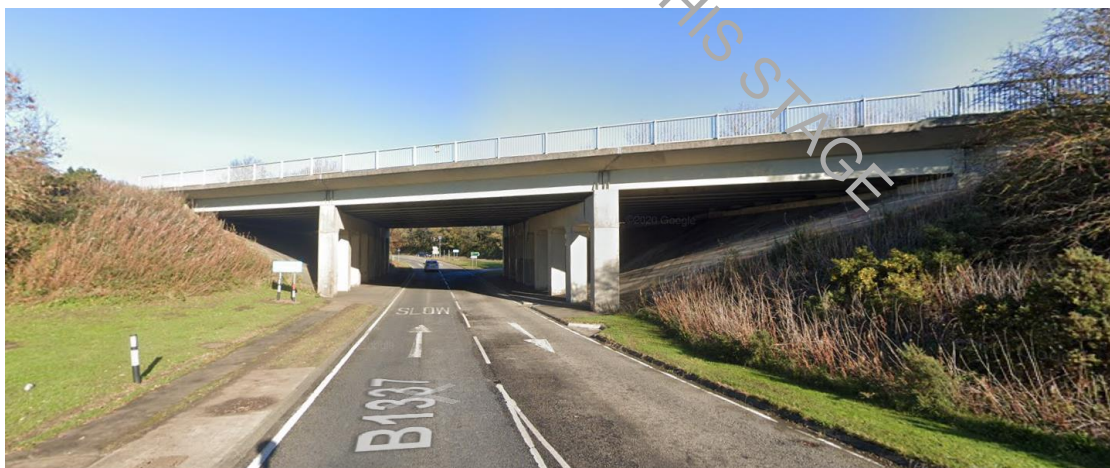
Figure 2: View under Clifton Bridge looking North

The superstructure is formed of twin composite decks comprising reinforced concrete deck slabs and cantilevers supported by steel universal beams. Each carriageway is

supported on a separate deck. The universal beams are braced by pairs of steel channel sections. The substructures are constructed of reinforced concrete supported on piled foundations.

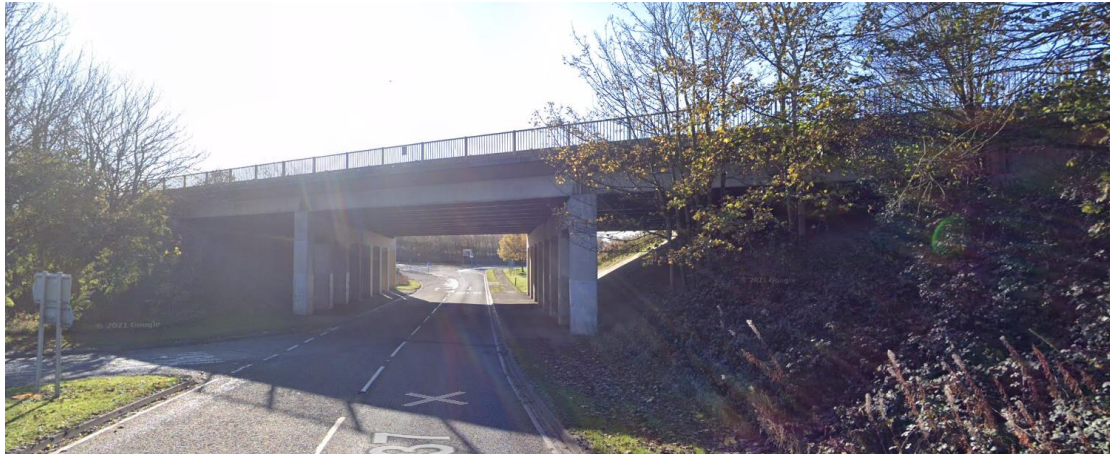
Figure 3: View under Clifton Bridge looking South
