TASK NO.	TASK/DESCRIPTION H7 BILGES	NOTES
H7.01	<p data-bbox="400 383 863 416">Steering Gear Compartment Bilge</p>

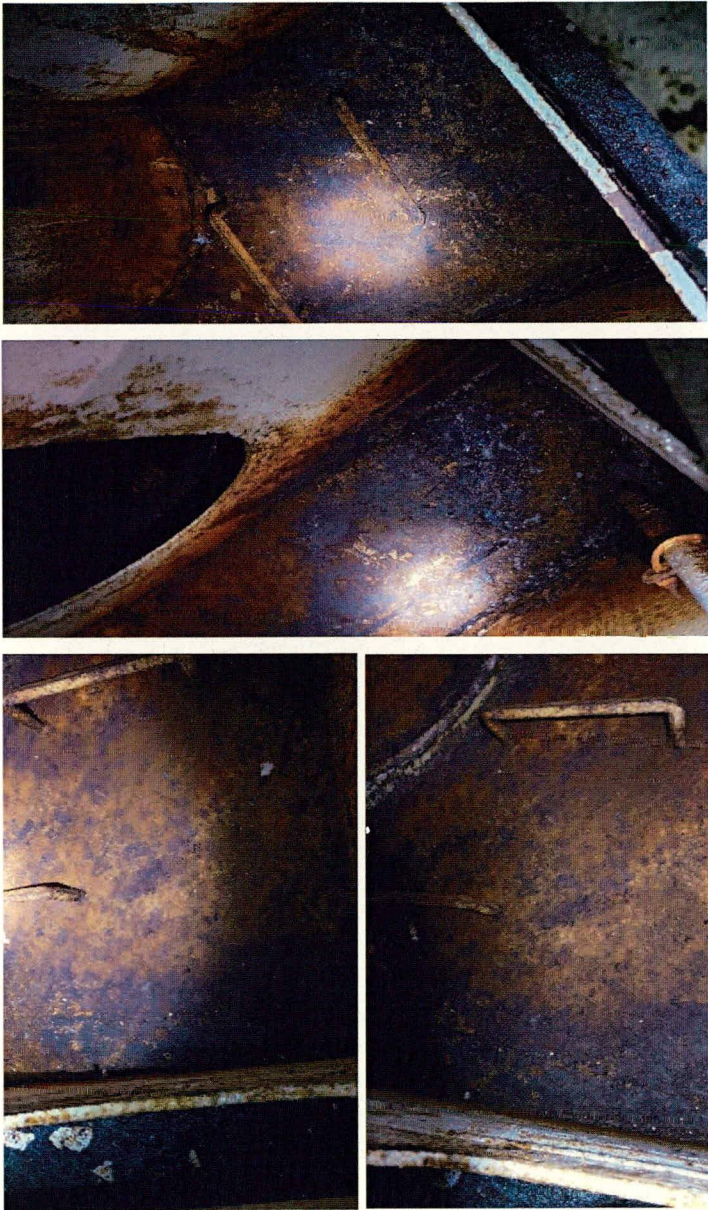
<p data-bbox="400 1648 1230 1733">The paint coatings have broken down allowing active surface corrosion on both port and stbd sides bilge wells. Area requires scaling back and cleaning before REPRESENTATION.</p> <p data-bbox="400 1747 970 1778">ALLOW for 8m² REPRESENTATION. either side.</p>	<p data-bbox="1251 383 1449 499">IAW Paint scheme -General 12 and Annex B refer.</p> <p data-bbox="1251 528 1410 645">Contractor to remove and dispose of all arisings.</p> <p data-bbox="1251 674 1449 840">Adequate ventilation to be arranged before work commences IAW General 3.2.</p>

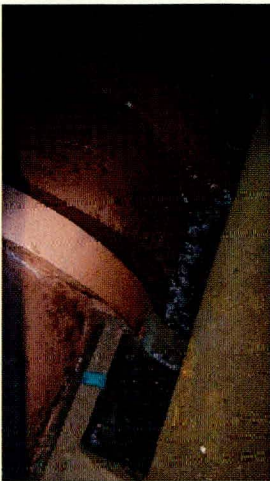
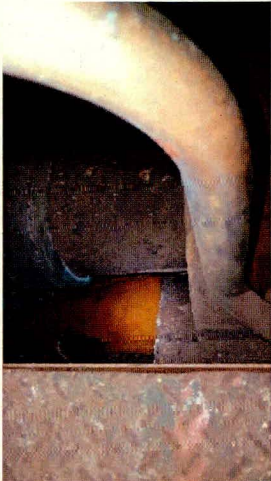
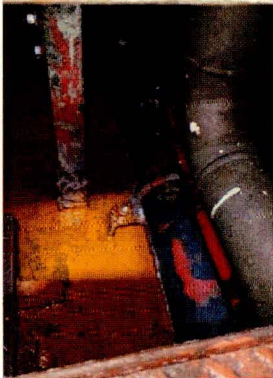
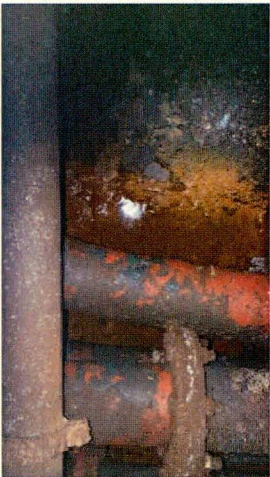
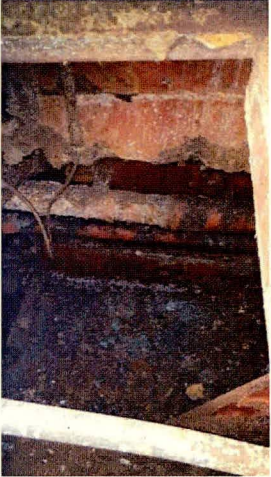
TASK NO.	TASK/DESCRIPTION	NOTES
	H7 BILGES	
H7.02	<div>Engine Room and Generator Compartment Bilge</div> <div>

</div>	<div>IAW Paint scheme -General 12 and Annex B refer.</div> <div>Contractor to remove and dispose of all arisings.</div> <div>Adequate ventilation to be arranged before work commences IAW General 3.2.</div>
	<div>Bilge wells contain standing water throughout. In some areas levels high enough to cover tank tops. Total breakdown of bilge coatings throughout resulting in active corrosion. Unable to check extent of corrosion below standing water. Bilges throughout to be pumped out, cleaned and dried to allow for scaling back, preparing and REPRESENTATION of affected areas.</div> <div>ALLOW for 50m² REPRESENTATION.</div>

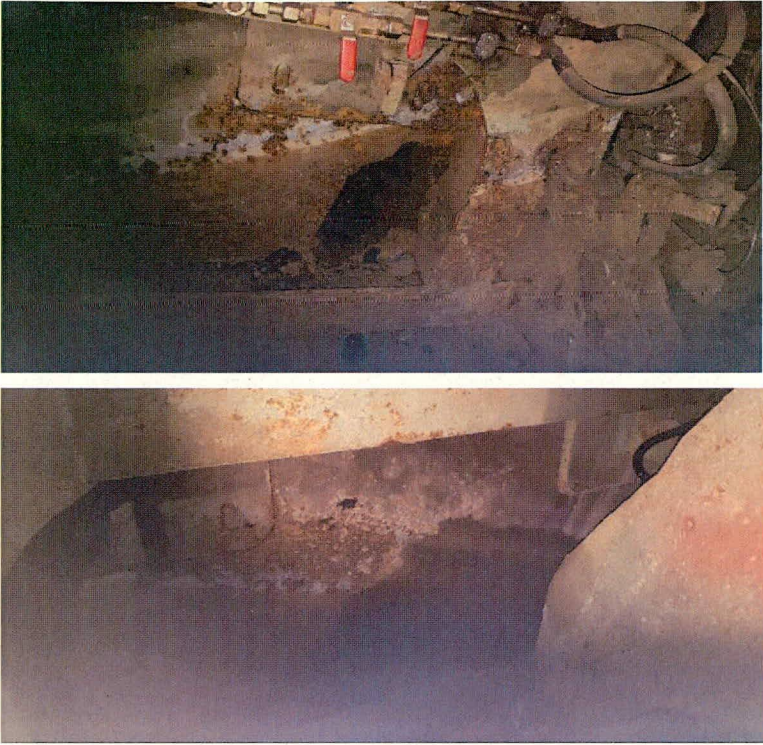
TASK NO.	TASK/DESCRIPTION	NOTES
	H7 BILGES	
H7.04	<p>Bow Door and Vehicle Ramp Compartment</p>

<p>Although dry at time of visit, evidence of previous free standing water in bilge of compartment which has lead to total breakdown of bilge coatings resulting in active corrosion. Bilges to be cleaned and dried to allow for scaling back, preparing and REPRESENTATION of affected areas.</p> <p>ALLOW for 20m² REPRESENTATION.</p>	<p>IAW Paint scheme -General 12 and Annex B refer.</p> <p>Contractor to remove and dispose of all arisings.</p> <p>Adequate ventilation to be arranged before work commences IAW General 3.2.</p>
