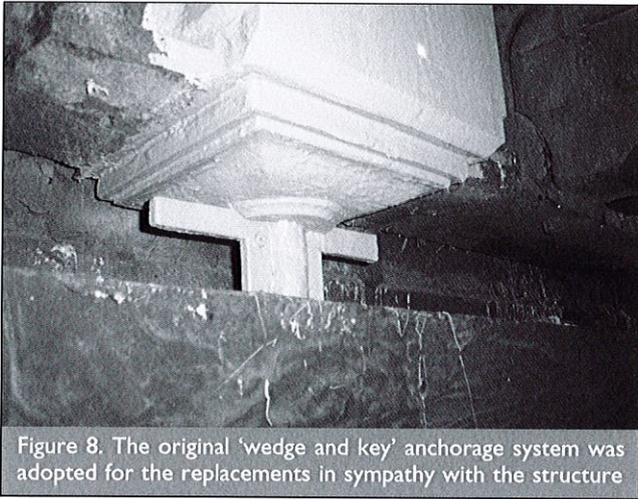
Figure 8. The original 'wedge and key' anchorage system was adopted for the replacements in sympathy with the structure

out within. The early 'safety critical' hanger replacements adopted a modern threaded bar with nut to facilitate ease of load transfer and confidence that hanger stresses had been reinstated. The design was subsequently modified to incorporate a replica of the original wedge and key anchorage system in sympathy with the rest of the structure (Figure 8). The future durability has been improved by the addition of drain holes, the application of a wax corrosion inhibitor and provision of inspection holes to allow convenient inspection and cleaning.

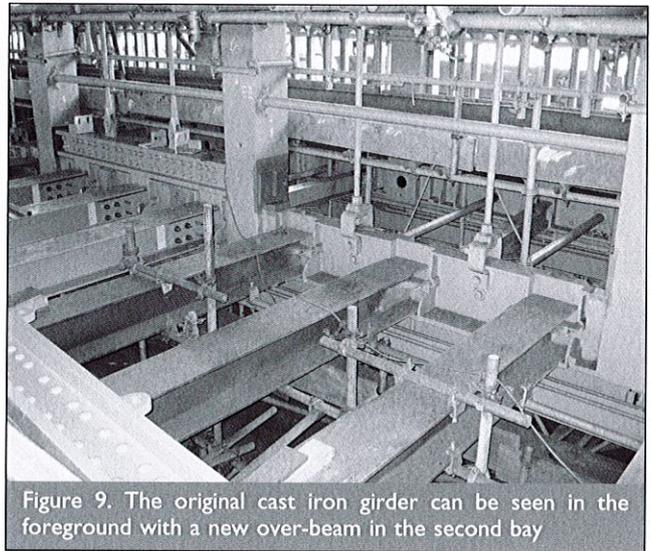
4.1.3. Concealed alternative load paths to 'fatigued' cast iron longitudinal girders. The cast iron longitudinal girders span between the columns and support the steel cross-girders of the road deck. Fatigue cracks were found at critical locations within the cast pockets that support the steel cross-girders. Cracks were widespread and the original cast iron girders were no longer considered reliable or capable of sustaining future loading aspirations.

Figure 9. The original cast iron girder can be seen in the foreground with a new over-beam in the second bay

The solution was to provide an alternative load path that, in the form of steel over-beams, was designed to isolate vertical load from the original cast iron elements. The new over-beams were designed and detailed such that all the original fabric was retained while concealing the new steelwork beneath the footpath. In all, 144 over-beams were fabricated, assembled and painted off site before being brought to site and connected to new steel intermediate suspension hangers and the new steel cross-girders (Figure 9).

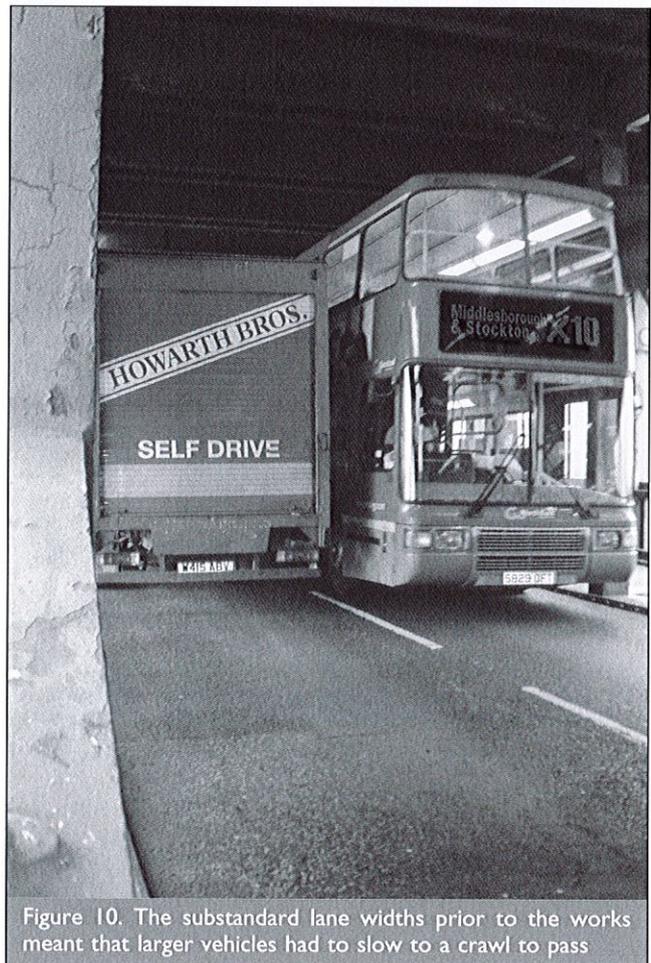
Figure 10. The substandard lane widths prior to the works meant that larger vehicles had to slow to a crawl to pass

and heavier loads perhaps and the need to conform to modern safety attitudes. Applying principles of conservation has resulted in judgements being made as to the significance of parts and the whole, that is what is required to allow the bridge to cope with needs of modern traffic while keeping its historic value (Figures 10 and 11).

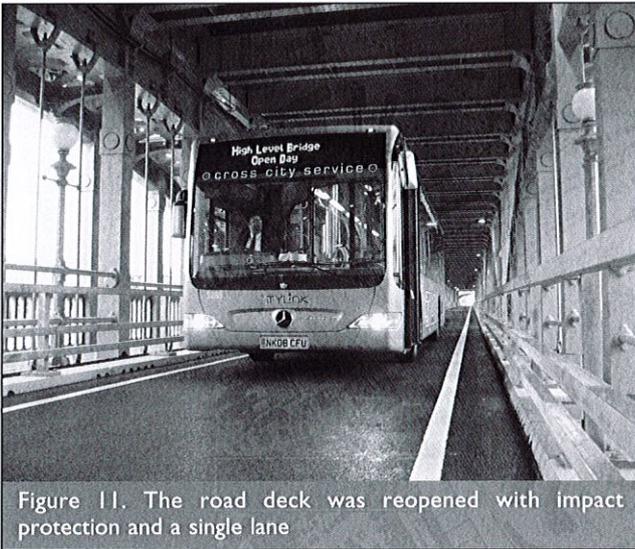
Figure 11. The road deck was reopened with impact protection and a single lane

4.1.4. Installation of vehicle impact protection. The cast iron columns of the road were assessed and found to be at risk of impact, which could have resulted in local loss of support to the rail deck and, ultimately, the potential for derailment of trains. The design incorporated impact protection to mitigate this risk. Special 'torsion beams' were necessary to support the barrier posts and distribute loads into a number of steel cross-girders and into the superstructure.

It was accepted that the introduction of the barriers was a modern intervention. The principle of reversibility was therefore adopted in this case. The barriers and torsion beams were designed such that they can be unbolted and removed.

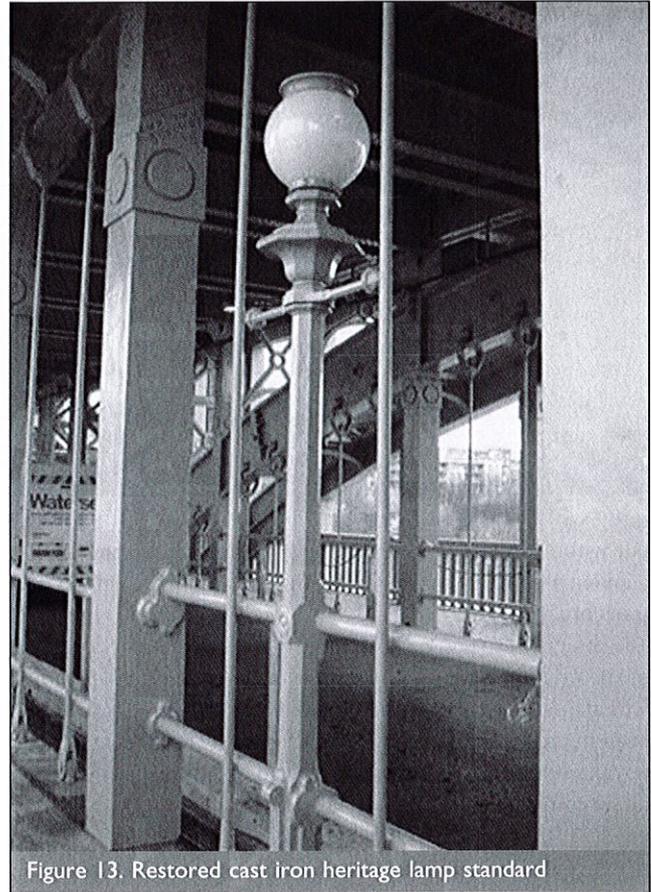
Figure 13. Restored cast iron heritage lamp standard

The lamp posts were in various states of dilapidation (Figure 12). All were removed from site, blast cleaned and inspected. Those in good condition were used as mould templates for the casting of missing components. Missing and cracked elements were connected and repaired using Metalock. Record drawings and archive photographs were referenced to allow informed restoration and detailing of the new lamp globes (Figures 13 and 14).

In order to avoid cutting holes into the lamp posts, the new electric cables were routed through existing voids within the

adjacent column and hand rail tube. The new inspection hole at the base of the column was also used for this purpose.

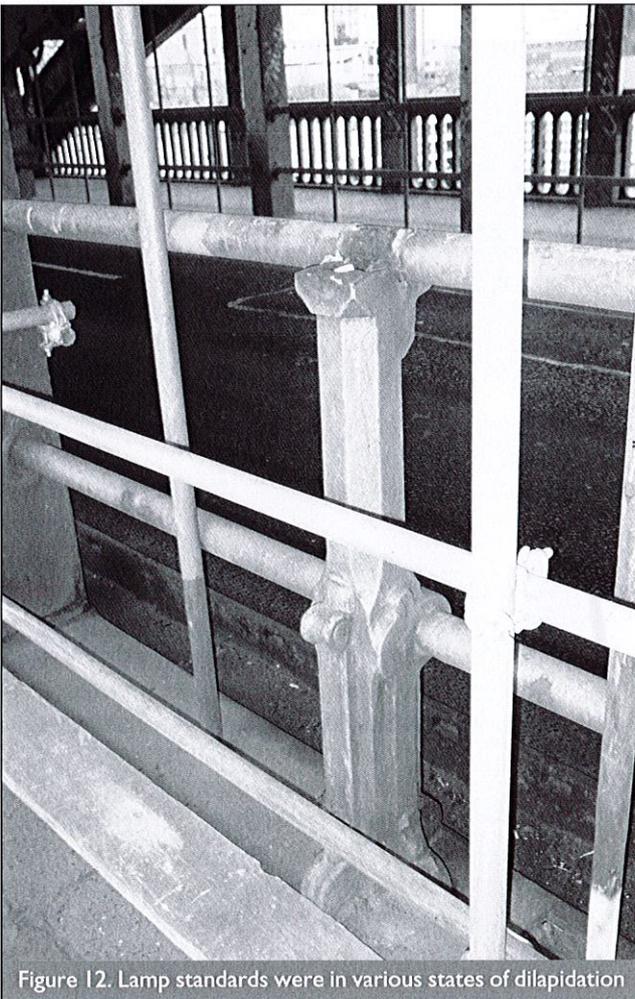
Figure 12. Lamp standards were in various states of dilapidation

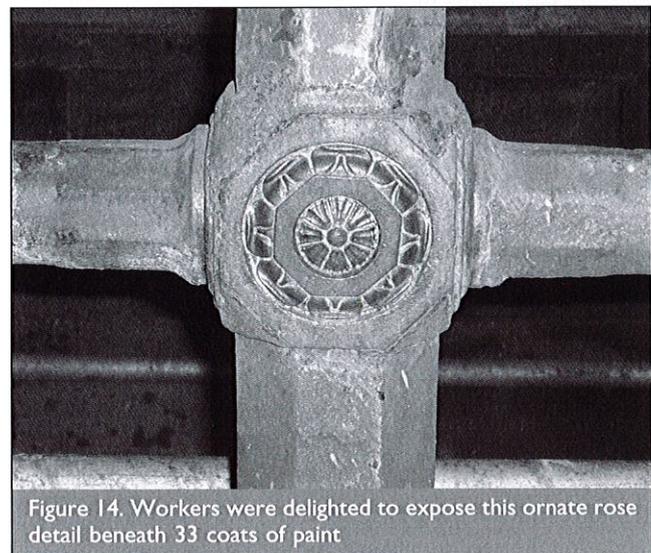
Figure 14. Workers were delighted to expose this ornate rose detail beneath 33 coats of paint

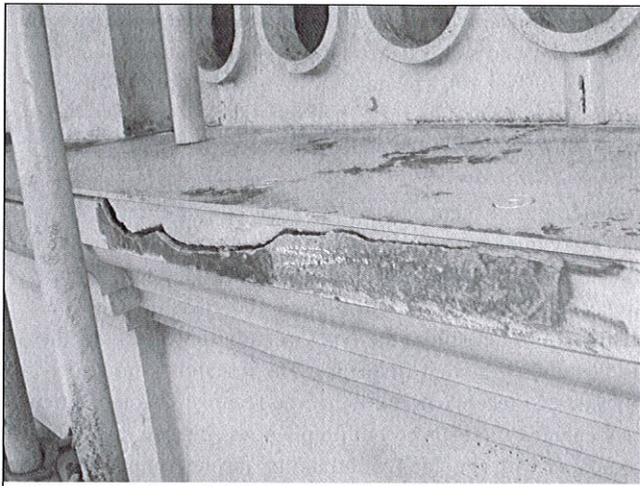
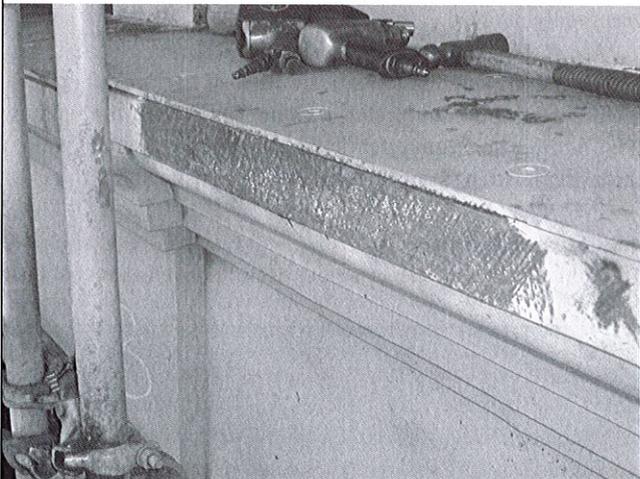
Figure 15. Cracks (a) were repaired using mechanical stitching (b)

4.3.1. *Crack repairs.* Metallock mechanical stitching was used extensively throughout the bridge to repair fractured cast iron members. This solution was favoured by conservation officers as retention of original fabric was maximised and, once painted, repairs were almost invisible. Steel plate bonding was also used extensively to bridge over cracks and provide non-intrusive and subtle strengthening solutions (Figure 15 and 17).

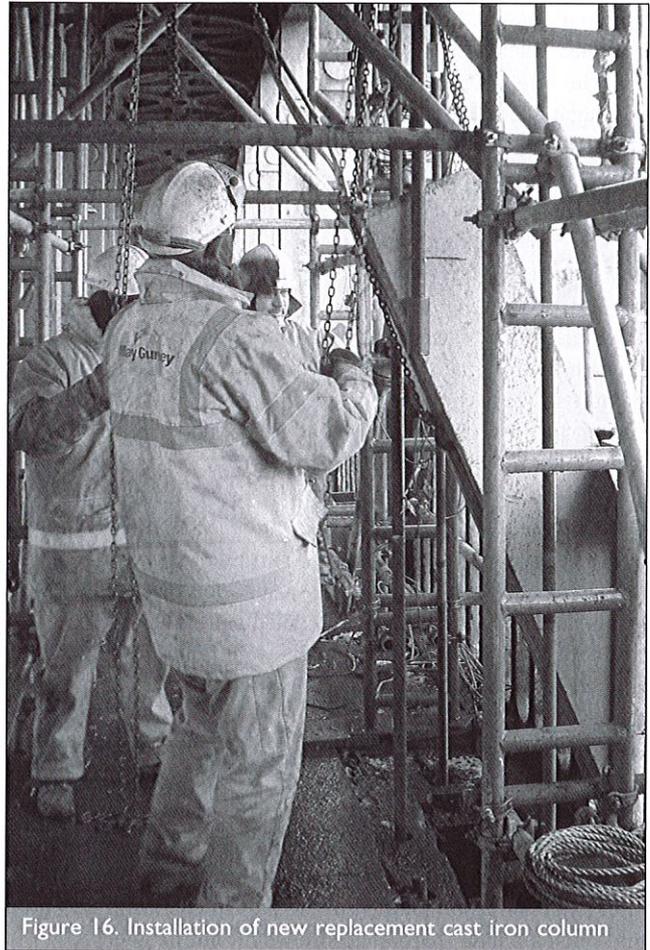
Figure 16. Installation of new replacement cast iron column

4.3.2. Column replacement. Two cast iron columns within the last Newcastle span (at the location of a major warehouse fire in 1866) were so badly damaged they were deemed beyond repair. The decision was made completely to replace the two columns using like-for-like detailing in cast iron. The columns were slightly modified from the originals in order to facilitate their installation in a different sequence to that of the originals (Figure 16). This work was all the more challenging as it was carried out while the bridge was still open to road traffic. The lower part of the column was detailed in two parts to allow clamping around the dovetail connections at the ends of the adjacent longitudinal girders.

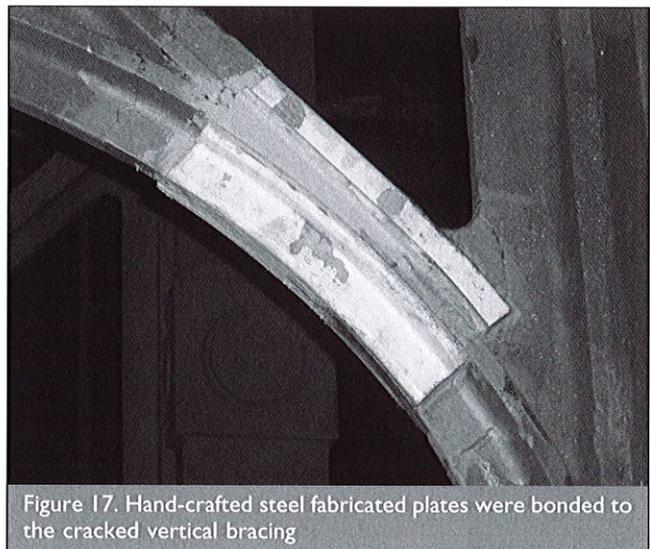
4.3.3. Repairs to cracked vertical bracing. The vertical bracing had also suffered cracking. Previous repairs had bridged the cracks with bolted angles, but this resulted in cracks forming at the next weakest location. Vertical bracing plays an important structural role and care had to be taken not to aggravate the situation. Analysis proved that the bracing would function satisfactorily using the 'compression only' members, so bridging across cracks to reinstate a tension load path was therefore not necessary. The solution adopted was to use subtle bonded plates that were glued to one side of the crack only (Figure 17). This ensured that the compression load path was maintained while allowing the crack to open slightly when in tension, all with

Figure 17. Hand-crafted steel fabricated plates were bonded to the cracked vertical bracing

minimum intrusion. Hand-crafted plates, when painted, resulted in a solution in sympathy with their environment.

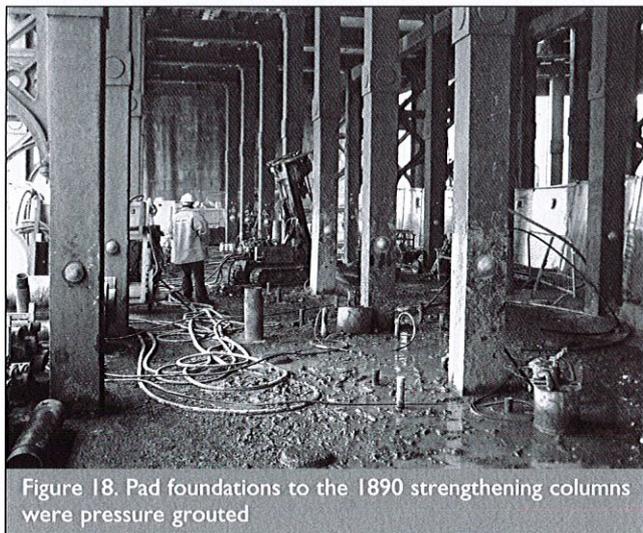
'hogging', that is, breaking their back over the newer internal columns. The assessment assumed similar support stiffness to both the original supports and the 1890 additions, but trial pit investigations highlighted gaps beneath the simple pad stones. Rather than providing support to the cross-girders, the columns and their pad foundations were effectively being suspended by them. The assessment situation instantly went from a 'hogging' problem to a 'sagging' problem. Analysis proved that a 'half-way house' would resolve the overstress without the need for any intrusive strengthening to the girders. The solution did, however, require careful injection and pressure grouting beneath the internal pad foundations such that the desired support stiffness could be achieved (Figure 18). Pre-determined jacking loads were then applied at the column tops to redistribute the bending stresses.

Figure 18. Pad foundations to the 1890 strengthening columns were pressure grouted

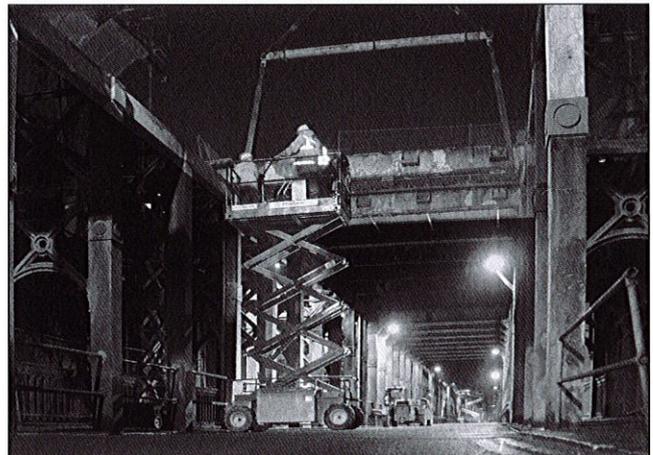
Figure 19. Three 12 m long cast iron rail deck cross-girders were removed from an un-trafficked area

The ambitious two-year programme of cast iron testing included the extraction of three full (12 m long) cast iron cross-girders

from the bridge, which were transported to the University of Manchester and subjected to fatigue loading until failure (Figures 19 and 20). The data provided the information necessary to determine the actual durability of the cross-girders on the bridge.

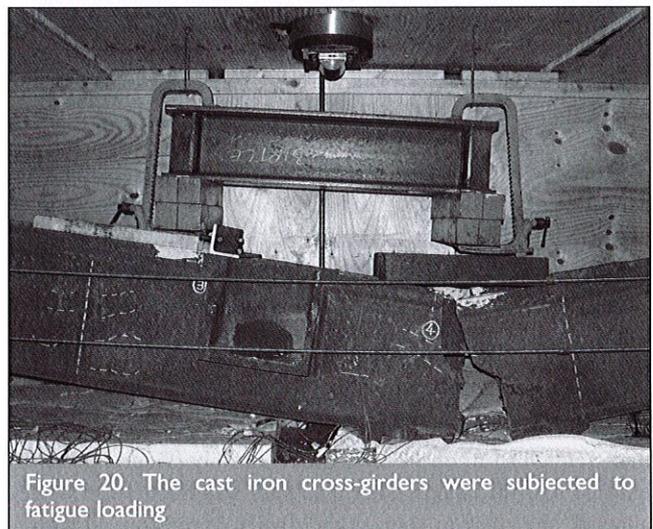
Figure 20. The cast iron cross-girders were subjected to fatigue loading

To determine if there was any residual fatigue life left, it was necessary to go back over history to determine what damage had already occurred. The project team visited the public records archive in Kew and trawled through 160 years of railway timetables to determine the types of train that had used the bridge, and with what frequency. The research team also investigated local coal and industrial records. This monumental task enabled the team to build up a stress history that, when compared with the 'fatigue durability' (as determined from the full-scale destructive testing), showed the cast iron to have useful residual fatigue life. As a result, intrusive strengthening was totally avoided.

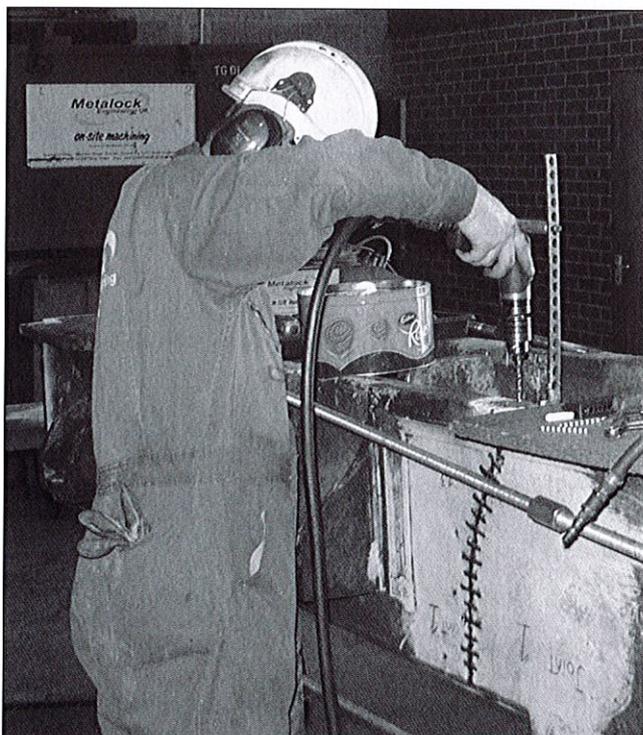
Figure 21. The fractured cross-girders were stitched back together

The three cross-girders tested were stitched back together (Figure 21) before reinforcing with bonded carbon fibre plates (Figure 22). The original fabric was therefore conserved while the working strength of the girders was reinstated.

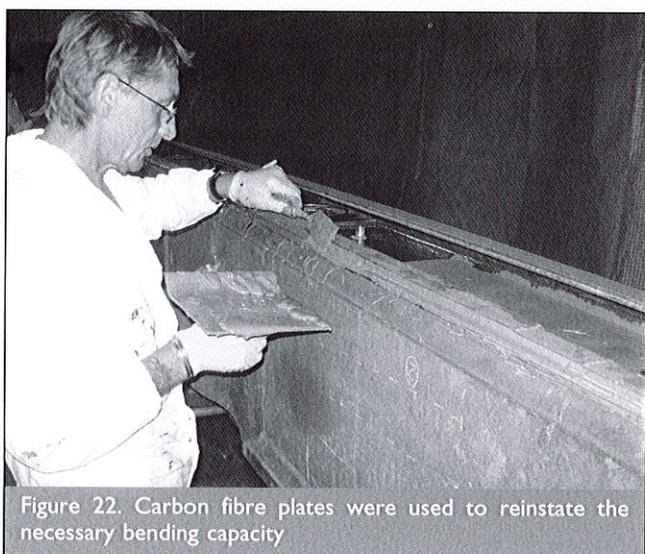
Figure 22. Carbon fibre plates were used to reinstate the necessary bending capacity

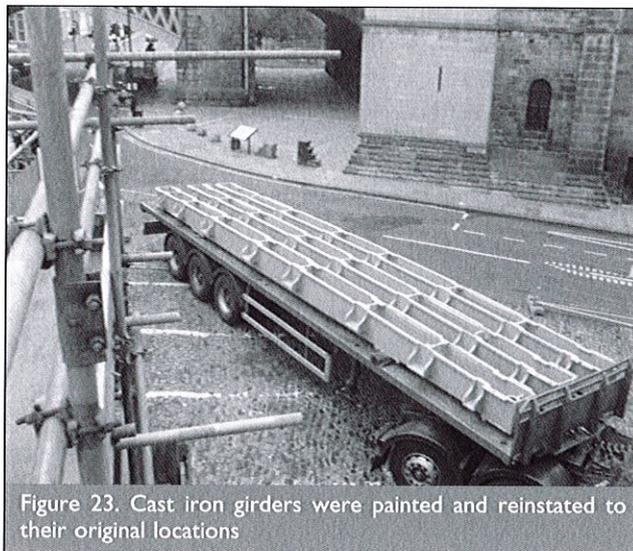
Figure 23. Cast iron girders were painted and reinstated to their original locations

modern high-performance paint system was specified for the bridge which, with maintenance, should have a life of 25 years. Old buildings have a patina that goes with their age and the loss of this is regrettable; however, although a small section of original paint has been retained, the removal of paint for the inspection of possible defects outweighed this loss (Figure 23).
