Phase II Geo-Environmental Assessment Report

C2522 - St Mary's Way, Melton Mowbray

March 2017

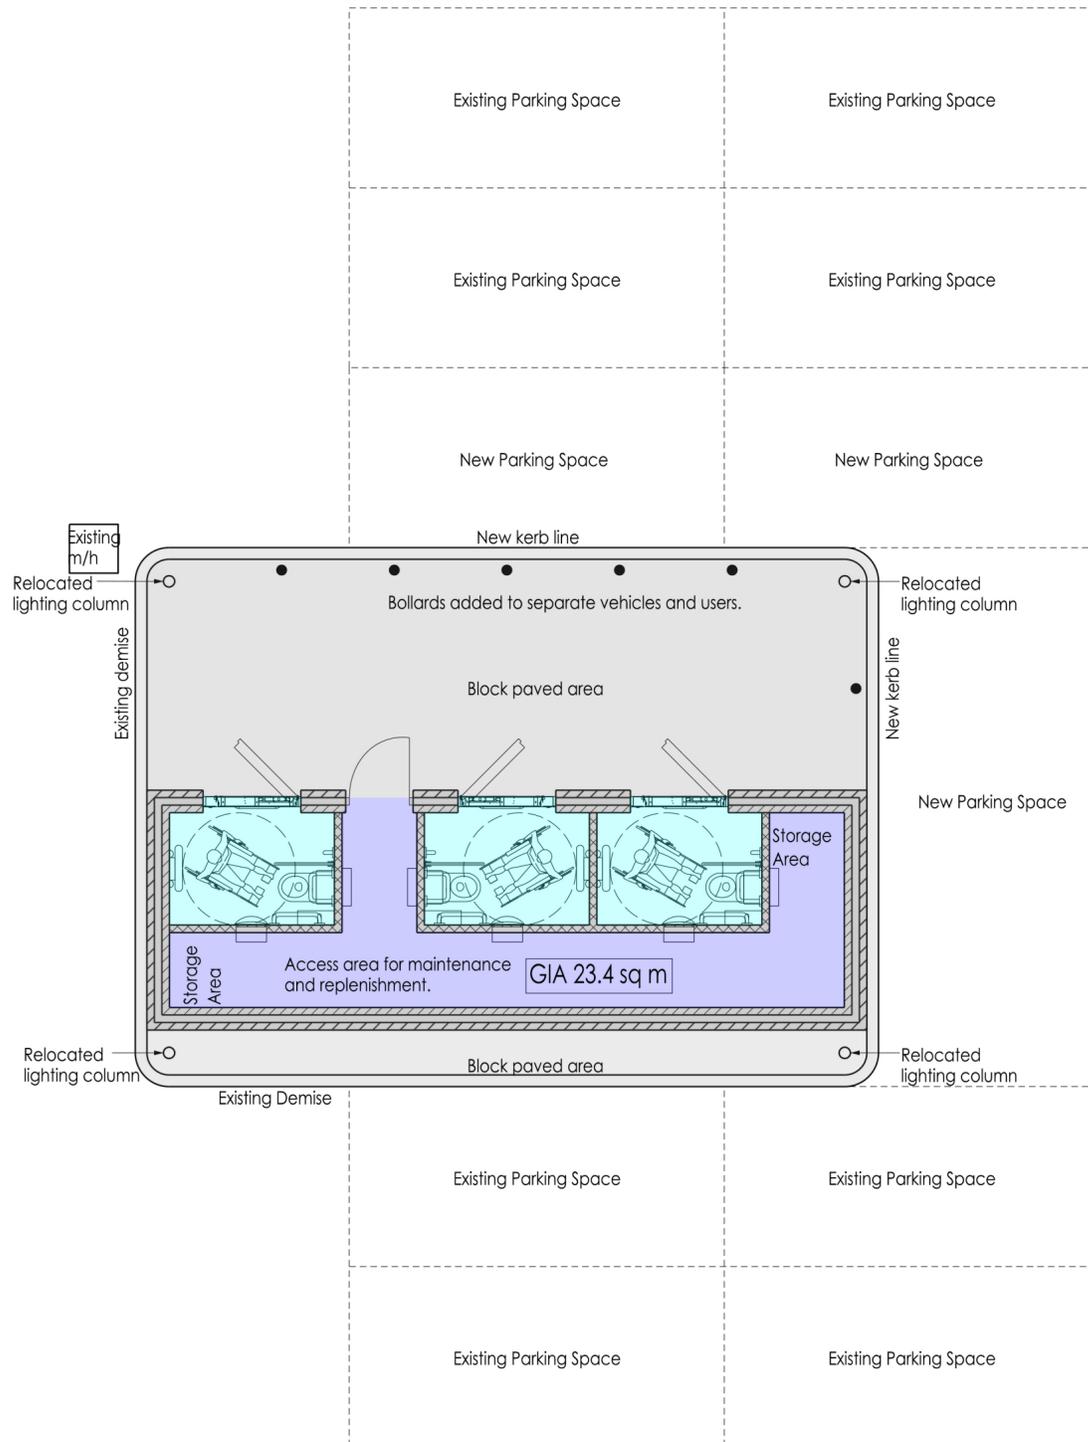
Layout Plan.

Melton Borough Council proposes to construct an accessible public convenience block in a car park of St Mary's Way, Melton Mowbray. The development proposals are included as Appendix I. Our Client requires an overview of the contamination and ground conditions at the site in order to inform the design of the building.

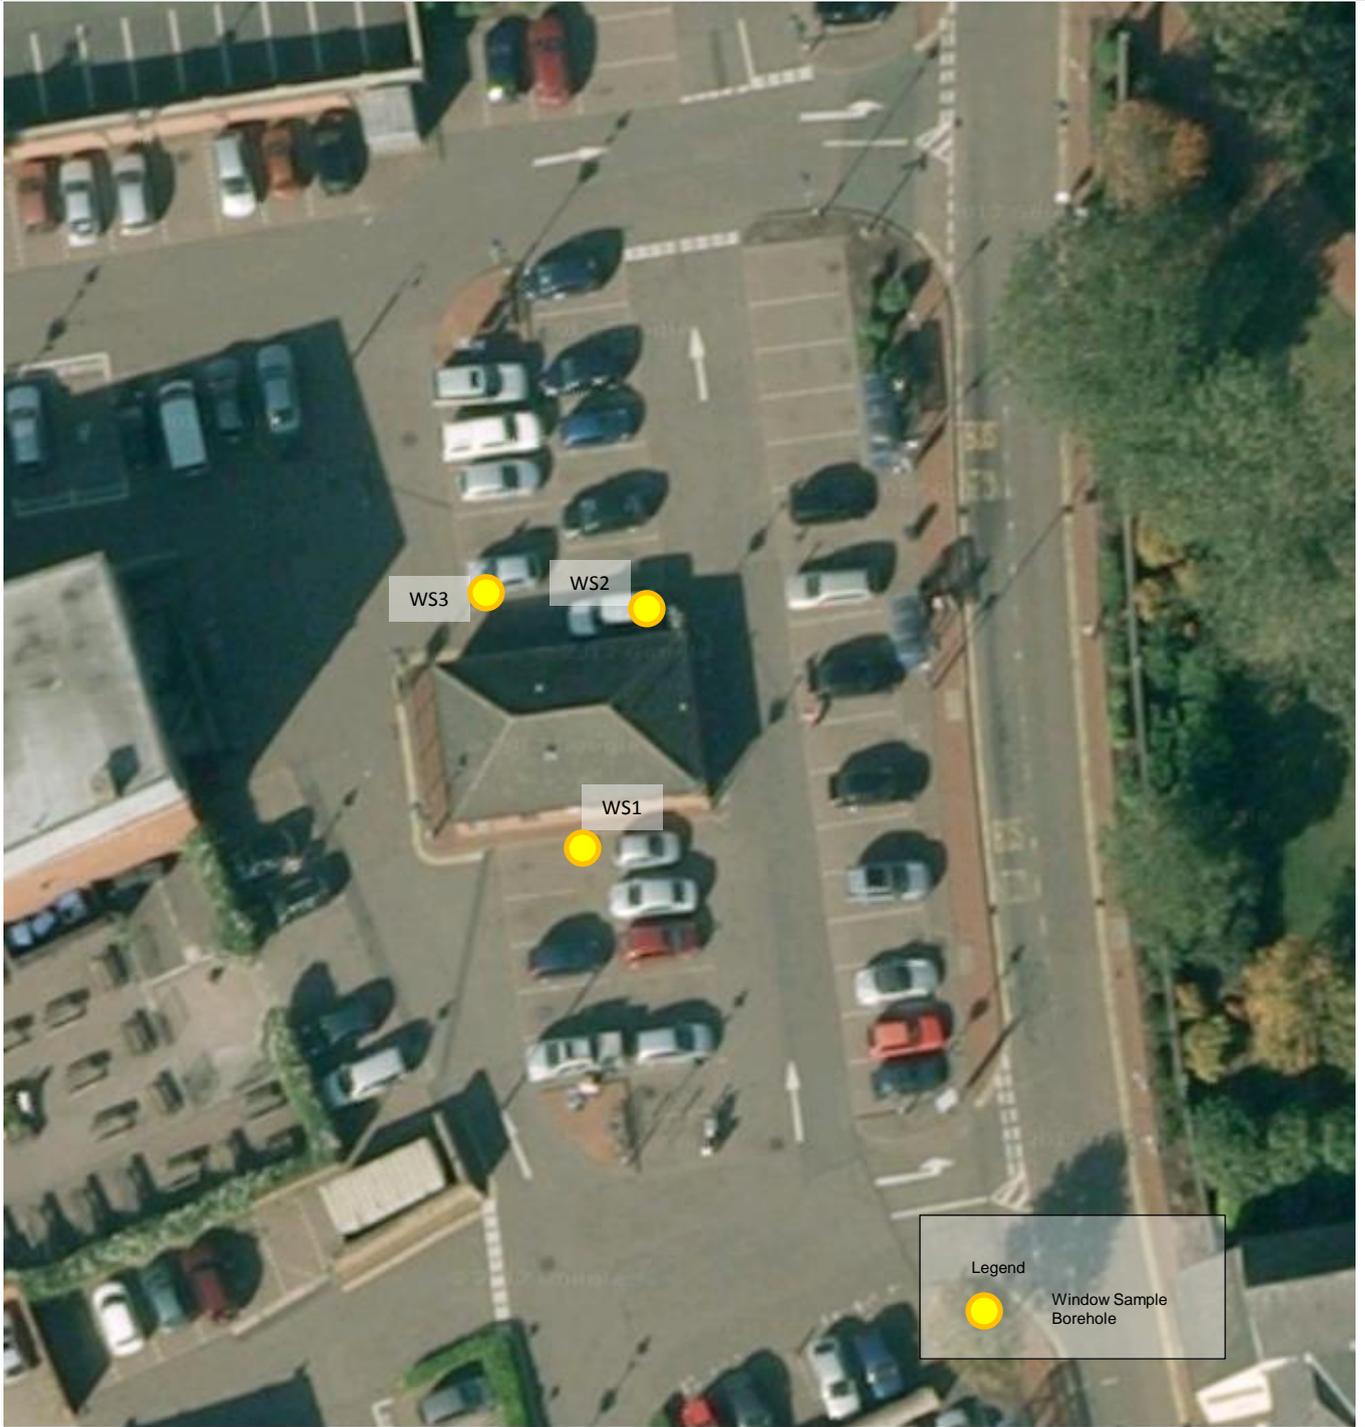
<p>Lawrence House, Meadowbank Way, Eastwood, Nottingham, NG16 3SB Tel: 0870 600 6090 www.hspsconsulting.com</p>				
	Checked By LEB					
Title Site Investigation Layout Plan	HSP Drg. No.					Rev.
	C2522-SK3a

The physical methods of investigation employed were 3No. window sample boreholes to a maximum depth of 4.50m begl to provide information for foundation design and obtain representative disturbed soil samples to forward for geotechnical and geo-environmental analysis. The geology of the site comprises Made Ground to a maximum depth of 0.80m begl. Underlying the Made Ground are glaciolacustrine superficial deposits consisting of brown and orangish brown clayey gravelly SAND to a maximum proven depth of 4.50m begl and firm orangish brown sandy gravelly CLAY to a maximum depth of 4.00m begl. Orangish brown clayey sandy GRAVEL of mixed lithology was identified in WS1 between 3.40m and 3.95m begl.

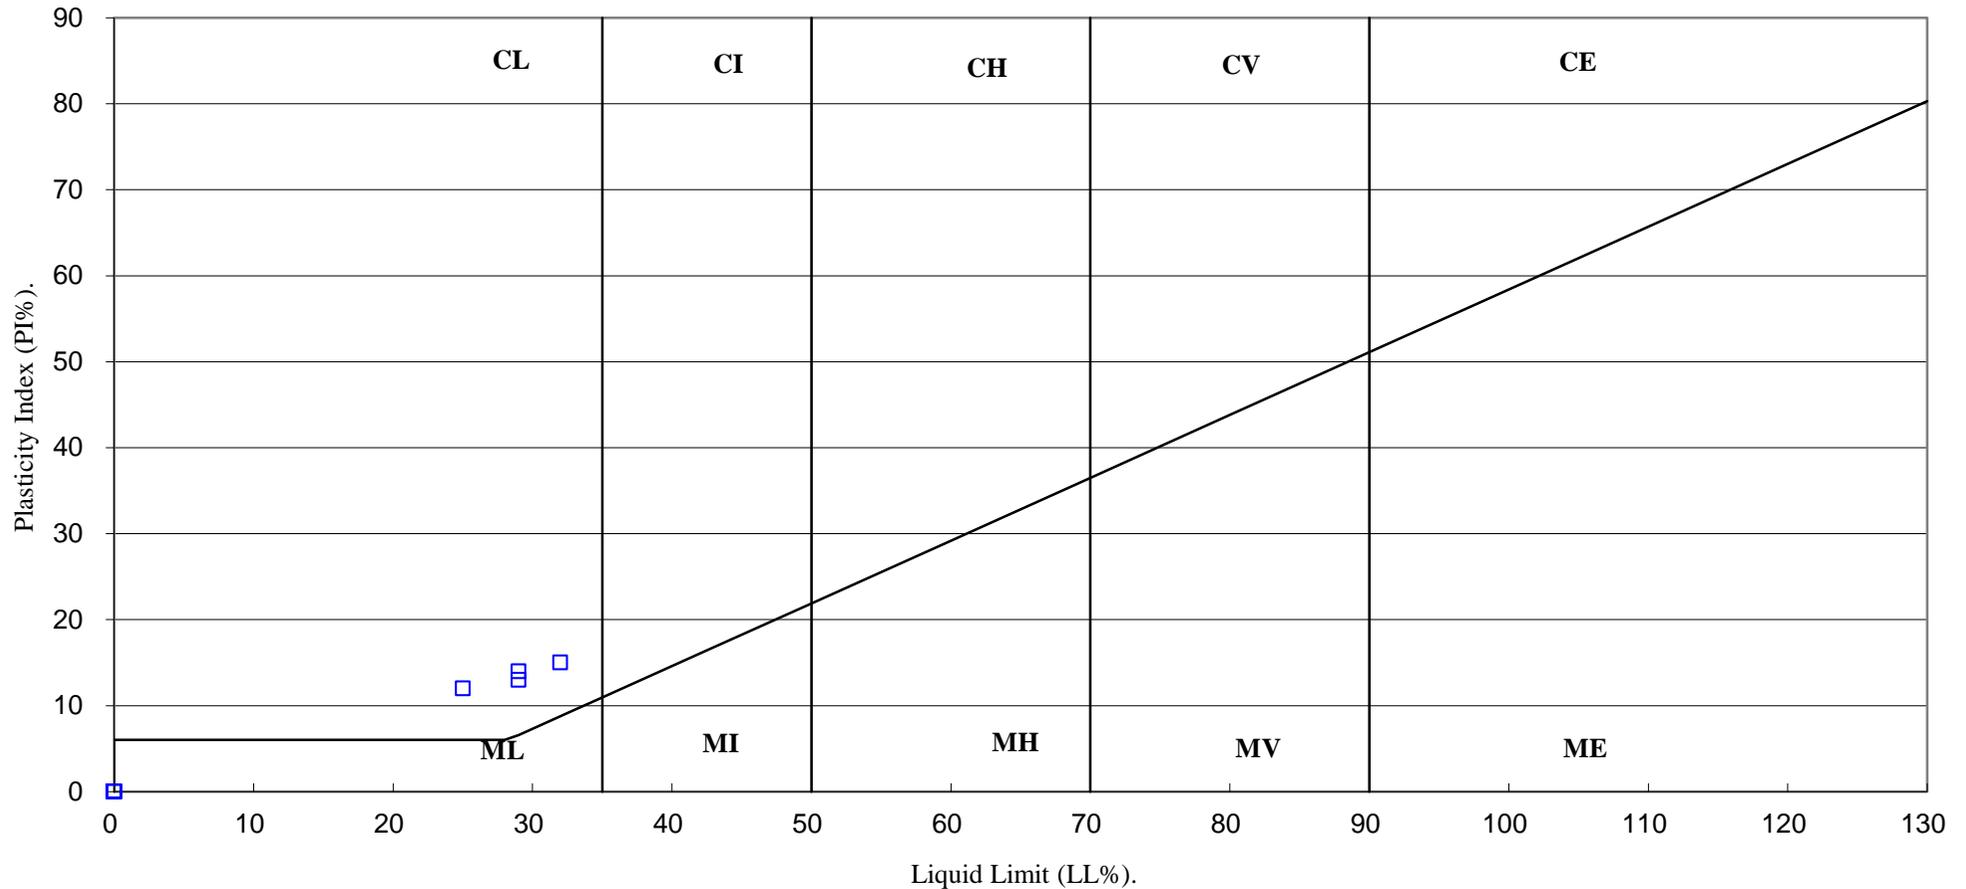
PLASTICITY CHART FOR CASAGRANDE CLASSIFICATION.

Four plasticity index and moisture content tests have been undertaken in the laboratory on disturbed samples of the fine deposits. The plasticity index of the fine deposits is in the range 12 to 15%. The modified plasticity index of the fine soils are in the range 7% to 12.6% indicating soils of low plasticity (CL) after the classification system of BS5930: 2015. These

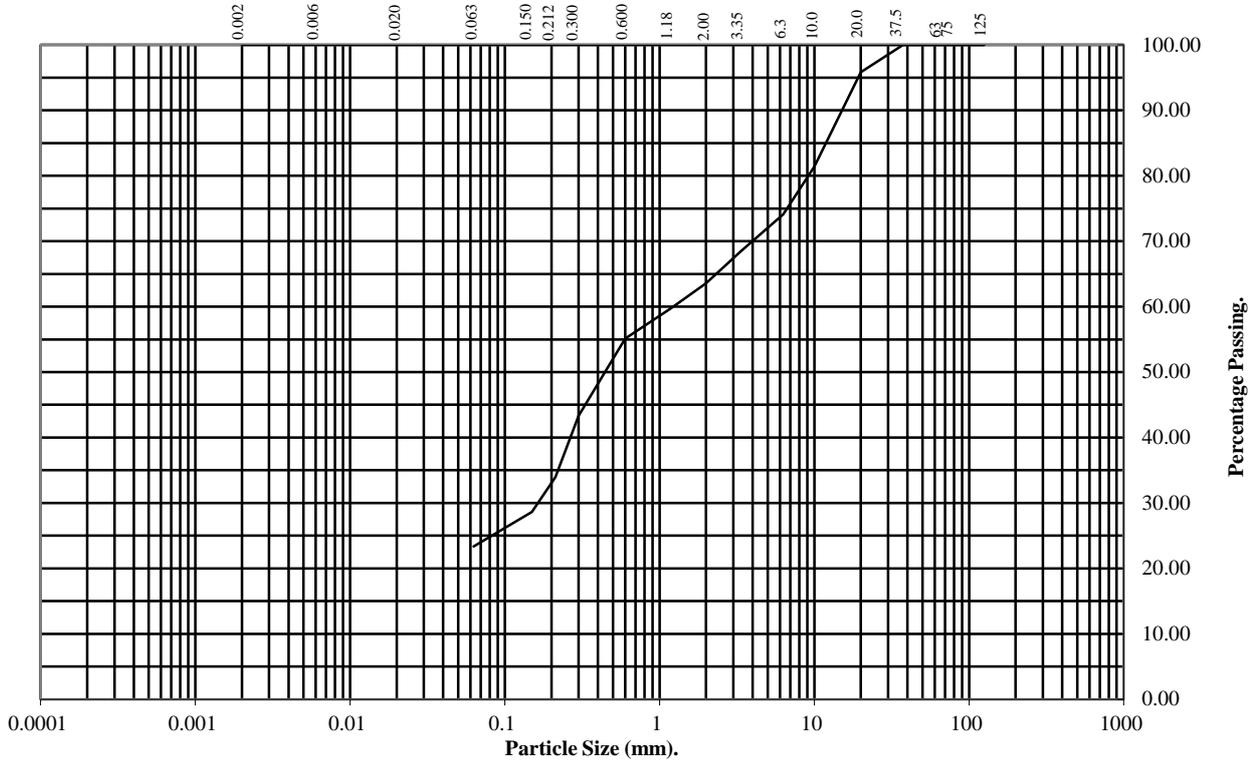
BS Test Sieve	Percentage Passing
125	100
75	100
63	100
37.5	100
20	96
10	81
6.3	74
3.35	68
2	64
1.18	60
0.6	55
0.3	43
0.212	34
0.15	29
0.063	23

Soil Fraction	Total Percentage
Cobbles	0
Gravel	36
Sand	41
Silt/Clay	23
