CHURCH OF ST. JOHN
THE EVANGELIST, SLIMBRIDGE
CONDITION REPORT ON 4 LISTED CHURCHYARD
MONUMENTS, WITH PROPOSALS

CENTRELINE ARCHITECTURAL
SCULPTURE

FEBRUARY 2023

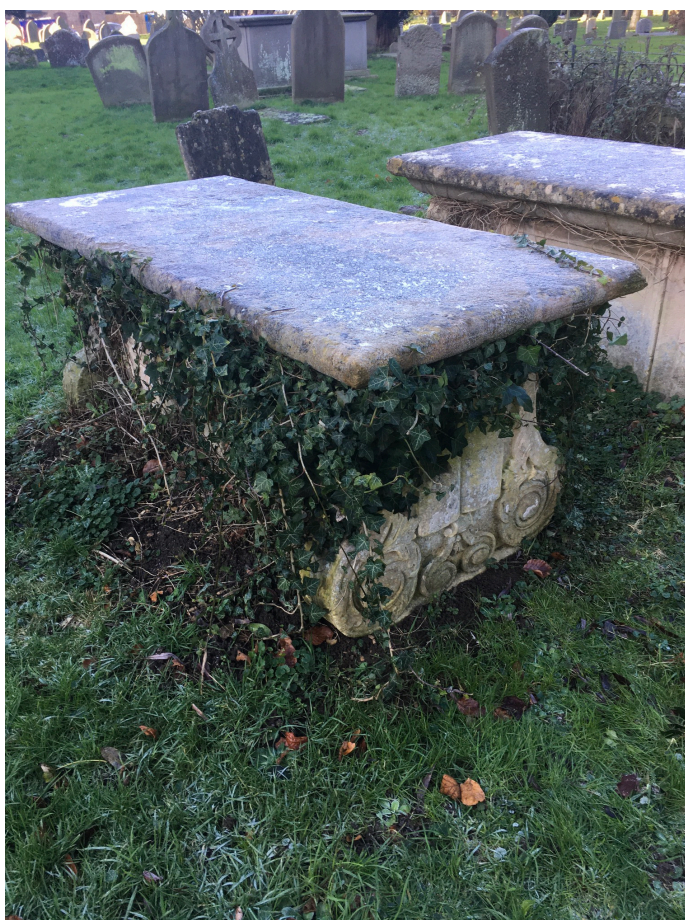
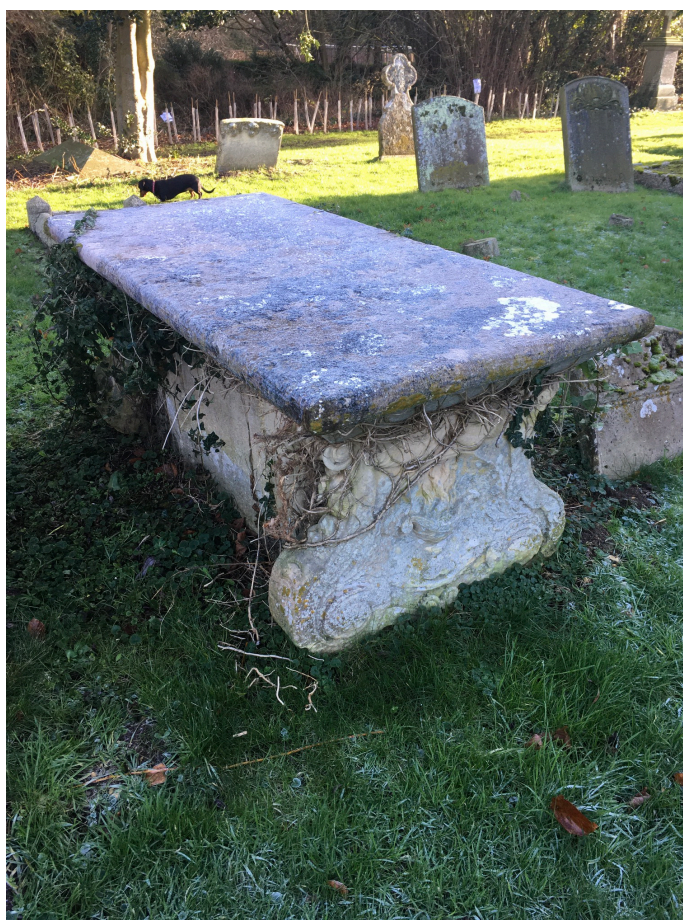
Limestone chest monument with a thick cyma moulded edge. Lyre ends embellished with an open Bible to the E symbolising the faith of the deceased and to W a flaming urn symbolising new life. Inscription panel to the S, now illegible but deciphered around 2000 in a survey by the Slimbridge Local History Society.

Condition of structure Good for the date, slight lean to N of entire monument.

Condition of surface Frost damage on S inscription panel and delamination especially on the flames of the urn on the W end.

Cause of deterioration Natural weathering, frost damage, encroachment of ivy.

- Start process of removing the ivy by cutting the stems off at ground level.
- Restore ground level below base by digging away the build up of earth over the base.
- Lift top and remove all ivy growth.
- Replace original cramps by stainless steel set in lead.
- Repoint throughout with matching lime mortar.

Future requirements / maintenance Every year keep plant growth cut back, monitor the monument for any cracked or open joints. Thoroughly check the monument for any movement or invasive plant growth at least every 5 years.

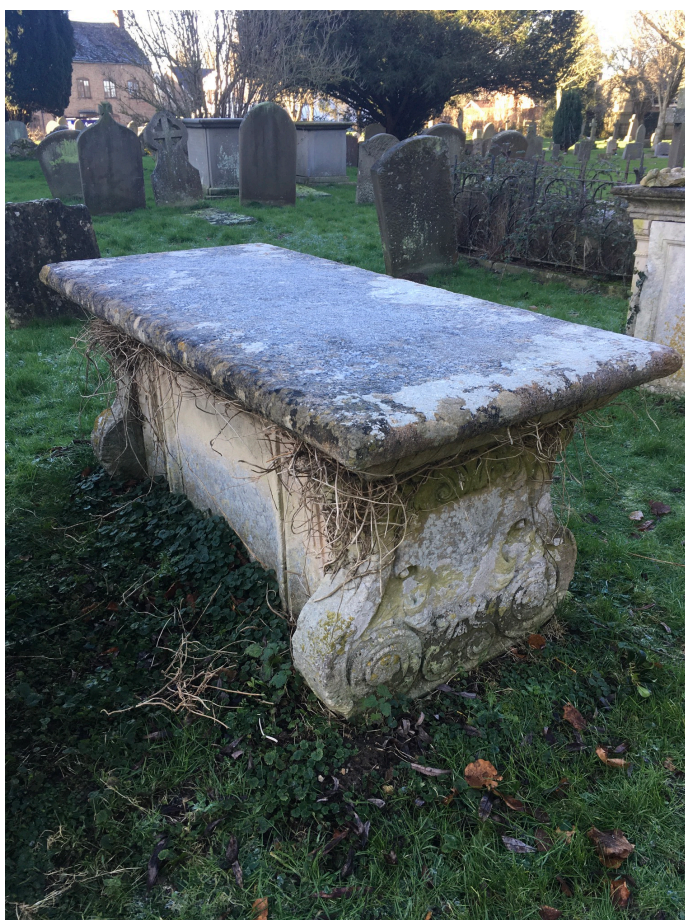
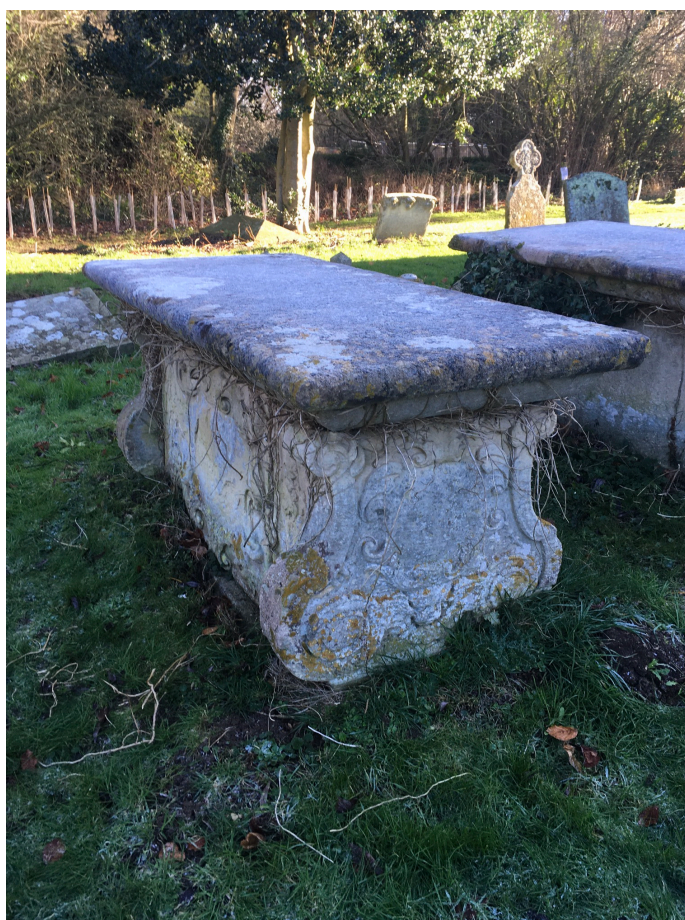
A limestone chest monument with lyre ends with inscription panel to the N with carved ribbons, foliage, buds and flowers on the panels on either side of the central cartouche. The lyre ends also have elaborate cartouches with scrolling and foliage. The N side has a rectangular sunken inscription panel flanked by carved drapery

Condition of structure Rusting iron cramps were identified by the spalling caused at the SE and NE corners

Condition of surface Delamination of the surface on the N side and frost damage along with normal weathering over the last 280 plus years.

Cause of deterioration Rusting iron cramps are causing the spalling at the top corners of the monument and the facet that face bedded stone has been used is causing delamination.

Proposals Lift top.

Remove the stems of the ivy remaining inside and through the joints.

Replace the rusting iron cramps with stainless steel cramps set in lead, replace top.

Reduce the build up of earth and grass around the base.

Repoint throughout with a matching lime mortar.

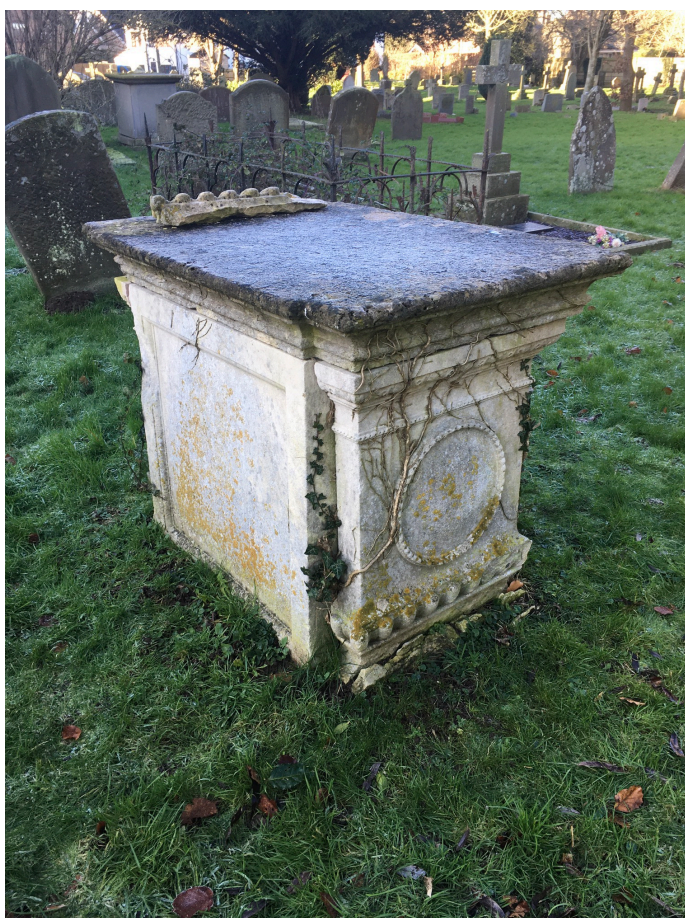
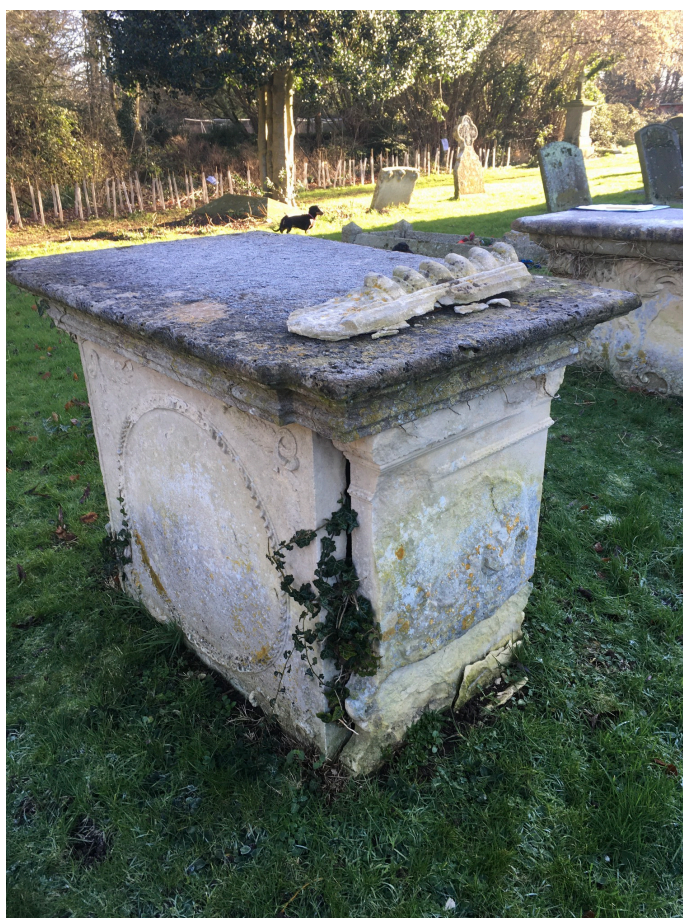
General Description A limestone pedestal monument with an a circular inscription panel to N and E which are edged by a fine band of guilloché carving (a term for repetitive architectural pattern of intersecting and overlapping spirals.) On the S is a plain sunk rectangular panel, the W has a cartouche. The gadrooning at plinth level on the W has become detached though it has survived at the E. A very thick top with a moulded edge.

Assessment of significance	This is an interesting pedestal monument with fine carving remaining to the N and E. Further research could be undertaken to located the property ownership of the Williams family in the mid 18thC in Slimbridge.
Condition of structure	<p>Top offset to N and iron cramps are missing from all four top corners. Therefore nothing holds the sides together apart from the weight of the top.</p> <p>This monument should be considered at risk of collapse.</p>
Condition of surface	Major delamination on the lower part of the E and W panels. A section of gadrooning has been salvaged and is laid on top of the monument.
Cause of deterioration	Delamination odf the surface due to the limestone being face bedded and frost damage.
Proposals	<p>Remove the top and dismantle the monument completely. Remove all ivy growth. Dig out the base from the built up soil.</p> <p>Carve new moulded plinth for E end to fit below the gadrooning.</p> <p>Carve new elements for W end as the gadrooning is still partially intact.</p> <p>Reassemble the monument replacing the failed cramps with stainless steel set in lead.</p> <p>Re-point throughout in a matching lime mortar.</p>

Affects of any proposed changes	The monument will be safe for the visitors to the churchyard and the monument will be in the best condition to survive the effects of the weather and plant encroachment.
Future requirements / maintenance	Keep plant growth cut back, monitor the monument for any cracked or open joints. Thoroughly check the monument for any movement or invasive plant growth at least every 5 years.
Additional notes	<p>Although there is no evidence at the moment of Rice William's presence in Slimbridge in the mid 18thC, there is evidence of the Williams family owning land in Slimbridge and Berkeley in 17th and 18thC and the will of one Rice Williams of Dursley is attached in Appendix 2.</p> <p>As a male Christian name Rice (and Ryys, Reece etc.) was common in Wales.</p>

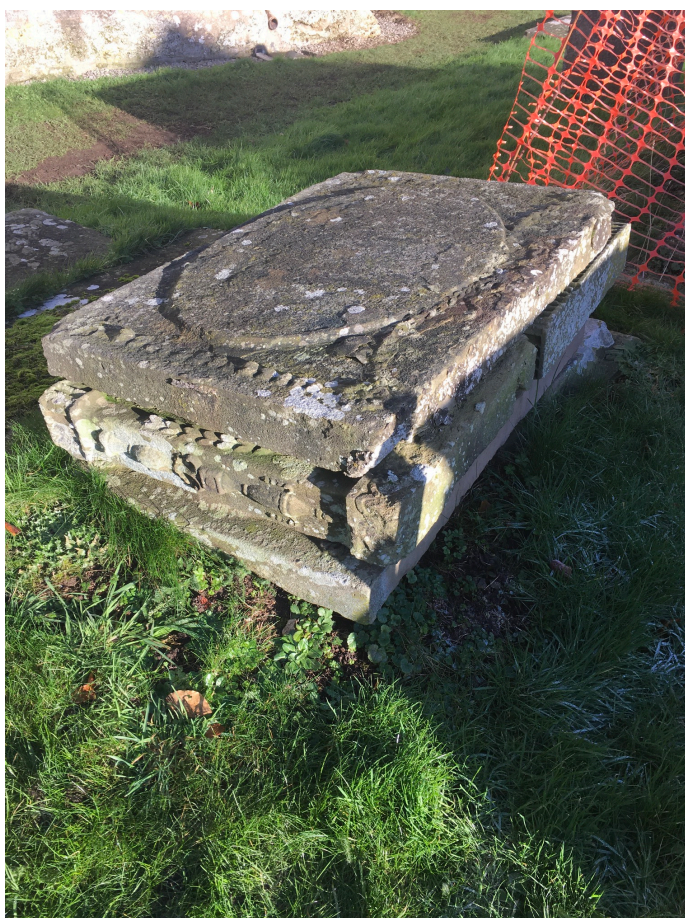
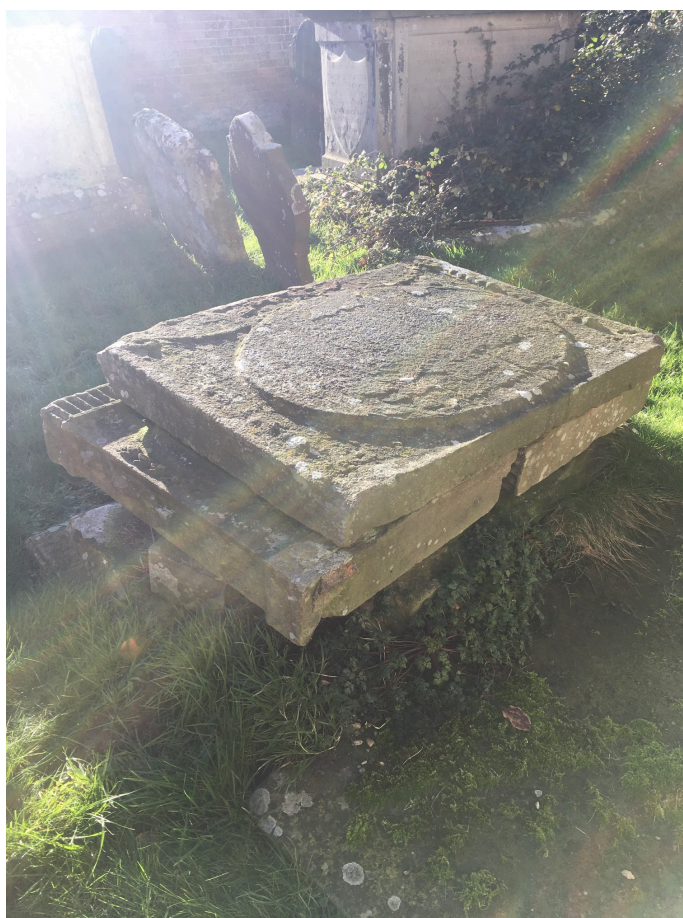
A Forest of Dean chest monument which is now dismantled with the sides laid in a pile on top of the original base and the top on the ground to N. Only one of the sides can be seen but the Listing description states that the E and W ends are decorated with a guilloché design (a term for repetitive architectural pattern of intersecting and overlapping spirals) at the top and a fluted decoration along the base: this and other details will help to reassemble the monument correctly. Elliptical inscription panels N and S with swags and rosettes.

Condition of structure Dismantled.

Condition of surface The dismantled sides are not packed between with carpet or any other material so there could be damage to the carvings mentioned in the Listing description. There was obviously a problem with the iron cramps rusting which caused the monument to be dismantled for safety reasons.
There will be some delamination of surfaces and normal weathering.

Cause of deterioration Rusting iron cramps.

Proposals Check all the pieces first for any further problems arising from being stored flat on the ground.

Level the base.

Reassemble the sides and use stainless steel cramps set in lead to fix. Lift the top from the ground and replace.

Repoint throughout with lime mortar and fill in the ground with turf to tidy the area where the top has been lying.
