WOODBIDGE TOWN COUNCIL – SUFFOLK

The Town Council is responsible for the provision and maintenance of leisure amenities, with a recent inspection self-identifying the need for remedial works to flooring areas around items of play equipment located at Kingston Field and Elmhurst Park. The chosen solution will need to be both environmentally friendly and installed in a manner which will provide longevity. Any arisings are to be appropriately dispersed in the immediate vicinity, preferably used as a top dressing for grass.

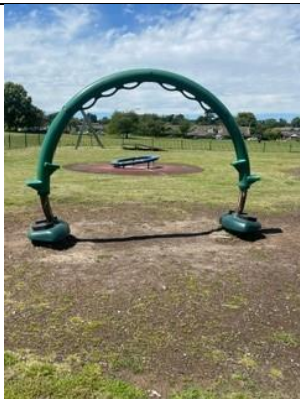
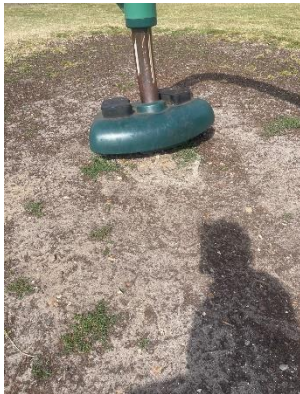
<u>Item 1</u> “Arch”

Prioritisation	Primary	
Equipment Dimensions	2.45 metres x 0.75 metres	
Fall Height	Maximum drop from underside of Arch to current ground floor level is 2.3 metres. Intended use less than 1.5 metres	
Surrounding Area	There is no vegetation with compacted and eroded soil immediately around the play equipment extending to approximately 7.7 metres x 6.5 metres	
Current ground conditions

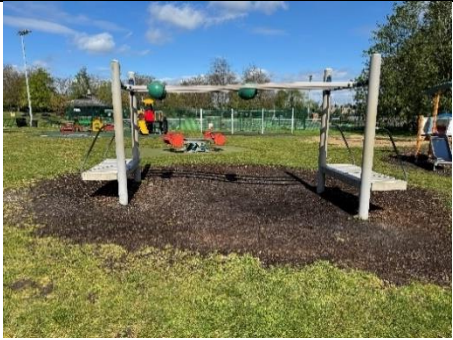
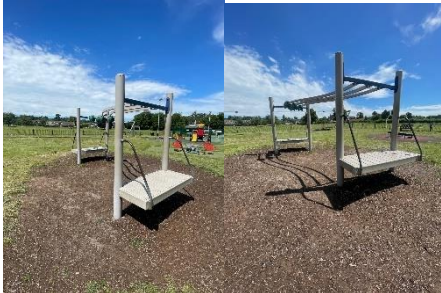
<u>Item 2</u>

Prioritisation	Primary	
Equipment Dimensions	3.9metres x 1.8 metres (Note each end is offset by 1.2 metres creating a parrellogram footprint)	
Fall Height	Maximum drop from play equipment to ground floor level is 2.1metres. Drop from intended use is 0.6metres	
Surrounding Area	There is no vegetation with compacted and eroded soil immeadiately around the play equipment extending to approximately 6.5 metres x 8 metres	
Current ground conditions

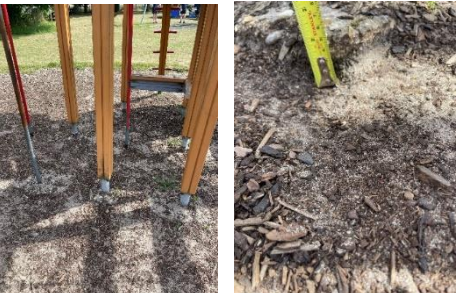
<u>Item 3</u> “Multi-play area”

Prioritisation	Primary	
Equipment Dimensions	9.8 metres x 6.4 metres	
Fall Height	Drop from intended use is 1.5 Metres	
Surrounding Area	There is no vegetation with compacted and eroded soil immeadiately around the play equipment extending to approximately 13 metres x 8 metres	
Current ground conditions	Concrete foundations are now exposed.

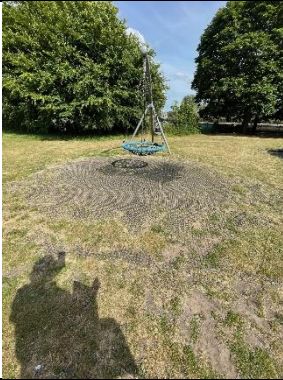
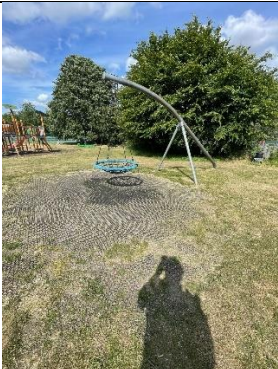
<u>Item 4</u> “Birdsnest Swing”

Prioritisation	Secondary	
Equipment Dimensions	N/A	
Fall Height	Less than 1.3 metres if used as intended	
Surrounding Area	There is a plastic grid system preventing erosion. There is some evidence of ground movement, with the separation of grid joints. The grid covers an area 6 metres x 6 metres	
Current ground conditions

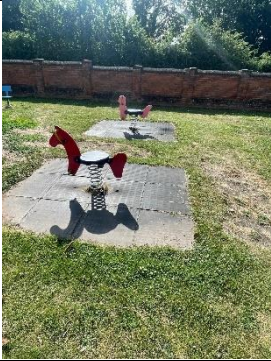
Item 10 “2x Spring seesaws”

Prioritisation	Secondary
Equipment Dimensions	N/A
Fall Height	Less than 1.3 metres if used as intended
Surrounding Area	0.6 metre rubber tiles covering two areas at 2.4 Metres x 1.8 Metres each
Current ground conditions	As Above
