# Piccadilly Line

Saloon and Cab Flooring Condition assessment Report.

Saloon and Cab Flooring Condition Report  
 Date: 22/04/2016  
 Revision: Issue 1  
 Robert Jenks

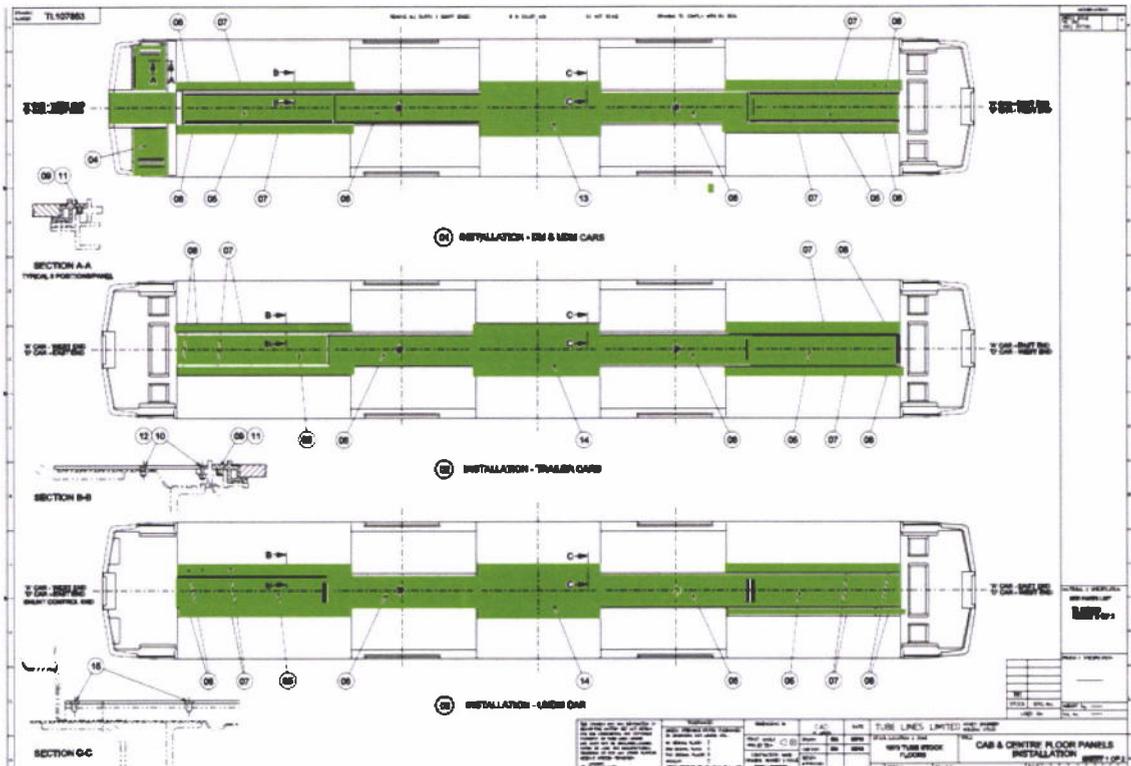
## APPENDICE A

Area's In Green to be replaced.

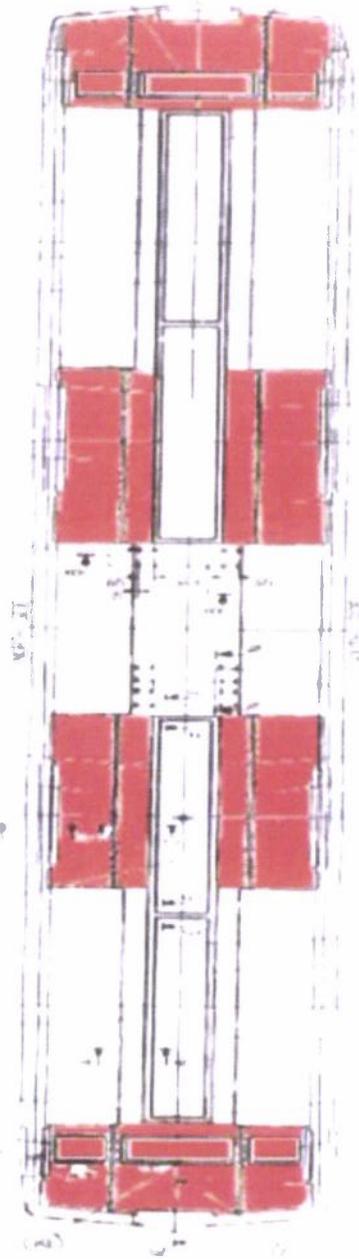
**Figure 1 – Scope of RPL Saloon Flooring Replacement Project**

As previously detailed, the saloon flooring is a combination of lino sections fitted during the Bombardier Refurbishment programme carried out between 1996 and 2001, and areas replaced during the recent scope of work undertaken by RPL LTD. In the following drawing, those areas detailed in red were replaced by RPL across the whole fleet between 2013 and 2015 where the original aluminium honeycomb sandwich arrangement was replaced with phenolic flooring panels topped with a synthetic rubber.

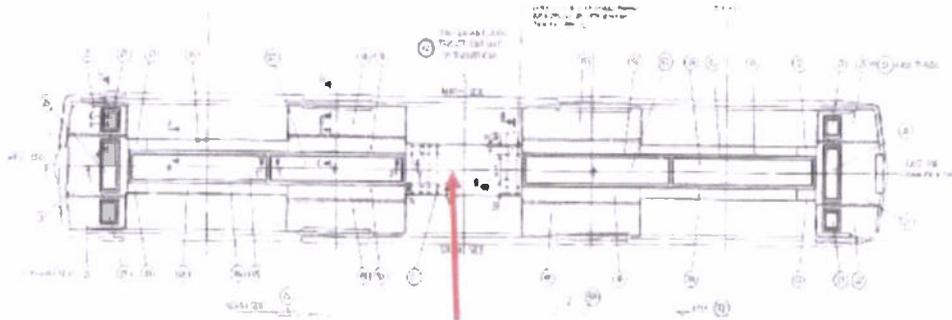
Figure 2 – Longitudinal Flooring, Centre Panel Location

The remaining centre or longitudinal sections have varying construction dependent upon location. The sections between seats (Centre Panel) as indicated in the drawing below comprise a solid aluminium alloy sheet supported by aluminium extrusions with the lino bonded onto the sheet

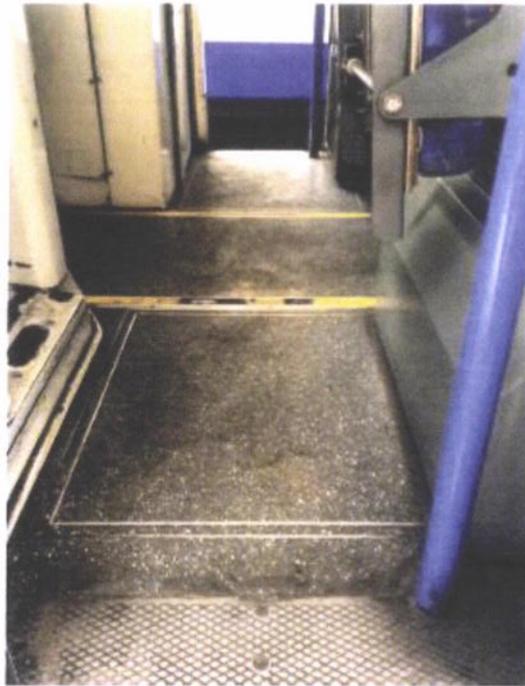
**Figure 6 – Example of Cab flooring arrangement**

The cab flooring has not been replaced other than as a result of casualty work since the Fleet Refurbishment project undertaken between 1996 and 2001. The flooring is made up from several separate sections of lino that are secured in a number of different ways as shown in the following drawings and photographs

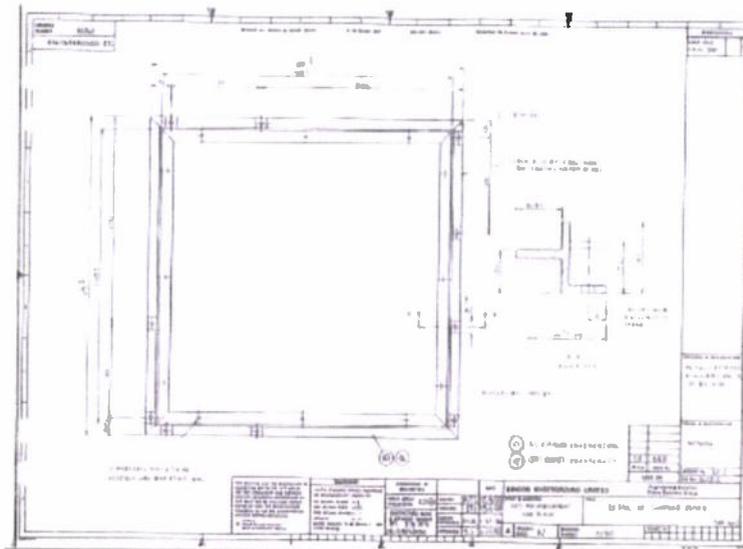
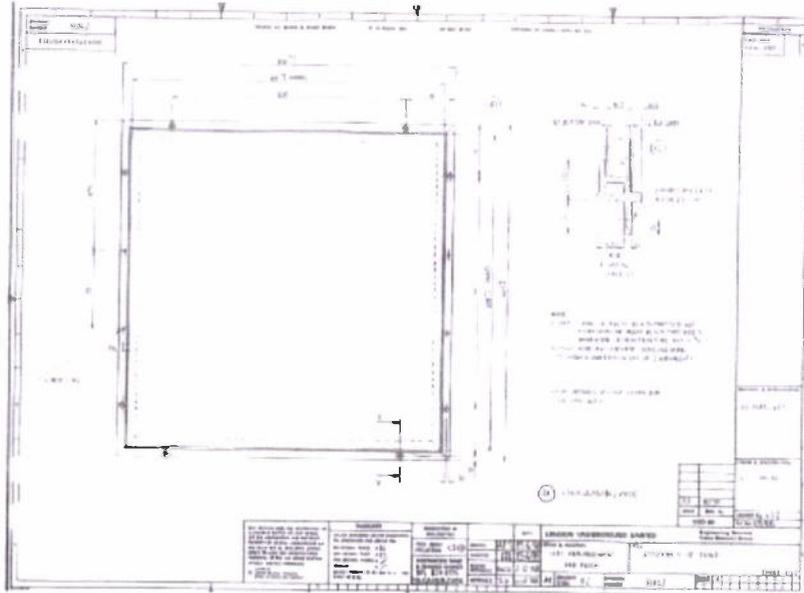
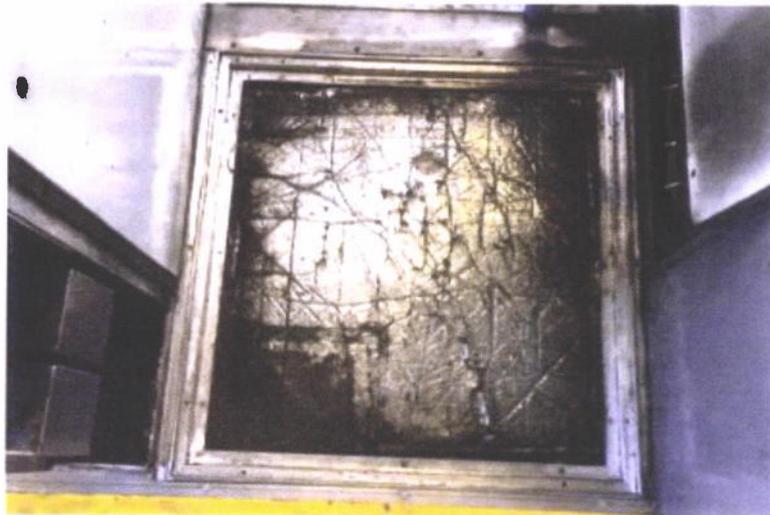
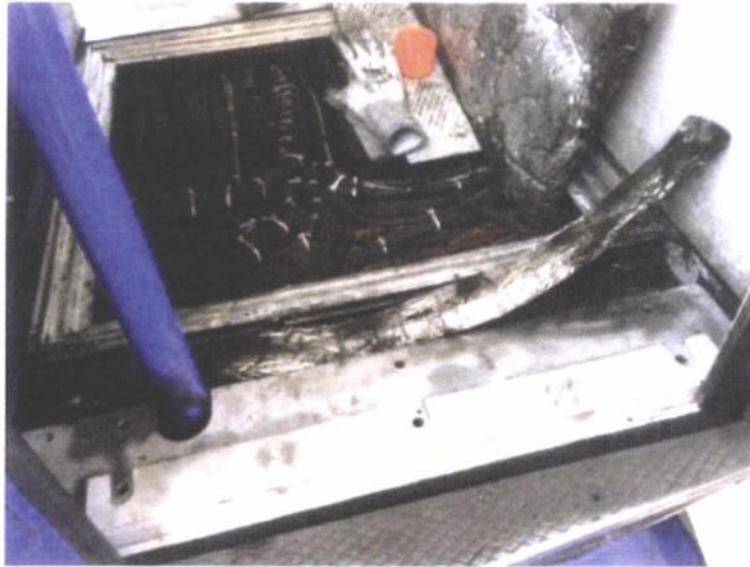
The two floor traps are constructed from Aluminium Alloy and comprise a frame and trap plate – See figures 9 to 12 below.

**Figure 9 - Cab Floor trap frame**

**Figure 10 – Cab Floor trap Plate**

**Figure 11 – Cab Floor trap Plate example**

Figure 12 – Cab Floor trap Plate removed

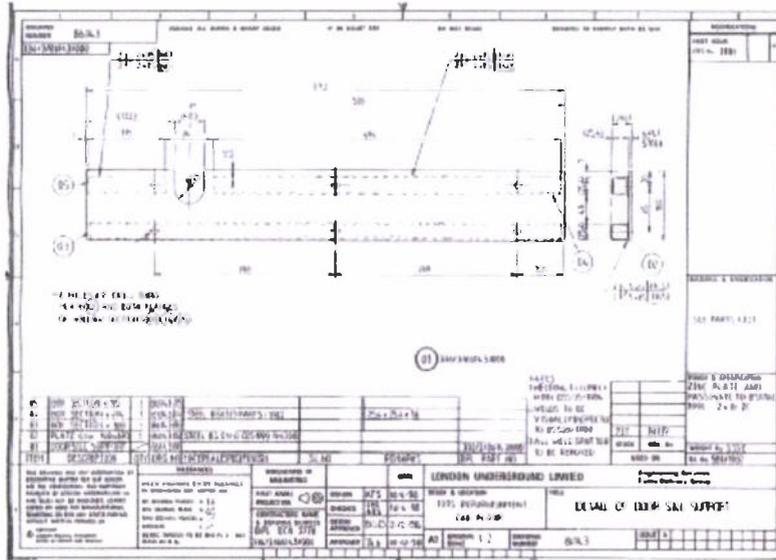
Figure 13 – Door Sill Support

The centre section of the cab floor consists of lino which is bonded directly onto the top section of the detrainment ladder housing. The remainder of the flooring comprises of a number of in-fill strips and metal sill plates as shown in the following drawings:

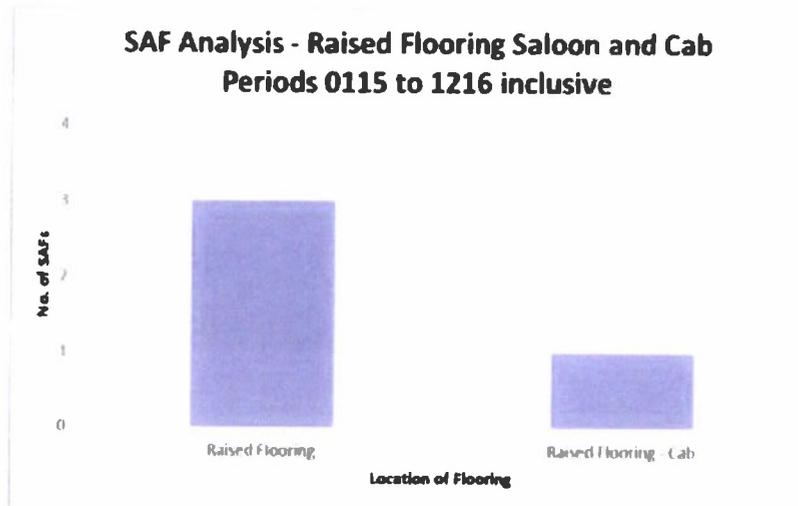
**Figure 16 – SAF Data relating to flooring**

Service affecting failure data for the last 2 years (Periods 0115 to 1216 inclusive) has been analysed for flooring related defects in both Cab and Saloon. It can be seen from the graph below that there have been a total 4 reports of raised flooring and therefore posing as trip hazards.

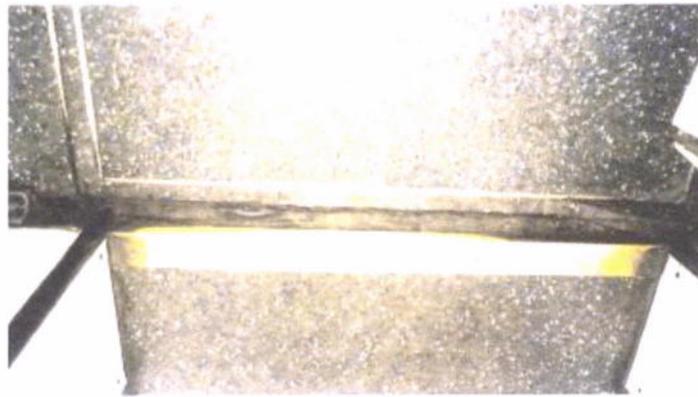
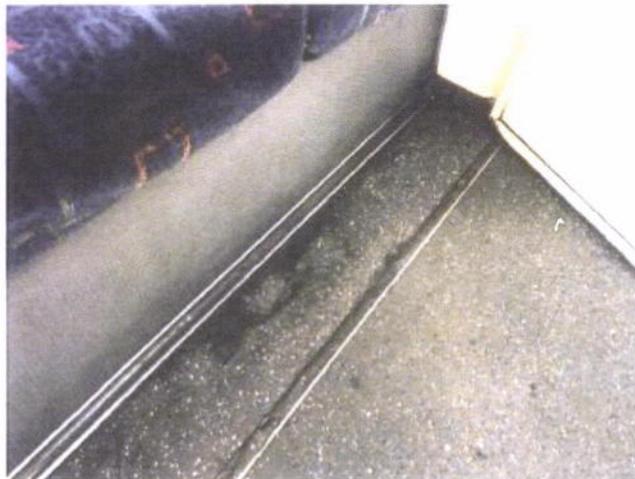
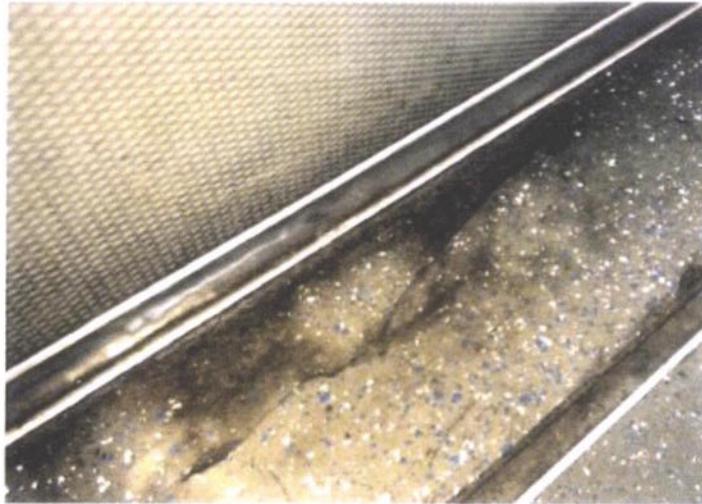
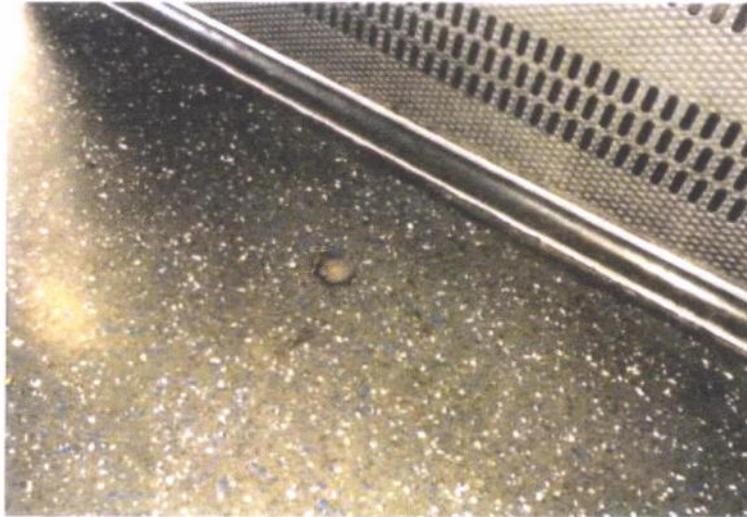
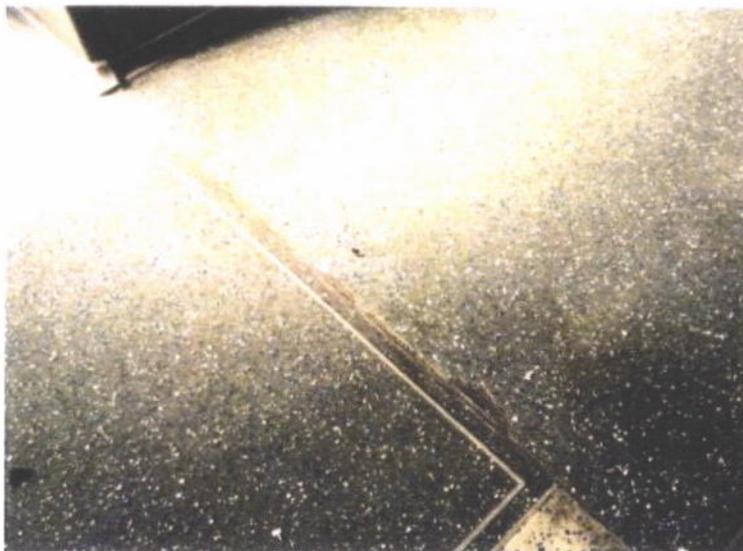
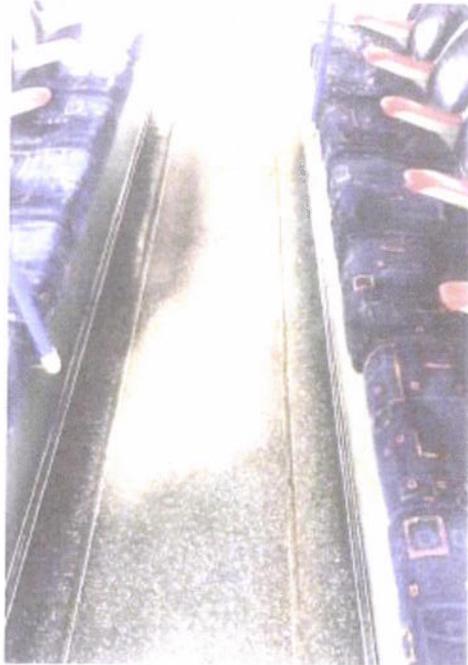
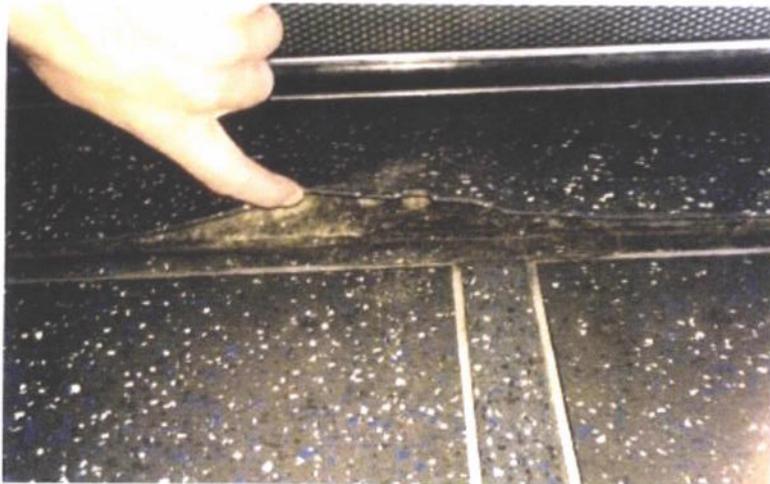
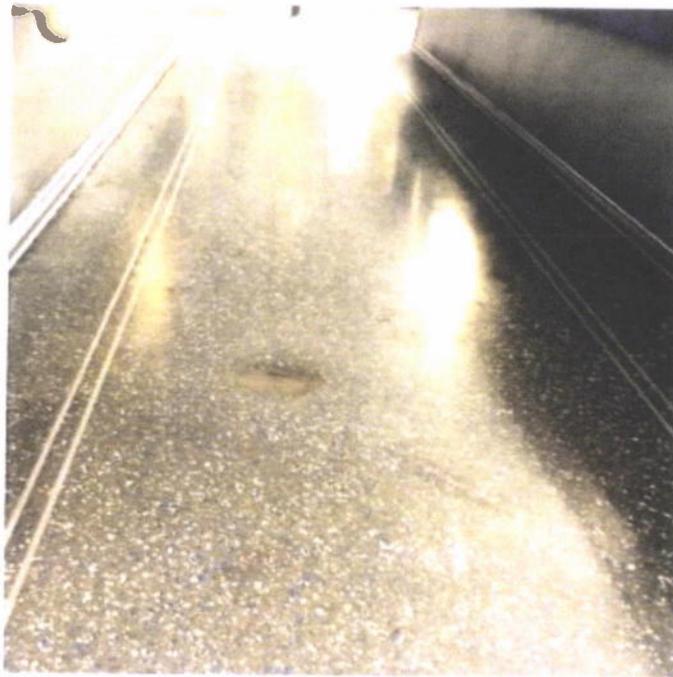
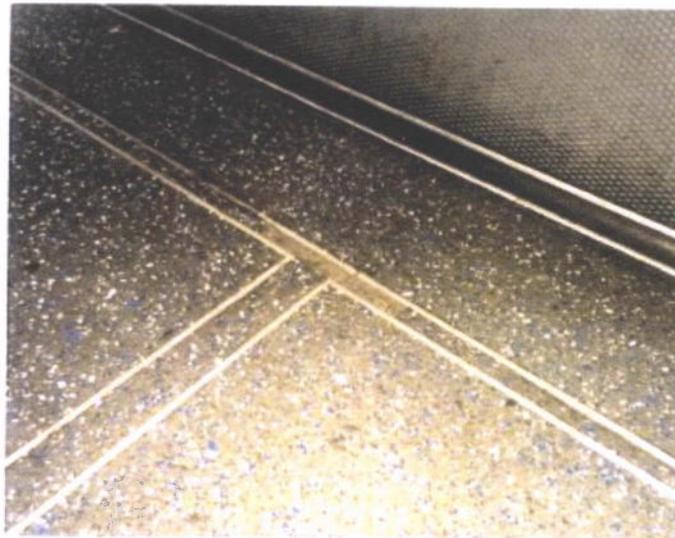
The condition of the original saloon flooring sections was observed to be generally poor, with wear levels ranging from minimal to significant identified in every car inspected. The wear patterns and locations were very similar and consistent between cars, with sections lifting and denting of the honeycomb underneath the lino seen on the vast majority of flooring sections. Examples of typical damage are detailed in the following photographs

**Figure 16 – Car 101, Saloon to cab threshold**

**Figure 17 – Car 108, Saloon floor condition in proximity to cab**

**Figure 18 – Car 108, Close up of Saloon floor condition in proximity to cab**

**Figure 20 – Car 195, Saloon floor condition, centre section**

**Figure 21 – Car 301, Saloon floor condition, centre section threshold**

**Figure 22 – Car 338, Saloon floor condition**

**Figure 23 – Car 338, Saloon floor condition, close up of damage, centre section**

**Figure 26 – Car 595, Saloon flooring damage**

**Figure 27 – Car 855, Saloon flooring damage, in-fill strip, centre section**

Given the remaining Fleet life, it is recommended that the longitudinal saloon flooring sections and Cab floors are replaced, as they will only continue to degrade further.

The saloon flooring sections replaced by RPL between 2013 and 2015 although only fitted to the fleet for a relatively short period of time are not showing any signs of wear, and therefore it is recommended that the same or a similar flooring construction is used for the replacement.

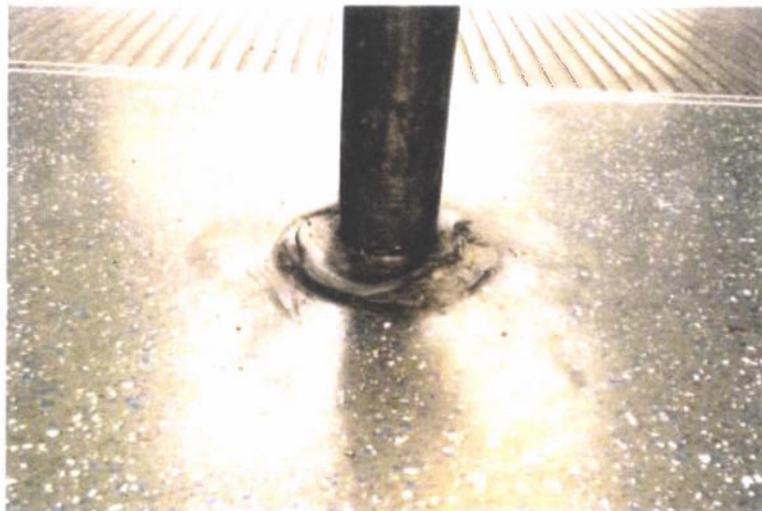
**Figure 19 – Car 108, Centre grab pole condition**

- The coving fitted in the saloons between panel edging and floor is in a poor state and starting to become detached, and this must therefore also be factored into the replacement.
- The majority of centre grab poles have damaged shrouds where the pole enters the floor panel which would need to be addressed.

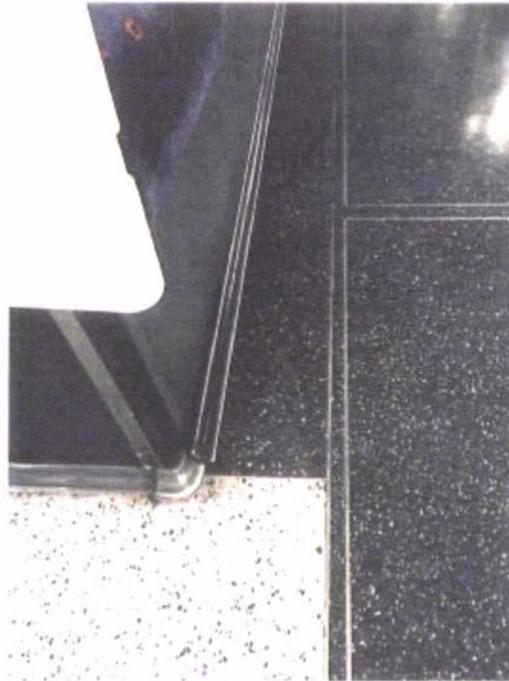
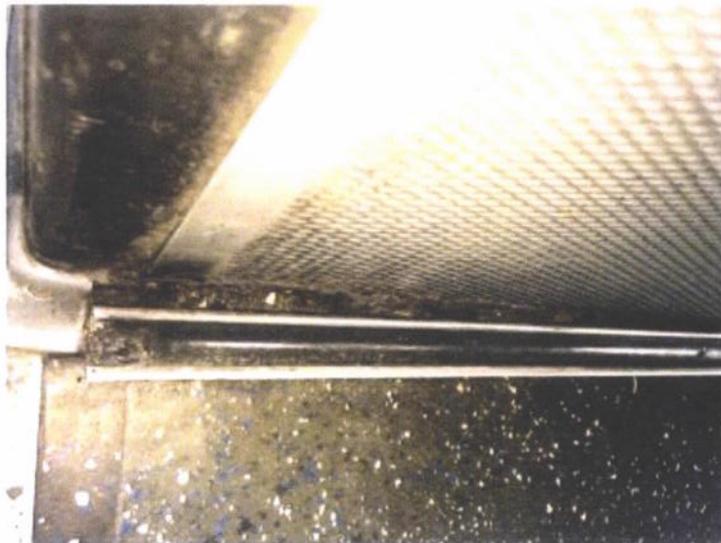
**Figure 24 – Car 356, Saloon flooring, damage to coving**

**Figure 25 – Car 356, Saloon flooring, damage to coving, close up**

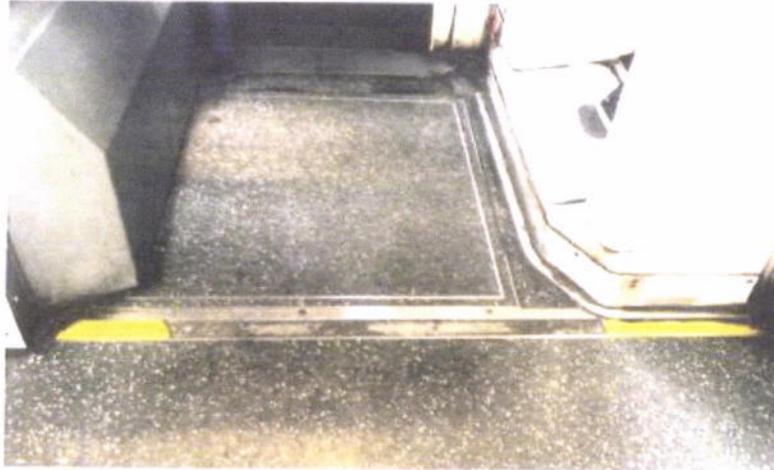
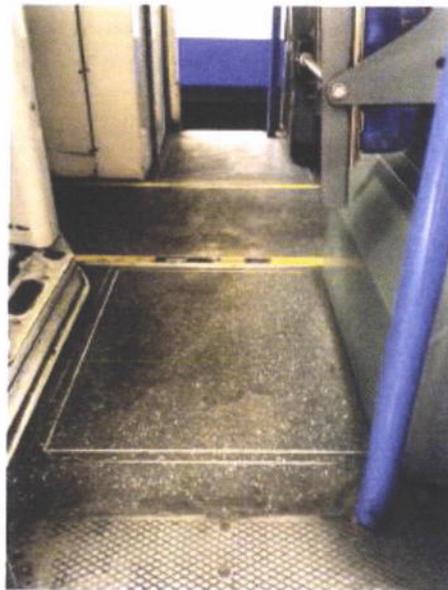
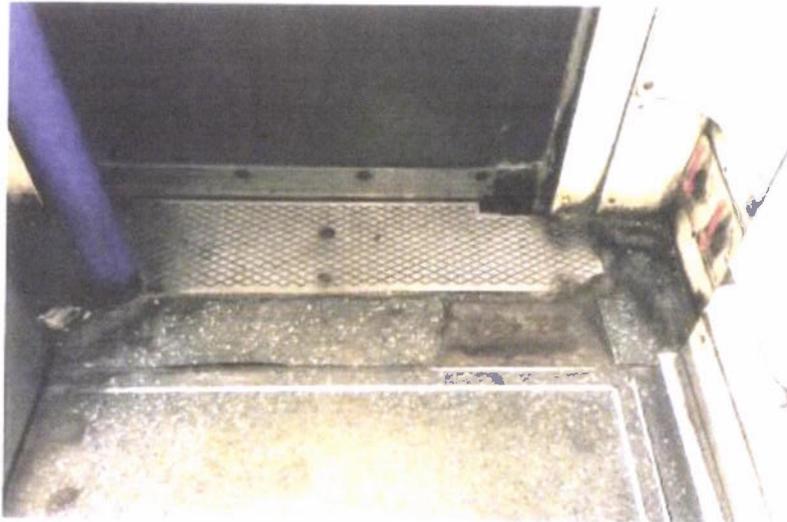
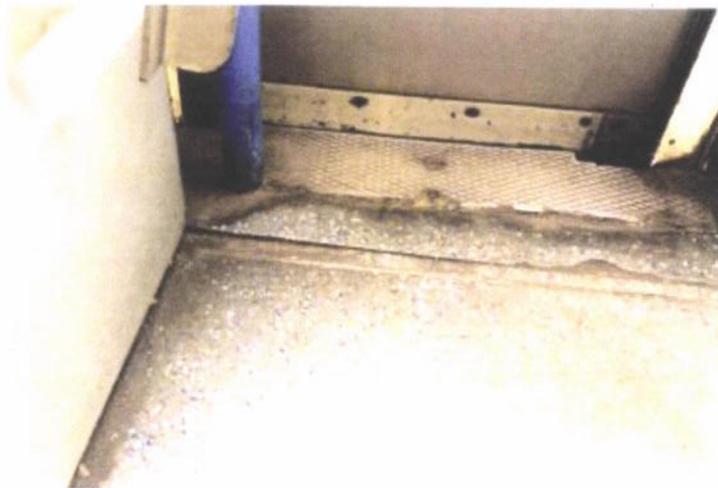
The condition of the cab flooring was found to be generally very poor, with the same wear patterns and locations of damage observed in every cab inspected. The following photographs provide an overview of the damage consistently observed.

Figure 28 – Car 101, Cab floor condition, damage to yellow in-fill strip

Figure 29 – Car 854, Cab floor condition, damage to yellow in-fill strip

**Figure 30 – Car 101, Cab floor, damage to drivers side lino**

**Figure 31 – Car 138, Cab floor, damage to drivers side lino**

It must be noted that the cab flooring has been found to be fairly corroded on units where the flooring has been lifted to a sufficient level to expose the substrate. Therefore, a cab floor repair programme which would include removal of the detrainment devices would have to be integrated into any flooring replacement programme. Whereby, the existing flooring would have to be lifted, detrainment device removed, cab flooring repaired, and then new flooring laid.
