National Trust Purbeck: Swan Brook NFM Opportunities

Feasibility Assessments

Dr Peter Stone

May 2024

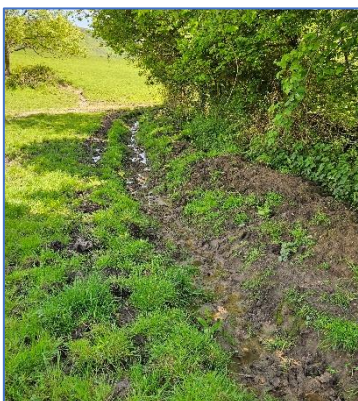
The spring head above the wooded area should be protected from poaching by livestock through fencing off the area which is naturally wet, to prevent access. Poaching influences both flow pathway but more importantly, is a source of fine sediment to the tributary stream.

A channel which has been created to concentrate the spring flow should also be infilled and flow allowed to spread as a diffuse flow in the protected area.

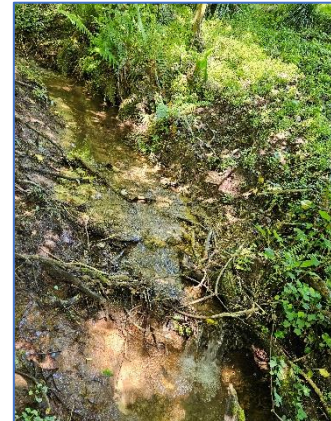
There is potential to slow the delivery of flow within the tributary channel by increasing the frequency of wood within the channel. Reaches for addition of wood should be considered where there is an availability of riparian “floodplain” for water to create overbank flow and occupy a wider cross section. Where the channel is confined, current accumulation of natural wood in the channel has caused a downward erosion into the bed of the stream so it is advised to avoid areas with no adjacent flatter land.

Two tributary reach locations are proposed, with addition of up to 5 dams per location.

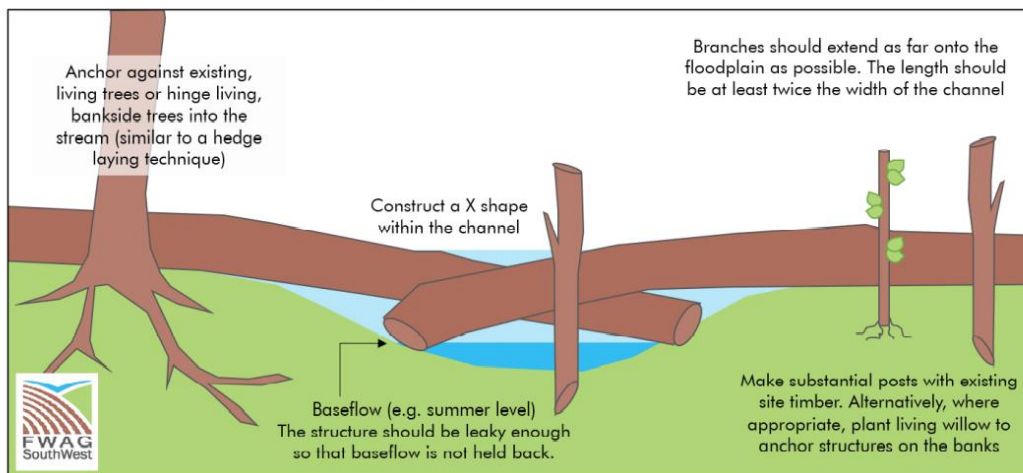
Structure configuration and Securing options

A basic design of woody debris in the channel is shown below.

The leaky woody debris dams will be installed manually. Works will be undertaken using a chainsaw and debris manually manoeuvred into place. Any fixings will be manually installed.

- Fell and lever the entire tree partially or entirely into the watercourse from the riverbank, with the branches facing either upstream or downstream;
- Fell with :
 - no hinge so that the tree is detached from the stump (requires staking of the trunk or securing to other trees on bank); or
 - (if possible) a hinge to enable the tree to carry on living, and to naturally secure it to the bank;
- Secure the head of the tree (main branches) and the trunk, with stakes made from local durable wood;
- Stakes securing the tree should be on the downstream side, angled so the top of the stake is pointing upstream and $>0.1\text{m}$ above the top of the felled tree;

Where stakes are used to secure the tree to the river bank and retain in-channel, the woody debris will be attached to the stake to minimise the risk that the tree floats away.

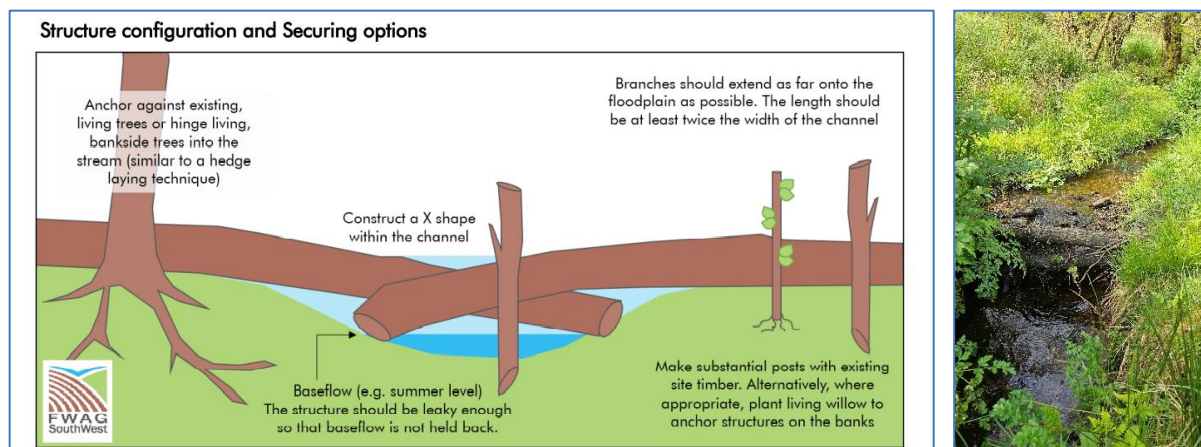
A basic design of woody debris in the channel is shown below along with an example.

The leaky woody debris dams will be installed manually. Works will be undertaken using a chainsaw and debris manually manoeuvred into place. Any fixings will be manually installed.

- Fell with no hinge so that the tree is detached from the stump (requires staking of the trunk or securing to other trees on bank);
- Secure the trunk, with stakes made from local durable wood;
- Stakes securing the tree should be on the downstream side, angled so the top of the stake is pointing upstream and $>0.1\text{m}$ above the top of the felled tree;

Where stakes are used to secure the tree to the river bank and retain in-channel, the wood will be attached to the stake to minimise the risk that the tree floats away.

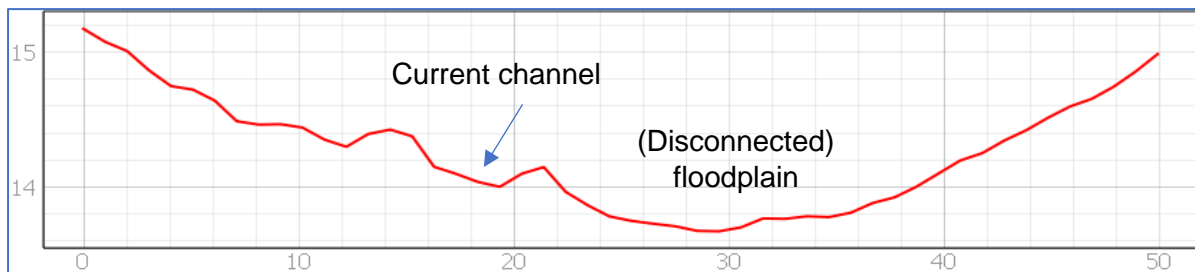
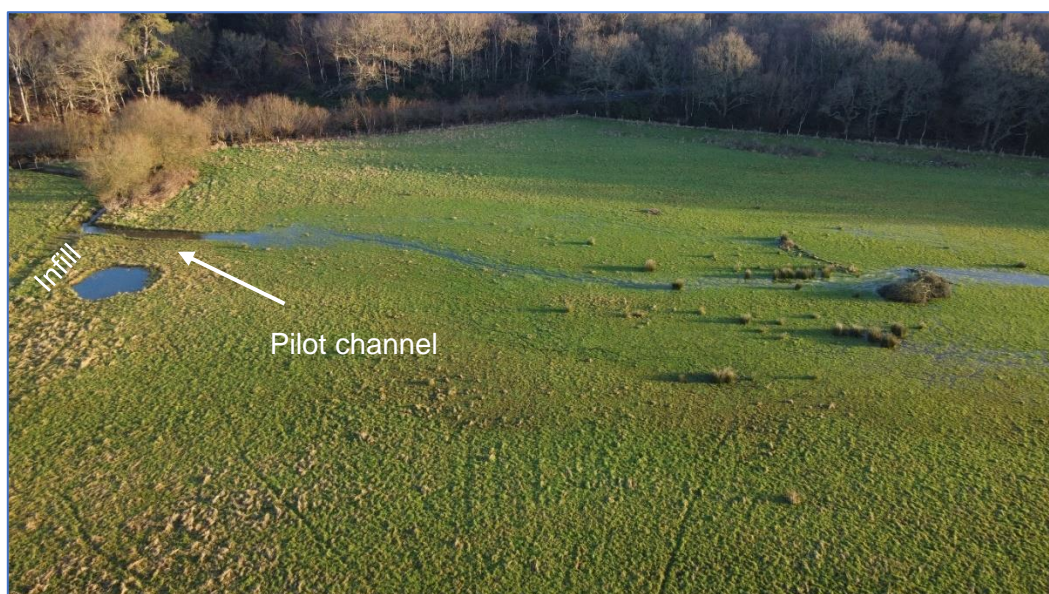
The analysis of flatness in the valley floor identifies the potential natural floodplain. Comparing to the course of the tributary streams it is clear that the channels have been realigned outside of the floodplain area. It is proposed to re-connect the tributary streams to the floodplain.

The points at which the channels deviate from the floodplain has been identified and will be the reconnection point. A simple infill of the channel is proposed at these locations. It is anticipated that there will be locally won availability of material to infill the channel. There is some evidence of an embankment along the channel (see below) but also it will be necessary to create a shallow pilot channel to direct flow onto the floodplain area (see example below). Material from the pilot channel can be used as infill. The infill should be immediately downstream from the reconnection point and only need to be for a distance of 10 to 20m.

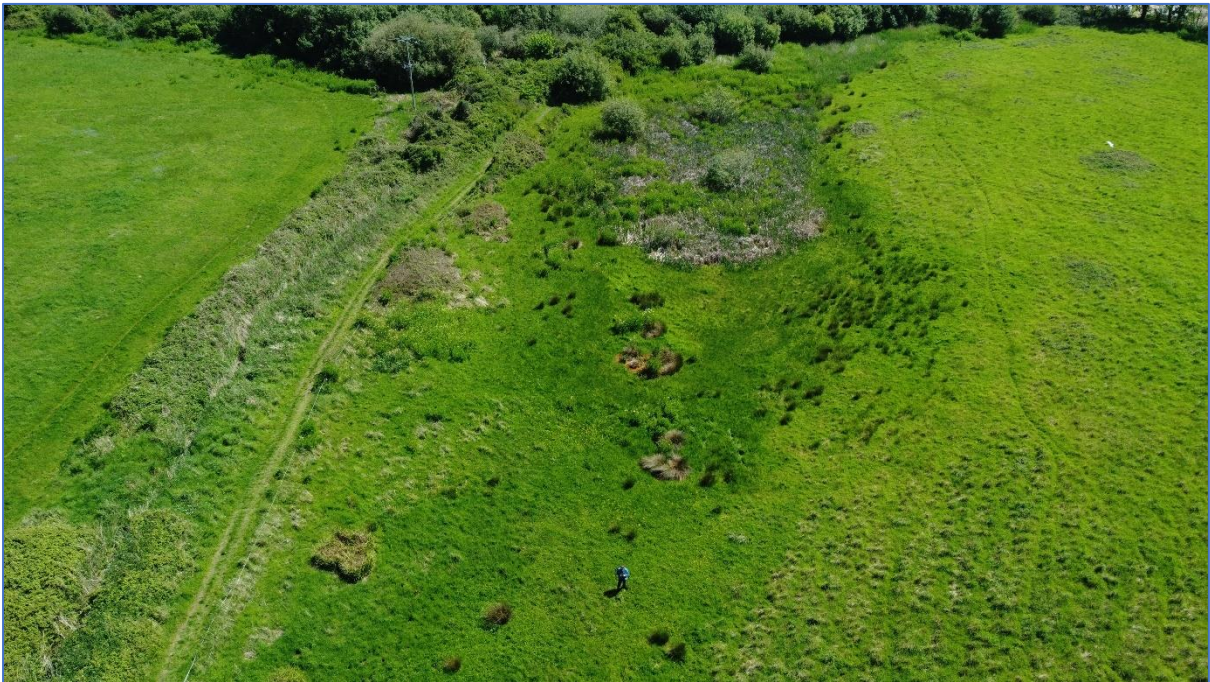
The downstream of the newly reconnected floodplain area is currently modified for use as floodplain storage. The storage area appears to work with a narrowing of natural valley form topography. Re-connecting the floodplain from the two tributary channels will make the current storage feature an on-line wetland feature. A wide and shallow diffuse flow will be created on the floodplain as the main flow path of the stream rather than the feature acting only as a storage feature.

There is no obvious engineering at the downstream end of the floodplain to hold water and it appears flow has a shallow connection back to the current single channel. The shallow connection will be the return of flow from the floodplain to the single channel for ongoing flow downstream of the floodplain connection.
