C78 Glasson Family Monument

Job No: **J20-077** Dwg No: 3025 Rev: A

Proposed Monument Elevations C78

Heritage Restoration of Falmouth's **Ponsharden Cemeteries**

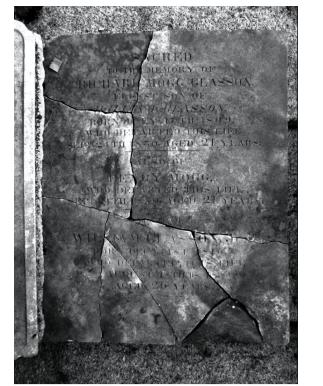
Inscribed top panel to monument with corner post loosely assembled for illustration purposes (Panel A)

Carefully disassemble tomb components and salvage marble top section panels and limestone corner posts. Build up honeycomb brickwork core walls off existing base within tomb to support lid 10mm above top of side and end panels. 50mm space between face of brickwork and back of panels. Repair broken south and east panels. Back fragmented marble top section panels onto 25mm thick slate slabs. Re-assemble side and top panels of both stages, cramp to each other and brickwork core with stainless steel cramps, and repoint joints. Refix top cover and decorative capping.

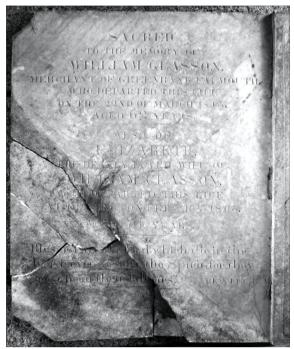
Inscribed top panel to monument with corner post loosely assembled for illustration purposes (Panel B)

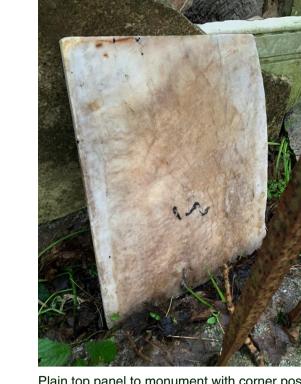
Plain top panel to monument with corner post still attached (along bottom edge as shown)

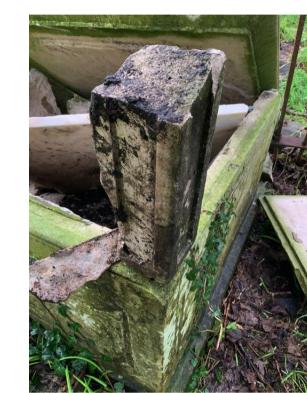
Fragment of corner post placed on bottom panels for illustration purposes

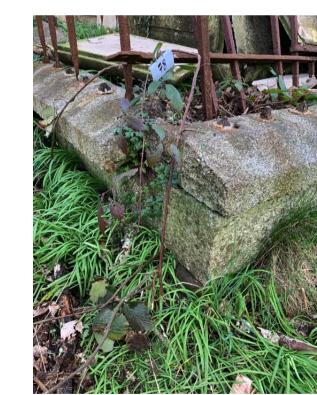
Spalled section of granite plinth, south west

Following removal of tree and roots, remove granite kerbs. Reset and re-bed granite kerbs to existing plinth as closely as possible to original line and level. Repoint joints between kerb stones. Ironwork

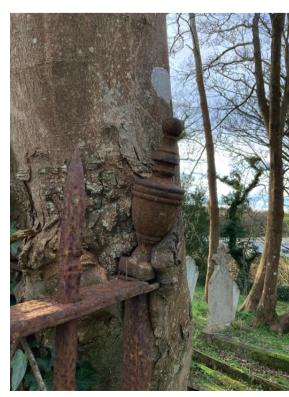
Tree grown around top cap of railings, north

Chain drill to remove railings from lead caulked sockets and remove to workshop. Disassemble and salvage reusable elements. Obtain replacement matching elements and reassemble railings including gate. Thoroughly de-rust ironwork and decorate. Fix back in place with molten lead caulk

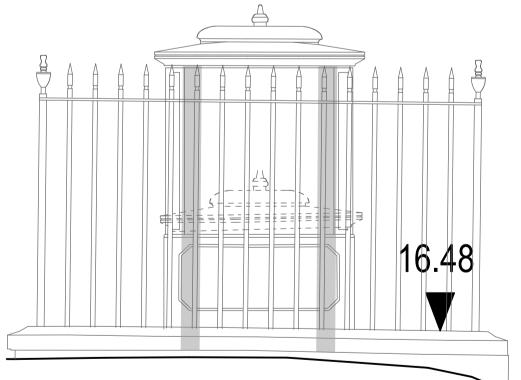
Detail of fractured south base panel of monument

Detail of fractured east base panel of monument
