Revised Heritage, Design and Access Statement

Royal Cornwall Museum – Re-roofing, Improvement Works and Repairs

12th August 2022

CGH/7377

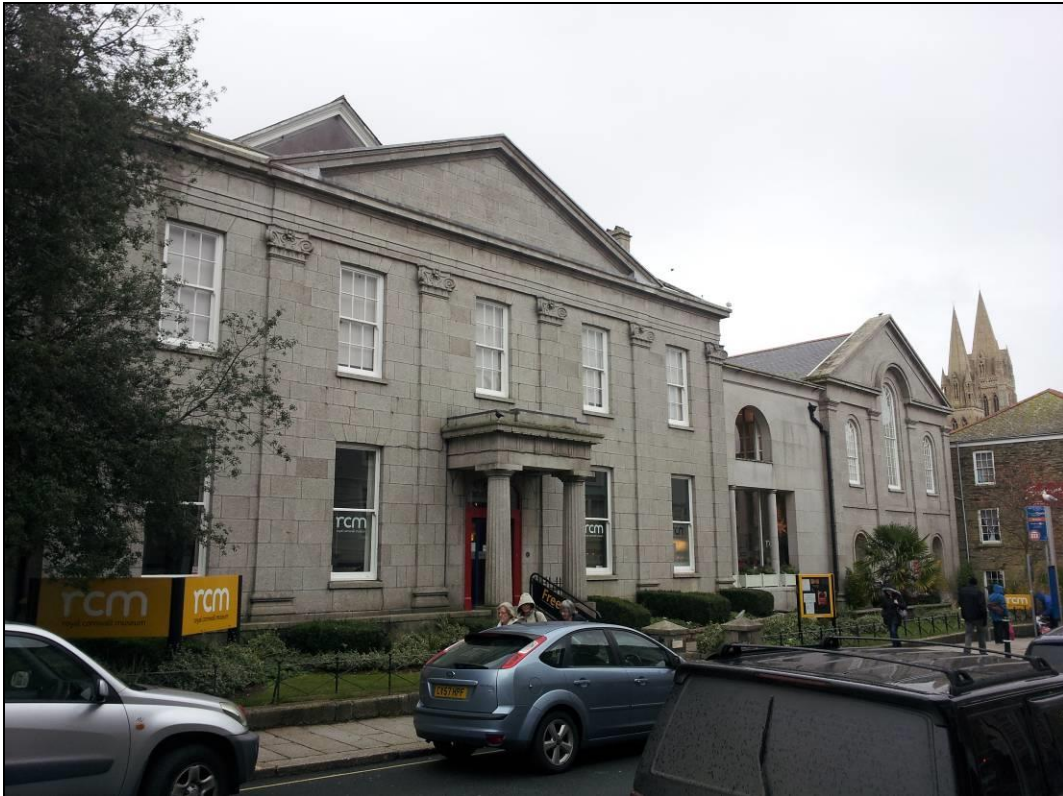
1. View of main south elevation from River Street. The museum sits on the left with the link between and the chapel to the far right of the shot.

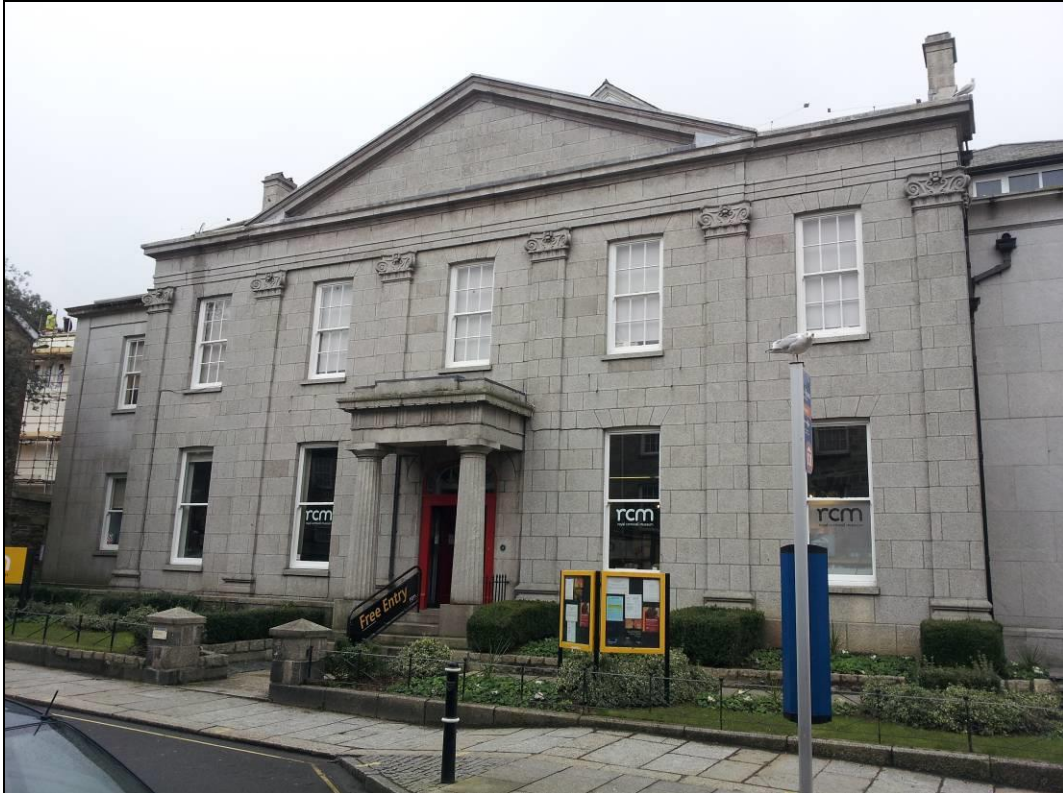
- 2.08** Both buildings were fronted with grey granite ashlar. The museum is of classical design with a symmetrical elevation originally in three bays (this is now distorted by the link to the east). The main section comprises five intermediate bays with sliding sash windows and giant iconic pilasters. The building runs to a triangular pedimented gable. To the west a smaller bay exists largely hidden by the trees to this end. A central porch with iconic pillars forms the primary entrance into the museum.

2. View of the main elevation of the museum.

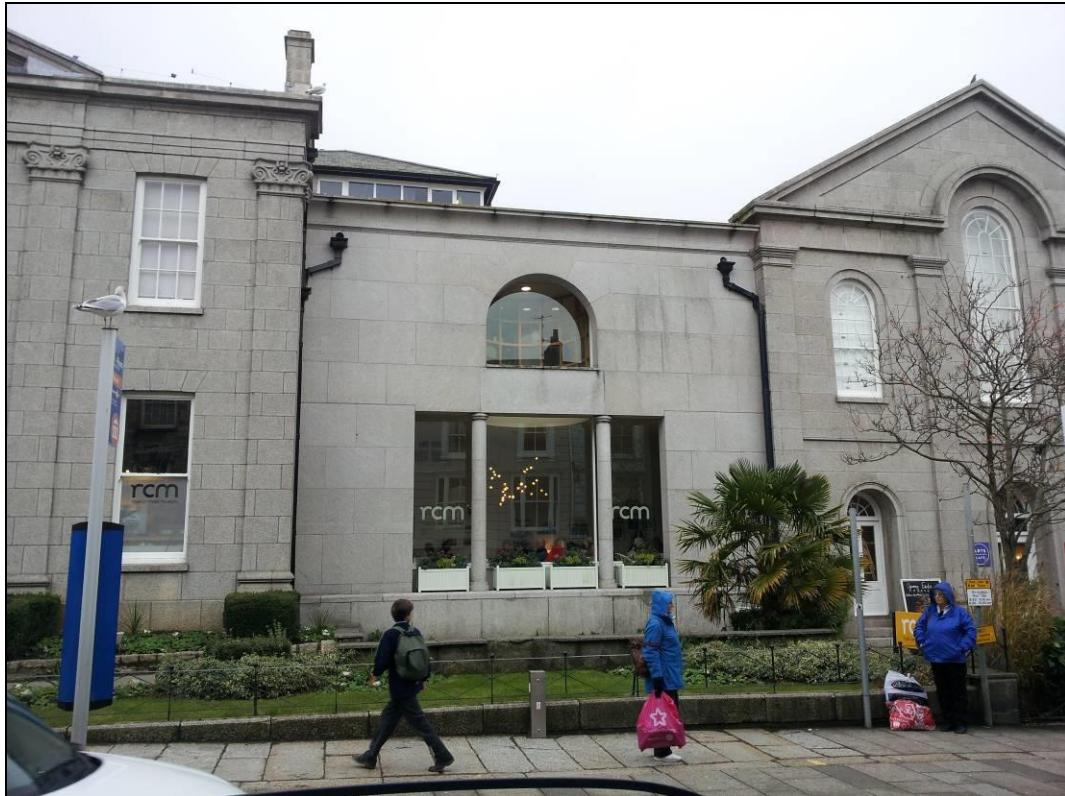
- 2.10** The link is faced with granite ashlar and is clearly of newer construction as the granite colour and style does not quite match in with the buildings on either side. This new structure runs the full length of the building between the museum and chapel to The Leats north of the building. The linking structure provides much of the vertical circulation of the museum and also contains the bulk of the lavatory facilities.

3. View of the 1998 link between the two buildings.

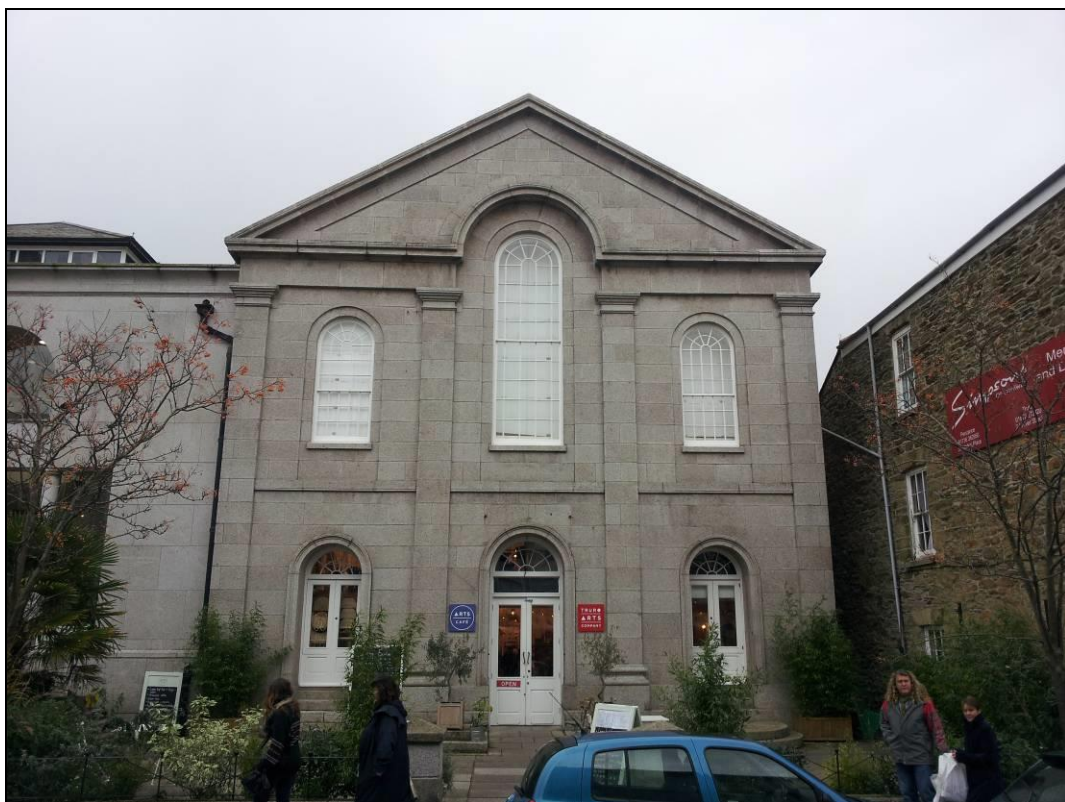
- 2.11** The chapel is designed in a classic fashion very similar to the Wesleyan and Baptist chapels that are found throughout Cornwall. It is a rectangular plan building with a 1:1:1 frontage to the street running to a large pedimented gable end. Pilasters divide up the elevation and arched headed doors / windows are provided to both floors. The ground floor is open with stores etc to the north.

4. View of the chapel from the south.

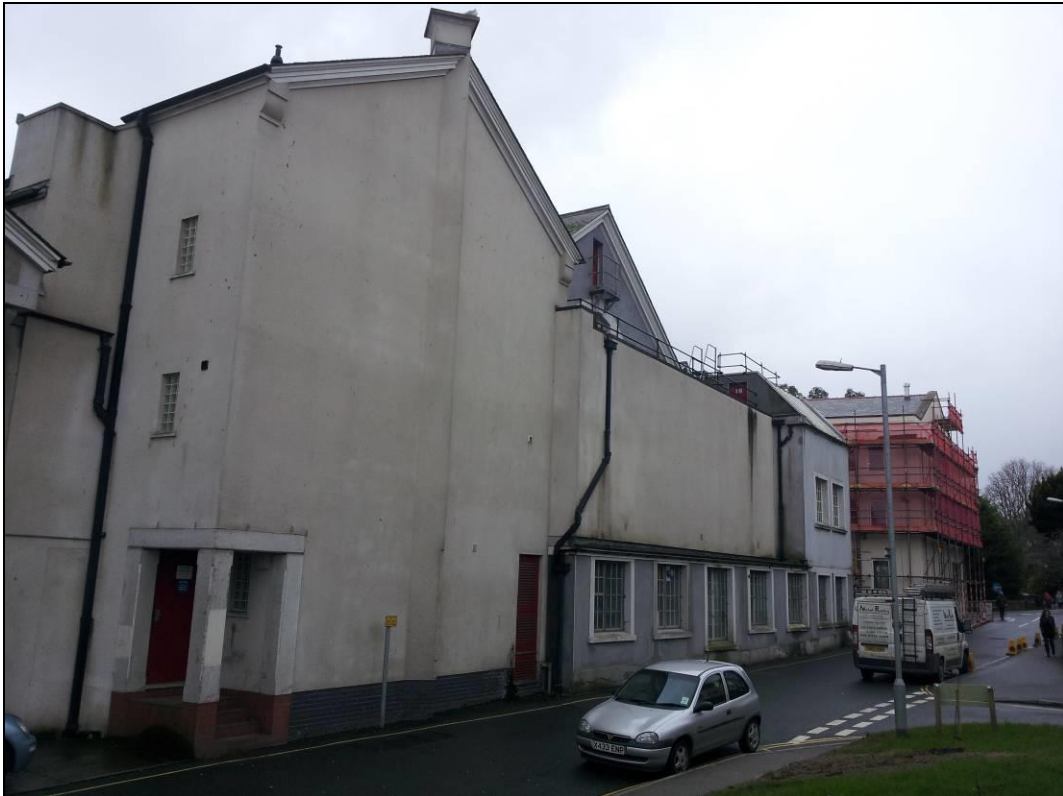
5. View of the rear elevation from the northeast. The downpipes will be replaced.

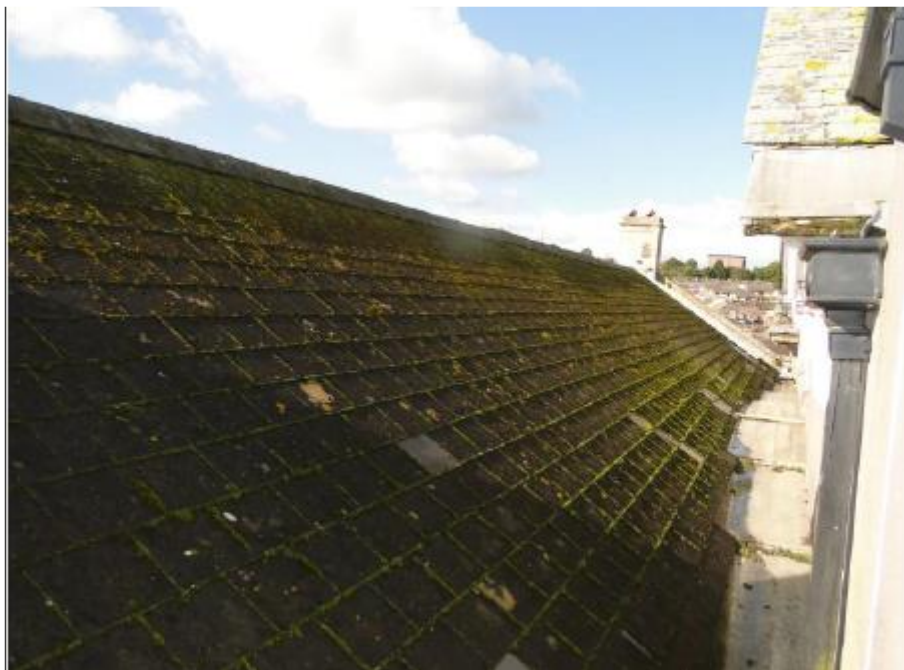
- 4.02** Existing pitched roof areas slated with a mix of natural and fibre cement (possibly asbestos) slates. The roof has black clay ridge tiles. Partial re-roofing was undertaken in 1994 although we believe existing slates in a lot of areas were re-used. Roof R1 has been replaced on the back side with a very thin profile artificial slate. Slippage is occurring to all slopes indicating that the slates have reached the end of their life and nail fatigue is taking place.

6. Slope to back of R1.

4.03 The roof covering will be stripped and the roof structure repaired as necessary with any insulation upgraded. New Cornish Delabole or Trevillet 7x14inch slates (or size as available) will be dry-laid to battens as existing. New black clay ridge tiles to match existing will be provided.

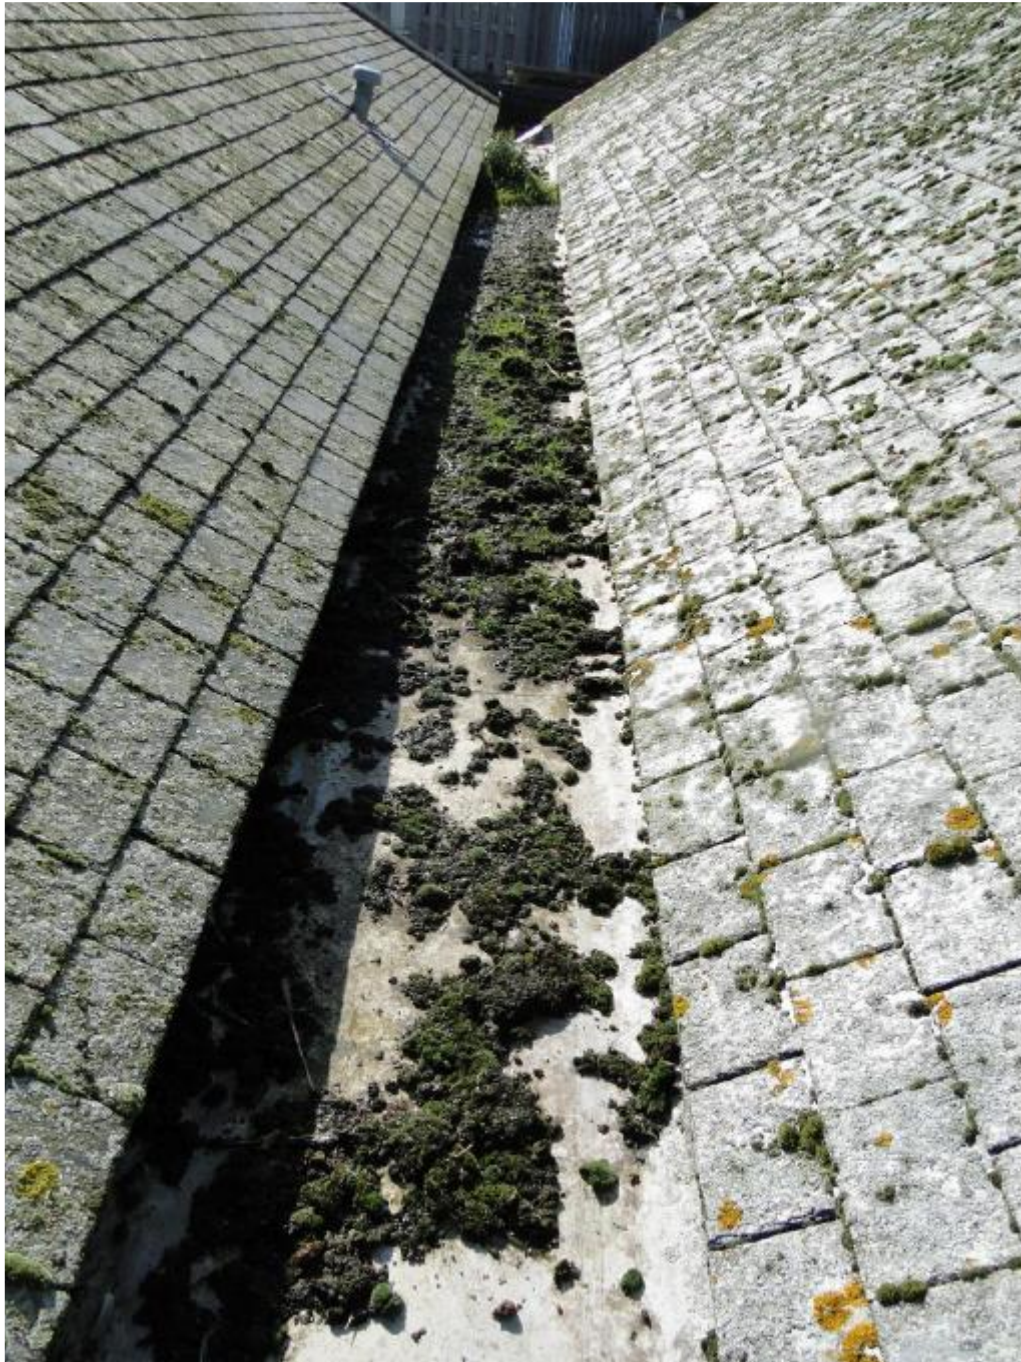
7. Inner slopes of R3 and R4

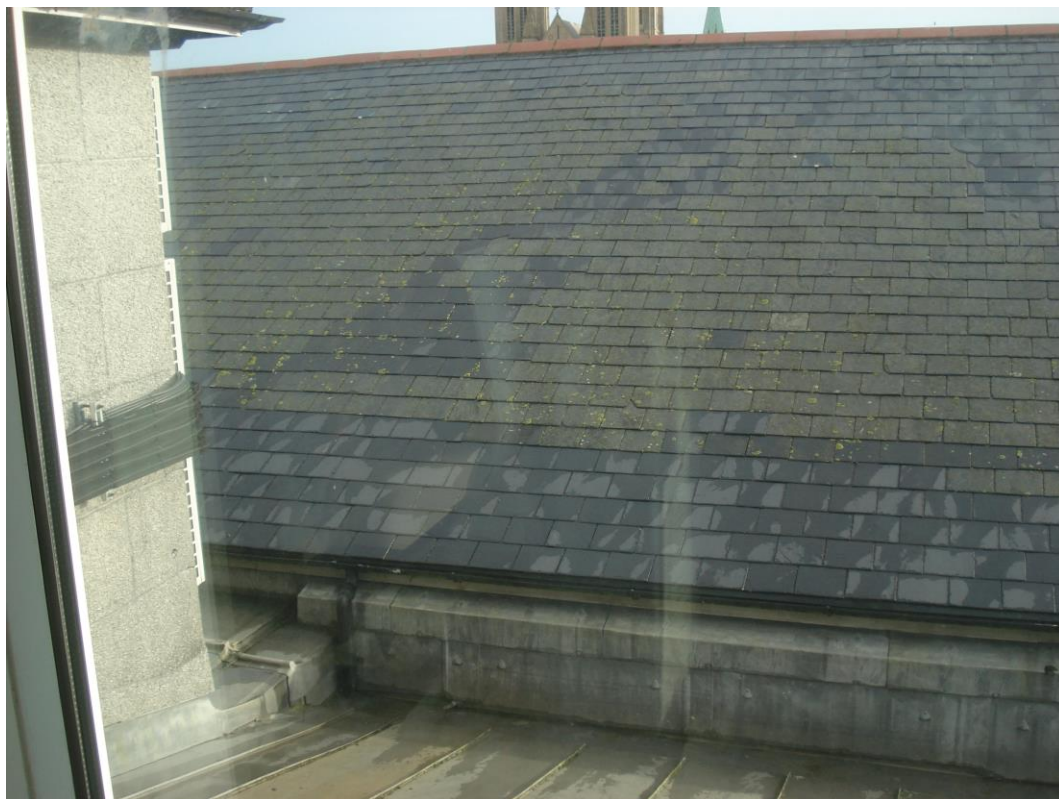
- 3.01** There is evidence of deterioration of the pitched roofs and a desire to amalgamate the covering of the slopes and bring them back to consistency with new Cornish slating throughout. A number of poorer quality imported slates have been used. There are areas of fibre cement slating as well and generally all slopes are showing signs of deterioration. Pitched slopes R2 and S5 were covered by application PA21/10106.

8. Imported slates to R5
