Timber External Door for Repair; Elevation

Project Title	Bacup Derelict Buildings		
Client	Rossendale Borough Council		
Location	Bacup		
Drawing Title	External Timber Door Glazed - Repair Detail Drawings -		
Date	11/12/2020	Scale	1:10 & 1:5
Checked	KC	Orig Paper Size	A1
		Status	Tender
Drawing ref	Job No	Drawing No	Revision
	8920	(32) 004	B

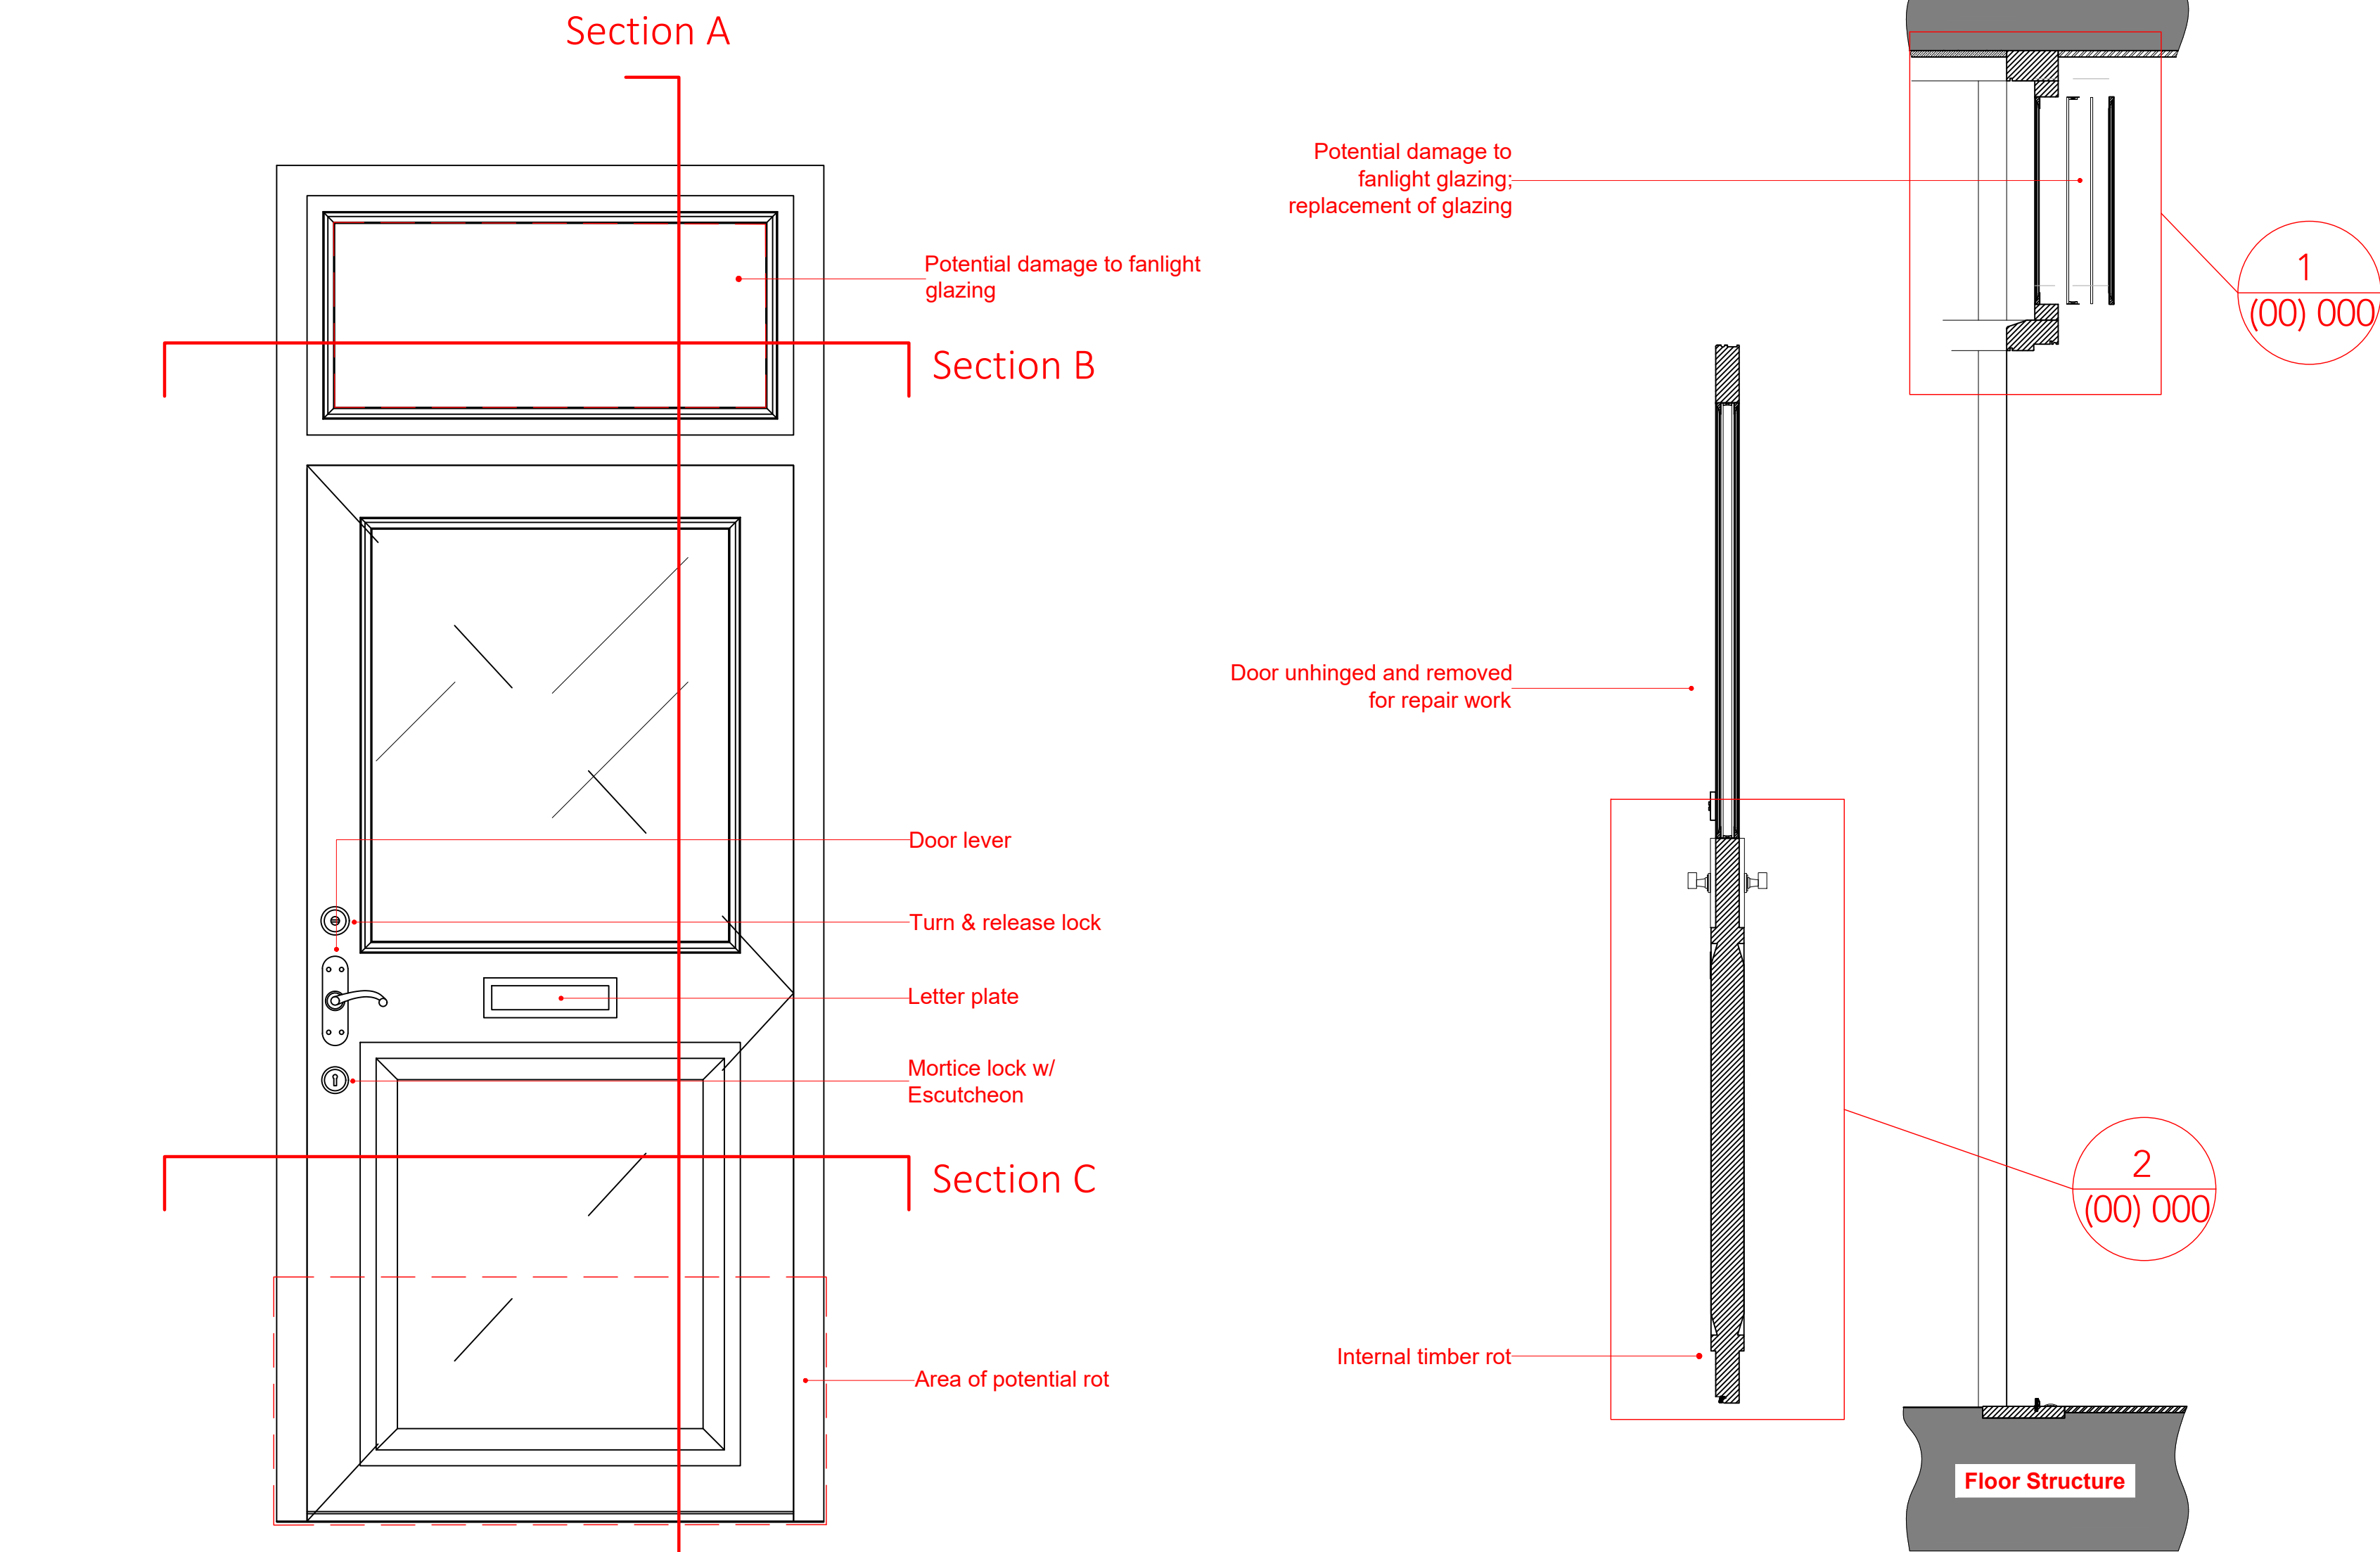
External Timber Door for Repair; Section

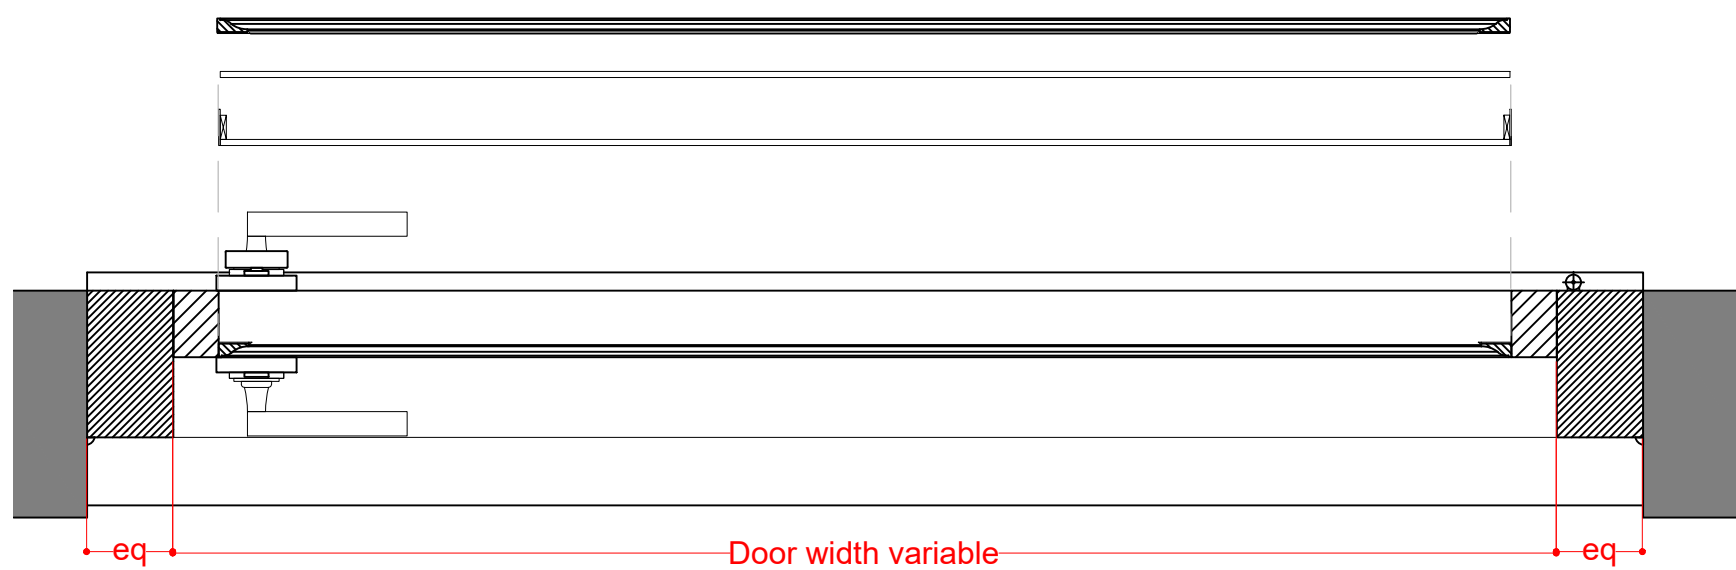
Glazed Fanlight Repair; Plan

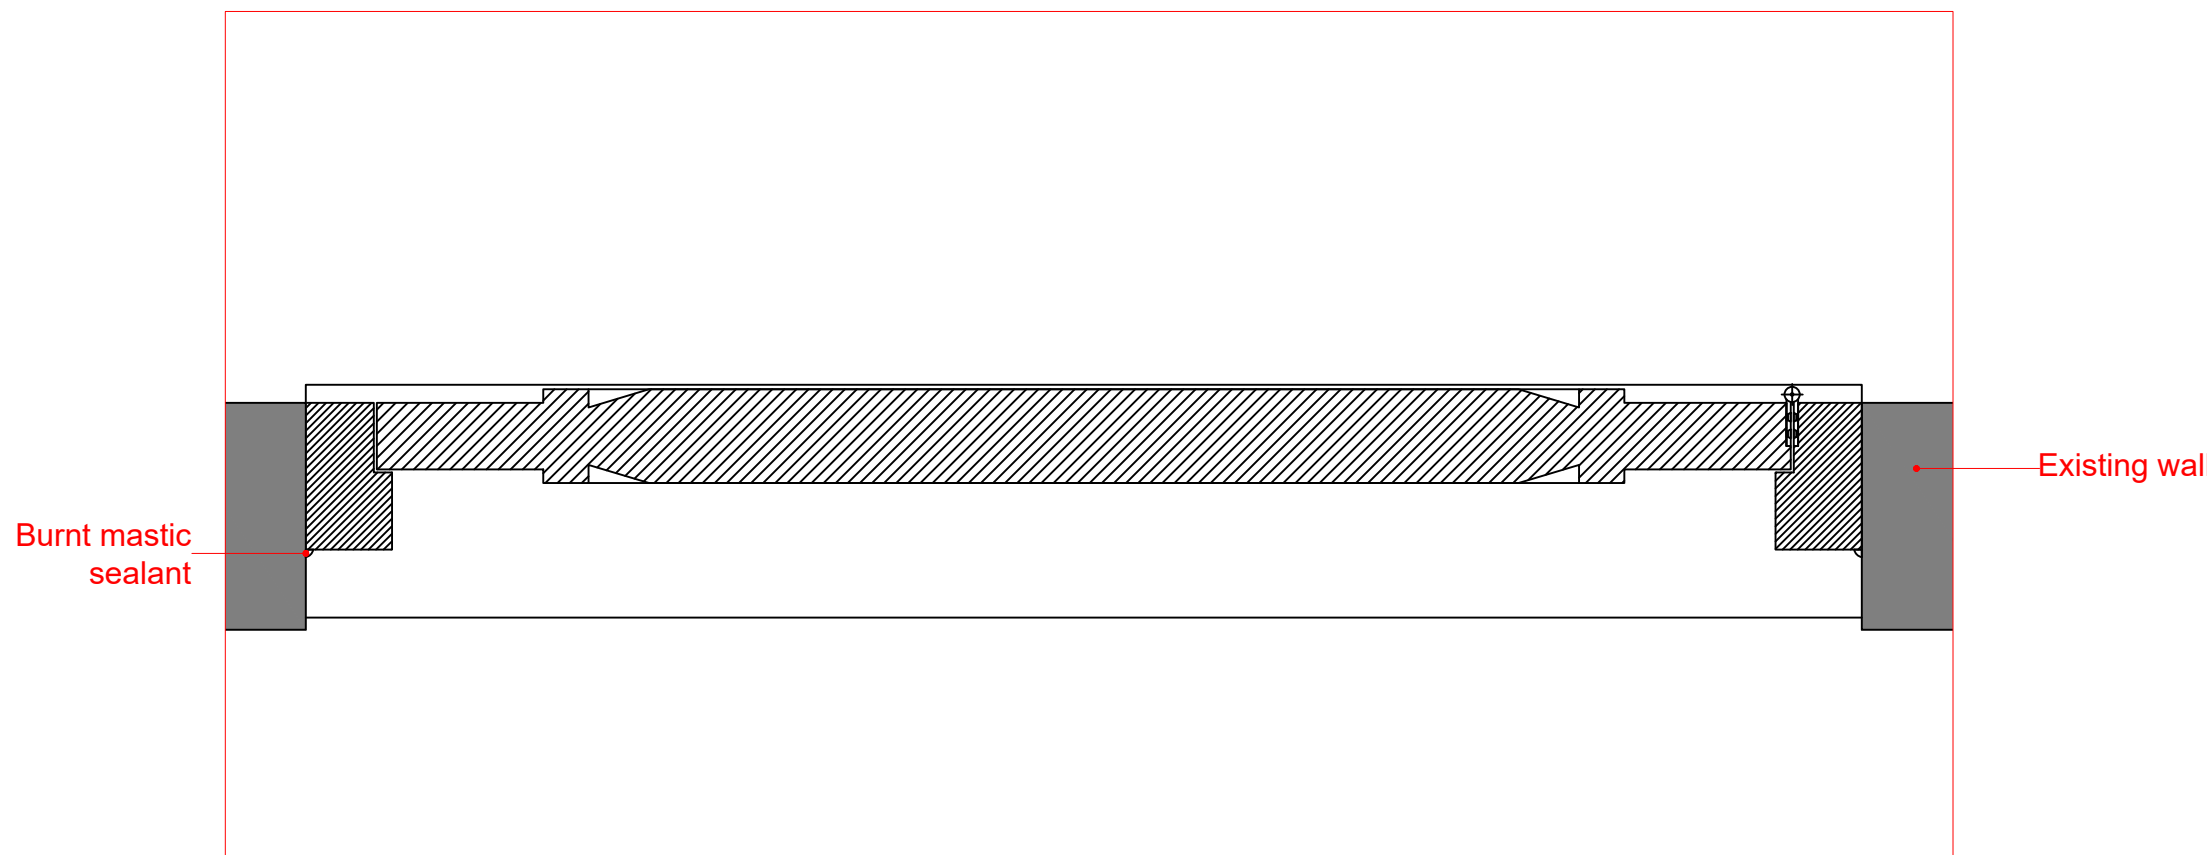
Internal Rotting Timber Repair; Plan

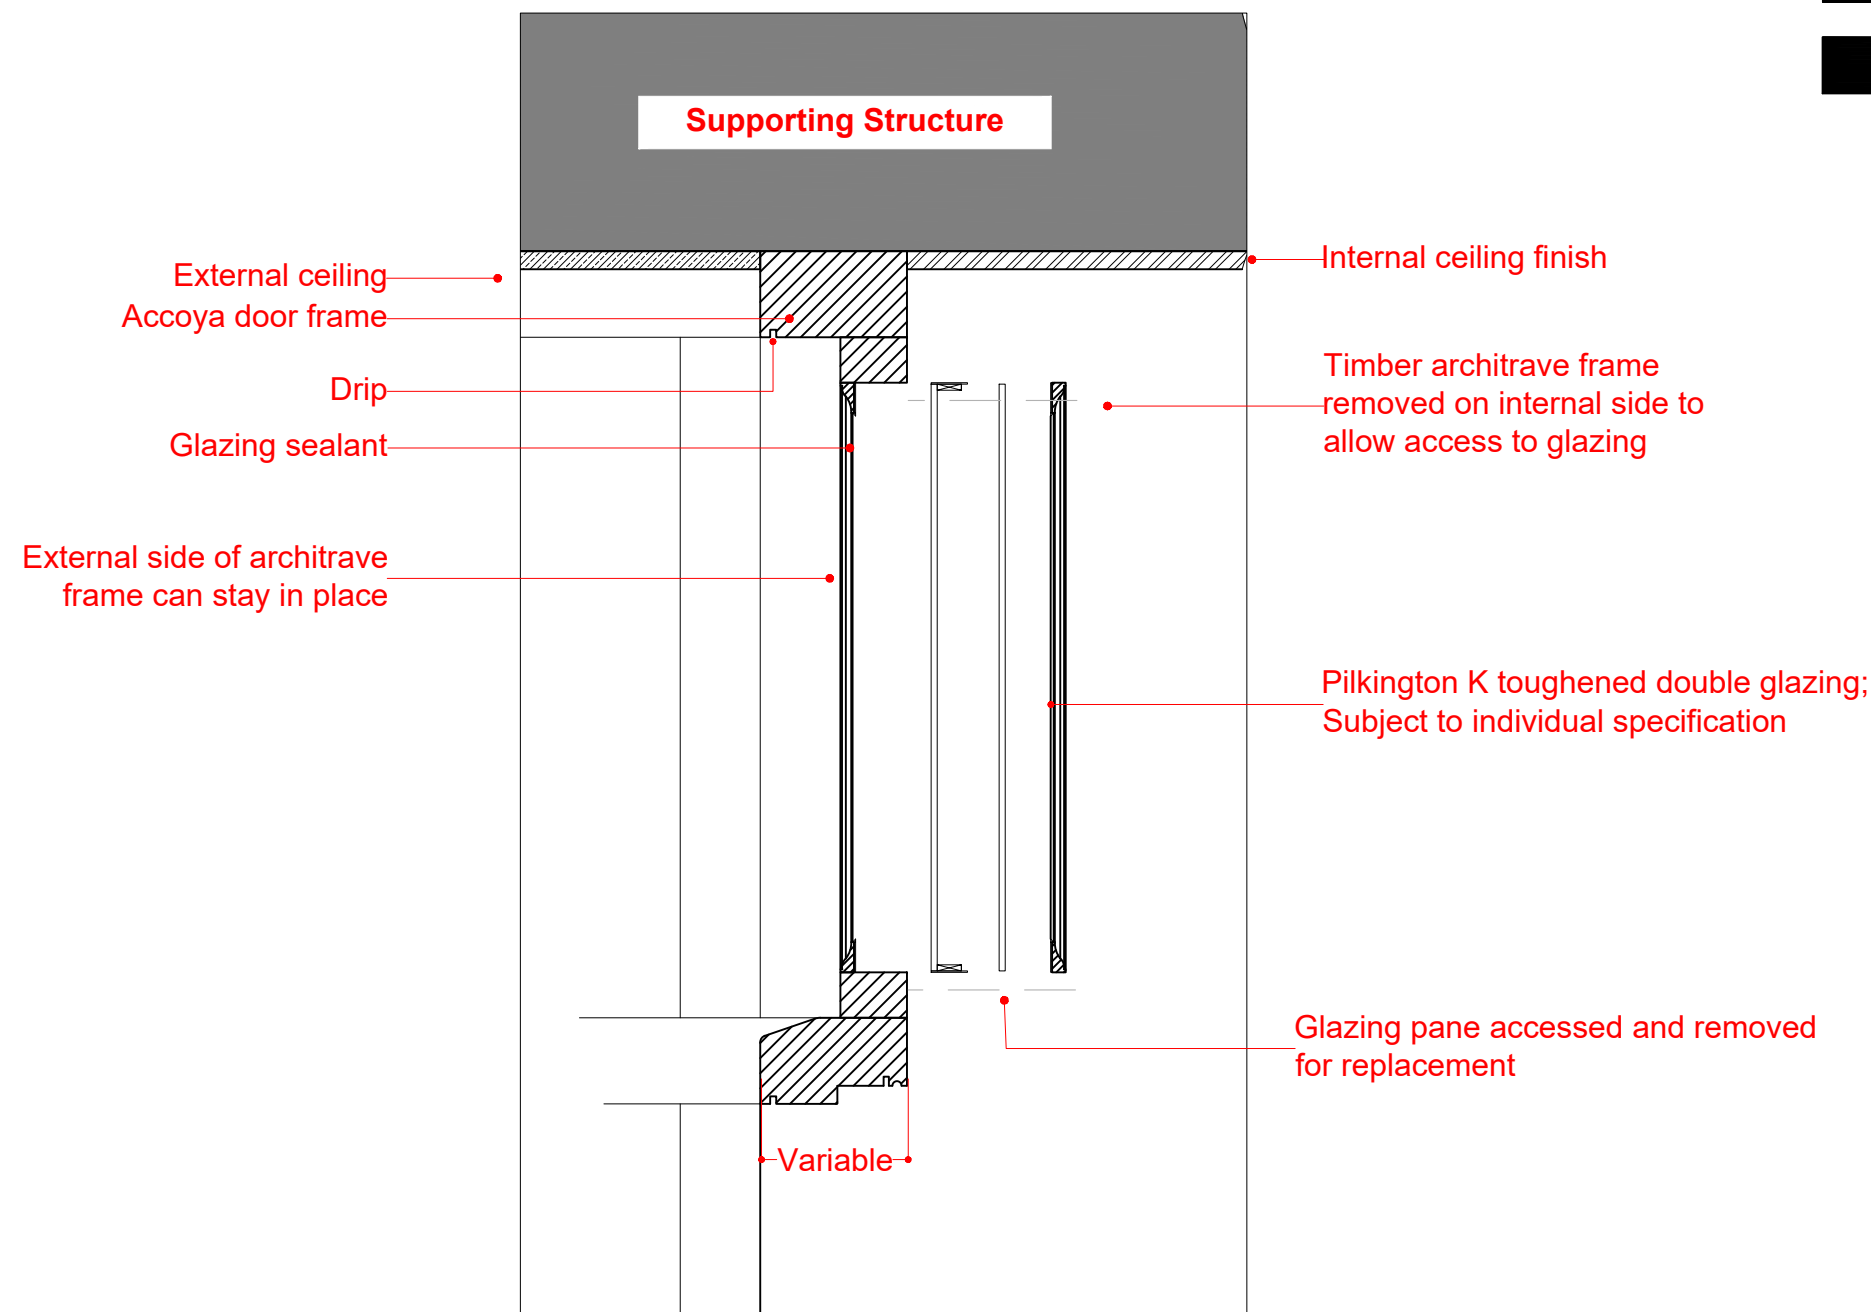
Glazed Transom Repair Detail; Replacement of Damaged Glass

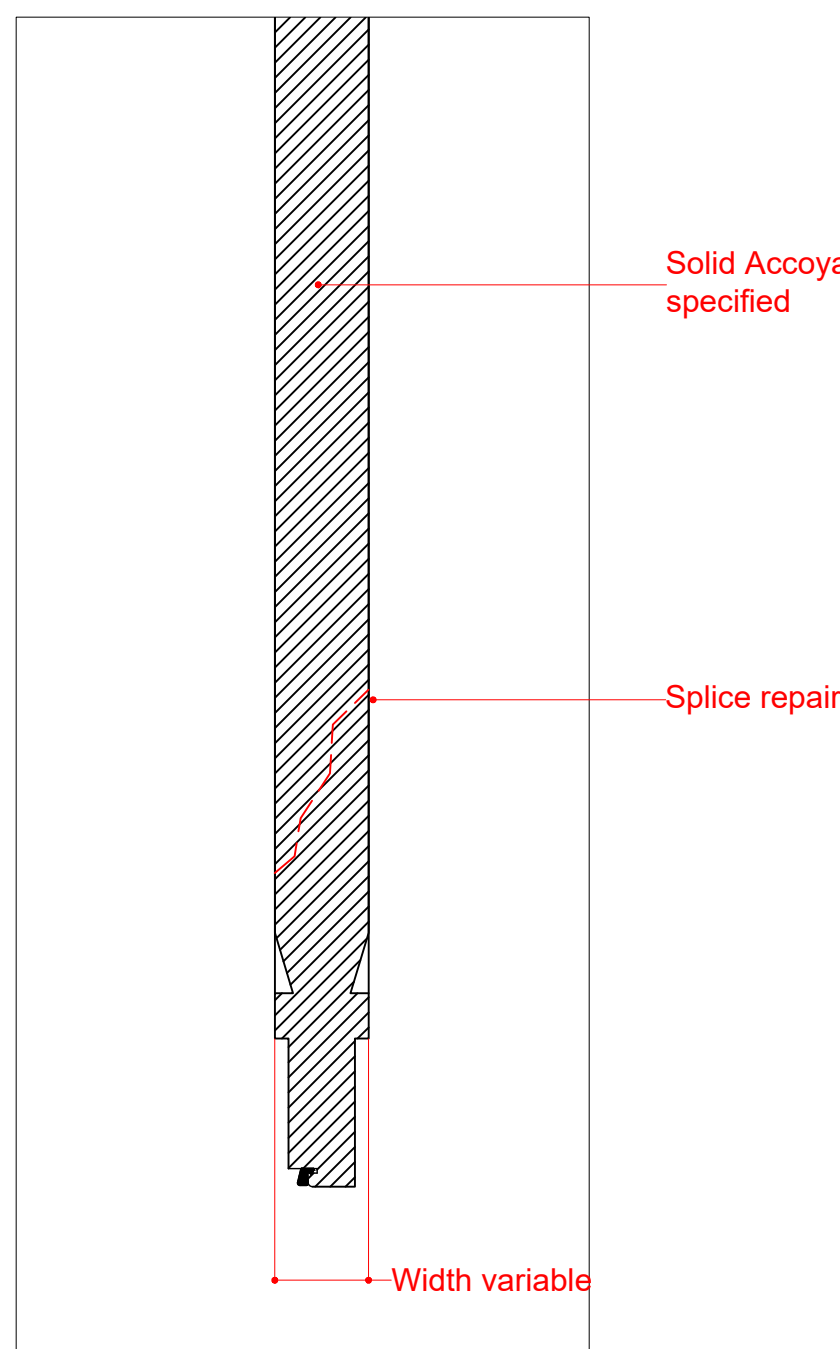
Splice Repair of Internal Timber Rot Detail
