GEOTECHNICAL ASSESSMENT REPORT

**BATTLE SPORTS PAVILION
NORTH TRADE ROAD
BATTLE
EAST SUSSEX**

PROJECT REFERENCE: P17031

REPORT REFERENCE: R16574

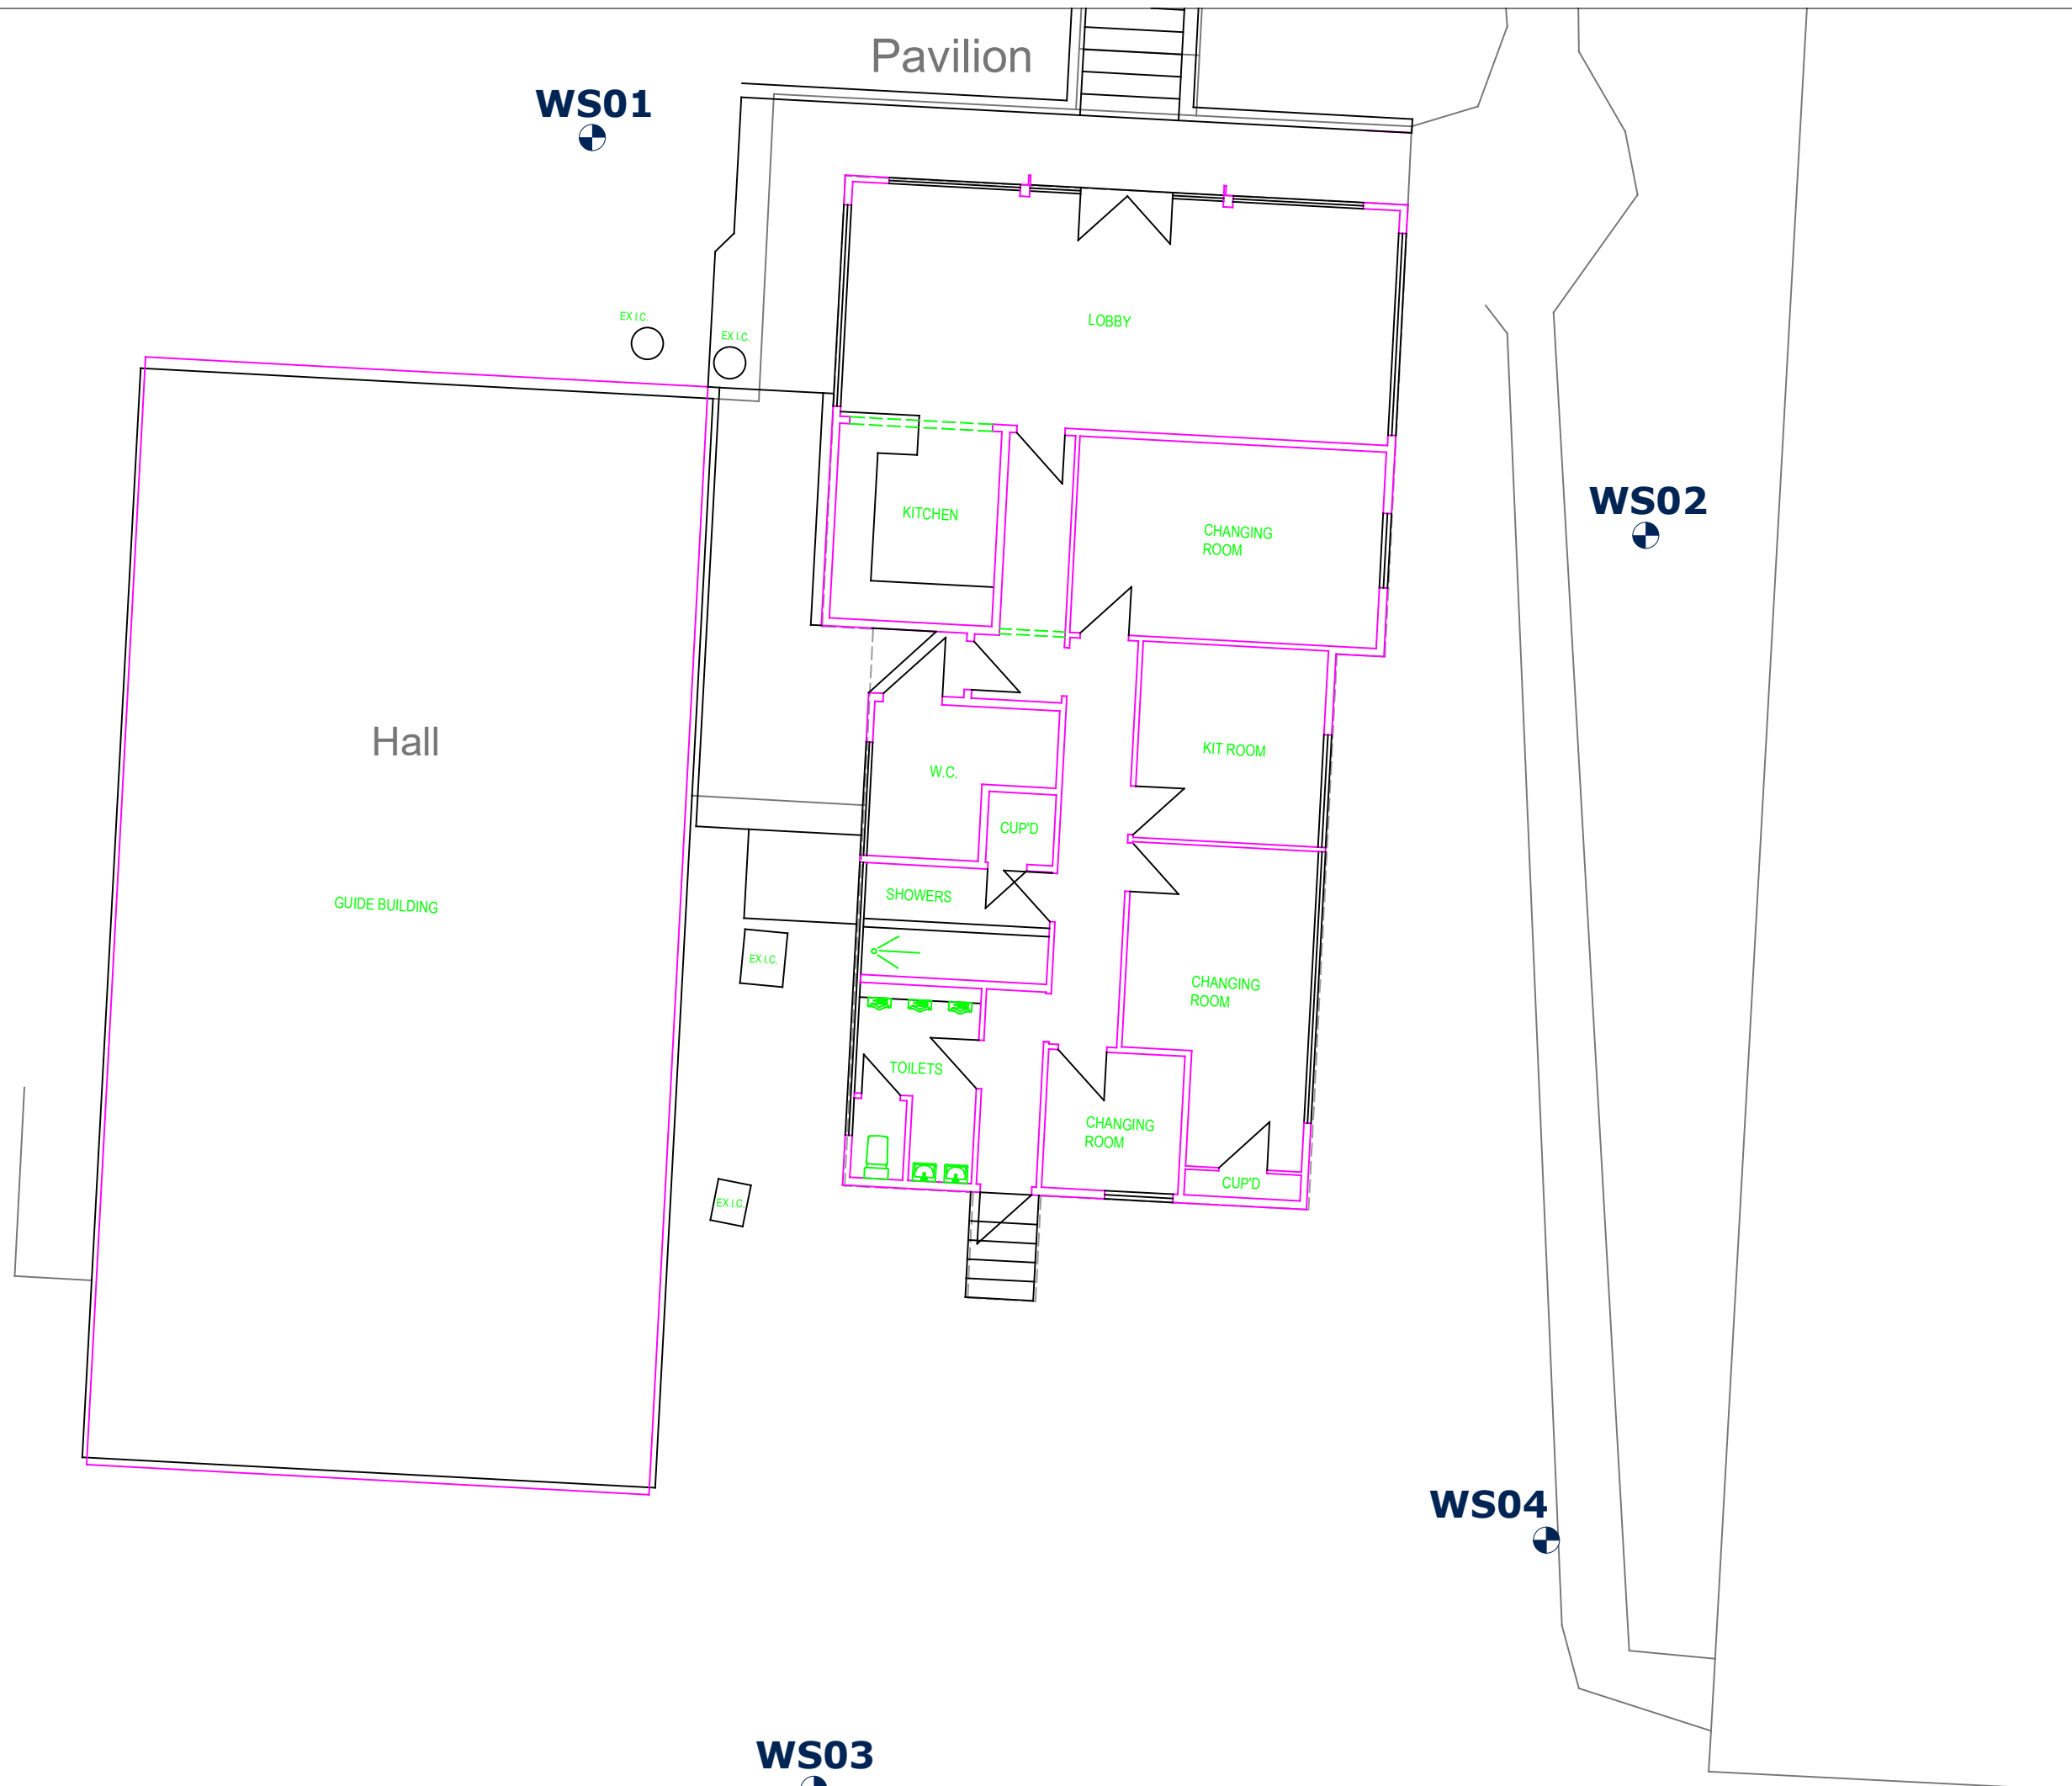
Head Office
Unit 3 The Old Grain Store Ditchling Common Business Park Ditchling East Sussex BN6 8SG contact@ashdownsi.co.uk
Site
Battle Sports Pavilion North Trade Road Battle East Sussex
Project Ref
P17031
Figure No
2
Drawing Title
Site Plan
Scale
Not To Scale

The intrusive site works comprised a series of dynamic sampler boreholes, together with accompanying in-situ geotechnical testing. The intrusive work was carried out on 3rd February 2025. The exploratory hole locations are shown on Figure 2.

The area of the proposed replacement sports pavilion lies within the northern part of Battle Recreation Ground located at North Trade Road, Battle, East Sussex, and is centred on the approximate Ordnance Survey national grid reference 574270, 116150. A site location plan and site plan are presented as Figure 1 and Figure 2, respectively.

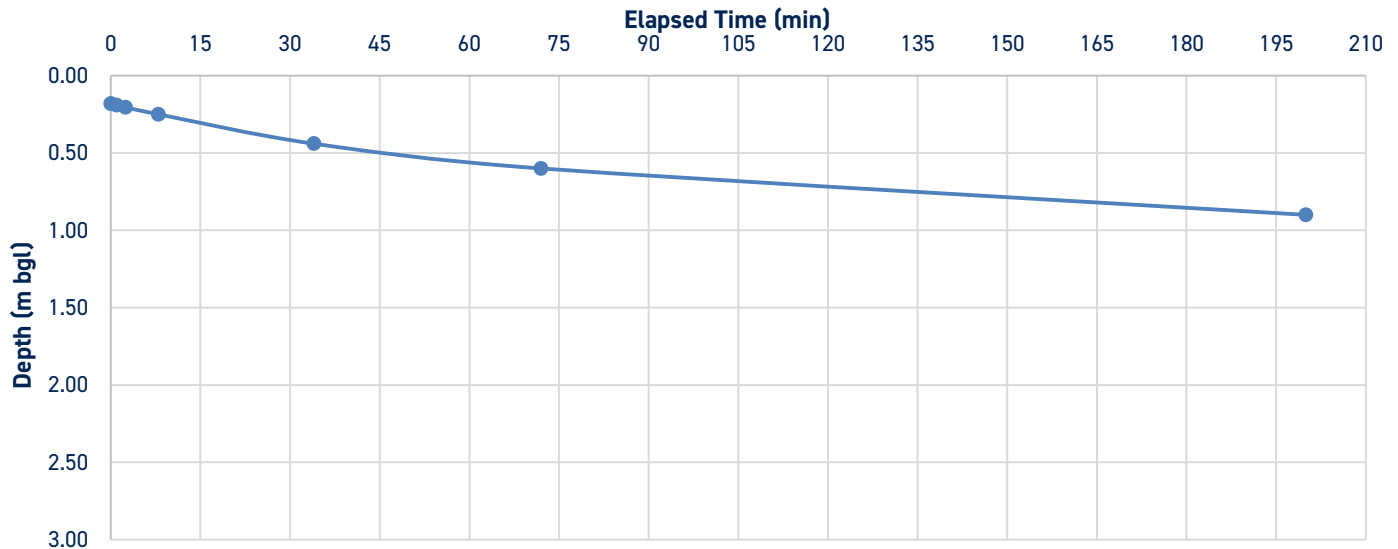
Length of Test Zone	1.00 m	L
Depth to Center of Test Zone	2.40 m	X
Water level at start of test	0.18 m	
Water level at end of test	0.90 m	
Duration of test	200 min	
Average Depth Of Water	2.36 m	
Average Drained Area	0.69 m ²	
Volume of Water Lost	0.005 m ³

Exploratory Hole	Top of Response Zone (m bgl)	Bottom of Response Zone (m bgl)	Stratum	Infiltration Rate (f) (m/sec)	Driving Head of Water (m)
WS04	1.90	2.90	Wadhurst Clay Formation	3.78 x 10 ⁻⁶	2.1
				1.17 x 10 ⁻⁶	1.7

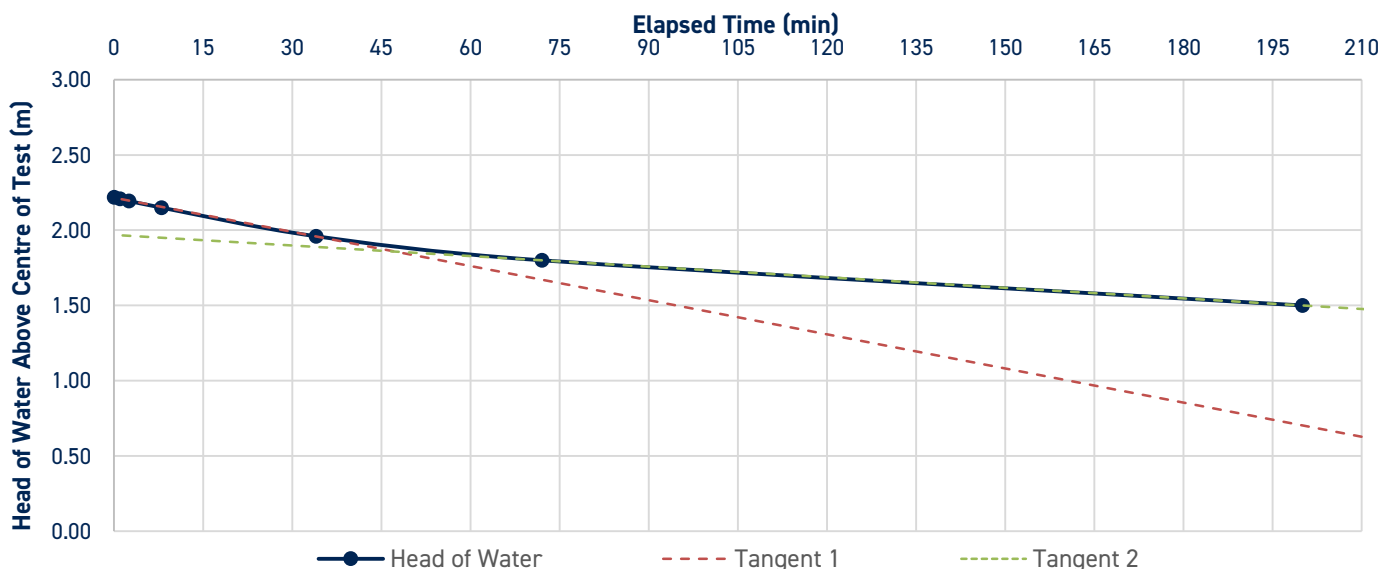
1.17E-06 m/sec

Calculation method: Calculated in accordance with The Soakaway Design Guide, published by Kent County Council, July 2000.

Infiltration testing within the Wadhurst Clay Formation soils recorded an infiltration rate of $1.17 \times 10^{-6} \text{ m/s}$ for a 1.7m driving head and $3.78 \times 10^{-6} \text{ m/sec}$ for a 2.1m driving head.
