# Wansbeck Nature Recovery Plan

River Restoration

Project number: 60676363

June 2022

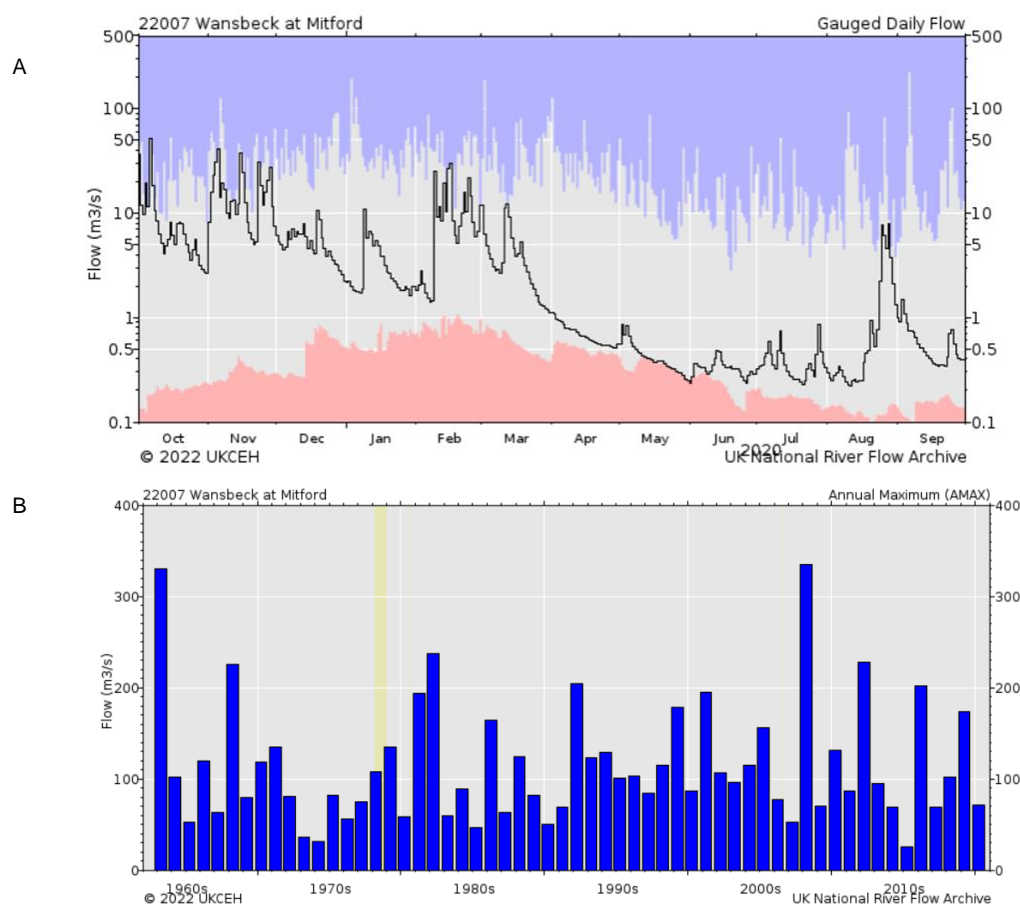
4.10 Catchment hydrology is driven by moderate rainfall – particularly within the upper, high elevation reaches of the catchment. Annual Average Rainfall is c. 800mm, which, coupled with the relatively low baseflow index of 0.37 and the mostly impermeable glacial till that dominates the catchment results in a flashy flood hydrograph and regular major flood events (EA, 2005). The River Wansbeck is gauged at Mitford Weir c. 2.5 km upstream of Morpeth from which a summary of data is provided in Figure 4-7 and Table 4-1.

Figure 4-7 A: Gauged daily flow from 2020 within max and min flows for each day of the calendar, and B: Maximum instantaneous peak flows from the 22007 – Wansbeck at Mitford NRFA gauge provided by CEH (2022). The maximum gauged flow occurred in September 2008. The yellow shading represents periods of missing data.

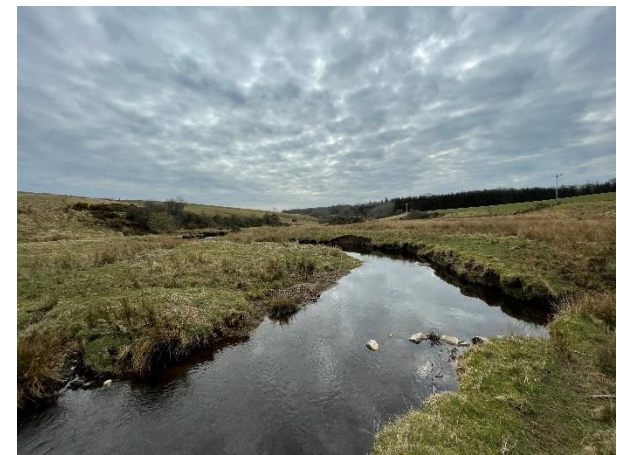
A. Sinuous channel planform with well-connected floodplain.

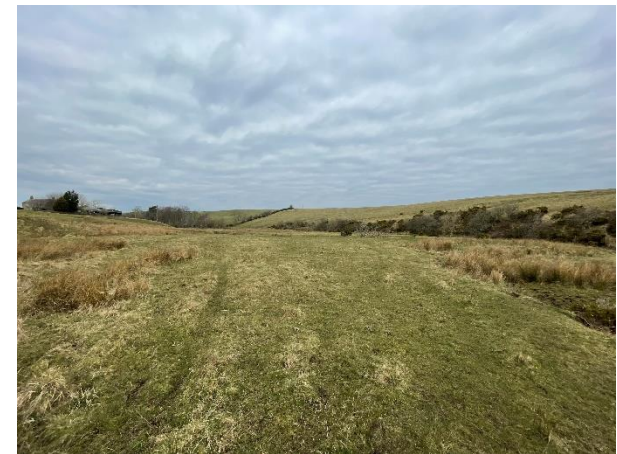
C. Limited habitat complexity on the local floodplain.

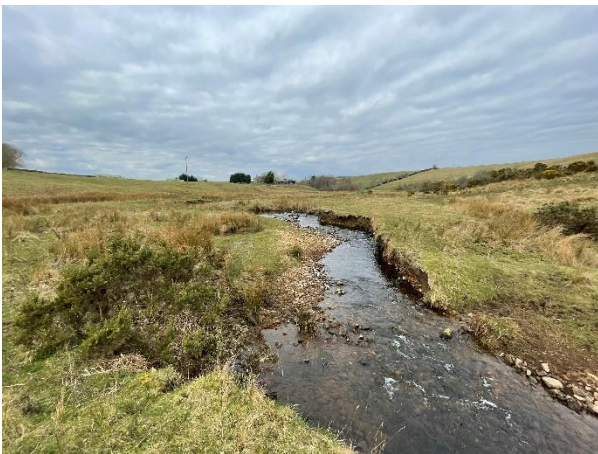
D. Hydraulic variance and complex bedforms.

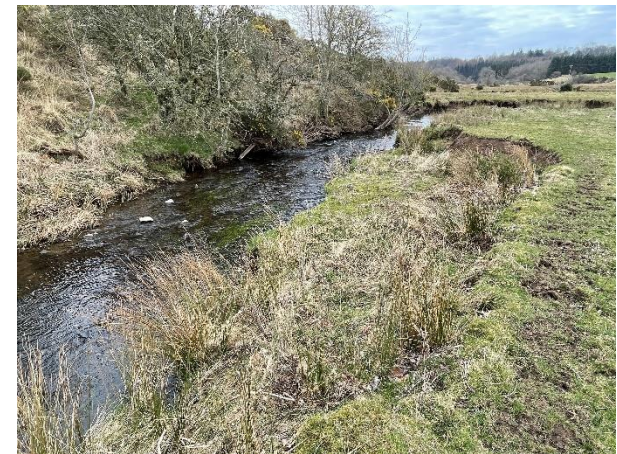
E. Laterally well-connected low-lying berm feature.

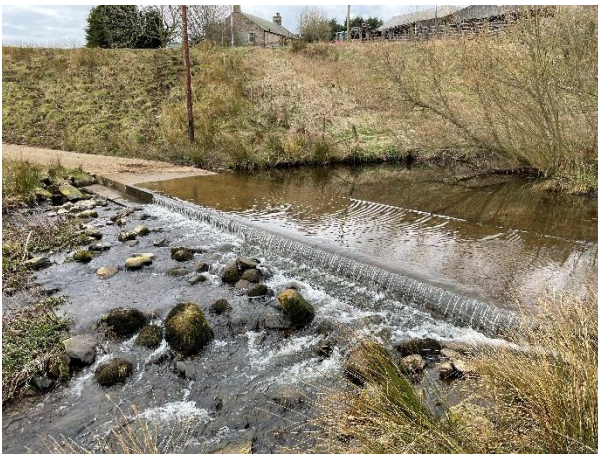
F. Concrete ford structure impounds flow and sediment and limits longitudinal ecological connectivity.

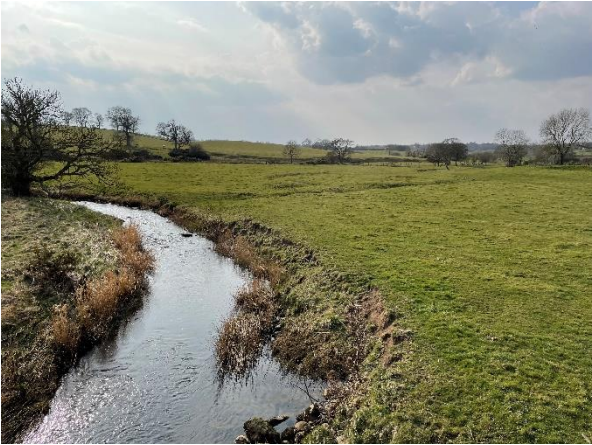
A. Slightly over-deep channel corridor with low-functioning floodplain.

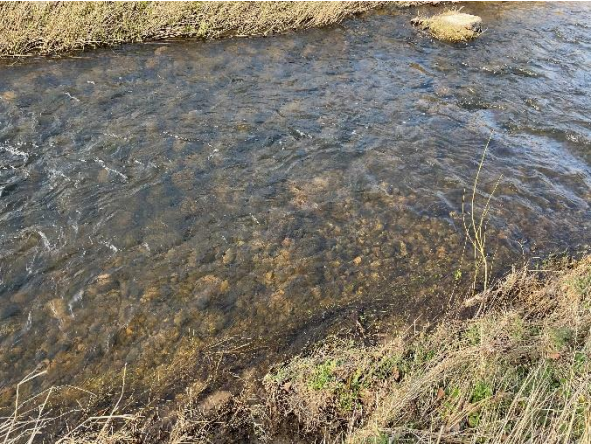
B. Typical channel substrate.

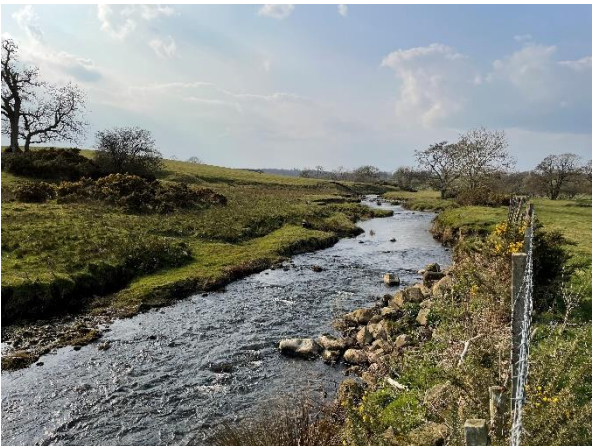
C. Complex flow structure and bedforms.

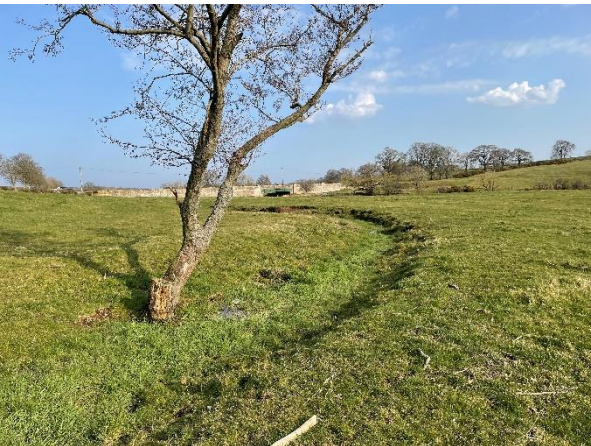
D. Disconnected palaeo-channel on low-functioning floodplain.

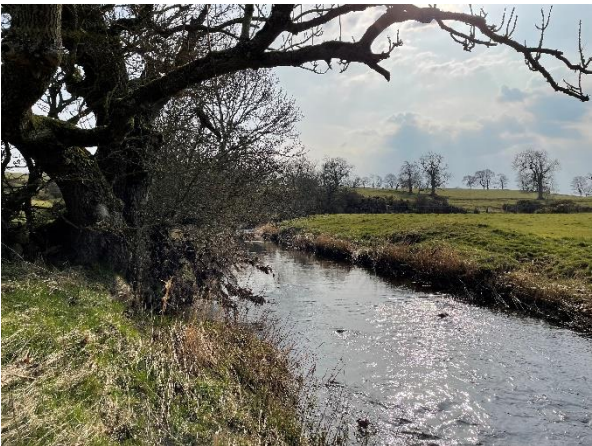
E. sparse riparian vegetation.

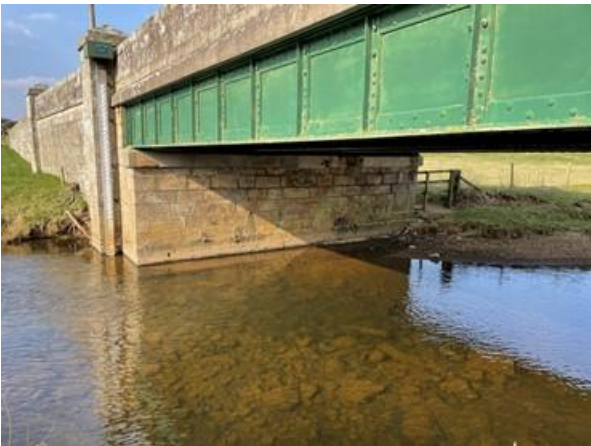
F. Bridge structure with abutments immediately adjacent to the channel.

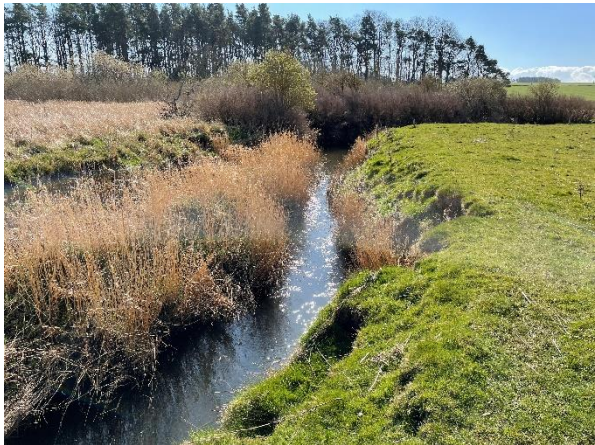
A. Grossly over-deep channel corridor.

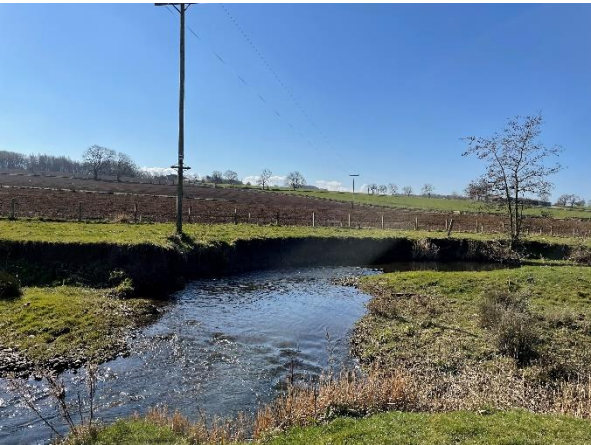
B. Morphologically diverse riffle unit brought about by wider cross-sectional geometry and low-lying, well-connected lateral berms.

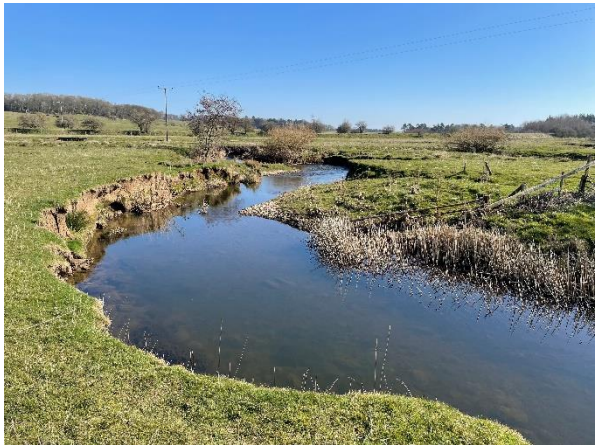
C. Typical laminar flow structure within sinuous channel.

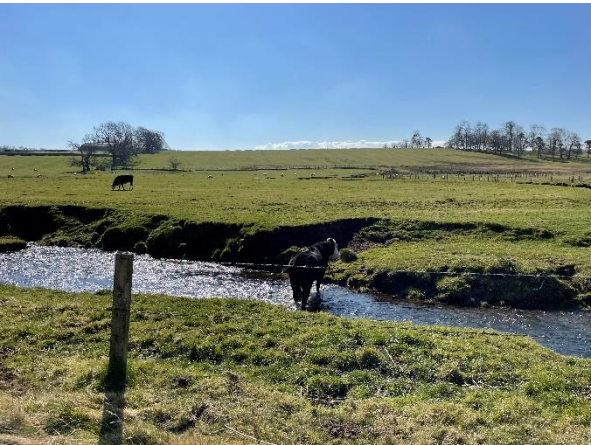
D. Sparse, heavily managed floodplain and riparian zone with obvious livestock issues.

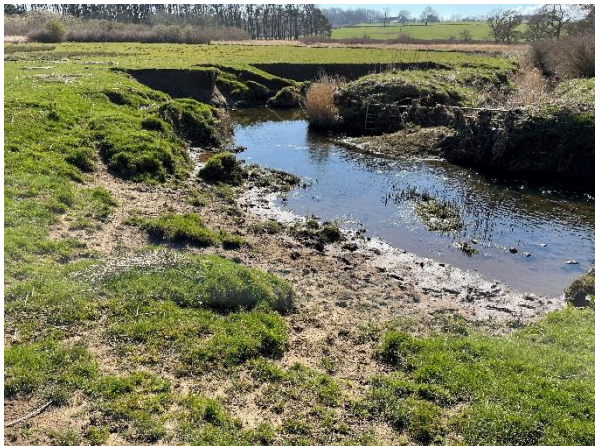
E. Severely degraded riparian zone with evidence of livestock poaching and river bank mass failure processes.

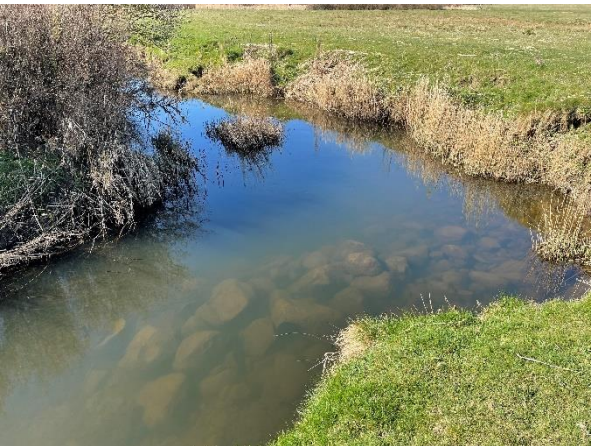
F. Ad hoc and ineffective erosion protection.

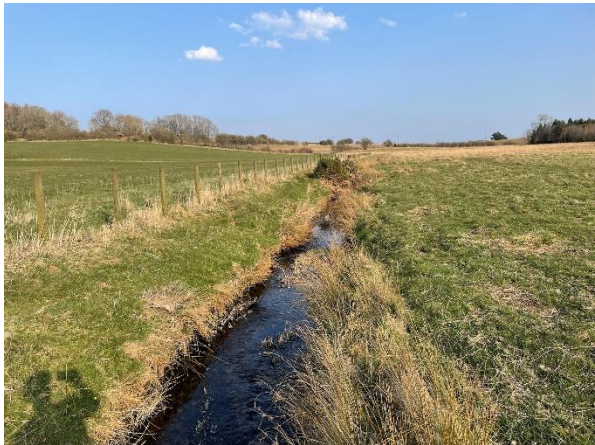
A. Straightened planform of Middleton Brun.

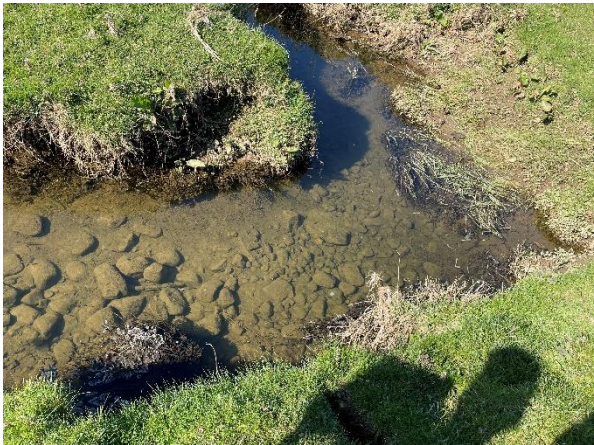
B. Coarse cobble and gravel substrate.

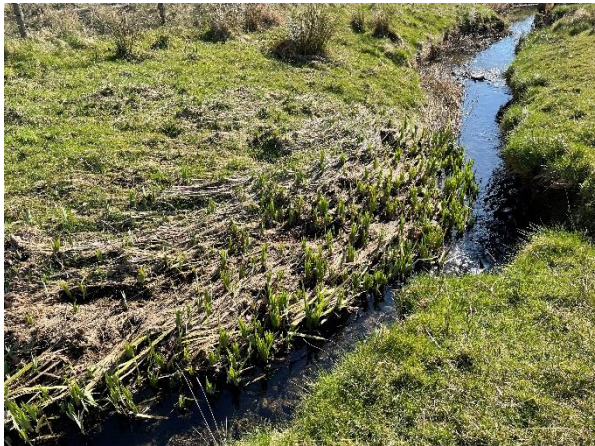
C. Vegetated sediment berm feature with localised hydraulic variance.

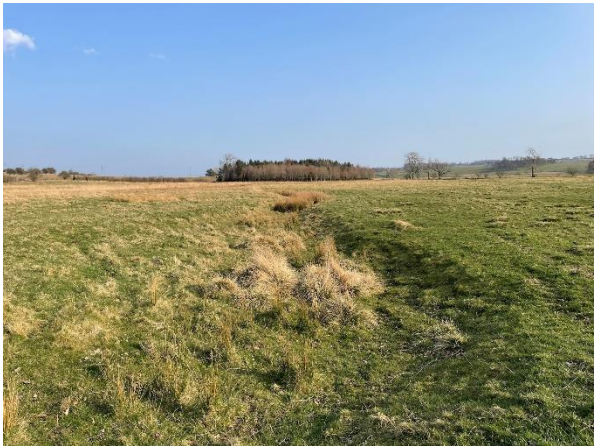
D. former course of the watercourse across a low-functioning floodplain.

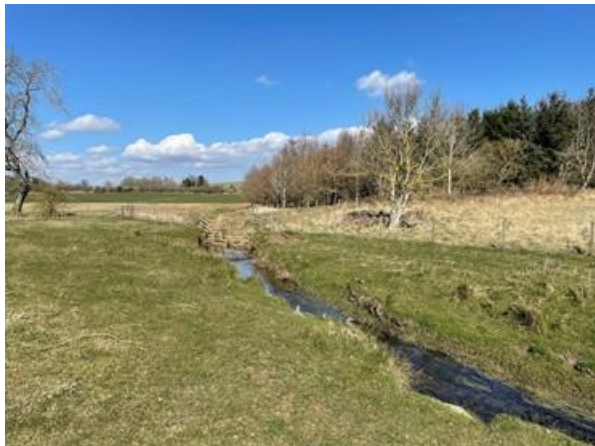
E. Homogenous floodplain and riparian habitat.

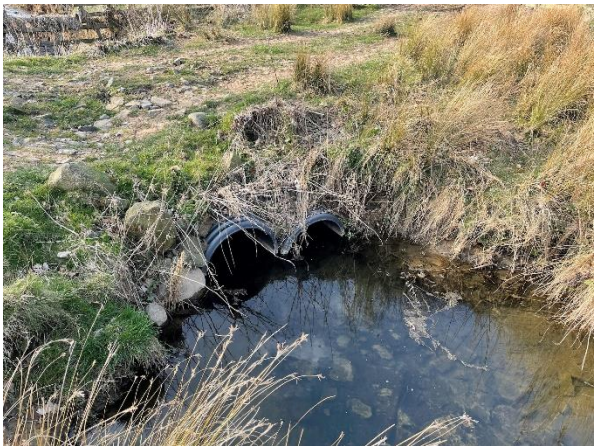
F. Dual pipe culvert structure.

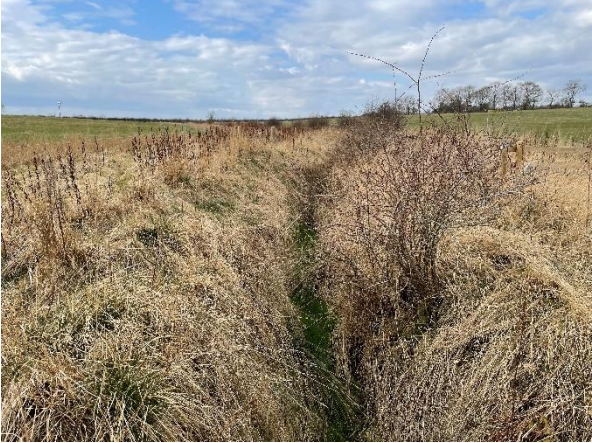
A. Over-deep cross-sectional form.

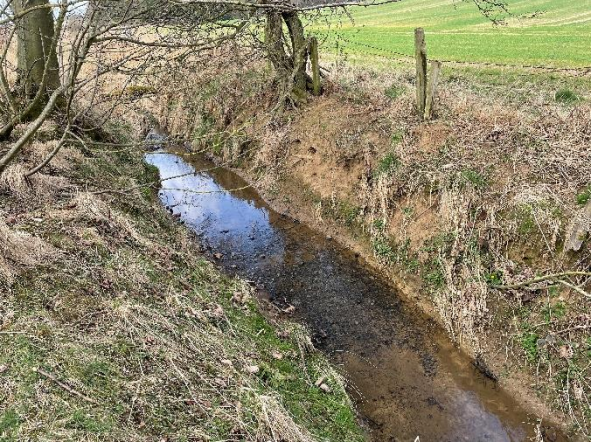
B. Fine sediments with coarser material arranged into a riffle feature.

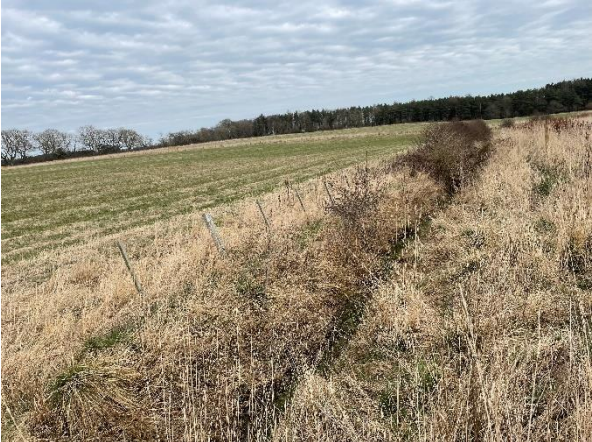
C. straight, over-deep channel within heavily managed agricultural setting.

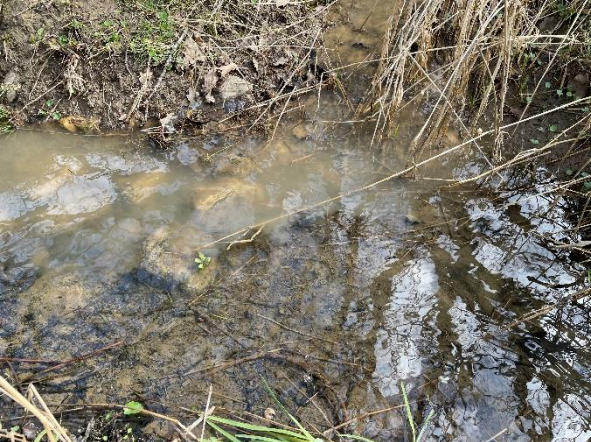
D. flow mixing with an adjacent stream. Coloured water is joining the Tributary of Hart Burn from the south.

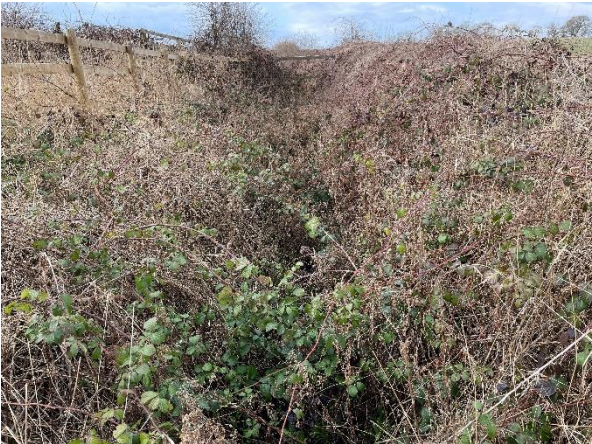
E. Dense scrub vegetation comprises the channel's riparian zone.

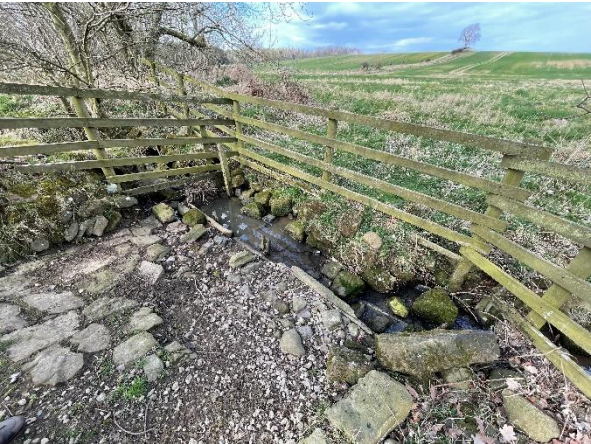
F. Historical obsolete ford crossing.
